Expertise

Protocol number: 46718707  
Order No. / Reference: 26627524  
Inspection date: 23 Jul 2026

Manufacturer: Volvo

Model: XC60 B4 D AWD Geartronic Momentum Pro

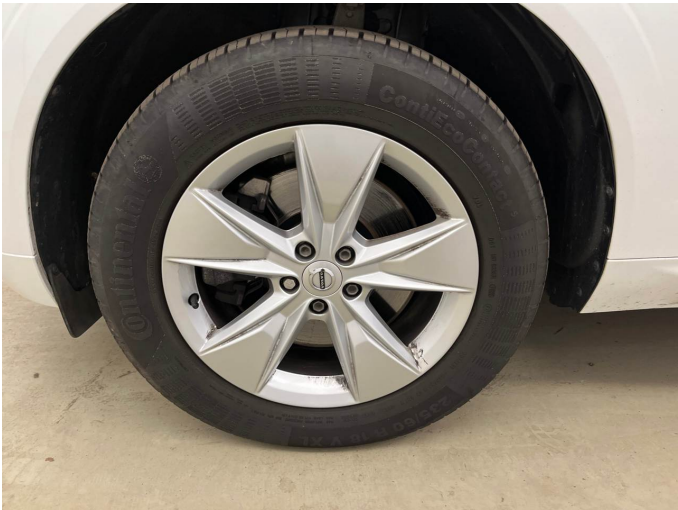
Figure 12: Mounted tyres

| # | Tyre size | Type of tyre | Manufacturer | Tread depth |
|---|---|---|---|---|
| 1) | 235/60 R18 107V | Summer tyres on Light alloy | Continental | 6mm / 6mm |
| 2) | 235/60 R18 107V | Summer tyres on Light alloy | Continental | 5mm / 5mm |

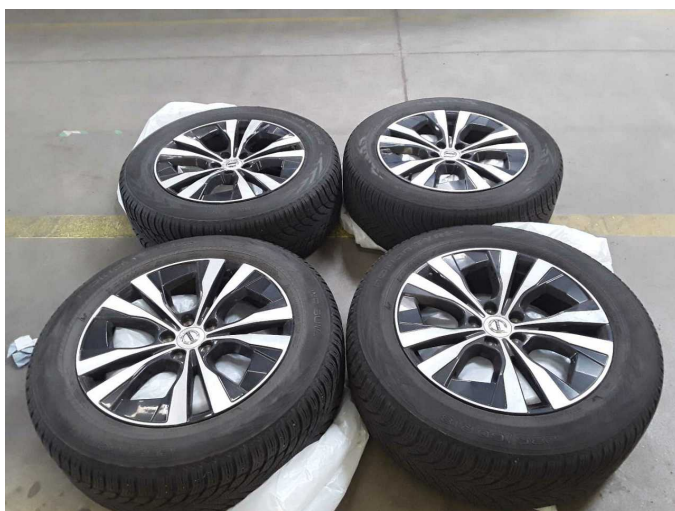
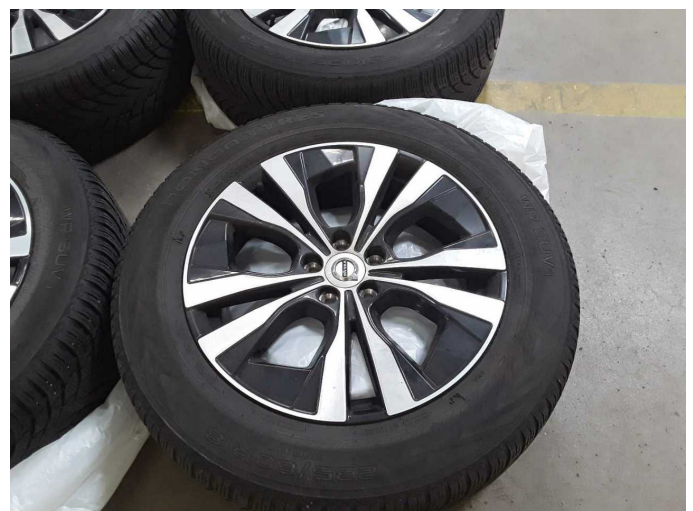
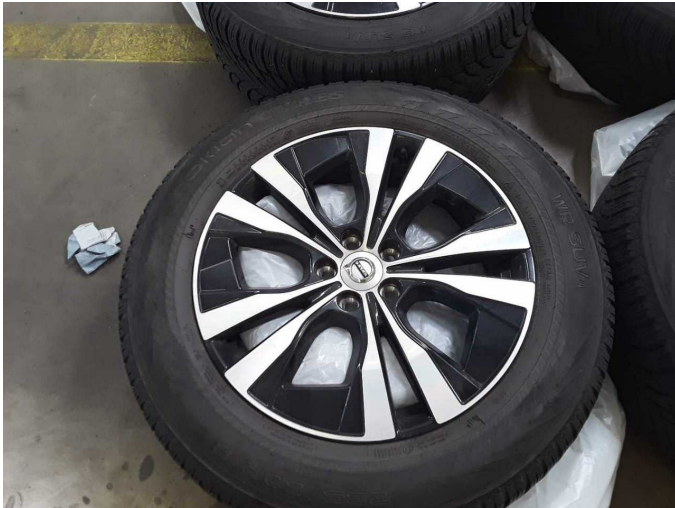
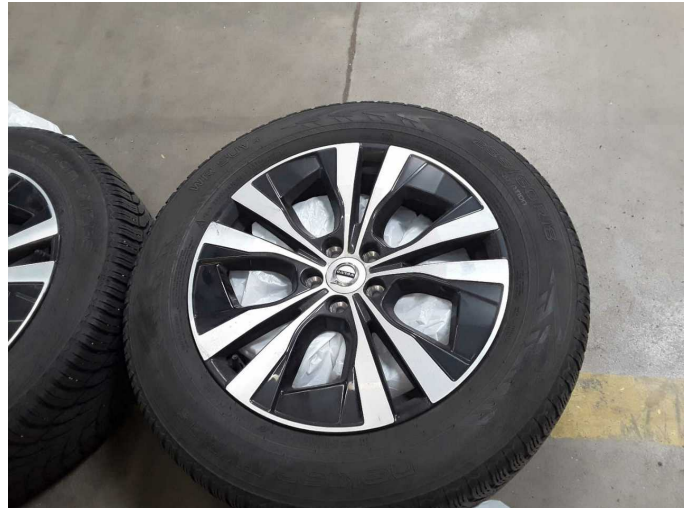
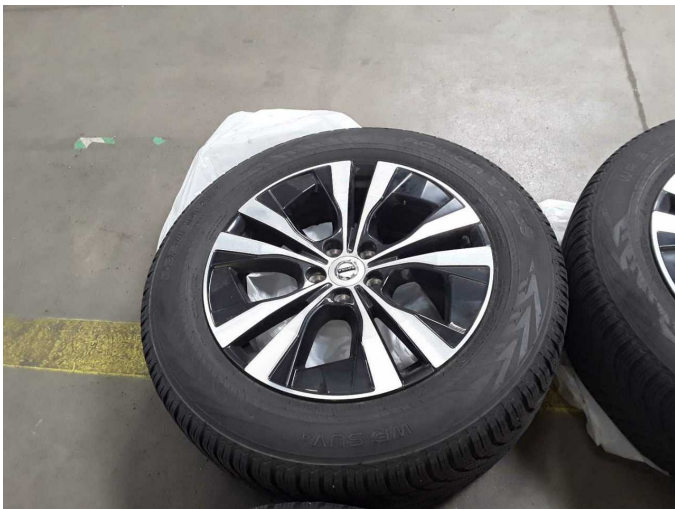
| # | Tyre size | Type of tyre | Manufacturer | Tread depth |
|---|---|---|---|---|
| 1) | 235/60 R18 107V | Winter tyres on Light alloy | Nokian | 3mm / 3mm |
| 2) | 235/60 R18 107V | Winter tyres on Light alloy | Nokian | 5mm / 5mm |

Figure 17: Additional tyres

Figure 18: Additional tyres

Figure 19: Additional tyres

Figure 20: Additional tyres

Figure 21: Additional tyres

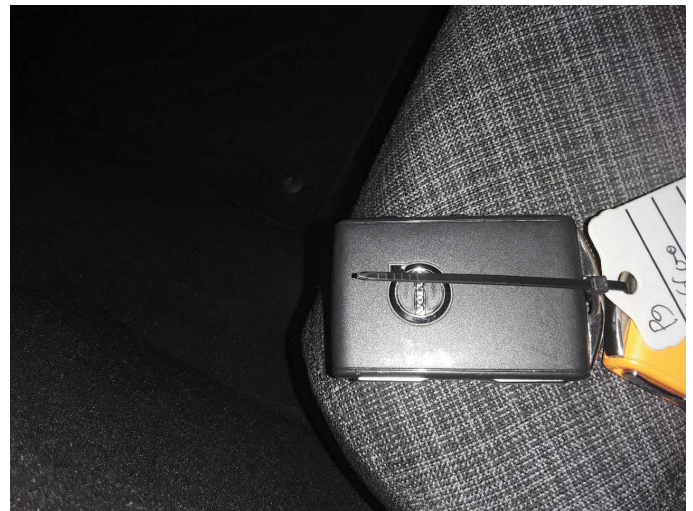
**Damage 1:** Equipment: Vehicle key with remote control - Non-operational  
- Perform diagnosis

| No. | Component group | Description |
|---|---|---|
| 1 | Equipment | Vehicle key with remote control - Non-operational - Perform diagnosis |

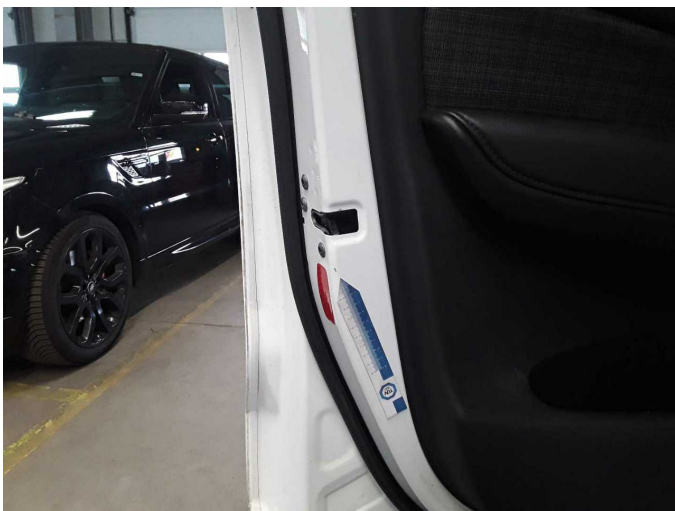
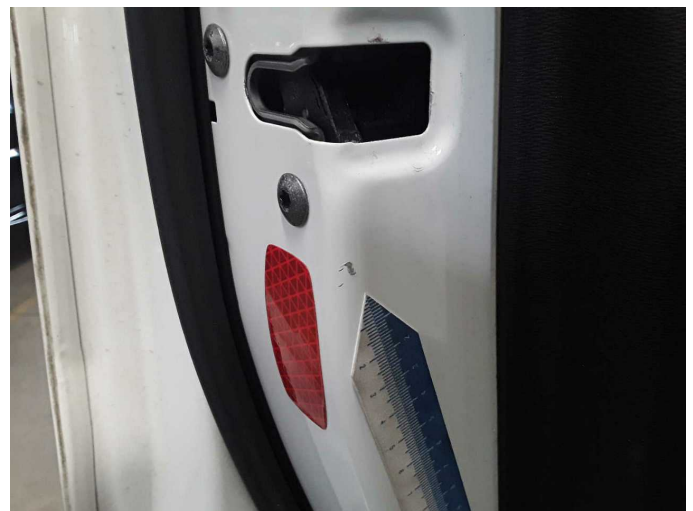
**Damage 2:** Door - front left side: Door - Scratched - Smart repair

| No. | Component group | Description |
|---|---|---|
| 2 | Door - front left side | Door - Scratched - Smart repair |

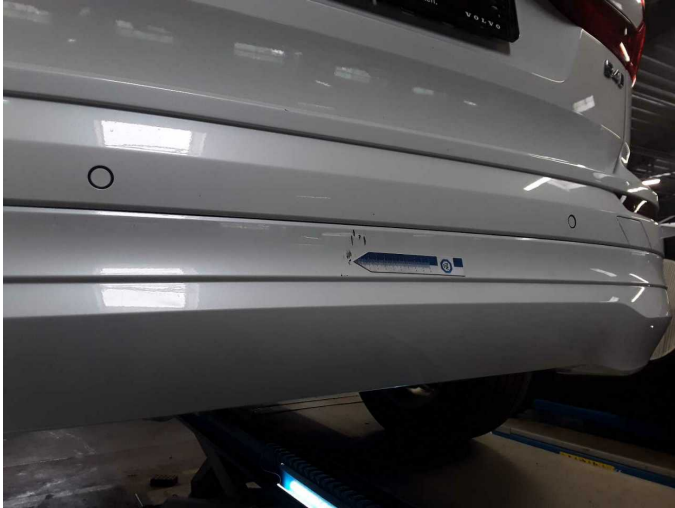
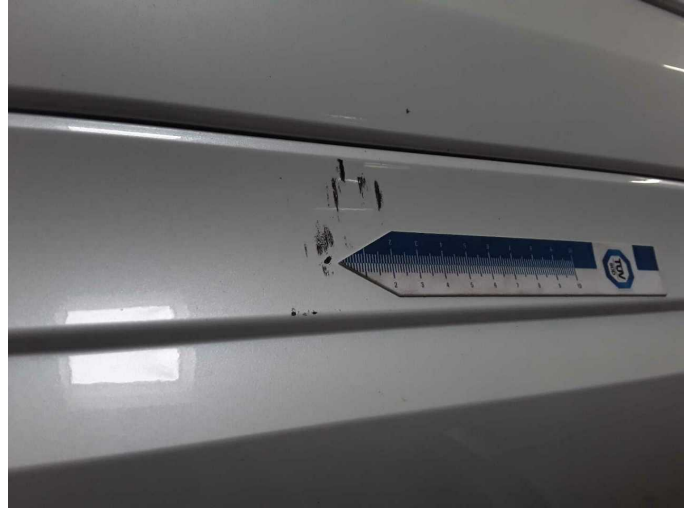
**Damage 3:** Rear bumper: Spoiler - Scratched - Smart repair

| No. | Component group | Description |
|---|---|---|
| 3 | Rear bumper | Spoiler - Scratched - Smart repair |

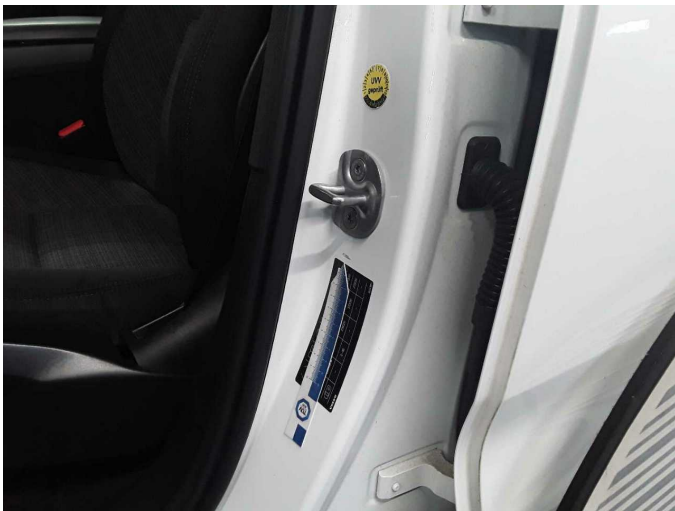
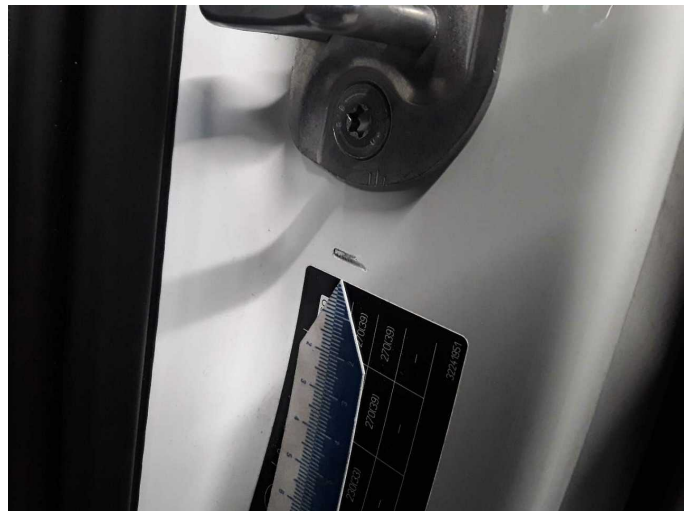
**Damage 4:** Body: B-pillar - left side - Scratched - Smart repair

| No. | Component group | Description |
|---|---|---|
| 4 | Body | B-pillar - left side - Scratched - Smart repair |

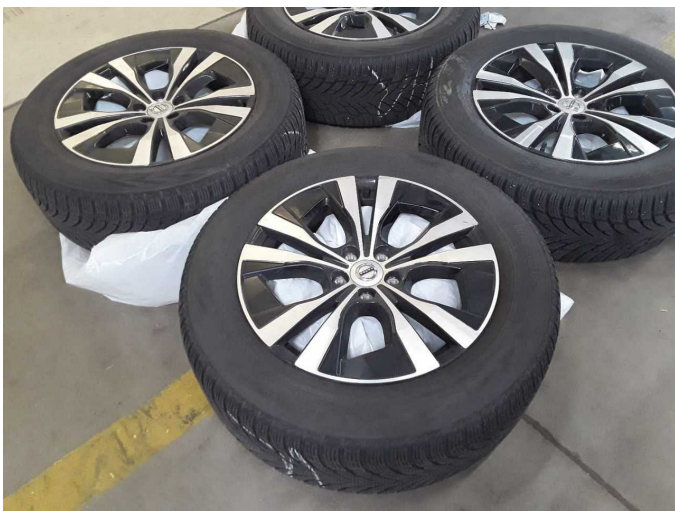
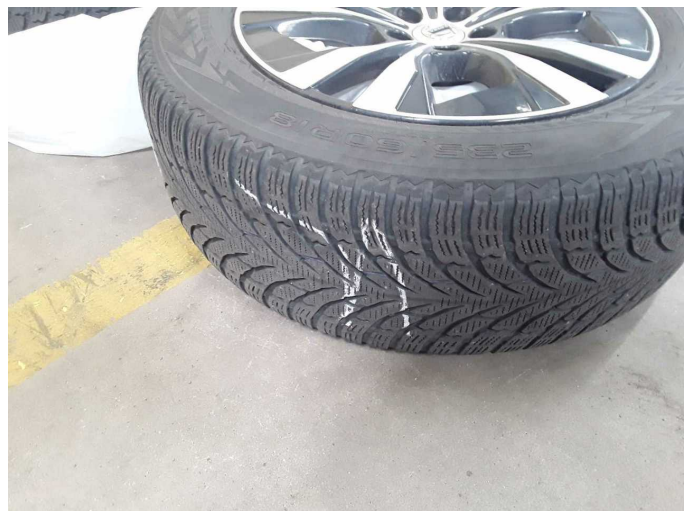
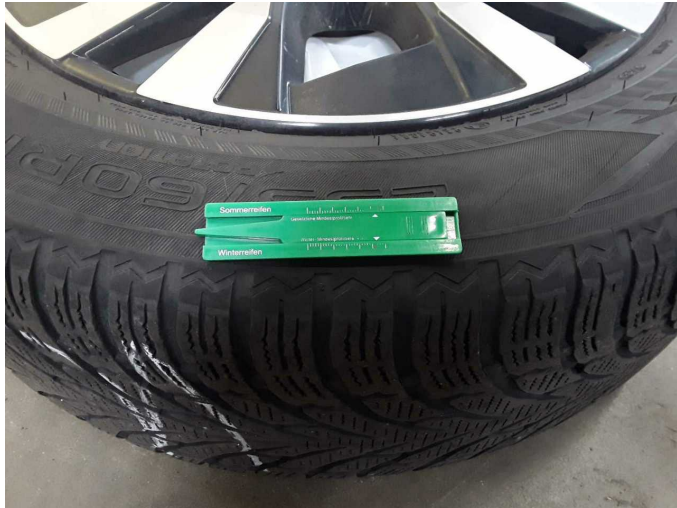
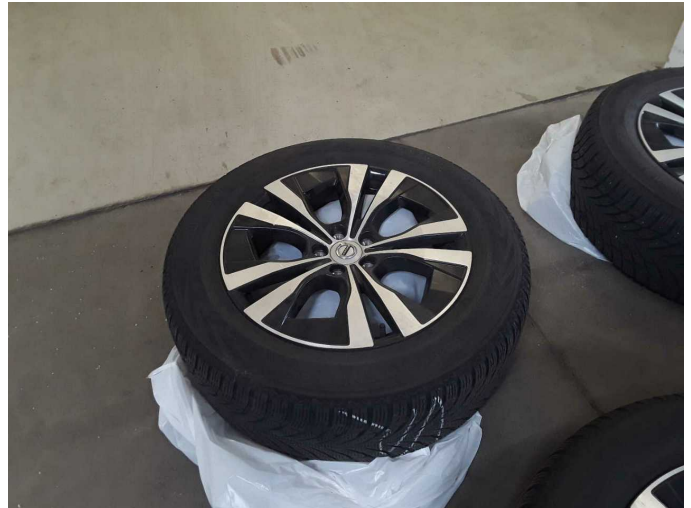
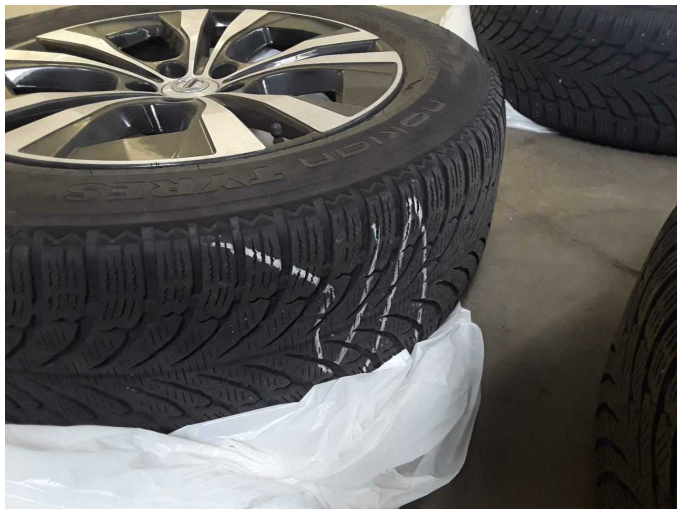
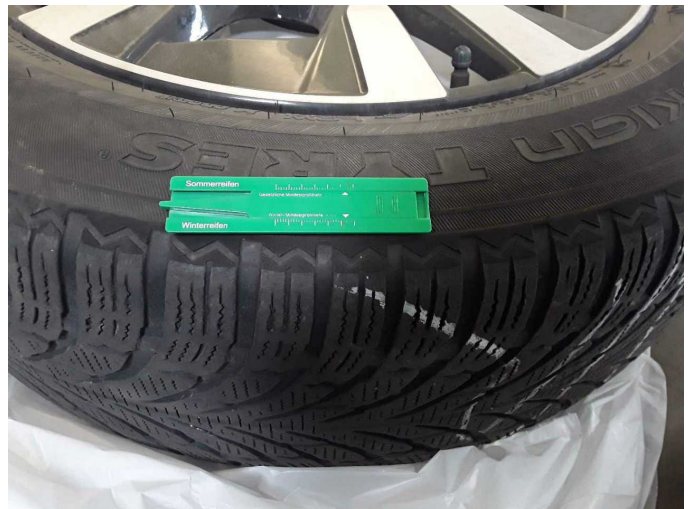
**Damage 5:** 2nd wheel set: 2 tyres (3mm) - Does not meet the leasing specifications - Replace

| No. | Component group | Description |
|---|---|---|
| 5 | 2nd wheel set | 2 tyres (3mm) - Does not meet the leasing specifications - Replace |

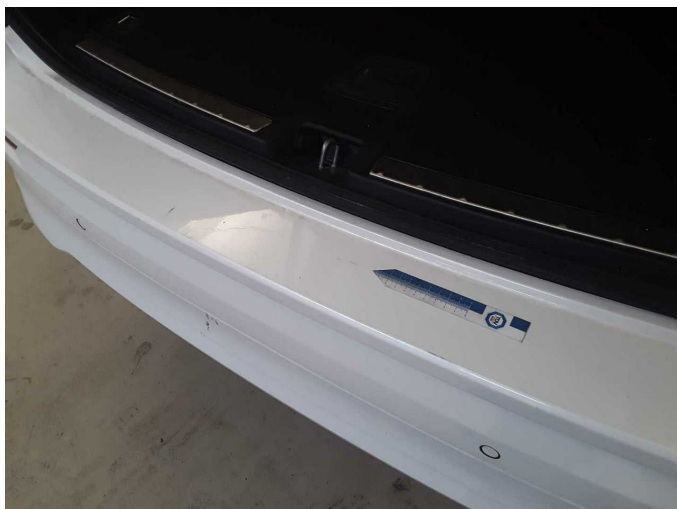
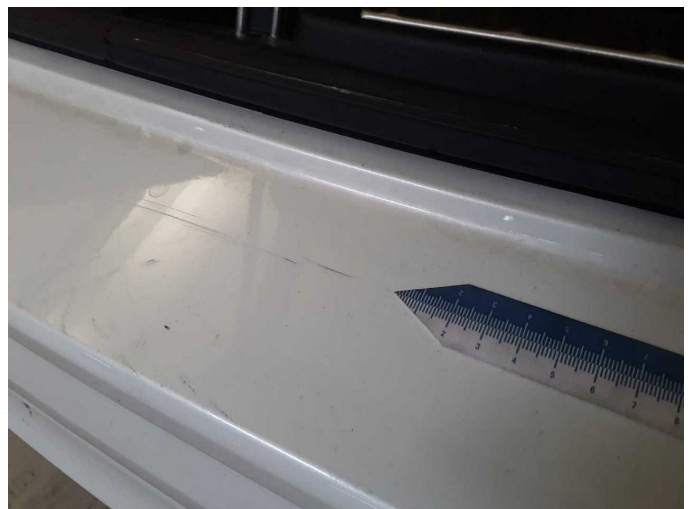
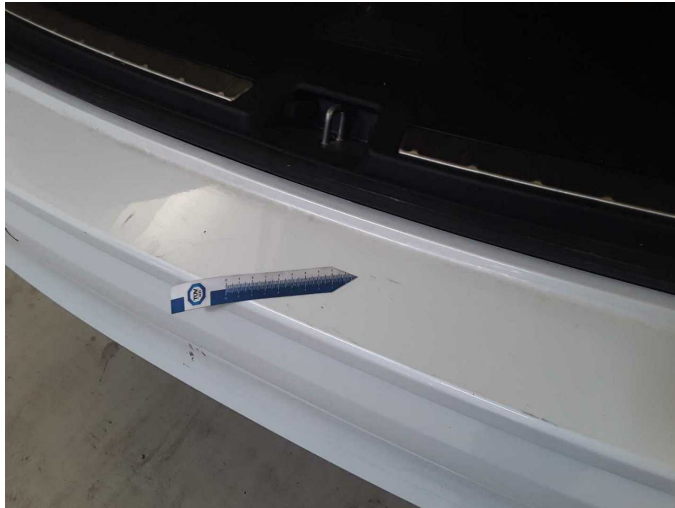
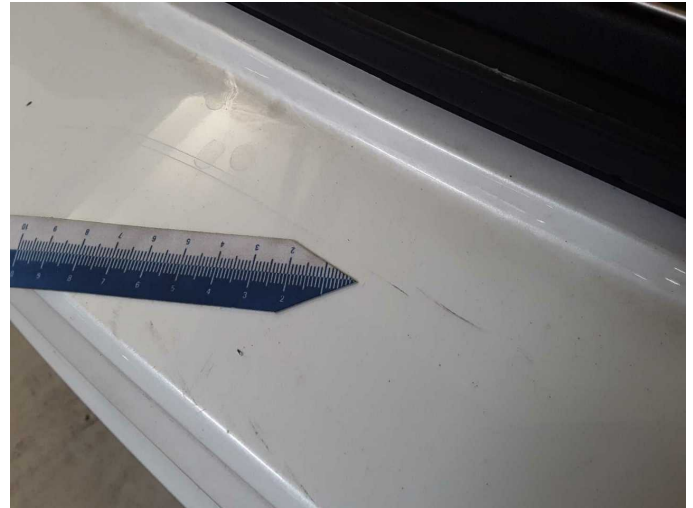
**Damage 6:** Rear bumper: Rear bumper - Scratched - Paint

| No. | Component group | Description |
|---|---|---|
| 6 | Rear bumper | Rear bumper - Scratched - Paint |

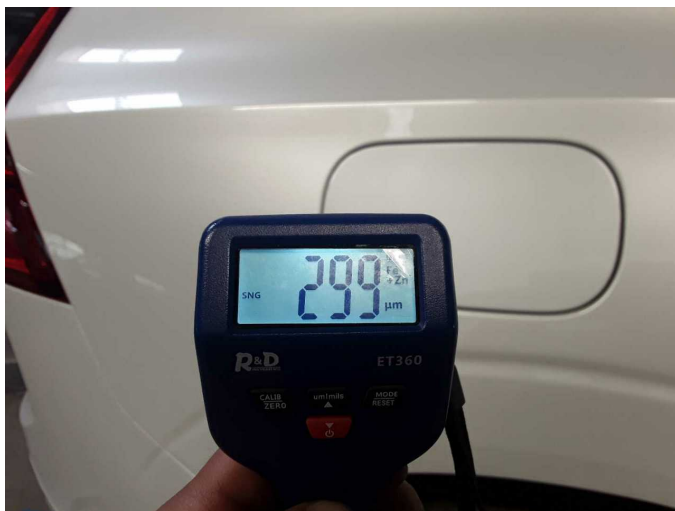
| No. | Repainting |
|---|---|
| 1 | Side panel - rear right side, Door - front right side, Professionally carried out |

| Side panel - rear right side | 299 µm | Door - front right side | 222 µm |

**Side panel - rear right side:** 299 µm

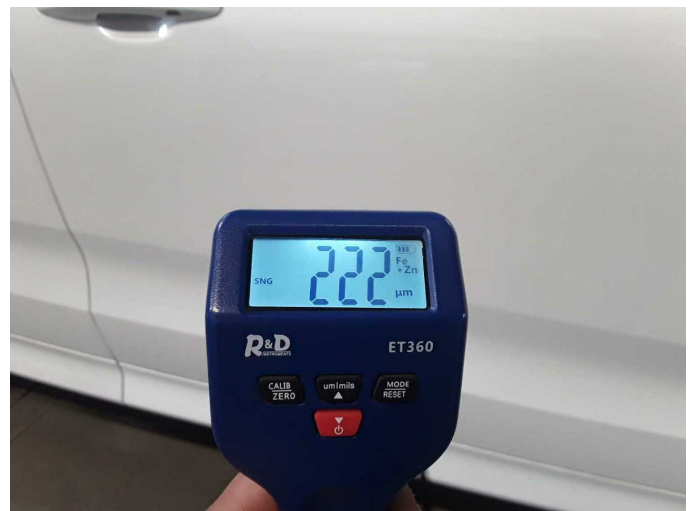
**Door - front right side:** 222 µm
