Expertise

Protocol number: 46506893  
Order No. / Reference: 26664348  
Inspection date: 14 Jul 2026

| Manufacturer: Opel | Model: Grandland 1.5 D Automatik Business Edition |

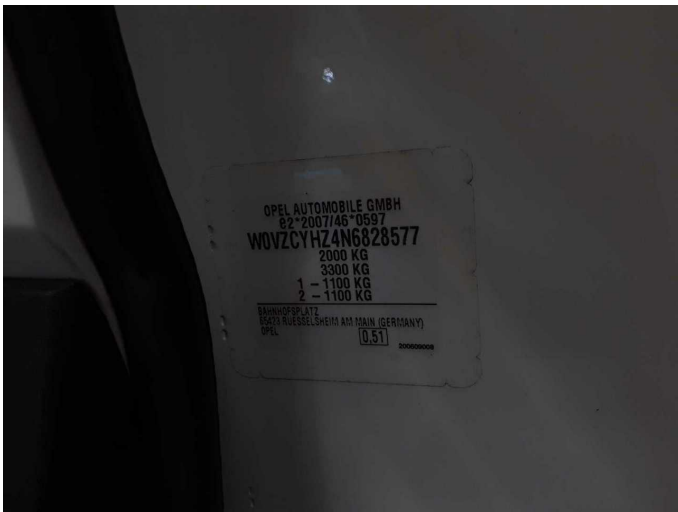
Figure 11: VIN

| VIN comparison | The vehicle identification number (VIN) was read from the vehicle and its conformity with the submitted documents was confirmed by the undersigned during the inspection. |

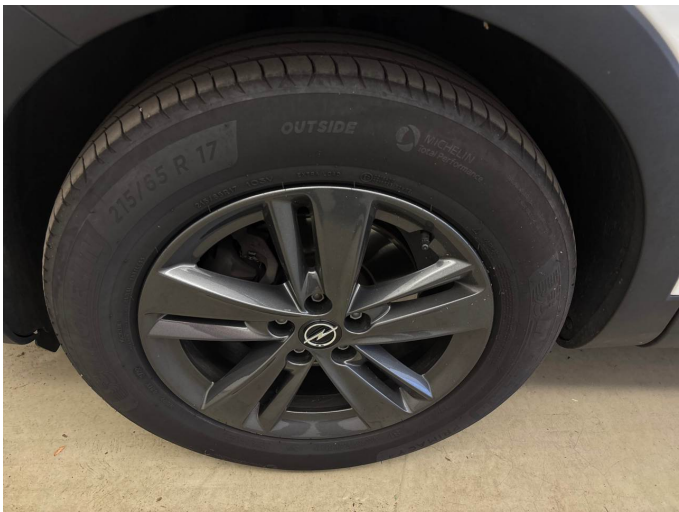
Figure 12: Mounted tyres

| Tyres | | | |
|---|---|---|---|
| 1) | 215/65 R16 103V | Summer tyres on Light alloy | 4mm / 4mm |
| 2) | 215/65 R16 103V | Summer tyres on Light alloy | 5mm / 5mm |

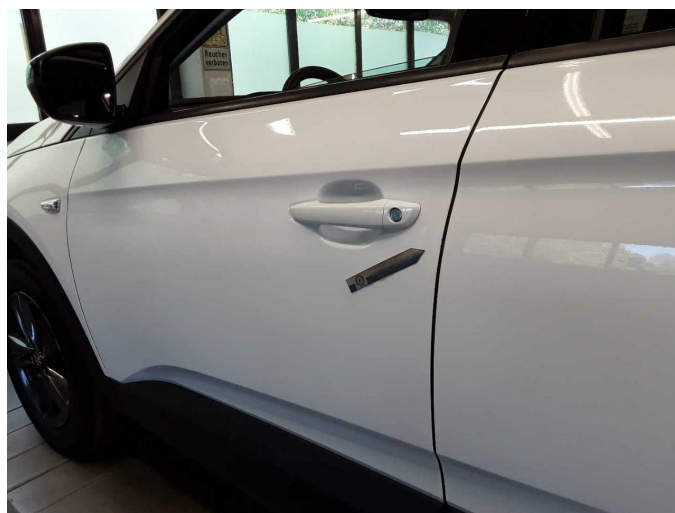
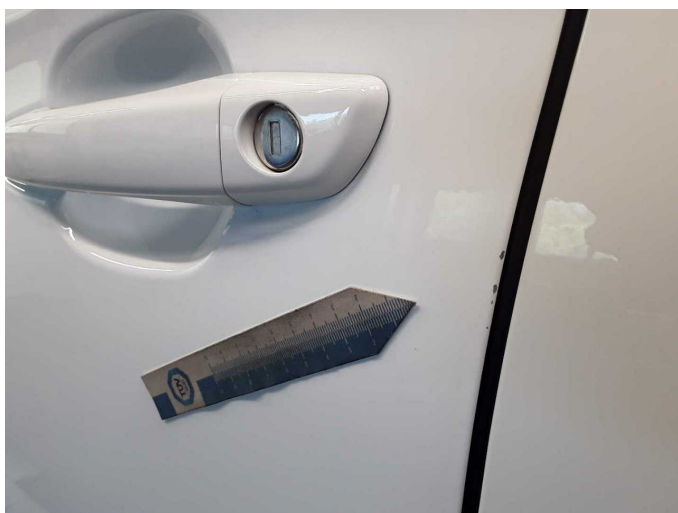
| No. | Component group | Description |
|---|---|---|
| 1 | Door - front left side | Door - Scratch(es) - Smart repair |

**Damage 1:** Door - front left side: Door - Scratch(es) - Smart repair

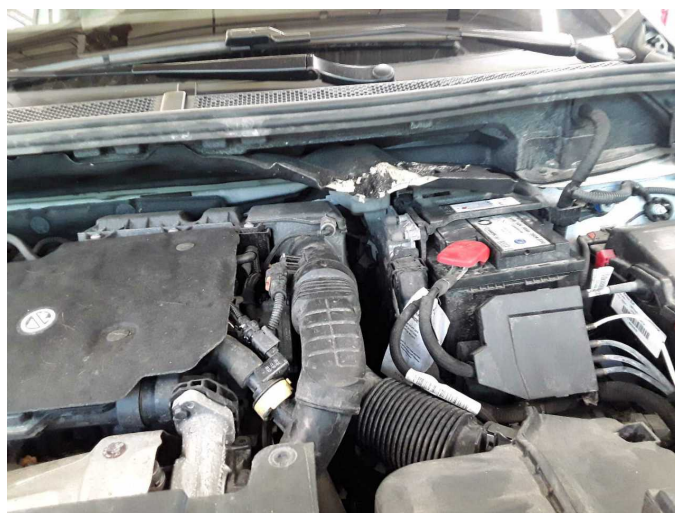
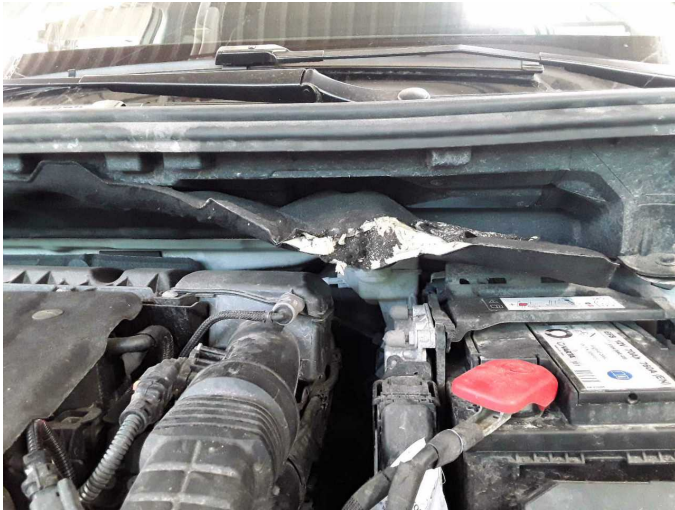
| No. | Component group | Description |
|---|---|---|
| 2 | Cab | Insulation lining - Damaged - Replace |

**Damage 2:** Cab: Insulation lining - Damaged - Replace
