Expertise

Protocol number: 46349161  
Order No. / Reference: 26600966  
Inspection date: 1 Jul 2026

Model: GLE 300 d 4Matic 9G-TRONIC AMG Line

VIN: W1N1671091A642630

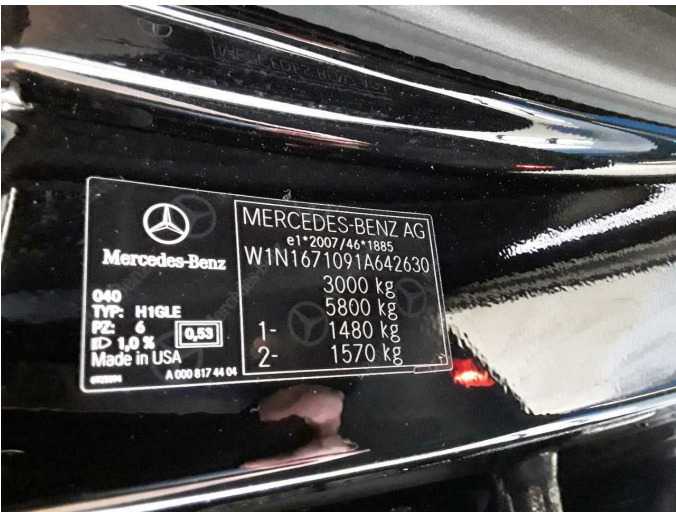
Figure 11: VIN

| VIN comparison | The vehicle identification number (VIN) was read from the vehicle and its conformity with the submitted documents was confirmed by the undersigned during the inspection. |

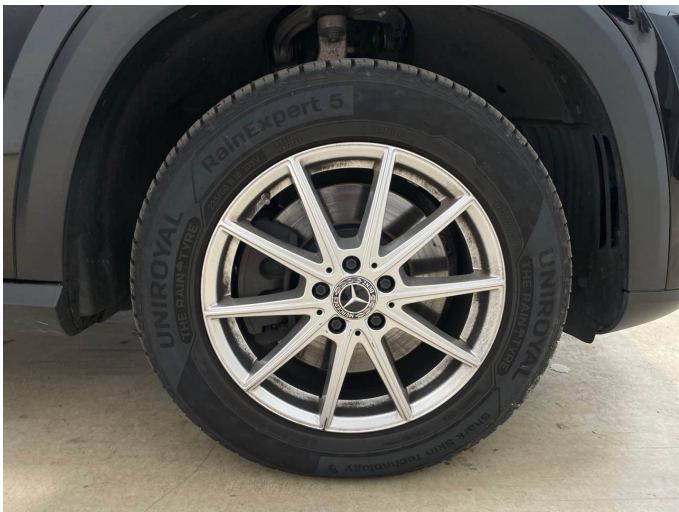
Figure 12: Mounted tyres

| # | Tyre size | Type of tyre | Manufacturer | Tread depth |
|---|---|---|---|---|
| 1) | 235/60 R18 103V | Summer tyres on Light alloy | Uniroyal | 6mm / 6mm |
| 2) | 235/60 R18 103V | Summer tyres on Light alloy | Uniroyal | 6mm / 6mm |

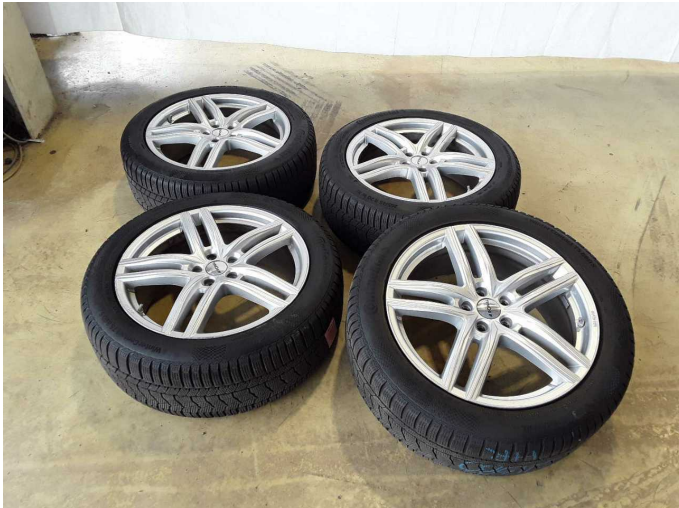
Figure 16: Additional tyres

| # | Tyre size | Type of tyre | Manufacturer | Tread depth |
|---|---|---|---|---|
| 1) | 265/45 R20 108W | Winter tyres on Light alloy | Continental | 6mm / 6mm |
| 2) | 265/45 R20 108W | Winter tyres on Light alloy | Continental | 7mm / 7mm |

Der beiliegende Winterradsatz ist nicht Bestandteil der Ausstattung.

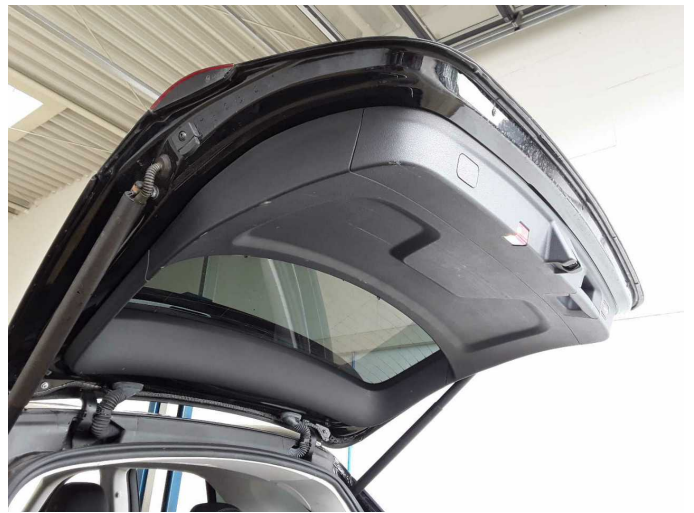
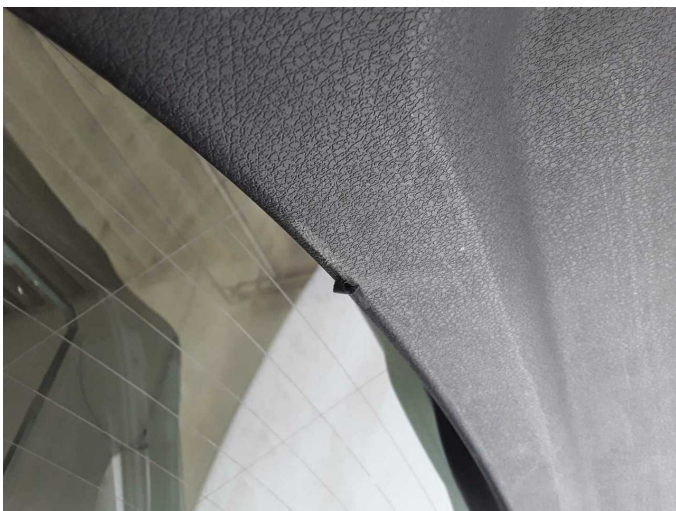
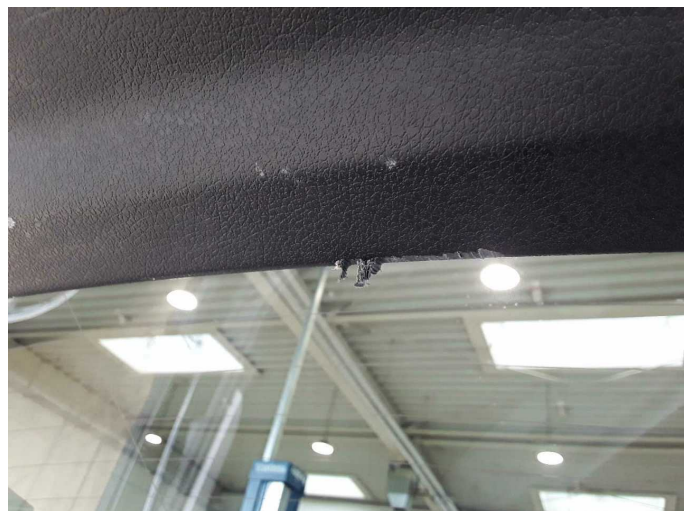
| No. | Component group | Description |
|---|---|---|
| 2 | Boot lid / rear door | Trim - standard - lower - Scratched - Replace |

Damage 2: Boot lid / rear door: Trim - standard - lower - Scratched - Replace

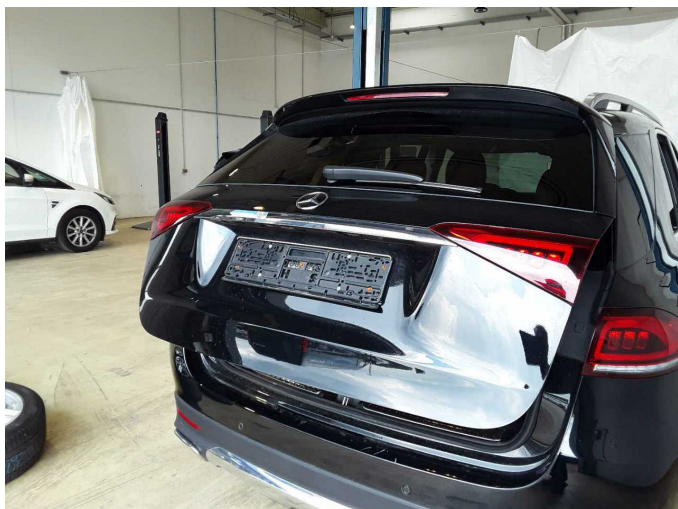
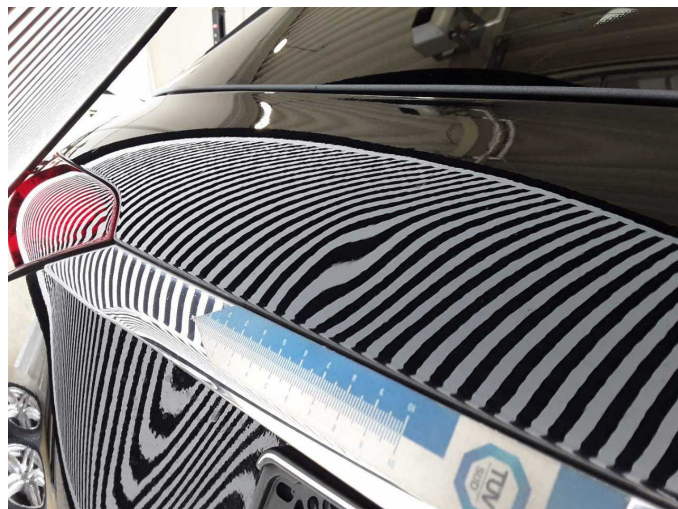
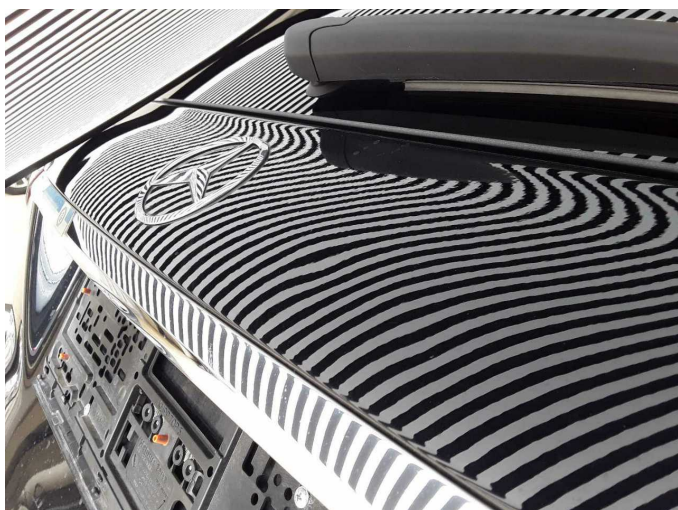
| No. | Component group | Description |
|---|---|---|
| 3 | Boot lid / rear door | Boot lid - dent(s) - Smart repair |

**Damage 3:** Boot lid / rear door: Boot lid - dent(s) - Smart repair

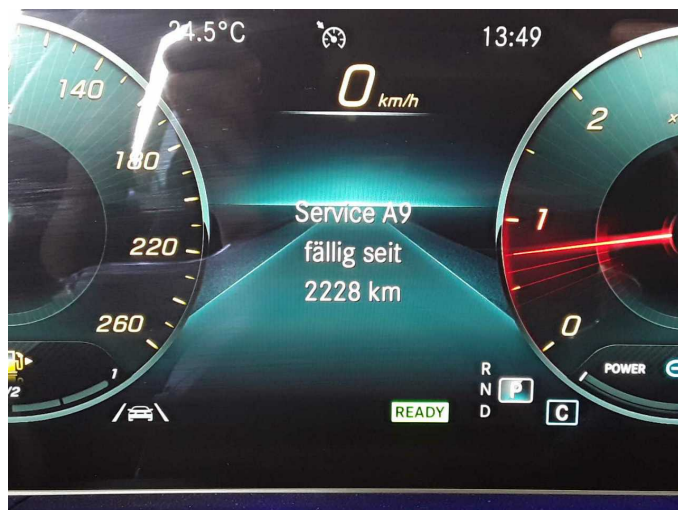
| No. | Component group | Description |
|---|---|---|
| 4 | Misc. | Inspection / maintenance - Due - Perform |

**Damage 4:** Misc.: Inspection / maintenance - Due - Perform
