Expertise

Protocol number: 46888966  
Order No. / Reference: 26708676  
Inspection date: 5 Aug 2026

Model: Touran 2.0 TDI SCR DSG Highline

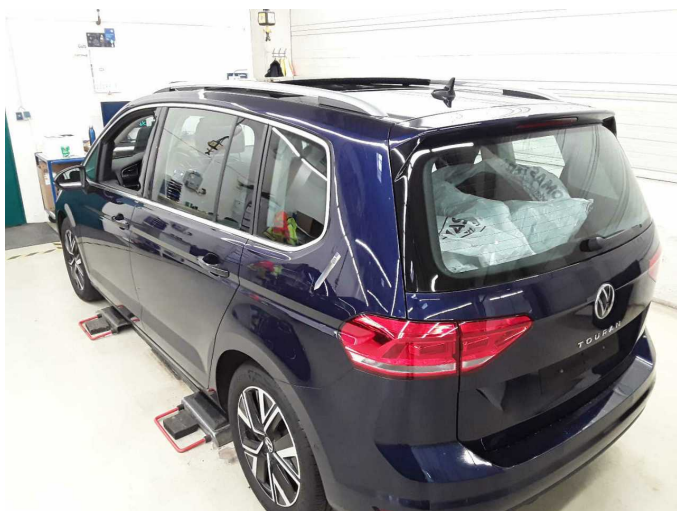
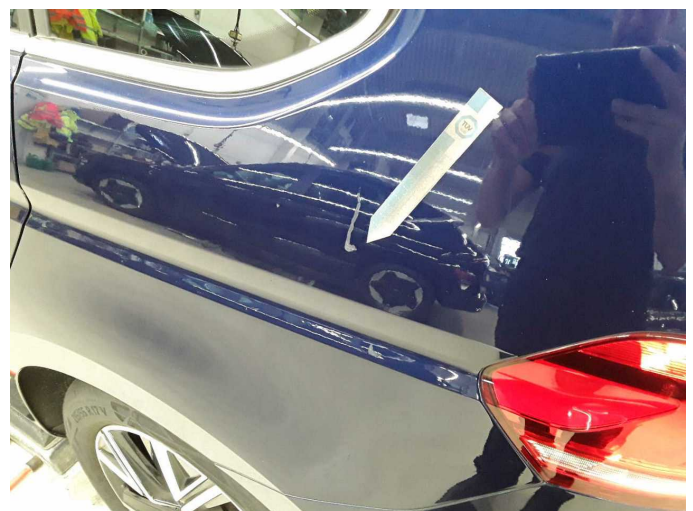
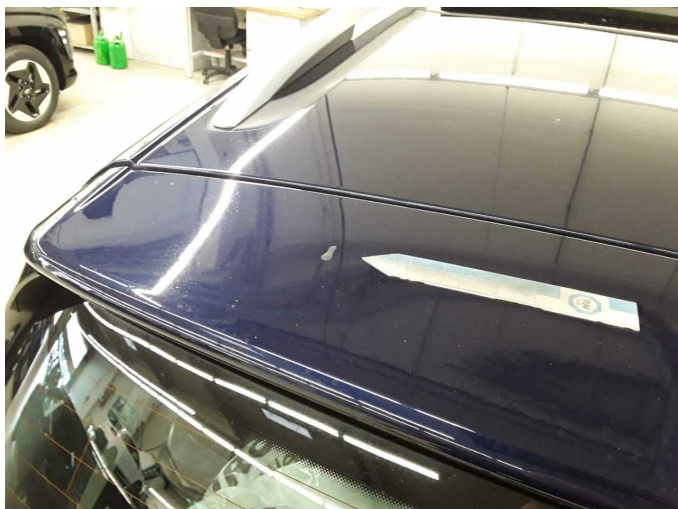
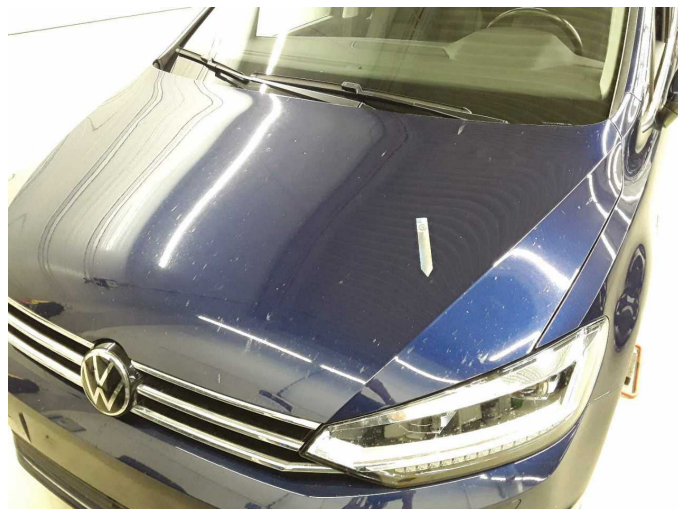
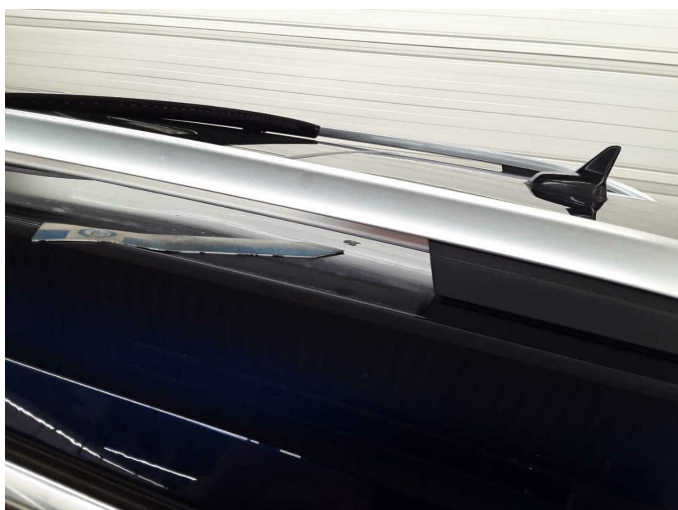
| No. | Component group | Description |
|---|---|---|
| 1 | Body | Body (Baumharz) - Soiled - Conditioning |

Damage 1: Body: Body (Baumharz) - Soiled - Conditioning

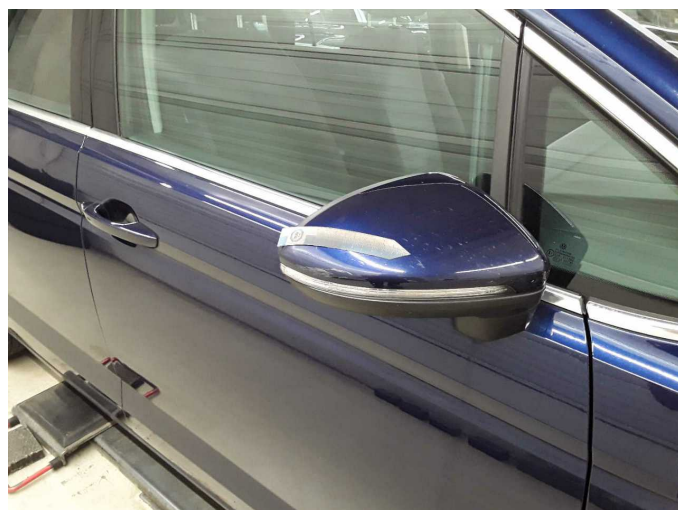
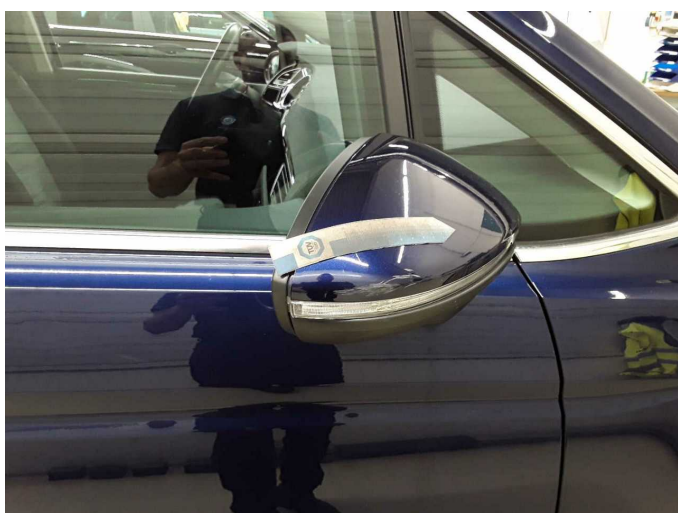
| No. | Component group | Description |
|---|---|---|
| 2 | Wing mirror - right side | Cap - Scratch(es) - Smart repair |

**Damage 2:** Wing mirror - right side: Cap - Scratch(es) - Smart repair

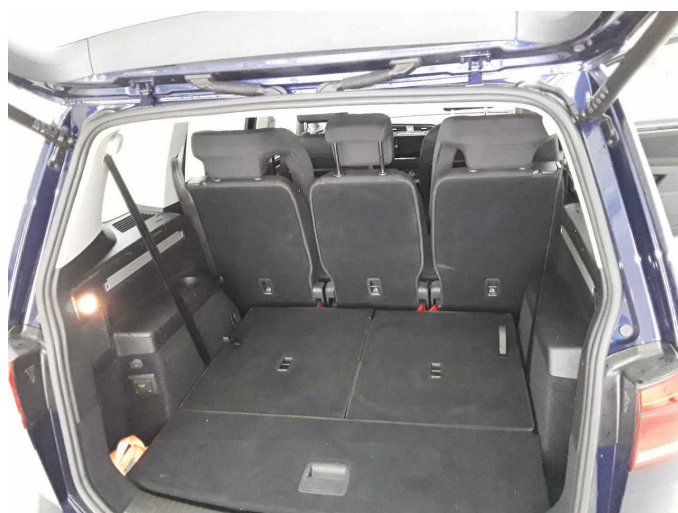
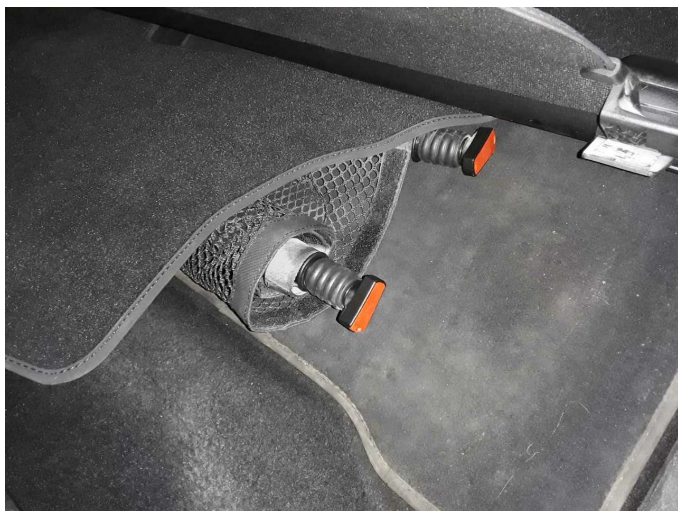
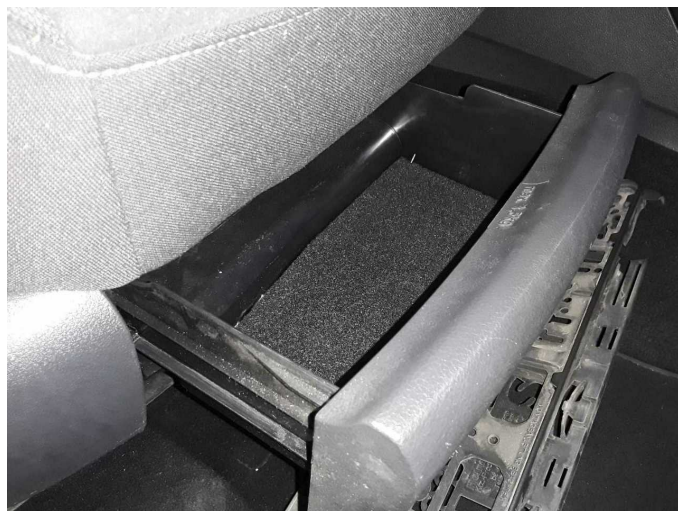
| No. | Component group | Description |
|---|---|---|
| 3 | Misc. | Misc. (Adapter und Halter für Ablagenetz) - Missing - Replace |

**Damage 3:** Misc.: Misc. (Adapter und Halter für Ablagenetz) - Missing - Replace

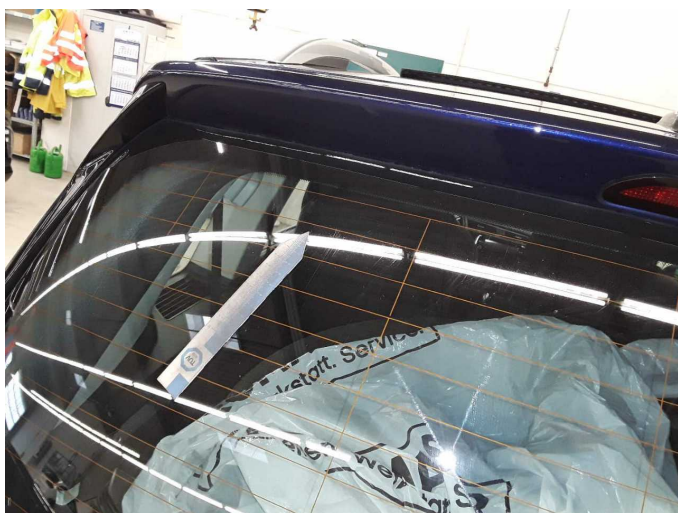
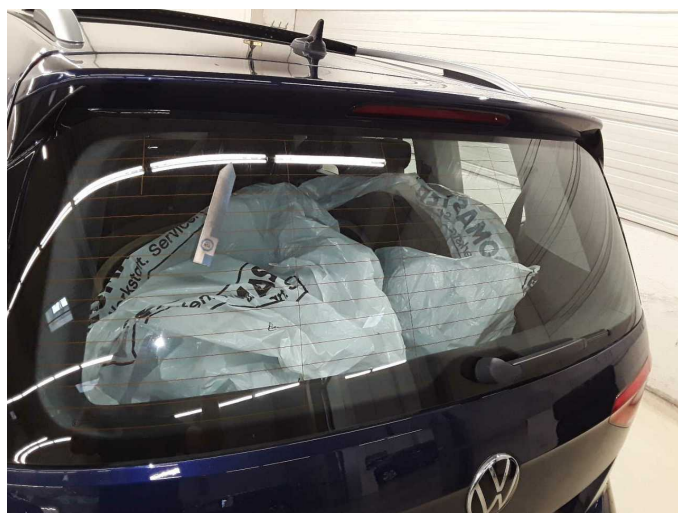
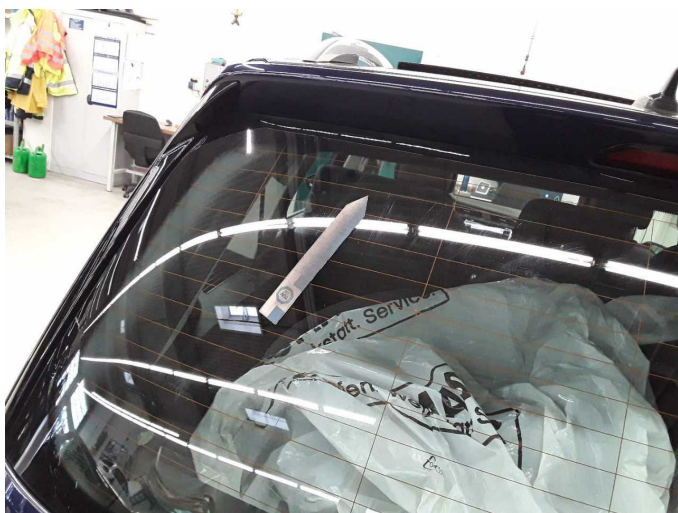
| No. | Component group | Description |
|---|---|---|
| 4 | Vehicle glazing | Rear window - Scratch(es) - Loss in value |

**Damage 4:** Vehicle glazing: Rear window - Scratch(es) - Loss in value

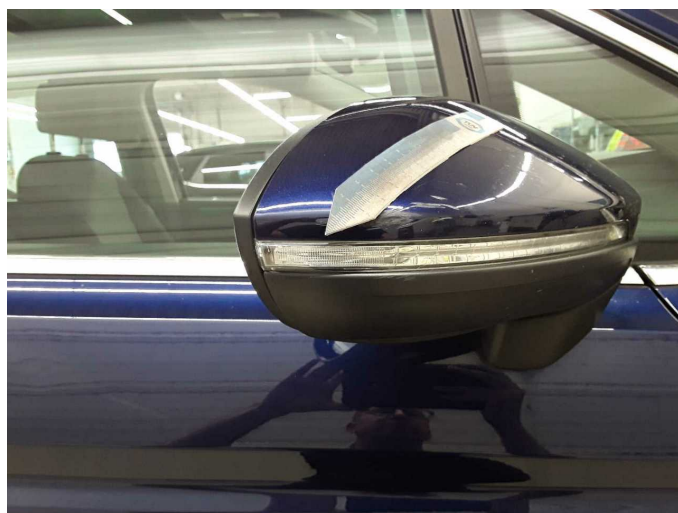
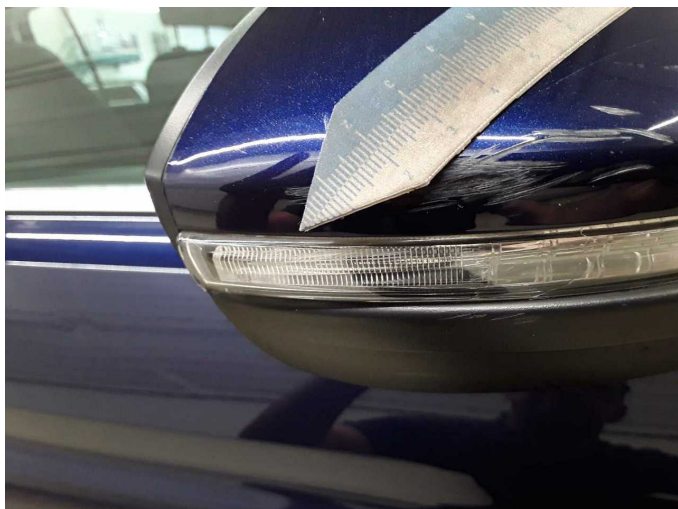
| No. | Component group | Description |
|---|---|---|
| 5 | Indicator - front | Mirror - right side - Scratched - Replace |

**Damage 5:** Indicator - front: Mirror - right side - Scratched - Replace

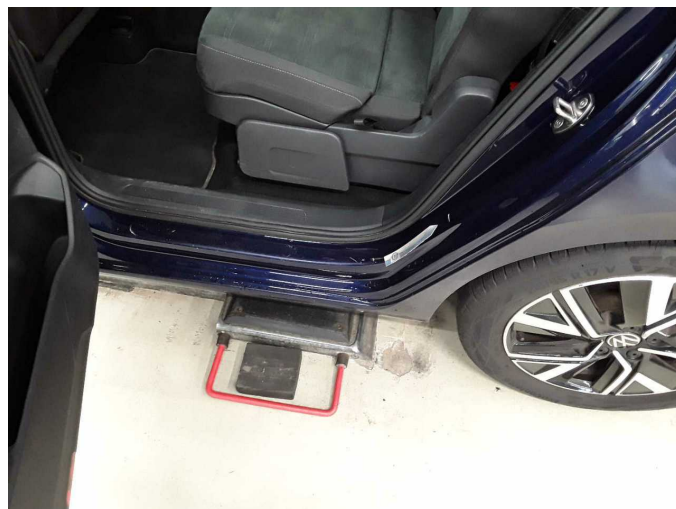
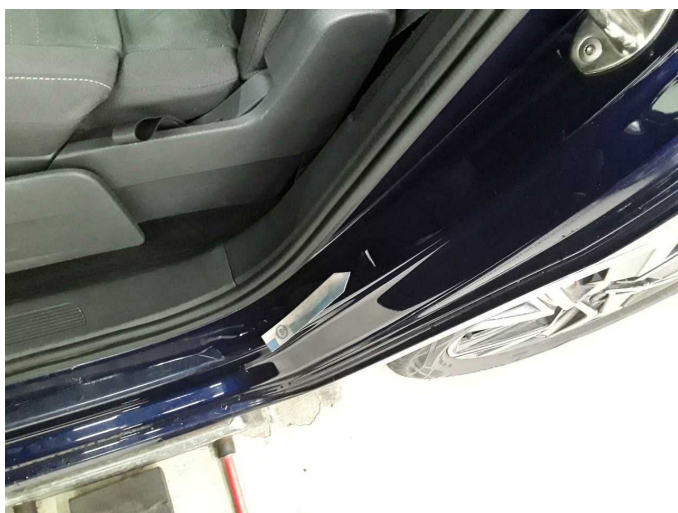
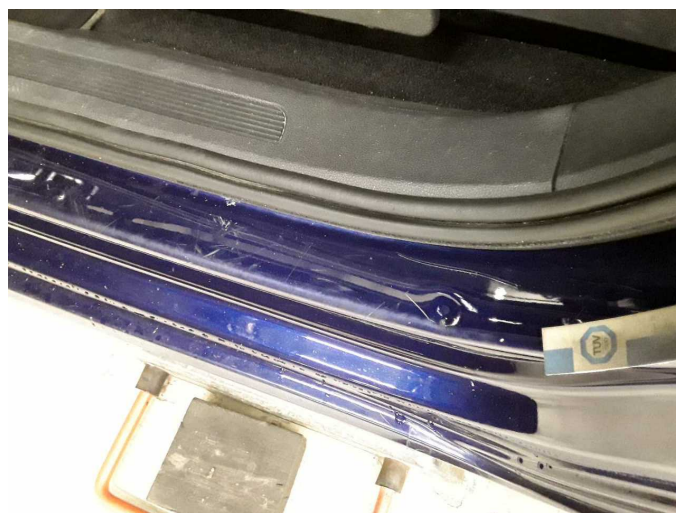
| No. | Component group | Description |
|---|---|---|
| 6 | Side panel - rear left side | Sill - Dent / paintcoat damage - Smart repair |

**Damage 6:** Side panel - rear left side: Sill - Dent / paintcoat damage - Smart repair

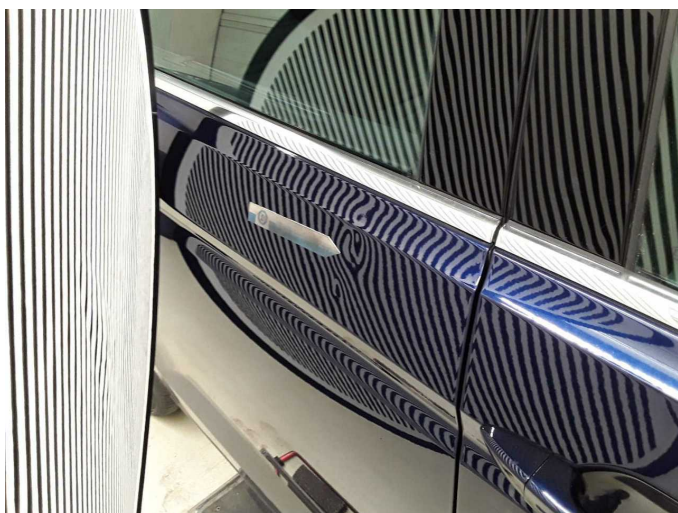
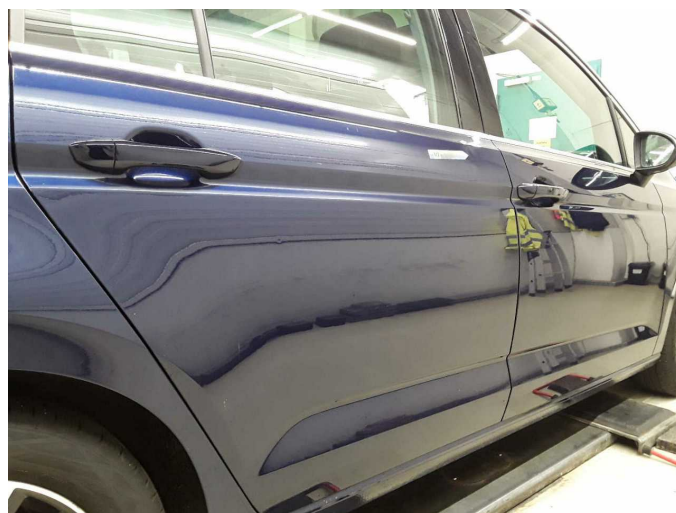
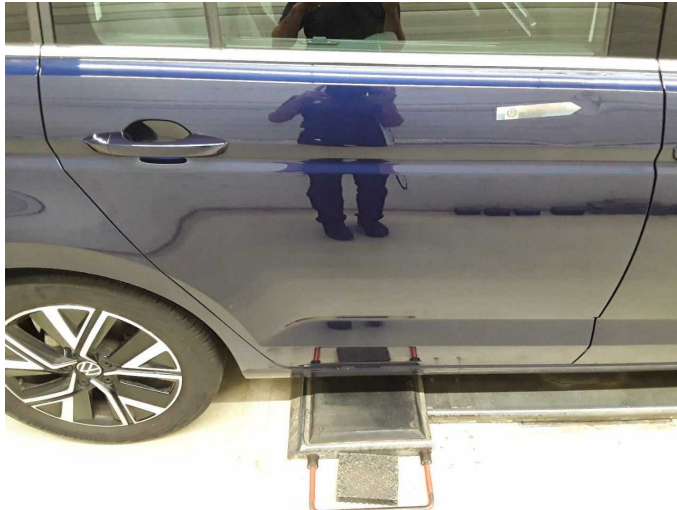
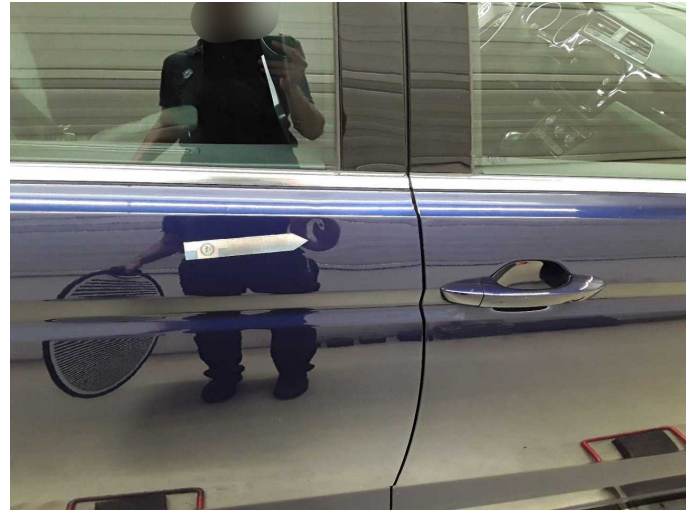
| No. | Component group | Description |
|---|---|---|
| 7 | Door - rear right side | Door - Dent / paintcoat damage - Smart repair |

**Damage 7:** Door - rear right side: Door - Dent / paintcoat damage - Smart repair

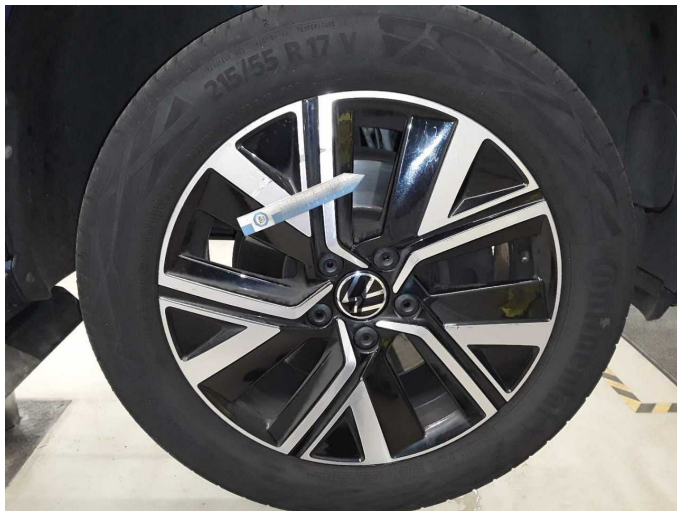
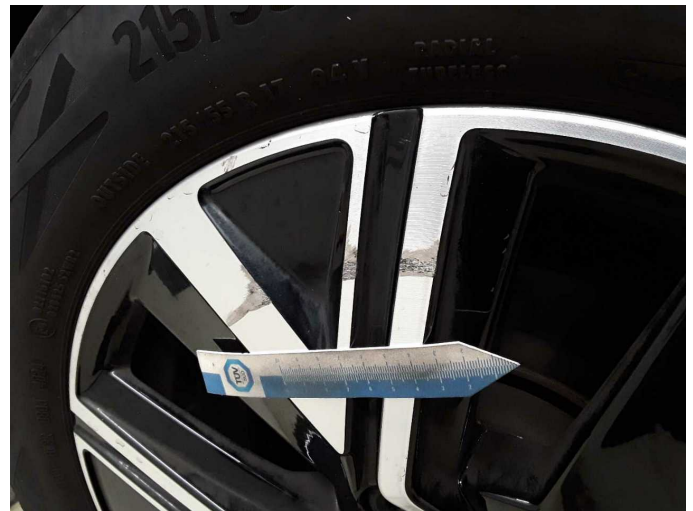
| No. | Component group | Description |
|---|---|---|
| 8 | Wheel / tyres | Alloy rim - front right side - Scratched - Loss in value |

**Damage 8:** Wheel / tyres: Alloy rim - front right side - Scratched - Loss in value

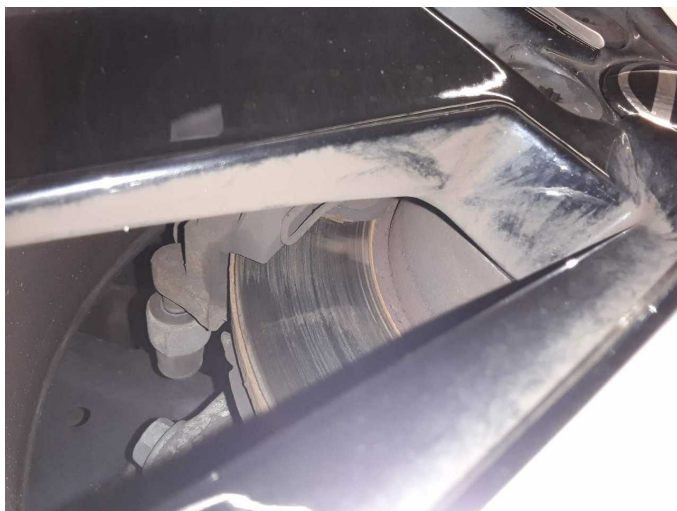
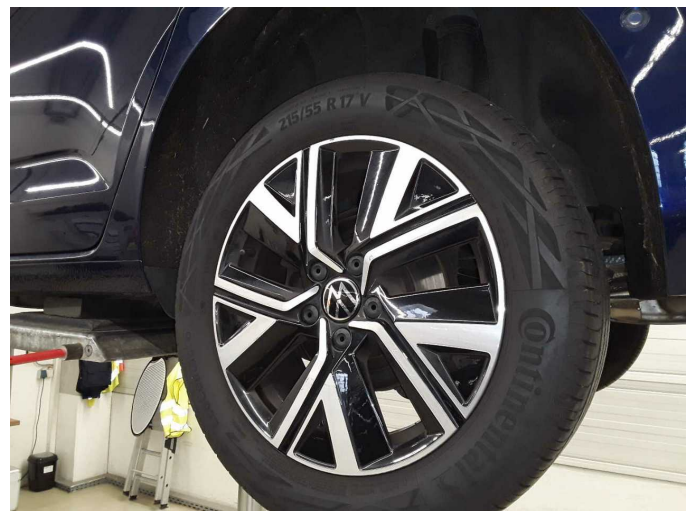
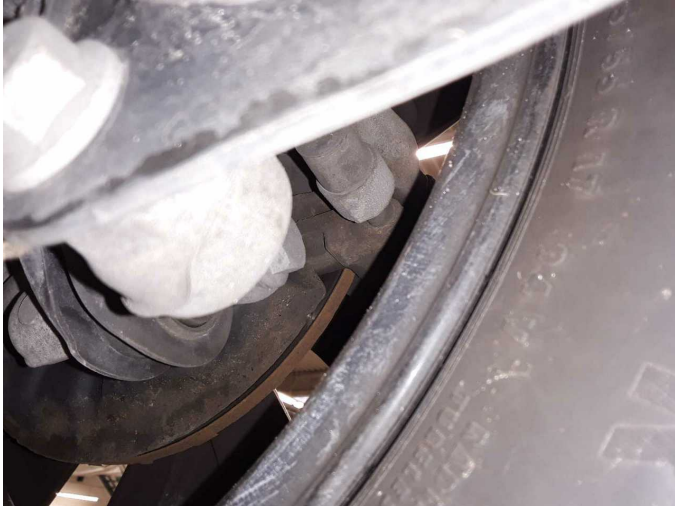
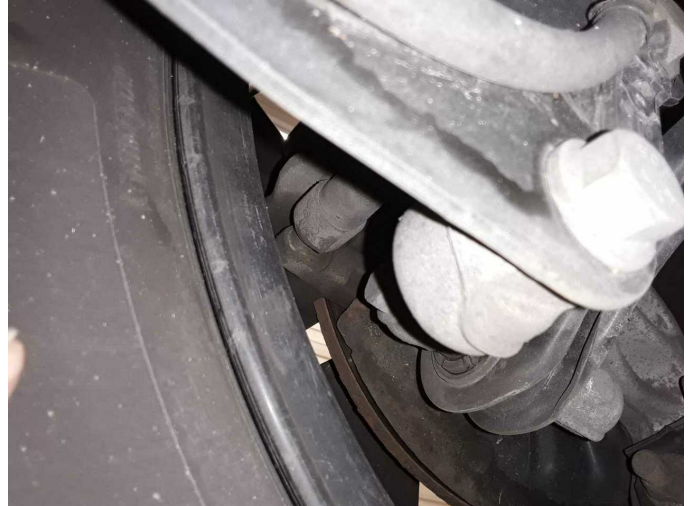
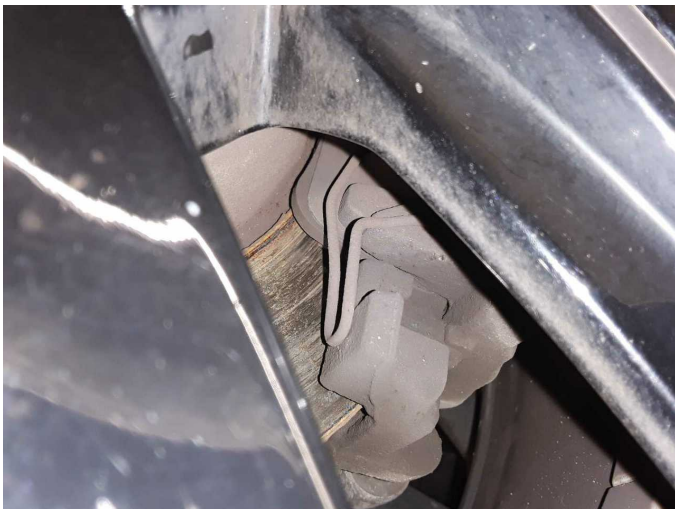
| No. | Component group | Description |
|---|---|---|
| 9 | Braking system | Brake pads - rear - Worn - Replace |

**Damage 9:** Braking system: Brake pads - rear - Worn - Replace

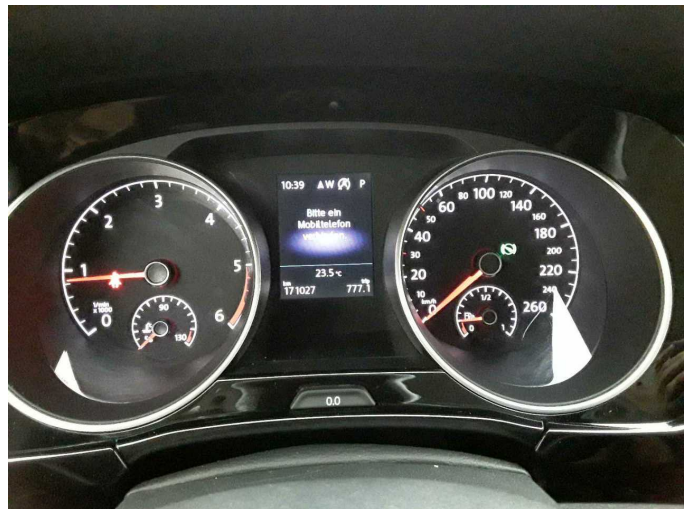
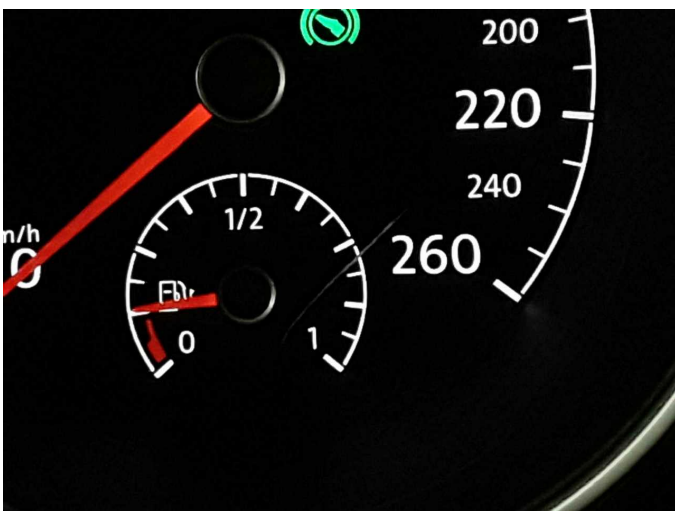
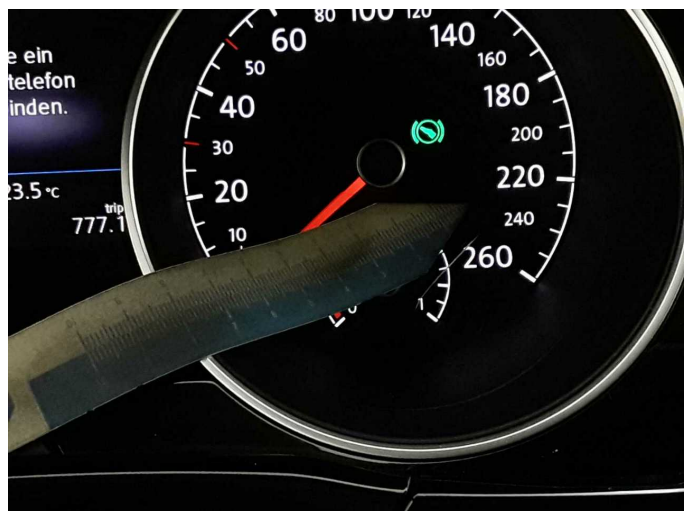
| No. | Component group | Description |
|---|---|---|
| 10 | Instrument panel | Instrument cluster - Scratch(es) - Loss in value |

**Damage 10:** Instrument panel: Instrument cluster - Scratch(es) - Loss in value

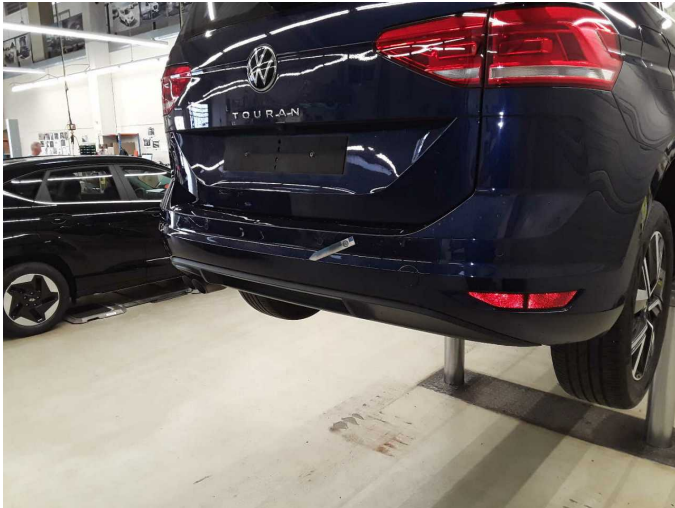
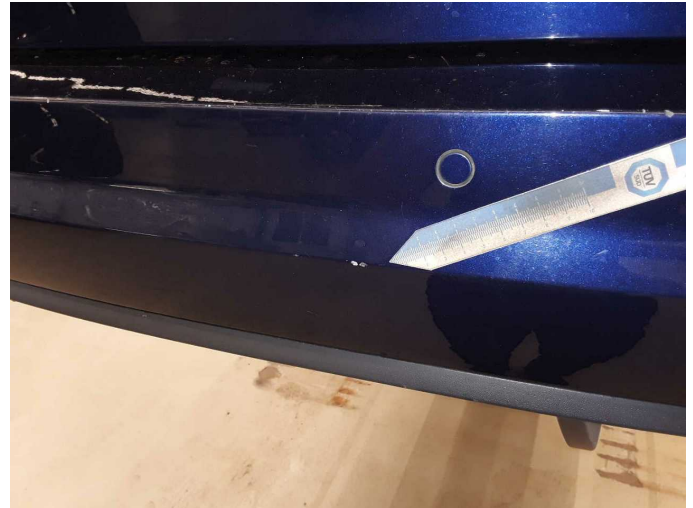
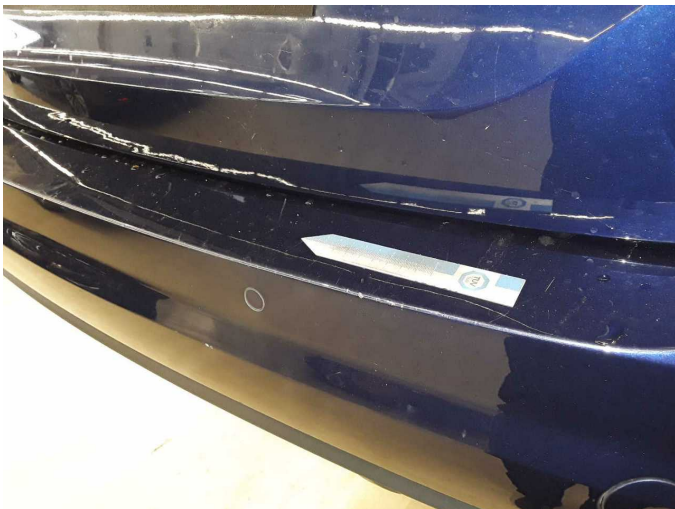
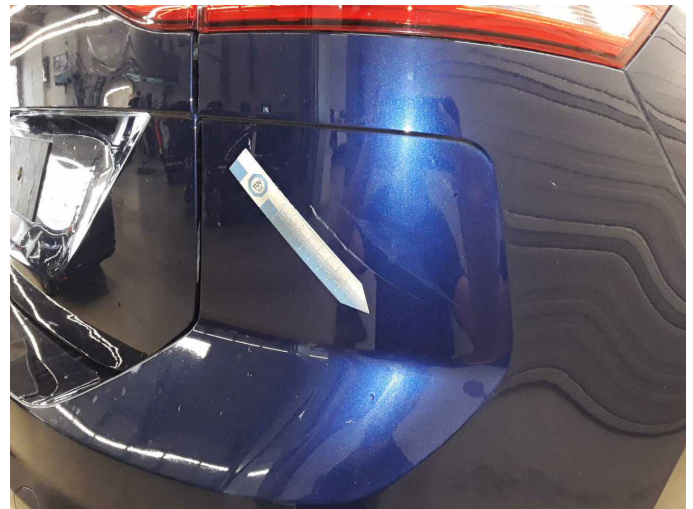
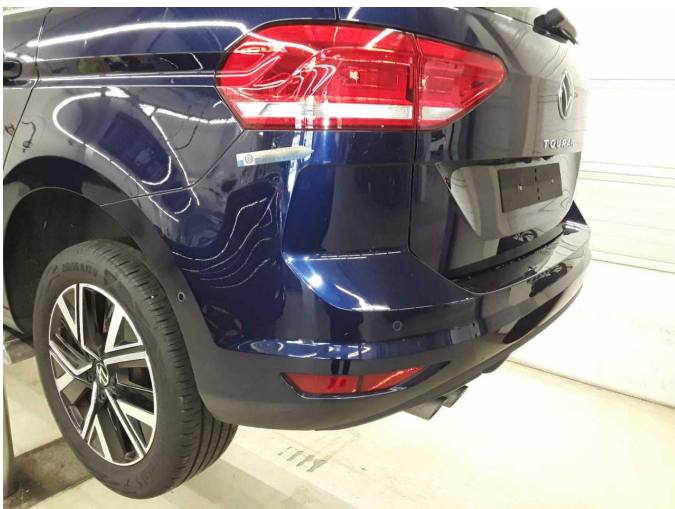
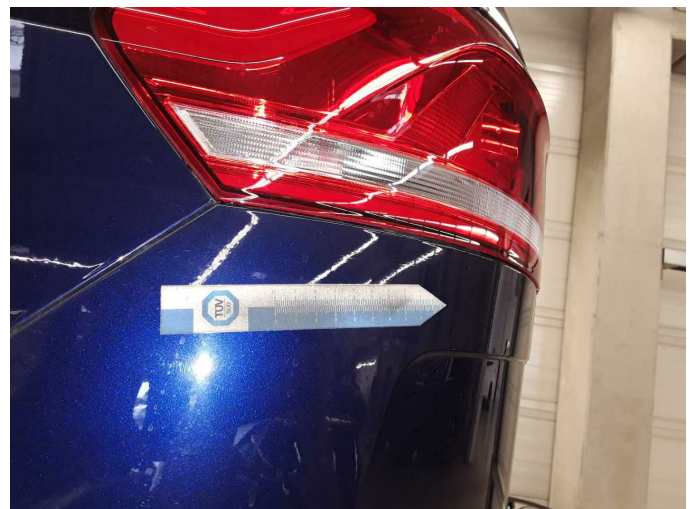
| No. | Component group | Description |
|---|---|---|
| 11 | Rear bumper | Rear bumper - Scratched - Repair and paint |

**Damage 11:** Rear bumper: Rear bumper - Scratched - Repair and paint

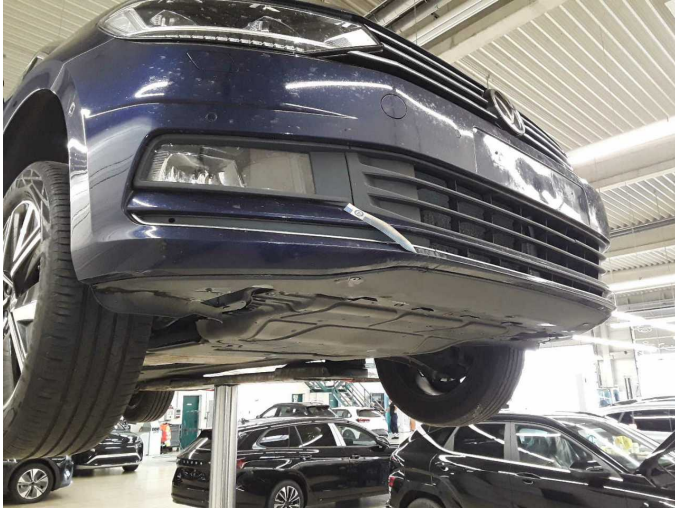
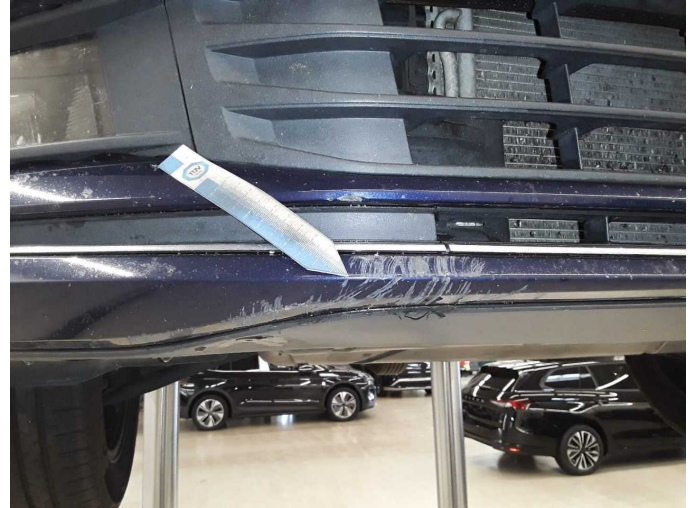
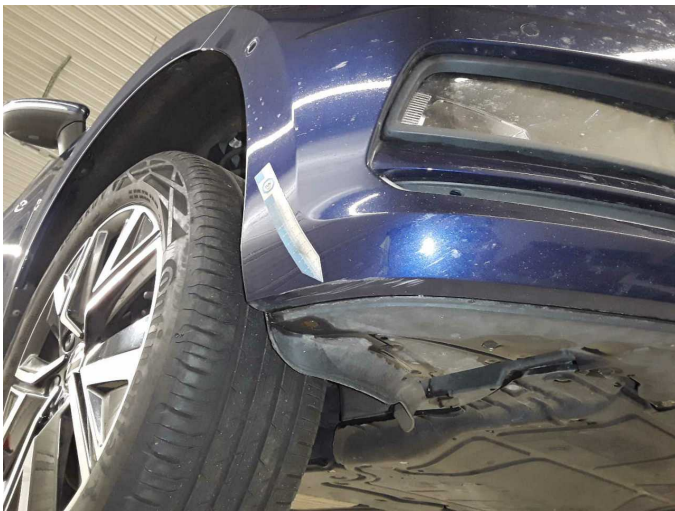
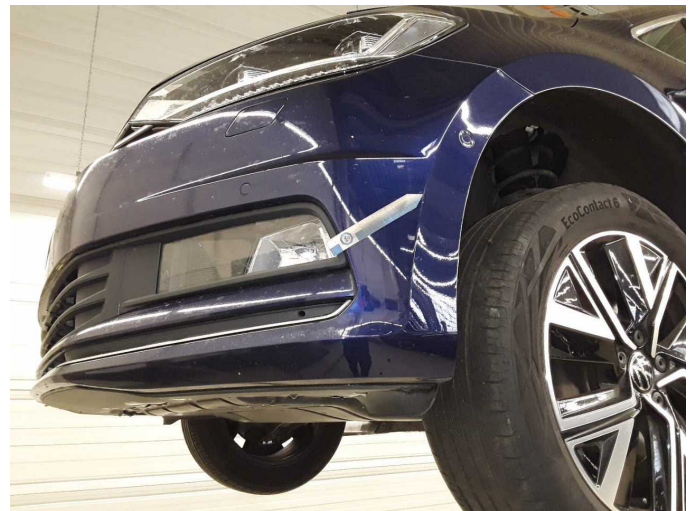
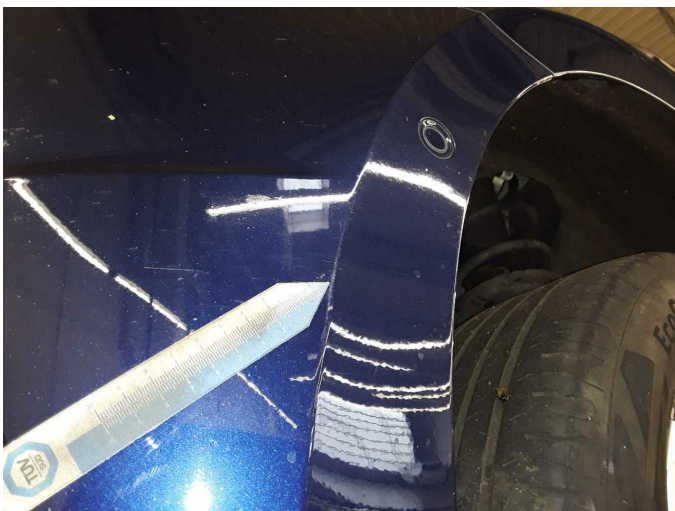
| No. | Component group | Description |
|---|---|---|
| 12 | Front bumper | Front bumper - Scratched - Repair and paint |

**Damage 12:** Front bumper: Front bumper - Scratched - Repair and paint

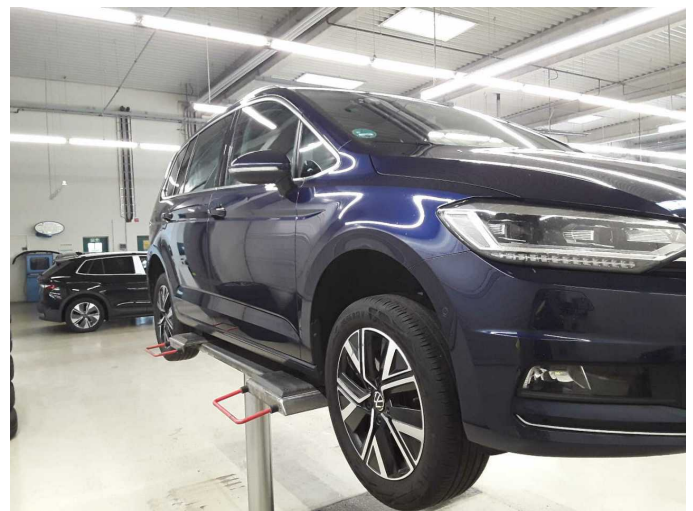
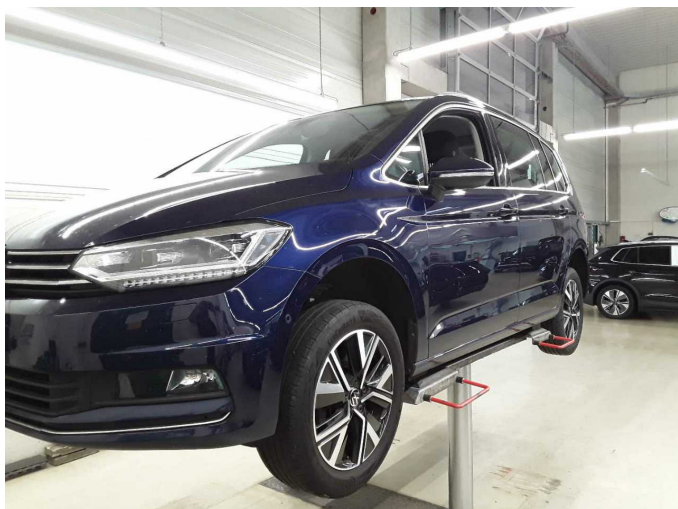
| No. | Component group | Description |
|---|---|---|
| 1 | Body | Body - Scratch(es) - No deduction |

**Wear and tear 1:** Body: Body - Scratch(es) - No deduction

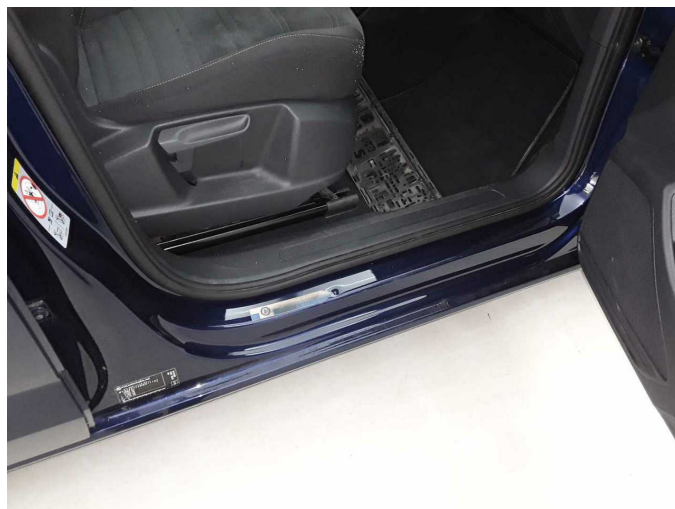
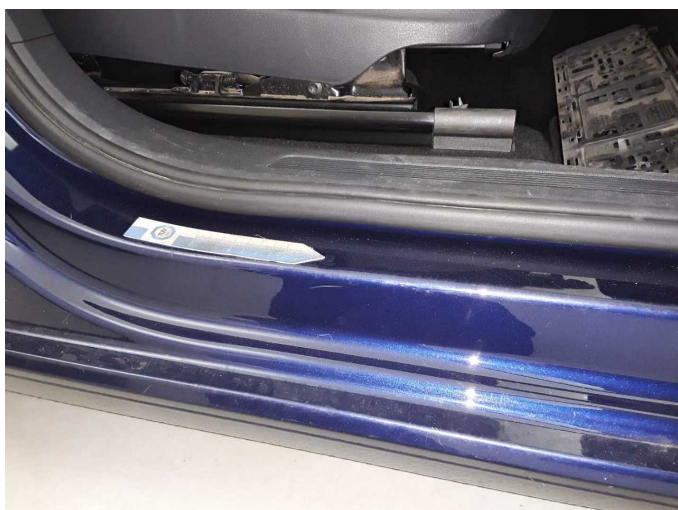
| No. | Component group | Description |
|---|---|---|
| 2 | Sill - right side | Sill - dent(s) - No deduction |

**Wear and tear 2:** Sill - right side: Sill - dent(s) - No deduction

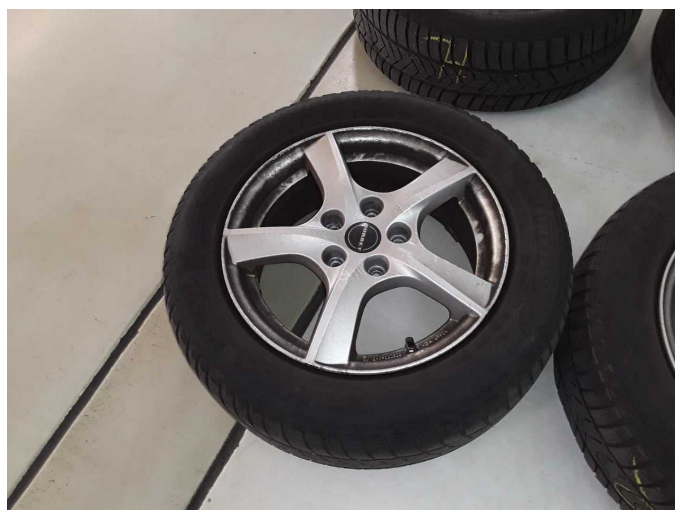
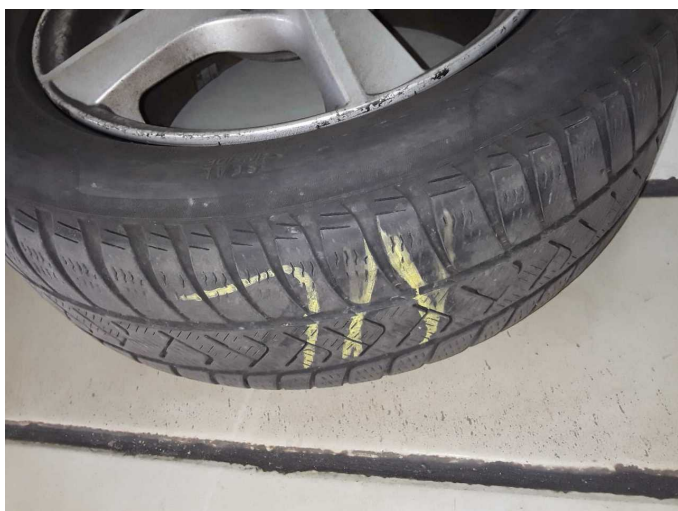
| No. | Component group | Description |
|---|---|---|
| 3 | 2nd wheel set | 1 tyre (Luftleer, Erneuern) - Leaking - No deduction |

**Wear and tear 3:** 2nd wheel set: 1 tyre (Luftleer, Erneuern) - Leaking - No deduction

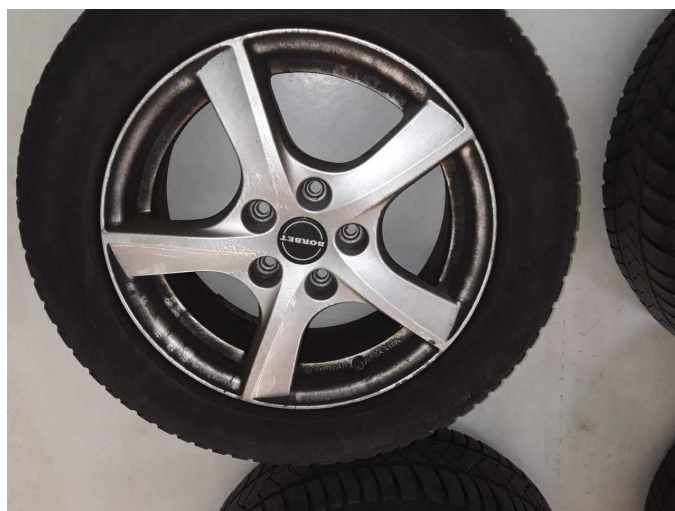
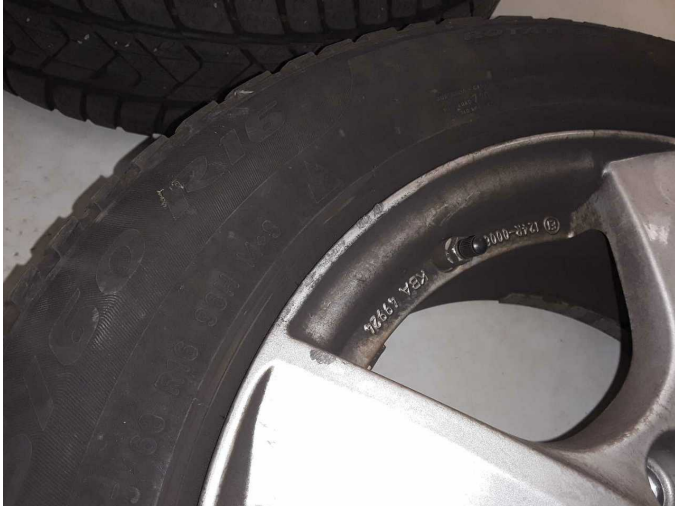
| No. | Component group | Description |
|---|---|---|
| 5 | 2nd wheel set | 1 alloy rim - Scratched - No deduction |

**Wear and tear 5:** 2nd wheel set: 1 alloy rim - Scratched - No deduction

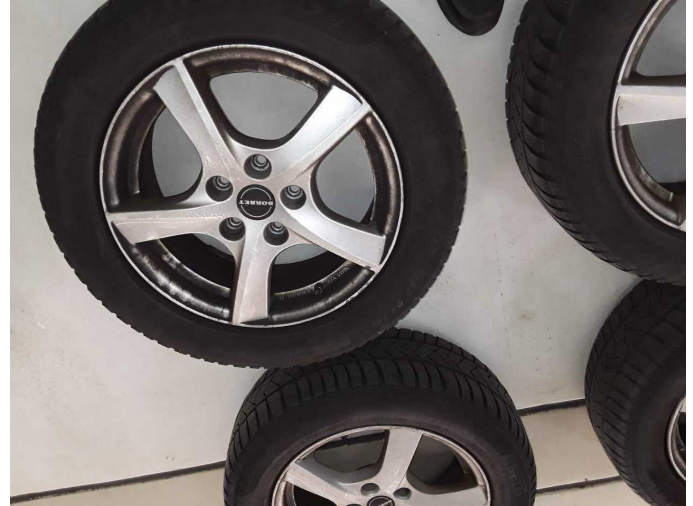
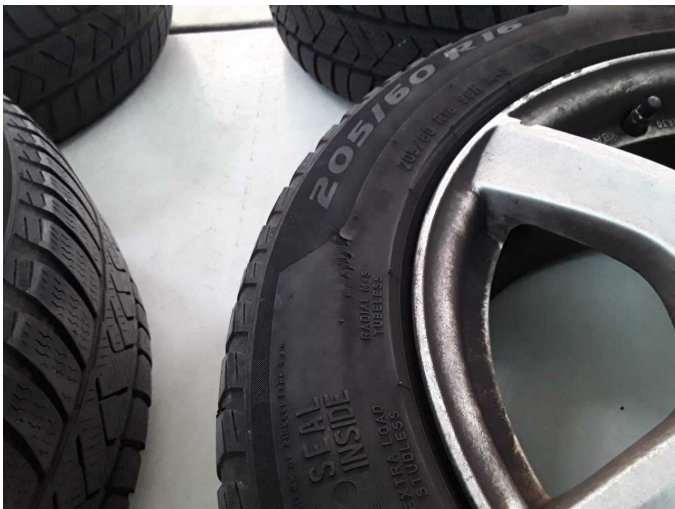
| No. | Component group | Description |
|---|---|---|
| 6 | 2nd wheel set | 1 tyre - Scratch(es) - No deduction |

**Wear and tear 6:** 2nd wheel set: 1 tyre - Scratch(es) - No deduction
