Expertise

Protocol number: 45910607  
Order No. / Reference: 26559321  
Inspection date: 12 Jun 2026

Manufacturer: Mercedes-Benz

Model: GLC 300 de 4Matic 9G-TRONIC AMG Line

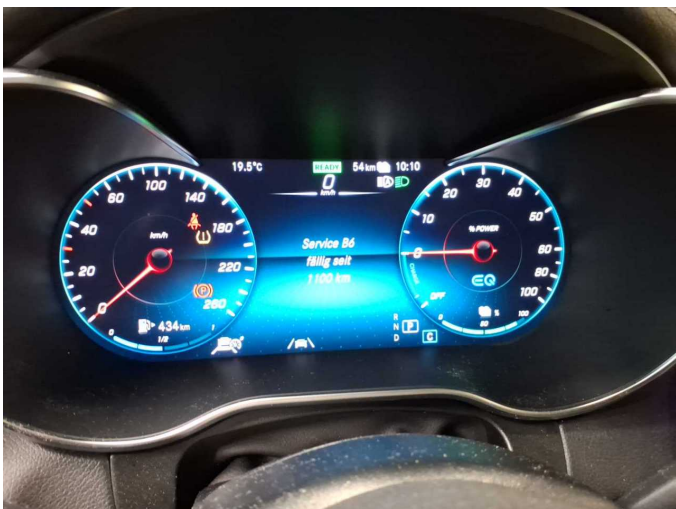
Damage 1: Misc.: Inspection / maintenance - Due - Perform

| No. | Component group | Description |
|---|---|---|
| 1 | Misc. | Inspection / maintenance - Due - Perform |

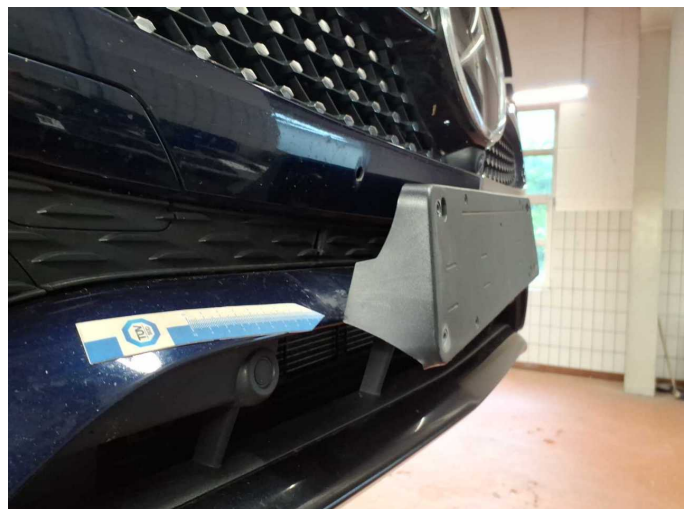
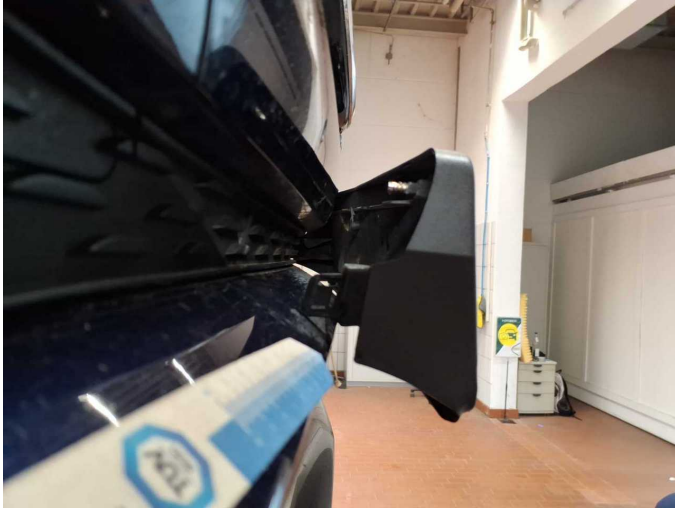
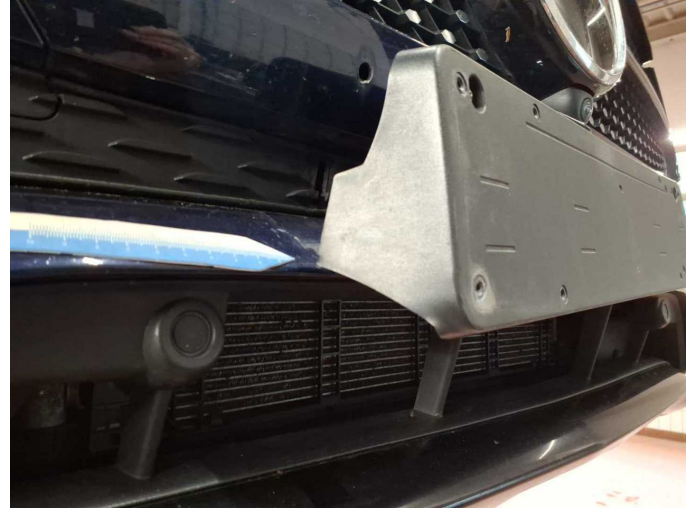
Damage 2: Front bumper: Licence plate holder - Broken / torn - Replace

**Damage 2:** Front bumper: Licence plate holder - Broken / torn - Replace

| No. | Component group | Description |
|---|---|---|
| 2 | Front bumper | Licence plate holder - Broken / torn - Replace |

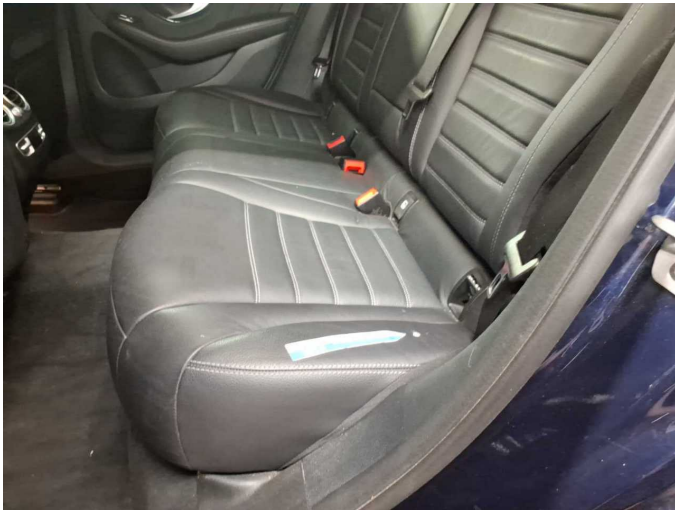
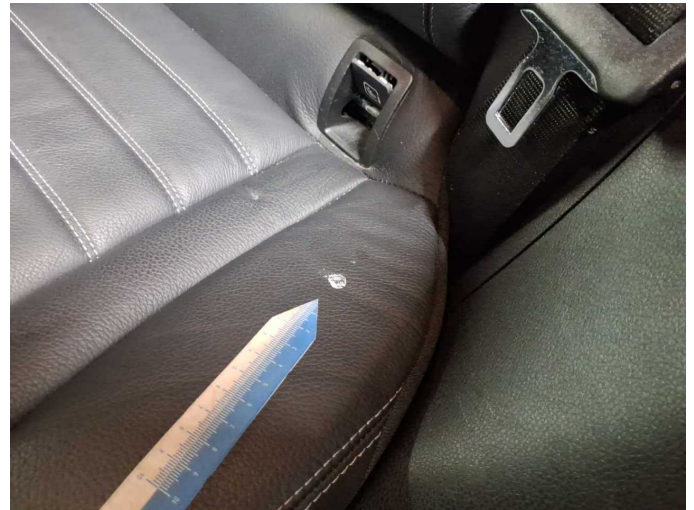
**Damage 3:** Seat - rear: Seat cover - 3 seater bench - Soiled - Clean

| No. | Component group | Description |
|---|---|---|
| 3 | Seat - rear | Seat cover - 3 seater bench - Soiled - Clean |

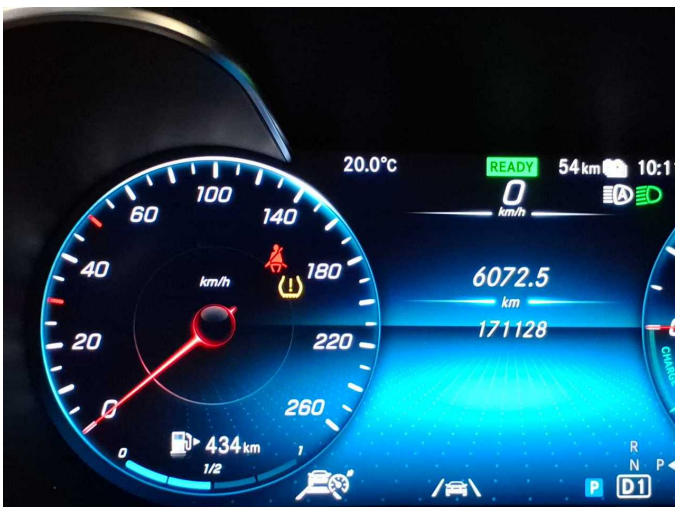
**Damage 4:** Wheel / tyres: Pressure sensor (Reifendruck) - Electrical fault - Diagnosed and repair if necessary

| No. | Component group | Description |
|---|---|---|
| 4 | Wheel / tyres | Pressure sensor (Reifendruck) - Electrical fault - Diagnosed and repair if necessary |

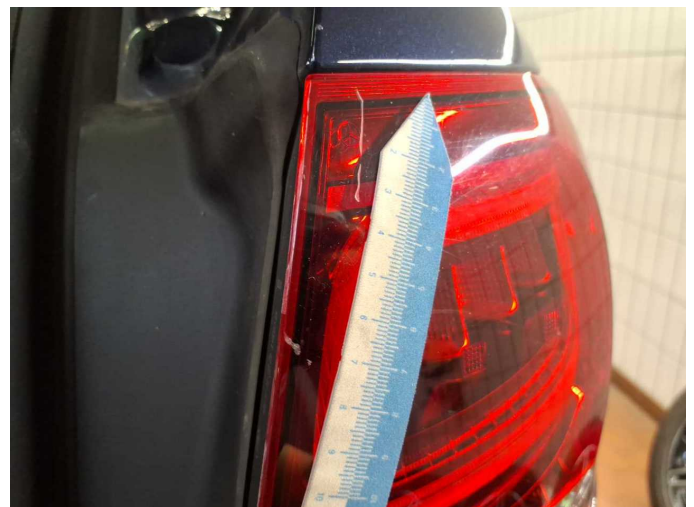
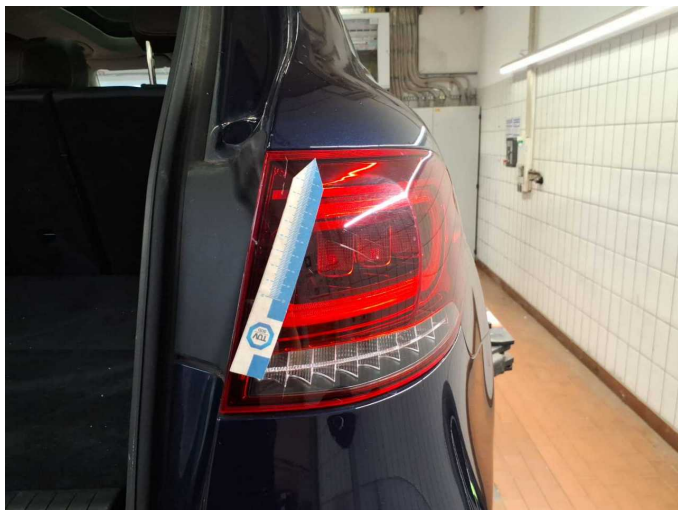
**Damage 5:** Tail light: Tail lamp - right side - Scratch(es) - Loss in value

| No. | Component group | Description |
|---|---|---|
| 5 | Tail light | Tail lamp - right side - Scratch(es) - Loss in value |

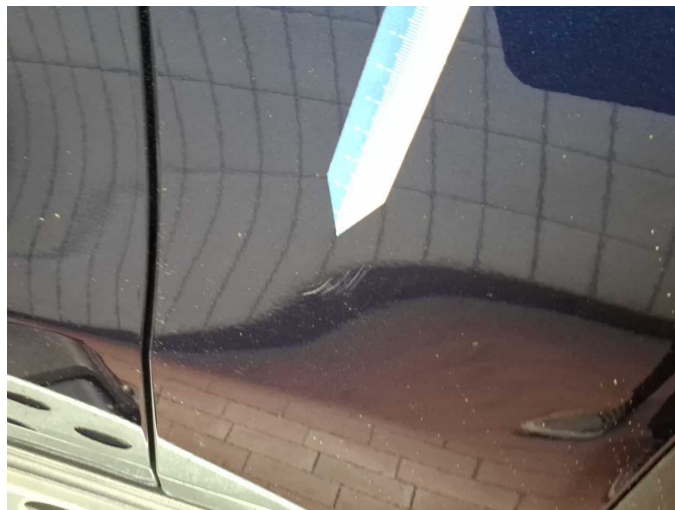
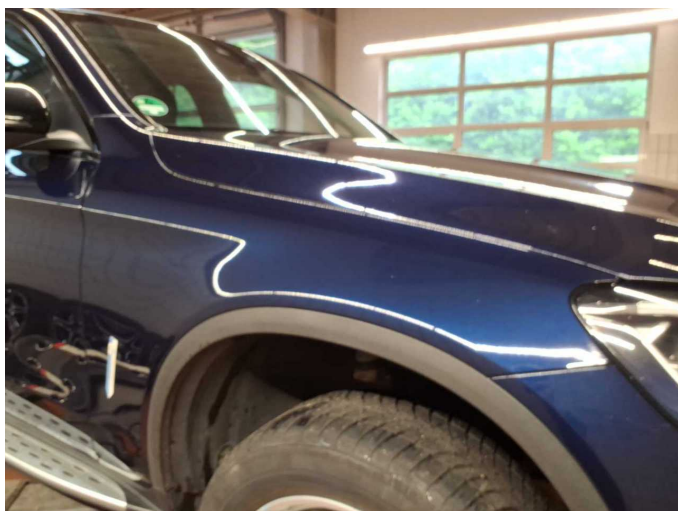
**Damage 6:** Mudguard - right side: Mudguard - right side - Scratch(es) - Smart repair

| No. | Component group | Description |
|---|---|---|
| 6 | Mudguard - right side | Mudguard - right side - Scratch(es) - Smart repair |

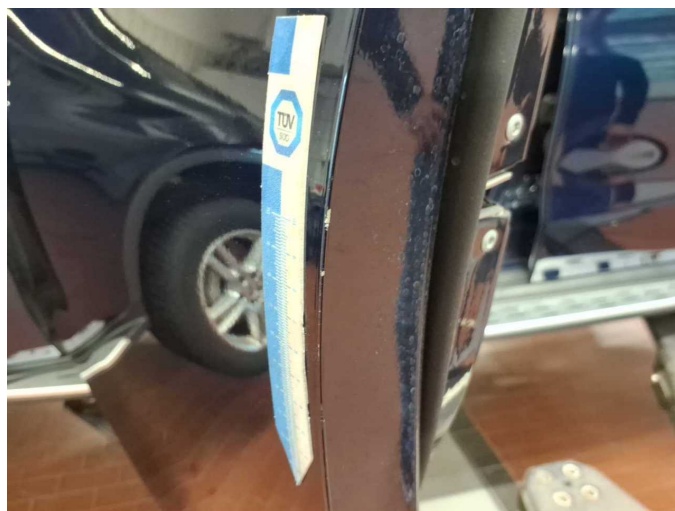
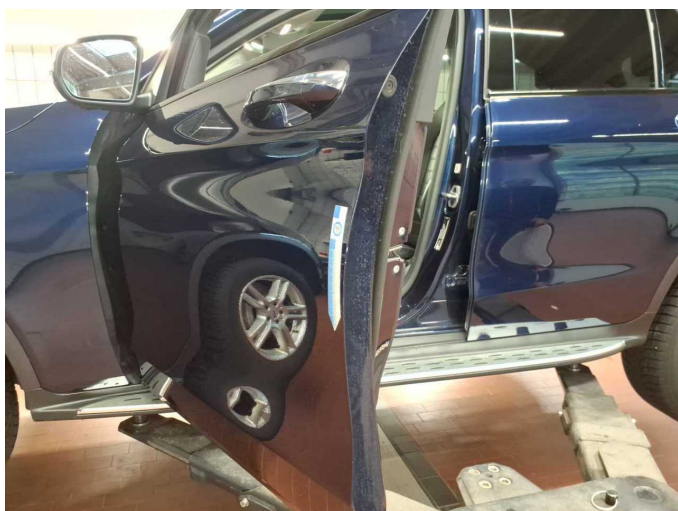
**Damage 7:** Door - front left side: Door edge - Scratch(es) - Smart repair

| No. | Component group | Description |
|---|---|---|
| 7 | Door - front left side | Door edge - Scratch(es) - Smart repair |

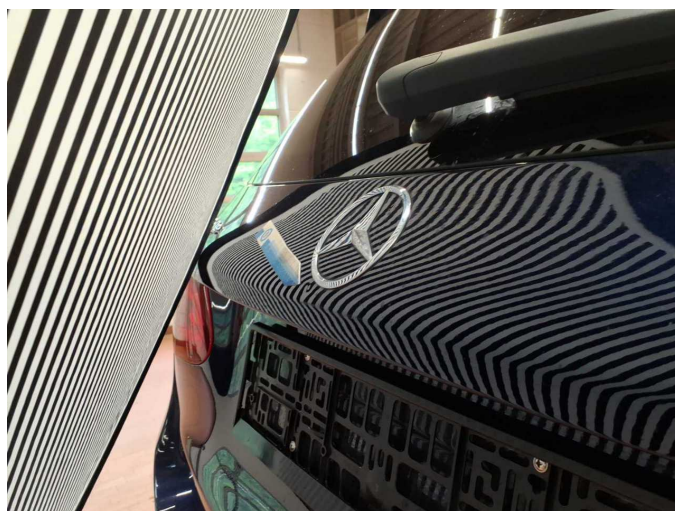
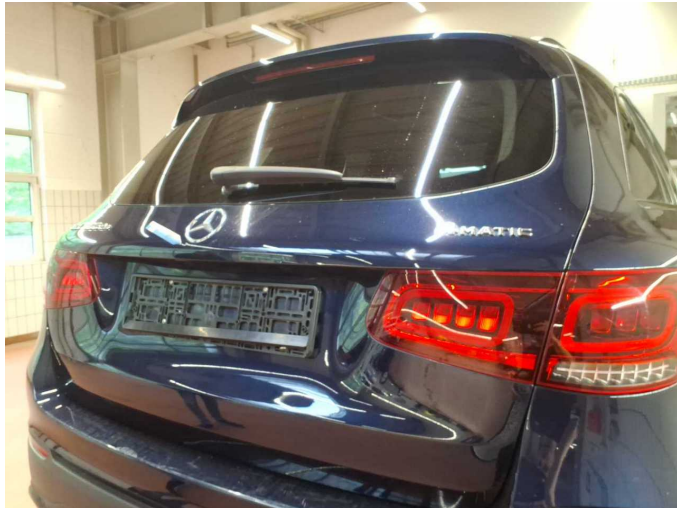
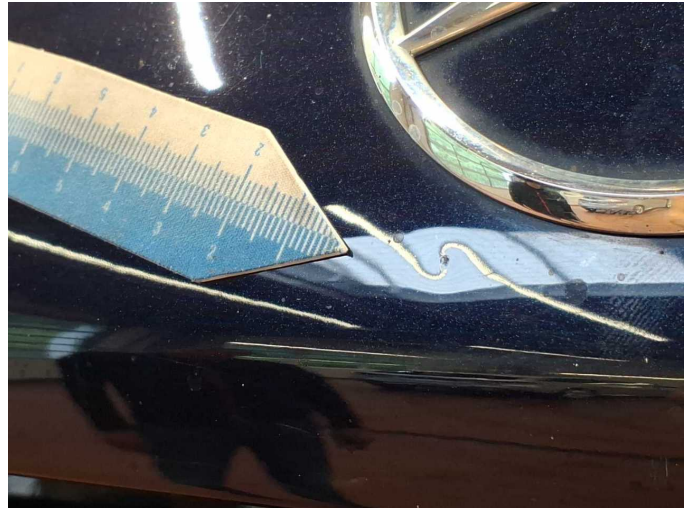
**Damage 8:** Boot lid / rear door: Boot lid - Dent / paintcoat damage - Smart repair

| No. | Component group | Description |
|---|---|---|
| 8 | Boot lid / rear door | Boot lid - Dent / paintcoat damage - Smart repair |

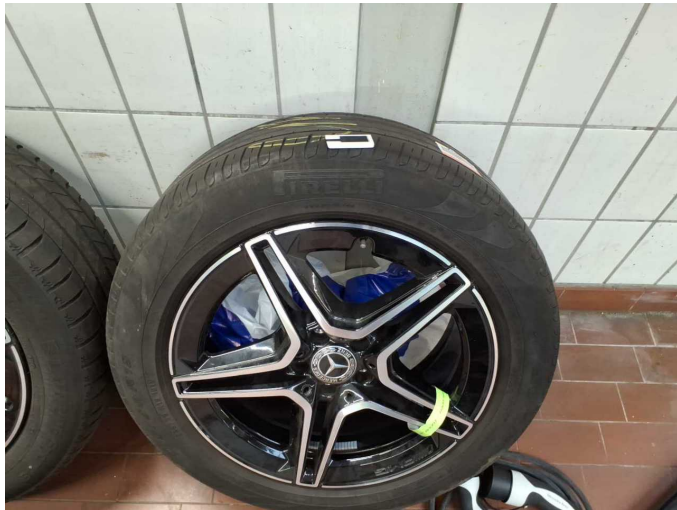
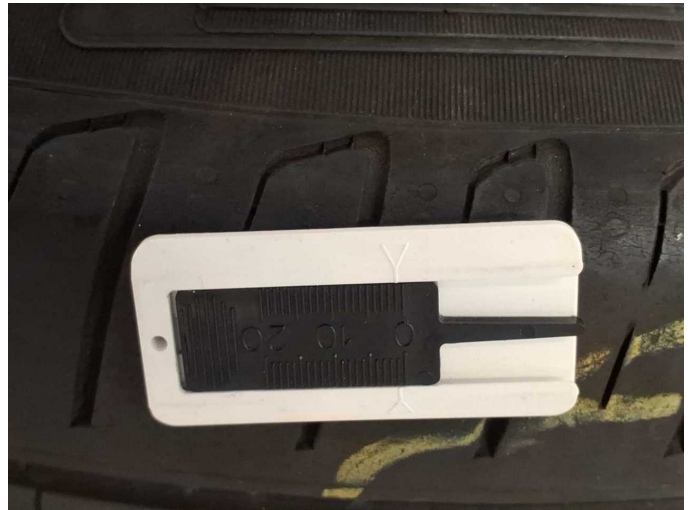
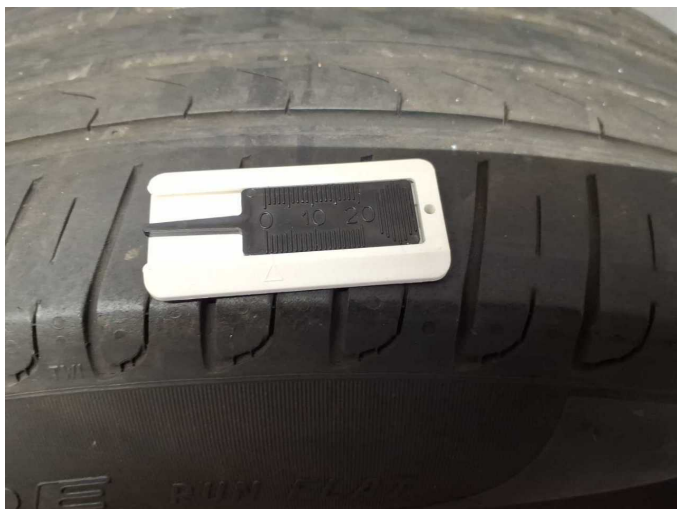
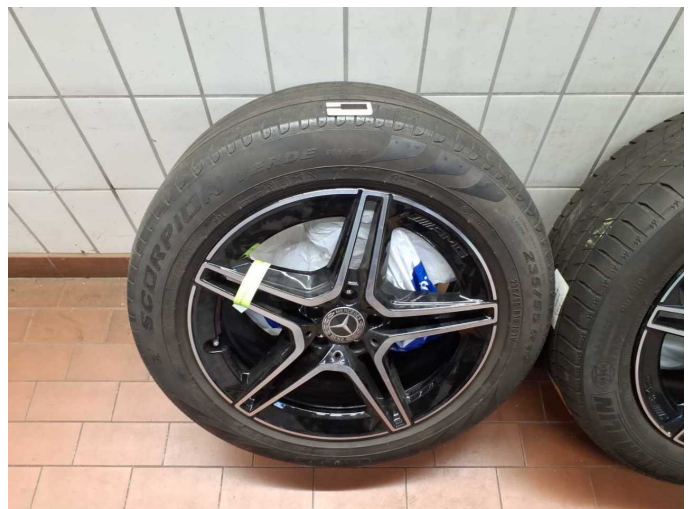
| # | Tyre size | Type of tyre | Manufacturer | Tread depth |
|---|---|---|---|---|
| 1) | 235/55 R19 101V | Summer tires (with run-flat tires) on Light alloy | unterschiedliche Hersteller | 1mm / 1mm |

**Damage 9:** 2nd wheel set: 2 tyres - Worn - Replace

| No. | Component group | Description |
|---|---|---|
| 9 | 2nd wheel set | 2 tyres - Worn - Replace |

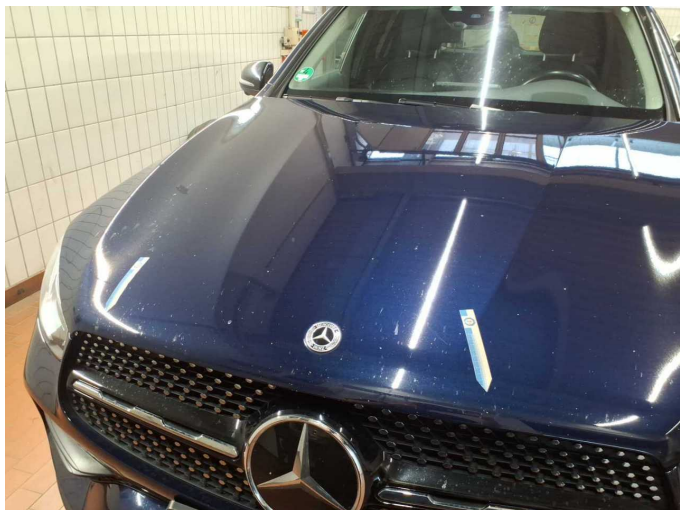
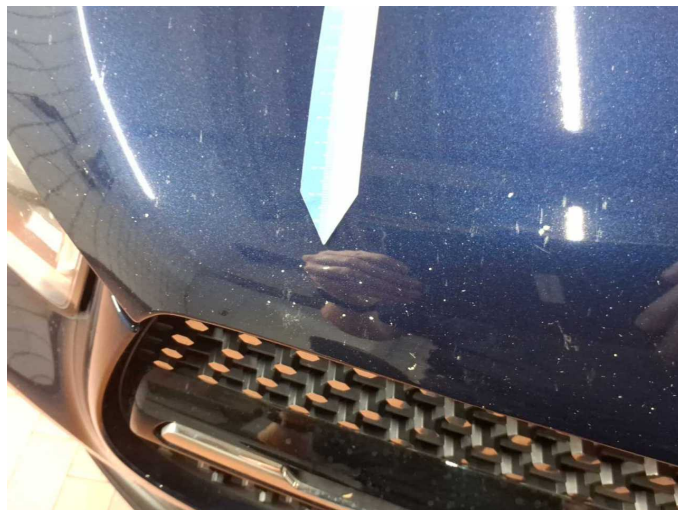
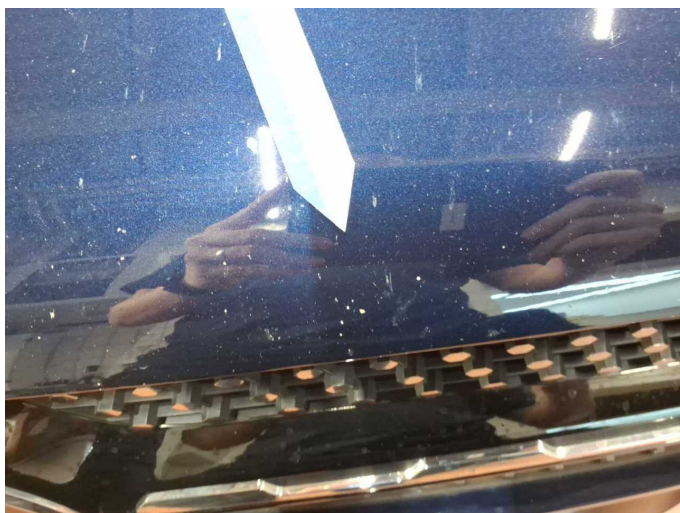
**Damage 10:** Bonnet: Bonnet - Stone chips - Paint

| No. | Component group | Description |
|---|---|---|
| 10 | Bonnet | Bonnet - Stone chips - Paint |

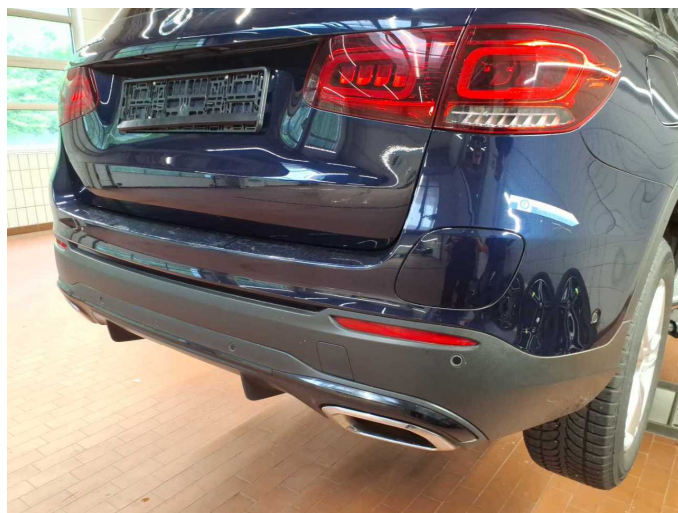
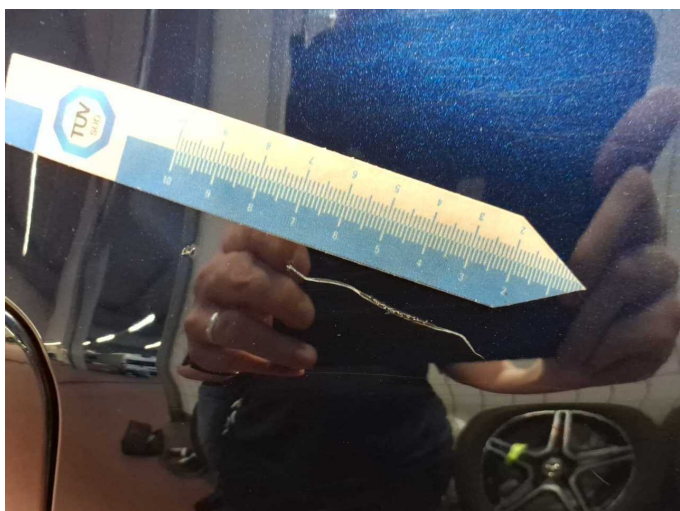
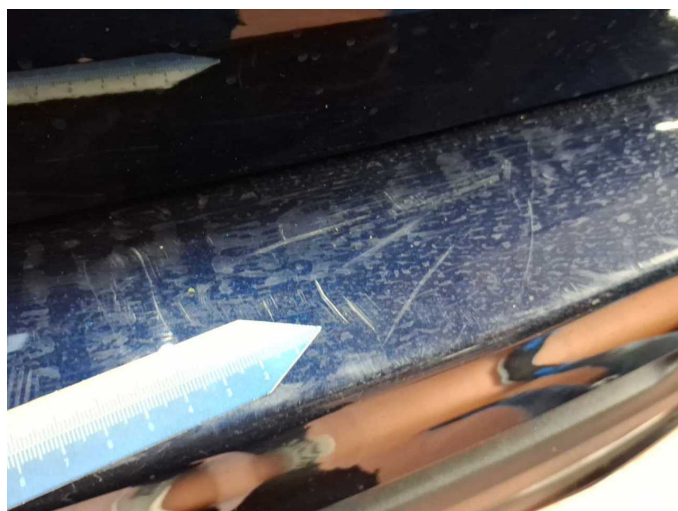
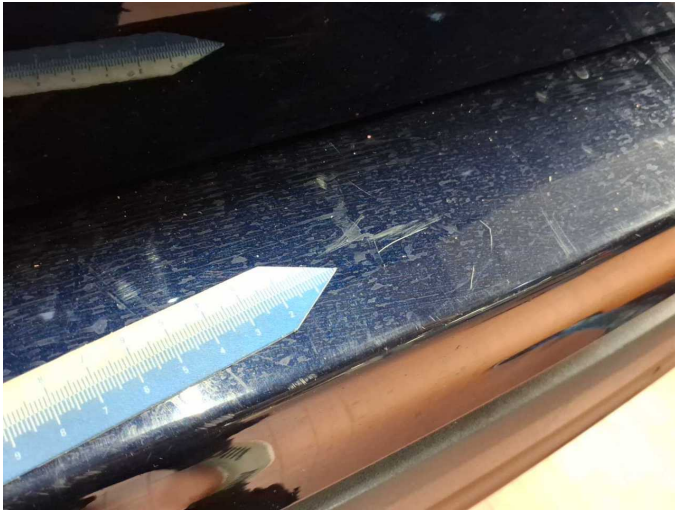
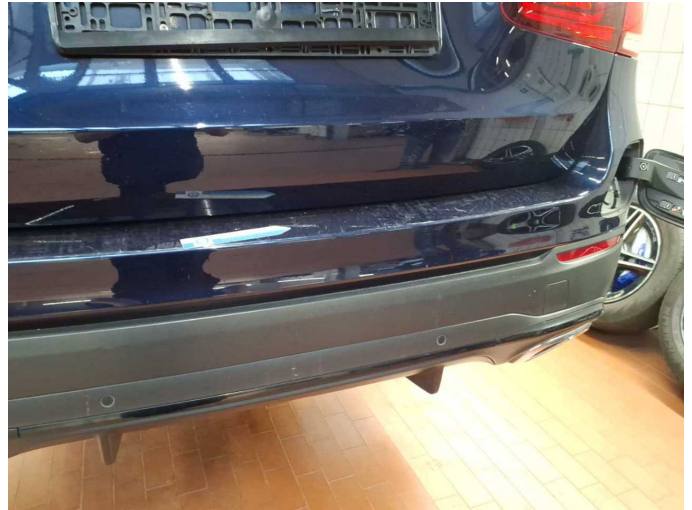
**Damage 11:** Rear bumper: Rear bumper - Scratch(es) - Paint

| No. | Component group | Description |
|---|---|---|
| 11 | Rear bumper | Rear bumper - Scratch(es) - Paint |

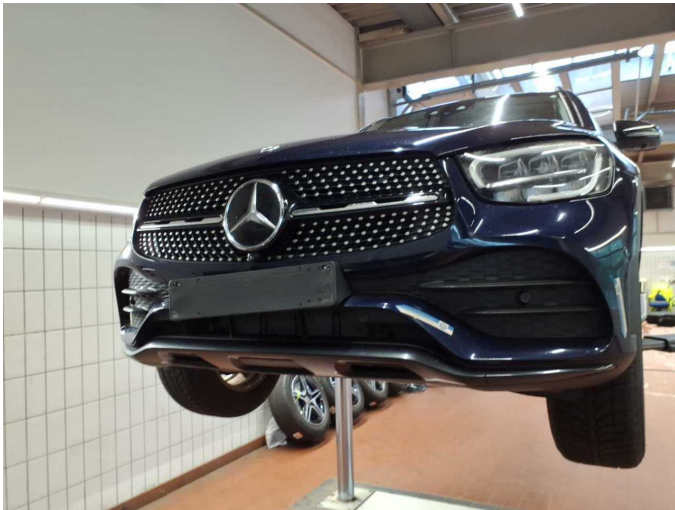
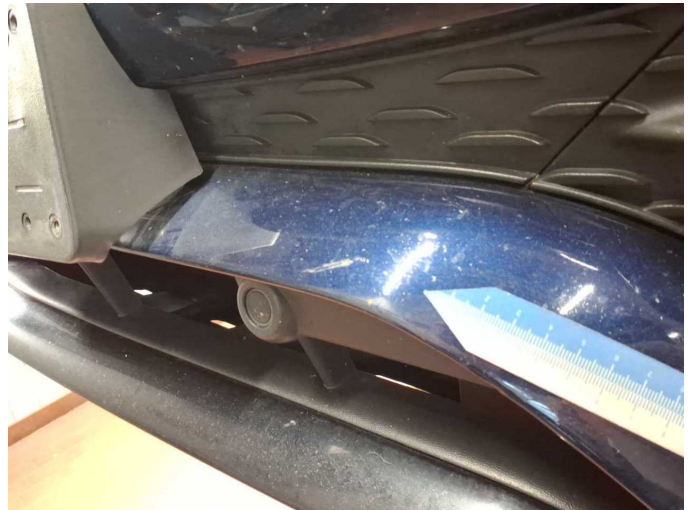
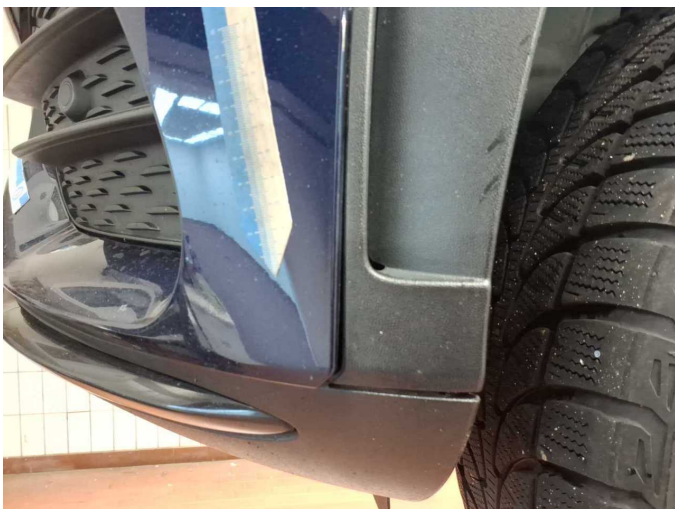
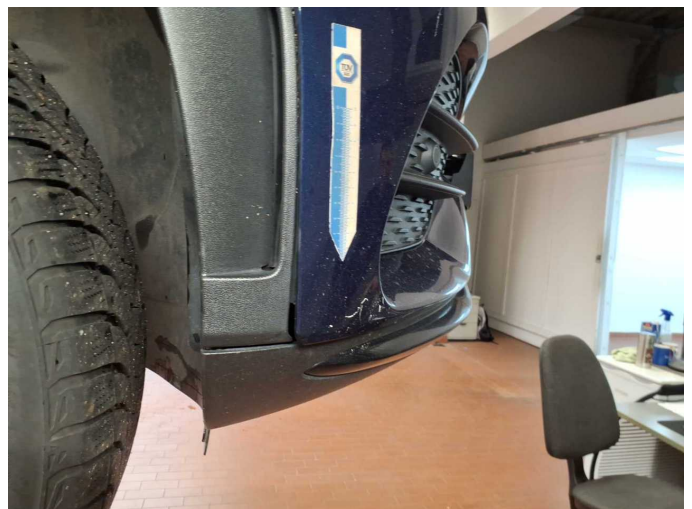
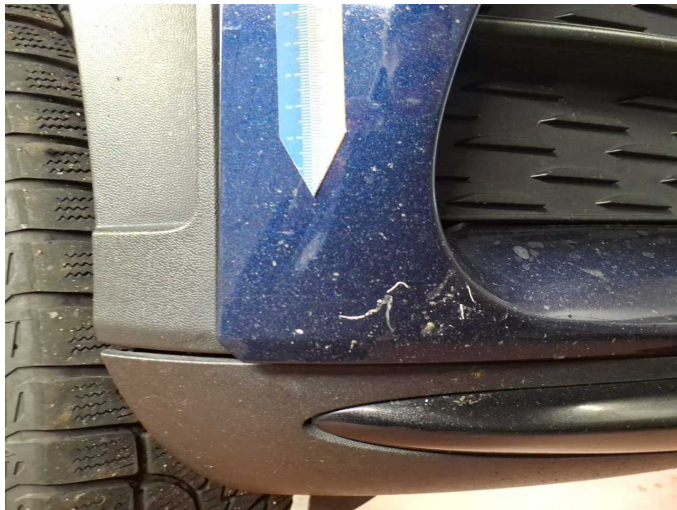
**Damage 12:** Front bumper: Front bumper - Scratched - Paint

| No. | Component group | Description |
|---|---|---|
| 12 | Front bumper | Front bumper - Scratched - Paint |

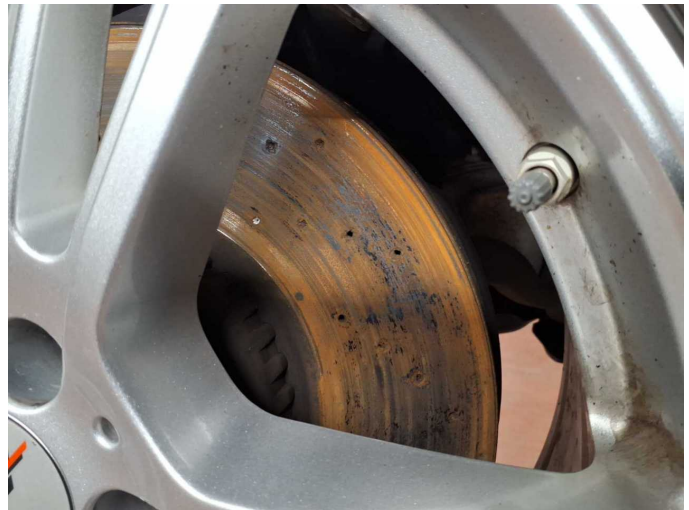
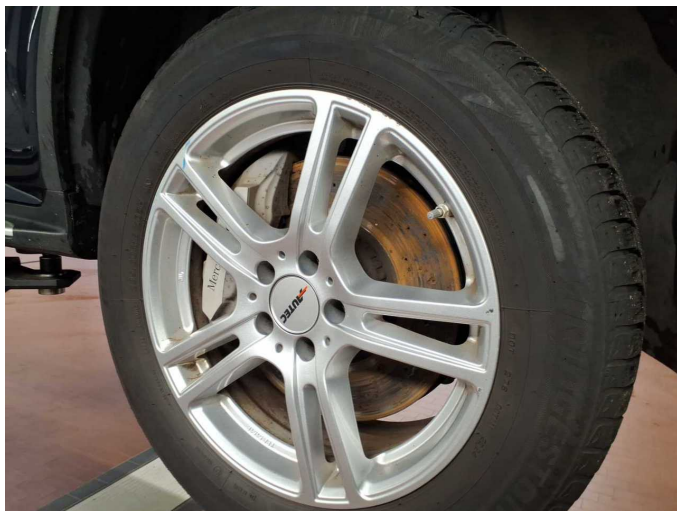
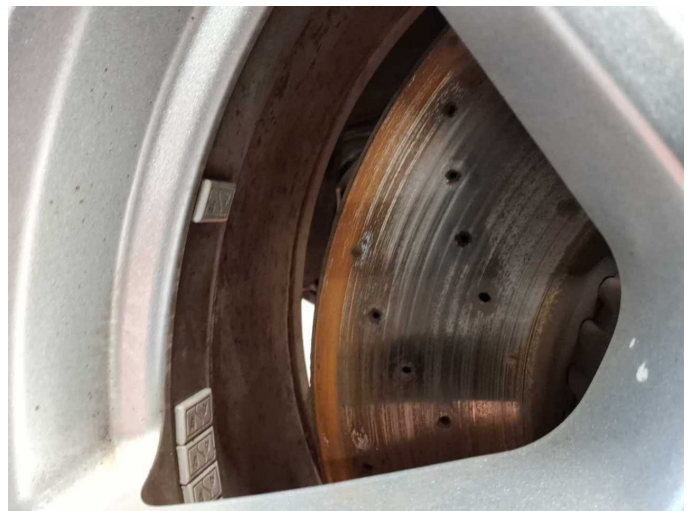
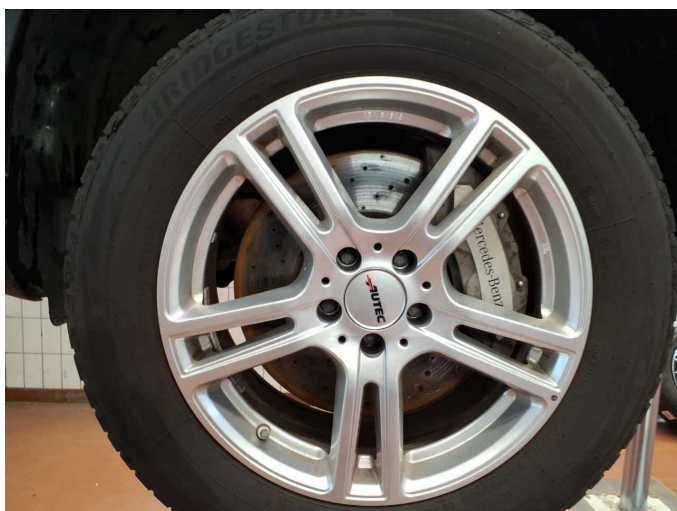
| No. | Component group | Description |
|---|---|---|
| 1 | Braking system | Brake discs and brake pads - front (Frei Bremsen/ Folgekosten möglich) - Corrosion - No deduction |

**Wear and tear 1:** Braking system: Brake discs and brake pads - front  
(Frei Bremsen/ Folgekosten möglich) - Corrosion - No deduction

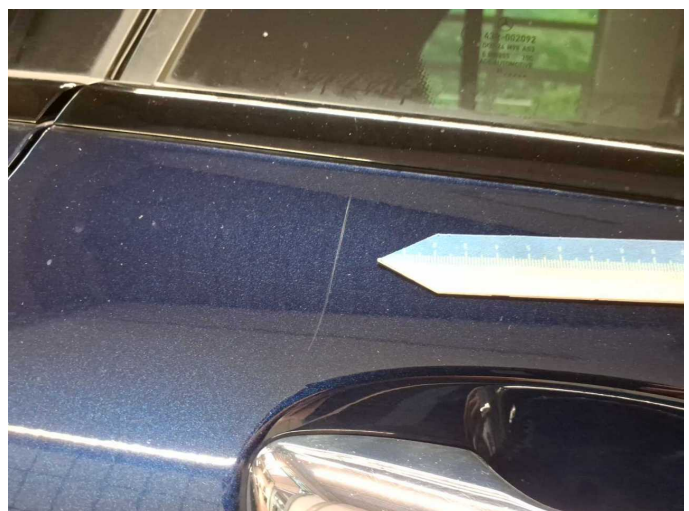
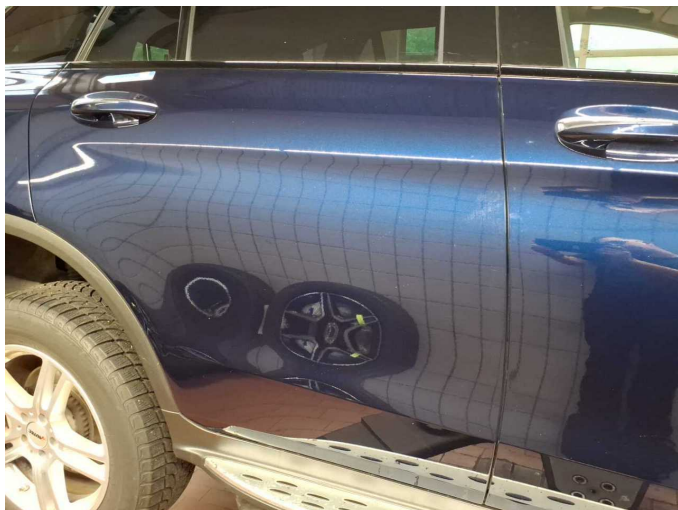
| No. | Component group | Description |
|---|---|---|
| 2 | Door - rear right side | Door - Scratch(es) - No deduction |

**Wear and tear 2:** Door - rear right side: Door - Scratch(es) - No deduction

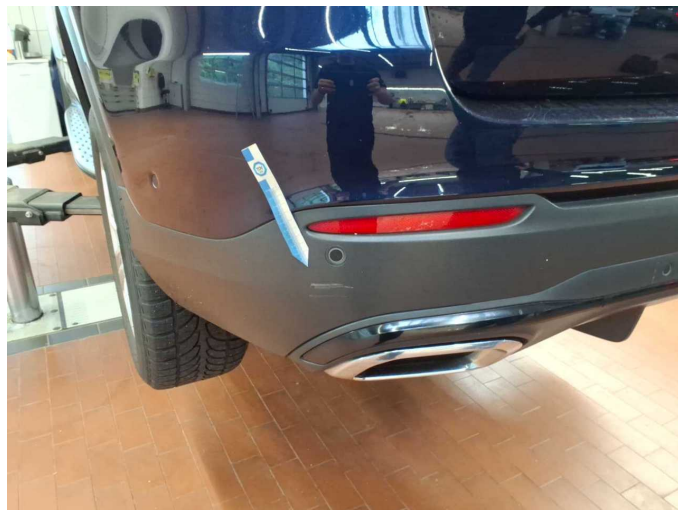
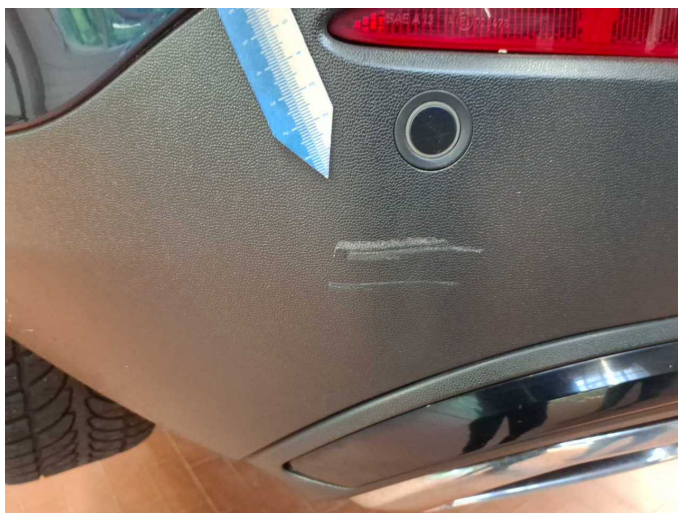
| No. | Component group | Description |
|---|---|---|
| 5 | Rear bumper | Spoiler - Scratch(es) - No deduction |

**Wear and tear 5:** Rear bumper: Spoiler - Scratch(es) - No deduction

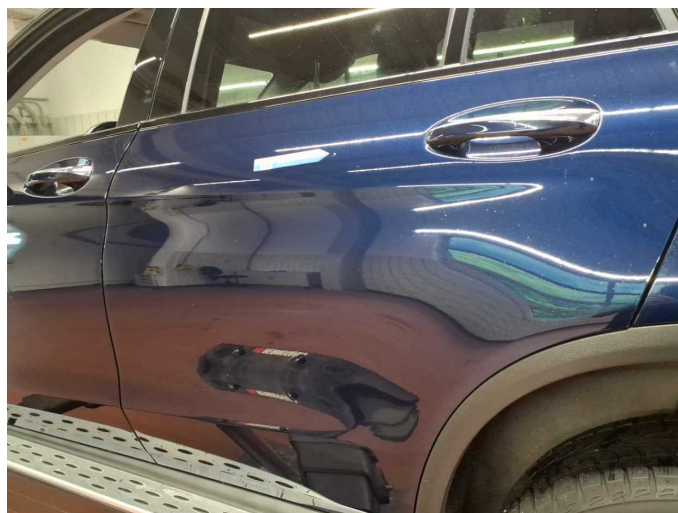
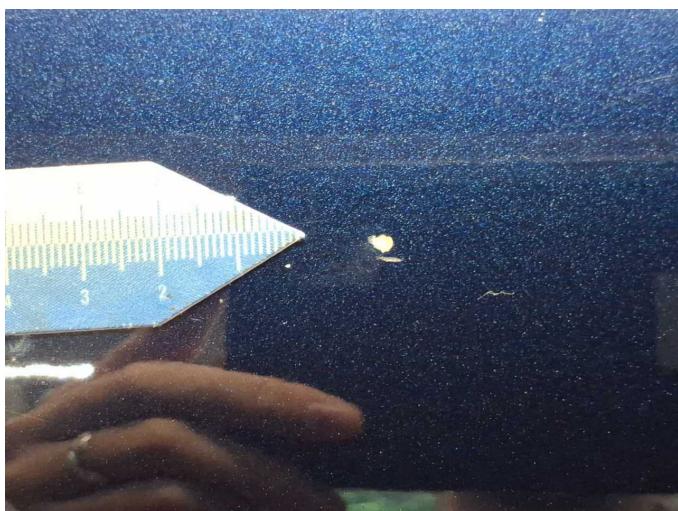
| No. | Component group | Description |
|---|---|---|
| 7 | Door - rear left side | Door - Scratch(es) - No deduction |

**Wear and tear 7:** Door - rear left side: Door - Scratch(es) - No deduction
