## Expertise

Protocol number: 45942488  
Order No. / Reference: 26384281  
Inspection date: 15 Jun 2026

Model: Octavia Combi 2.0 TDI DSG First Edition

An order was placed to prepare a sales report for the described vehicle. This report includes the following:

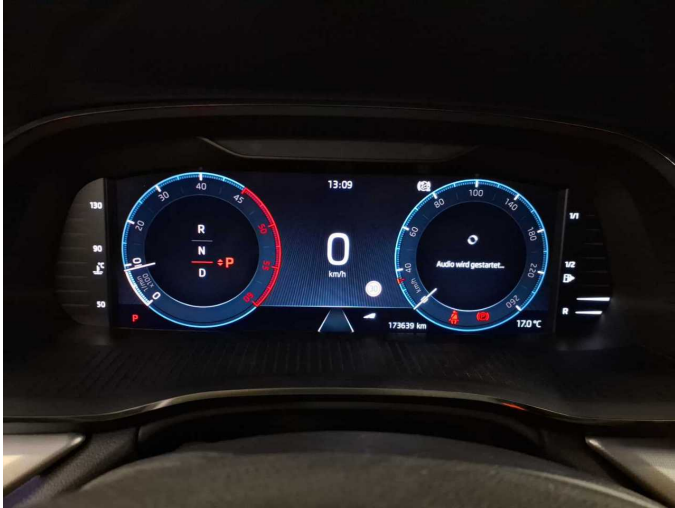
<b>Vehicle Identification number</b>	TMBJJ7NX0MY152299
<b>Mileage (Read)</b>	173,639 km
<b>First registration</b>	6 May 2021
<b>Number of holders</b>	1
<b>Next periodical technical inspection</b> (Report on hand)	06/2026

Figure 7: Instrument cluster

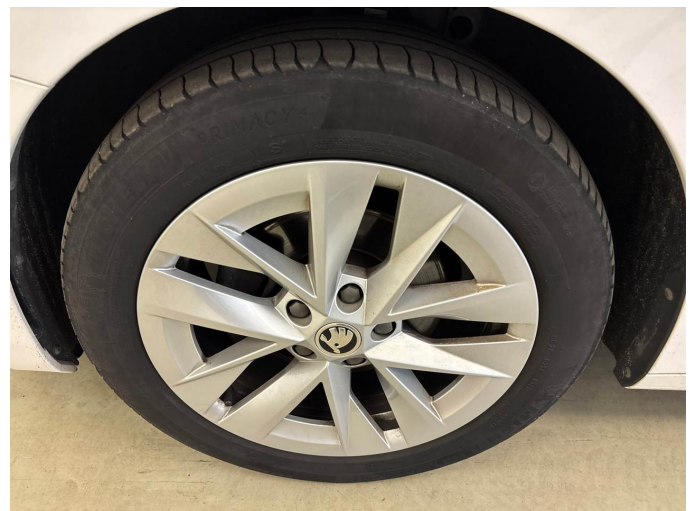
#	Tyre size	Type of tyre	Manufacturer	Tread depth
1)	205/55 R17 91V	Summer tyres on Light alloy	Michelin	5mm / 5mm
2)	205/55 R17 91V	Summer tyres on Light alloy	Continental	6mm / 6mm

Figure 12: Mounted tyres

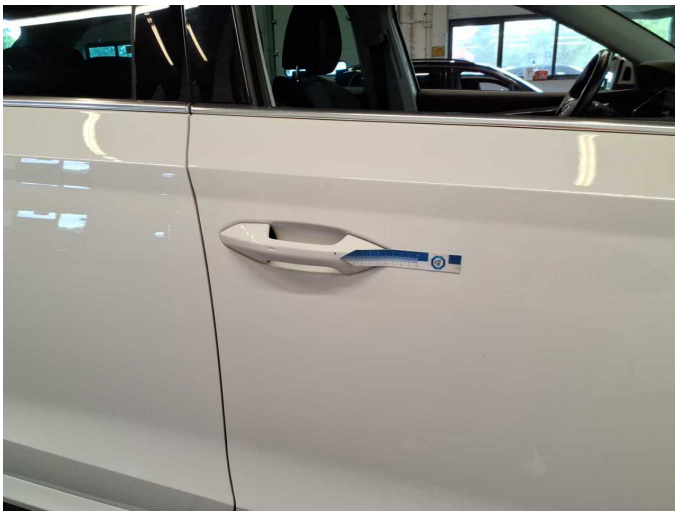
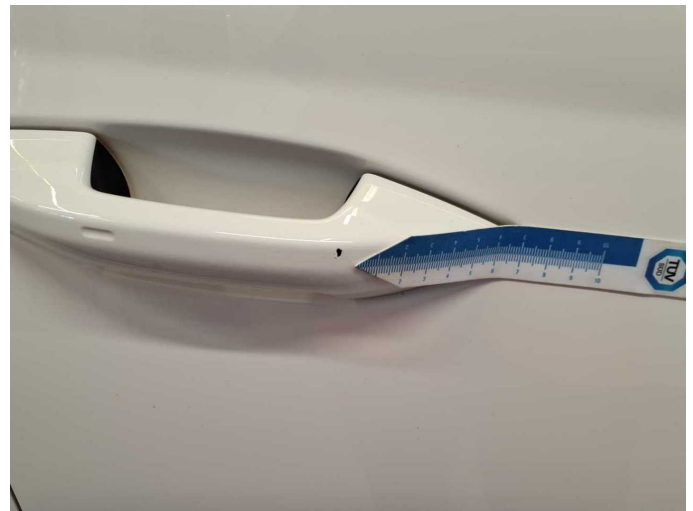
No.	Component group	Description
1	Door - front right side	Door handle - outside - Stone chips - Smart repair
2	Equipment	Tirefit filler - Expired - Replace
3	Misc.	Main inspection - Due - Perform
4	Rear bumper	Rear bumper - Scratch(es) - Repair and paint

Damage 1: Door - front right side: Door handle - outside - Stone chips - Smart repair

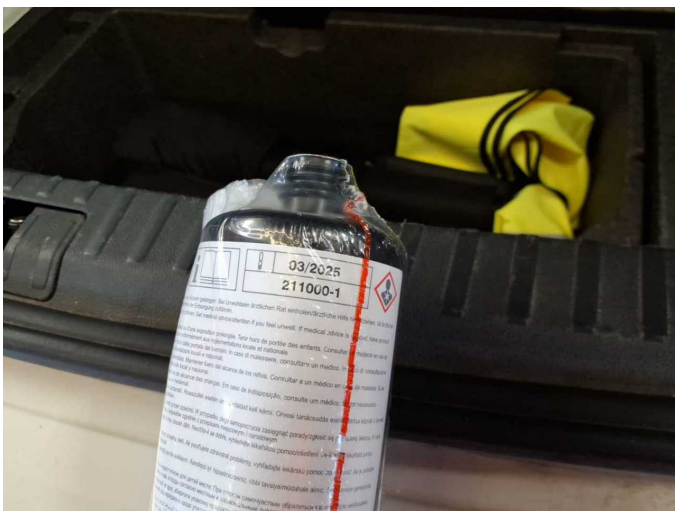
Damage 2: Equipment: Tirefit filler - Expired - Replace

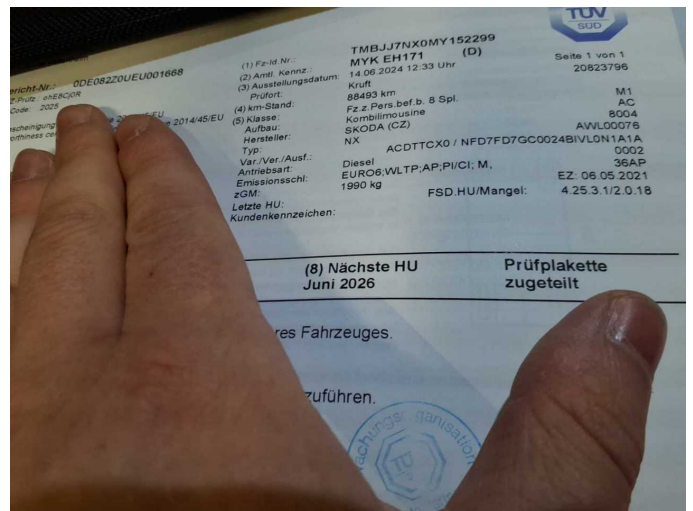
Damage 3: Misc.: Main inspection - Due - Perform

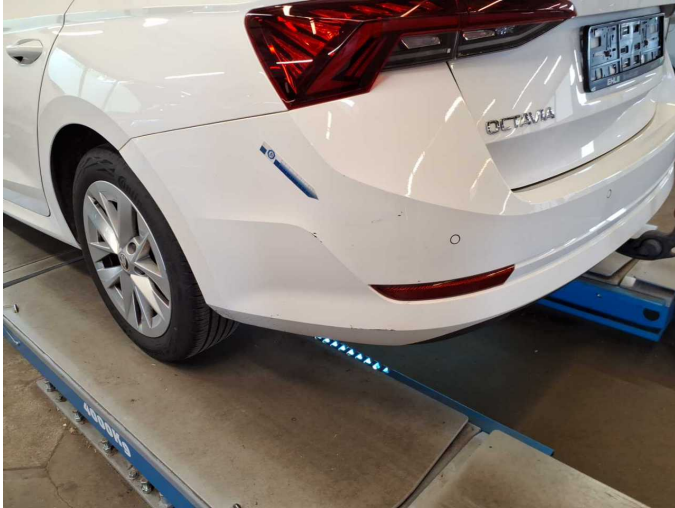
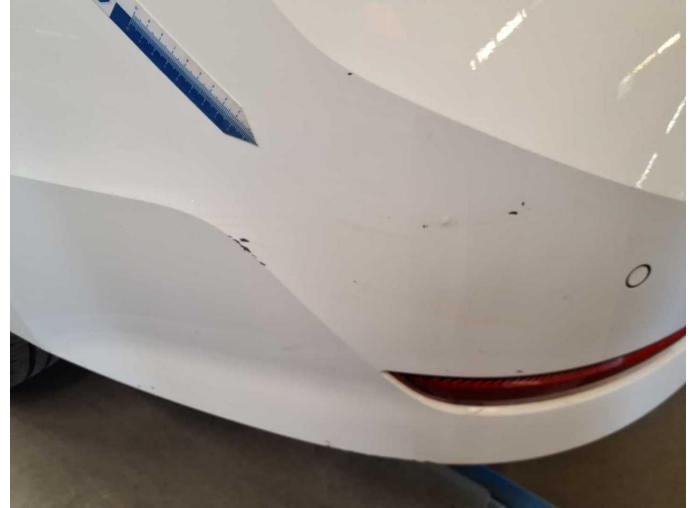
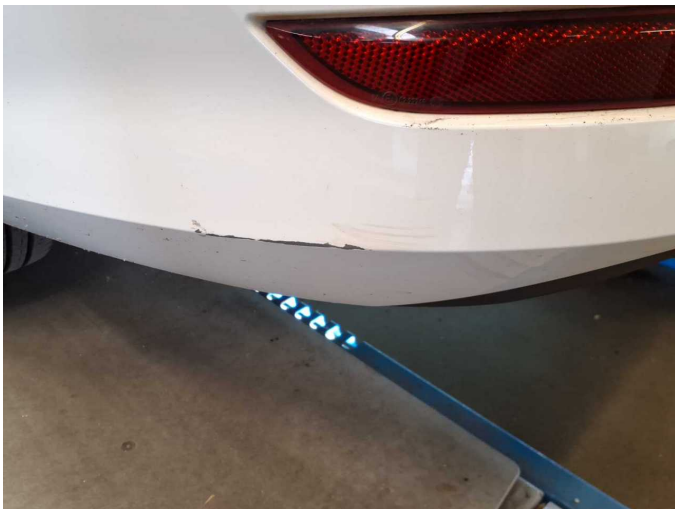
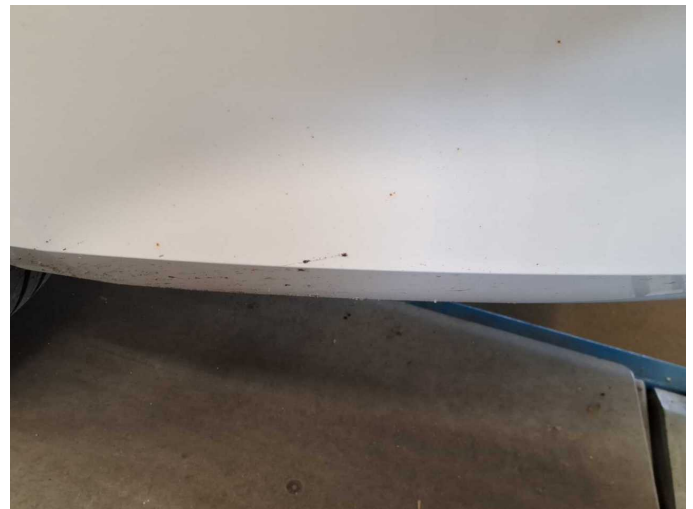
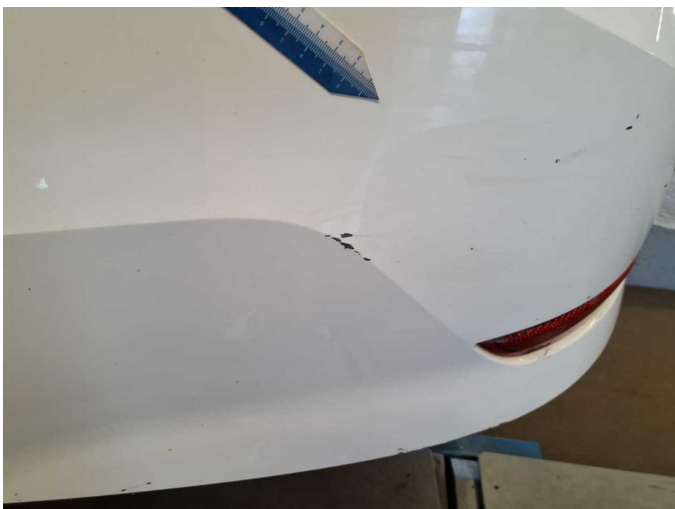
**Damage 4:** Rear bumper: Rear bumper - Scratch(es) - Repair and paint

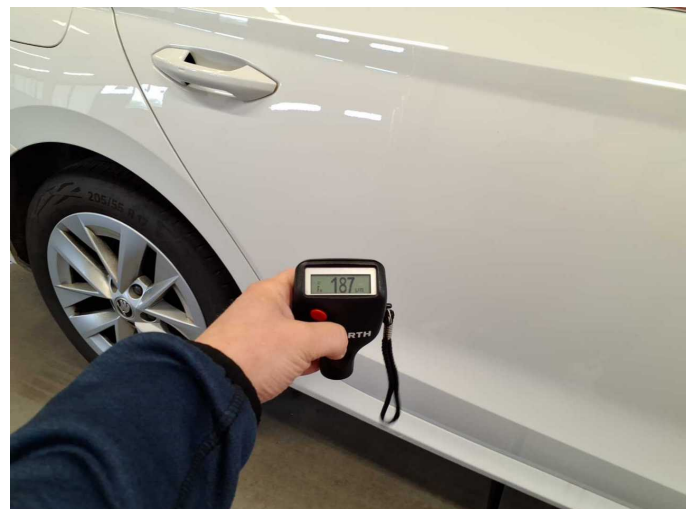
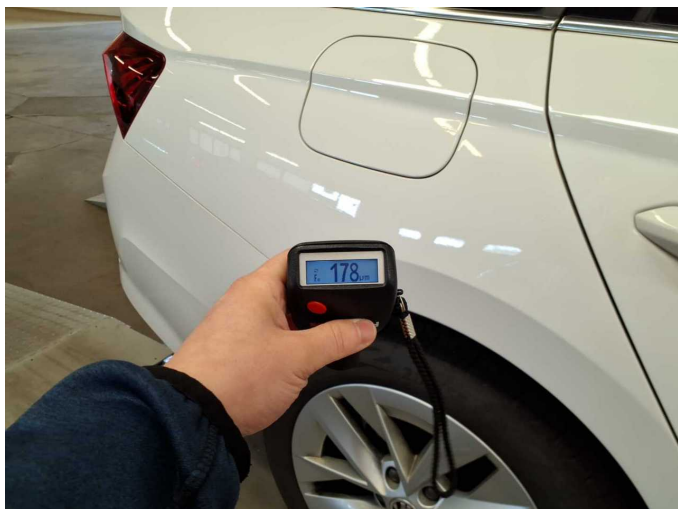
1 Side panel - rear right side, Door - rear right side, Professionally carried out, Invoice of repair done Non-existent

Side panel - rear right side	178 µm	Door - rear right side	187 µm
------------------------------	--------	------------------------	--------

**Repainting 1:** Side panel - rear right side, Door - rear right side
