Expertise

Protocol number: 46184590
Order No. / Reference: 26508552
Inspection date: 26 Jun 2026

Model: Mondeo Turnier 2.0 EcoBlue Titanium

VIN: WF0FXXWPCFNY61509

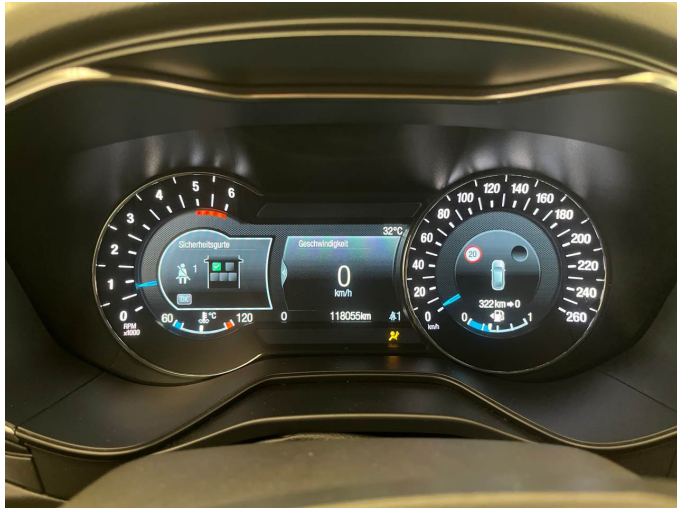
Figure 7: Instrument cluster

Mileage (Read) 118,055 km

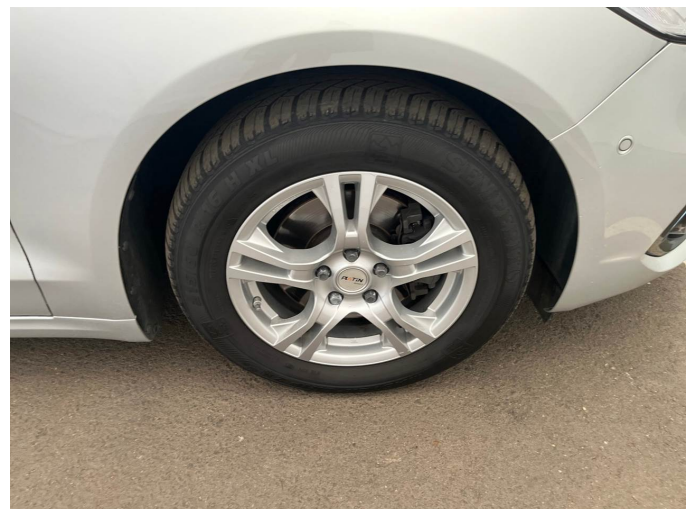
Figure 12: Mounted tyres

#	Tyre size	Type of tyre	Manufacturer	Tread depth
1)	215/60 R16 99H	Winter tyres on Light alloy	Semperit	3mm / 3mm
2)	215/60 R16 99H	Winter tyres on Light alloy	Continental	7mm / 7mm

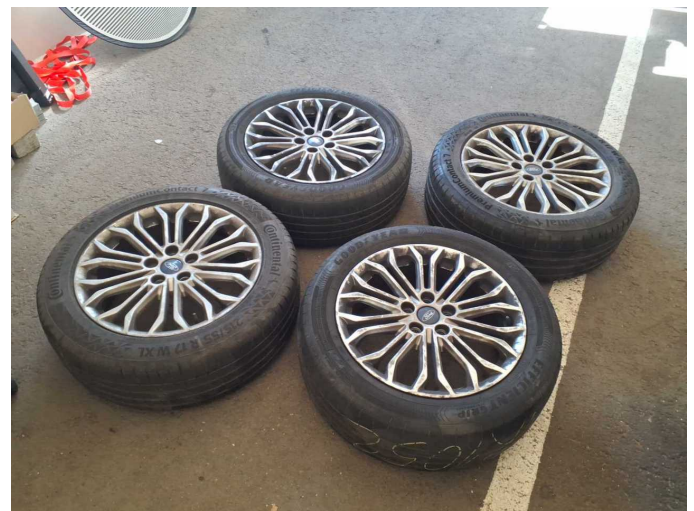
Figure 16: Additional tyres

#	Tyre size	Type of tyre	Manufacturer	Tread depth
1)	215/55 R17 98W	Summer tyres on Light alloy	Goodyear	6mm / 6mm
2)	215/55 R17 98W	Summer tyres on Light alloy	Continental	6mm / 6mm

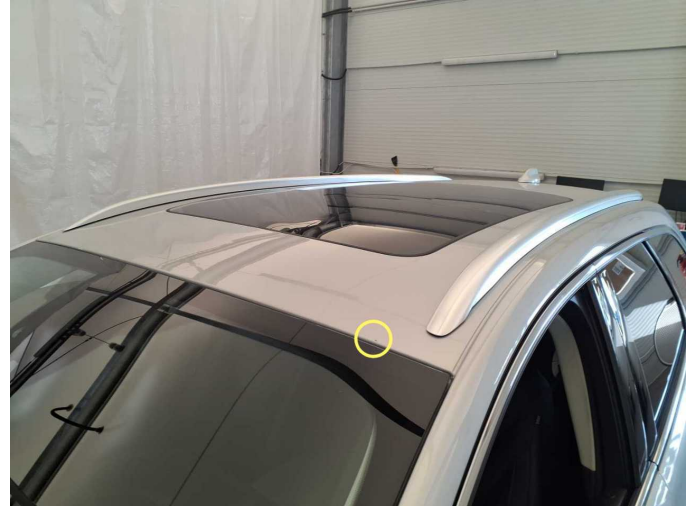
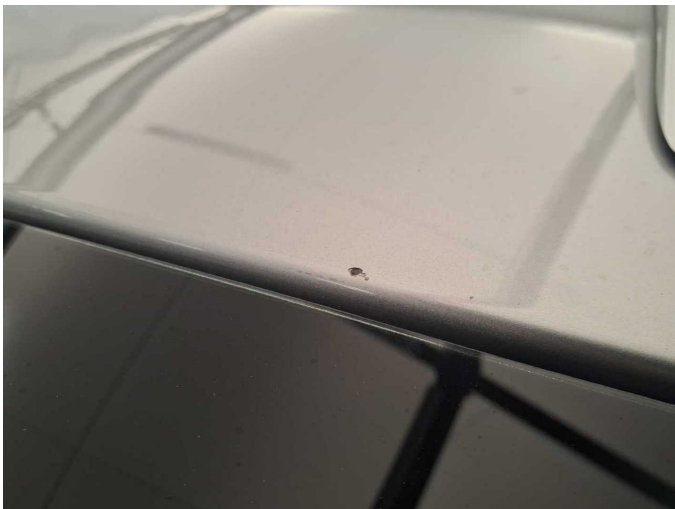
No.	Component group	Description
1	Roof	Roof - Stone chips - Smart repair
2	2nd wheel set	1 alloy rim - Scratched - Loss in value

Damage 1: Roof: Roof - Stone chips - Smart repair

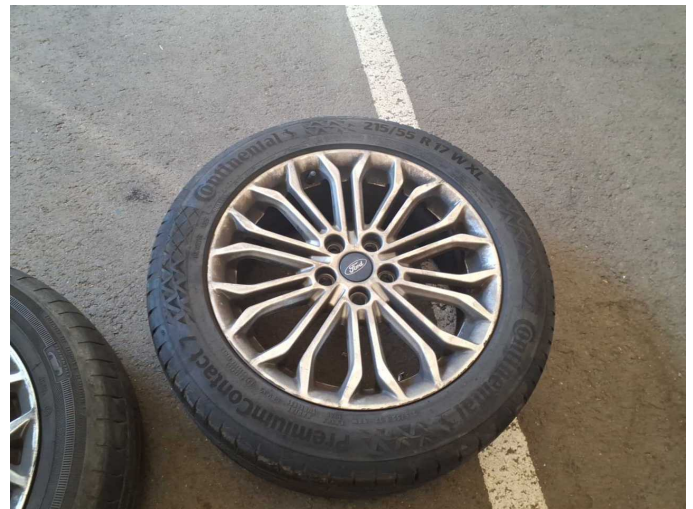
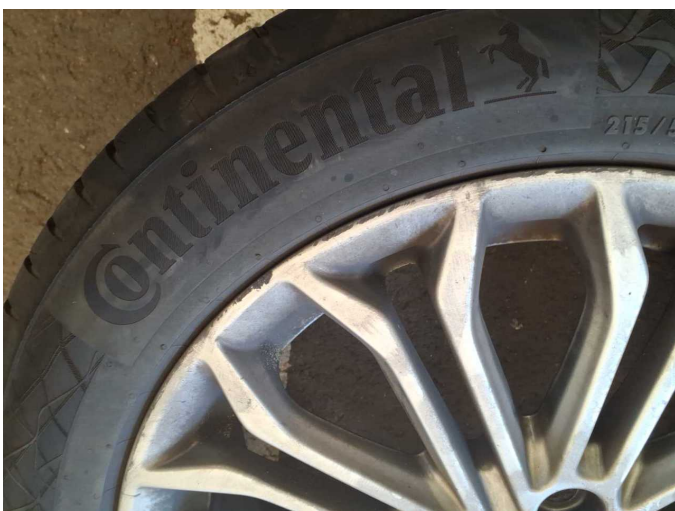
Damage 2: 2nd wheel set: 1 alloy rim - Scratched - Loss in value

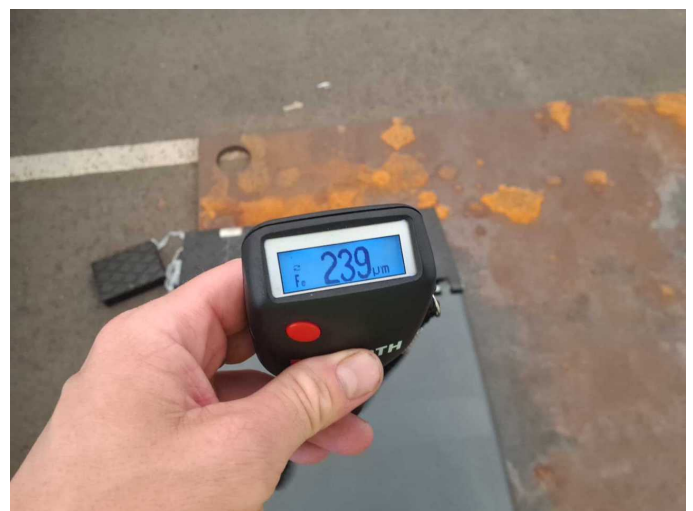
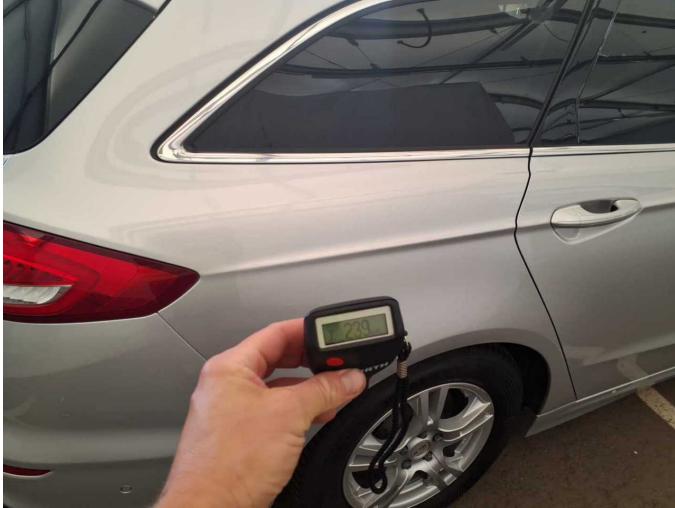
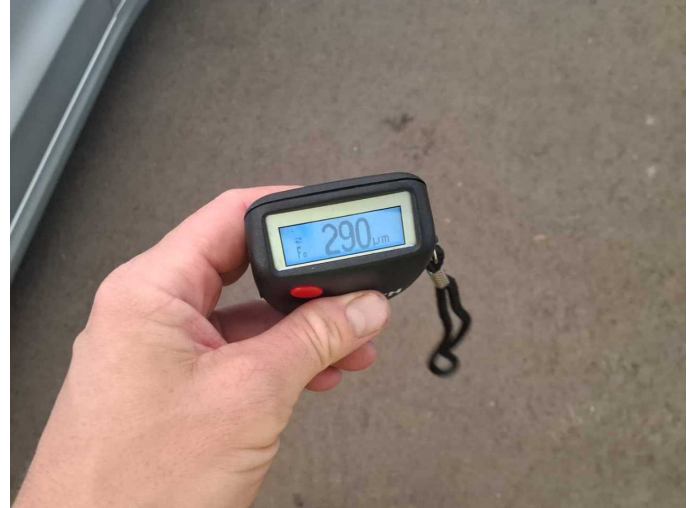
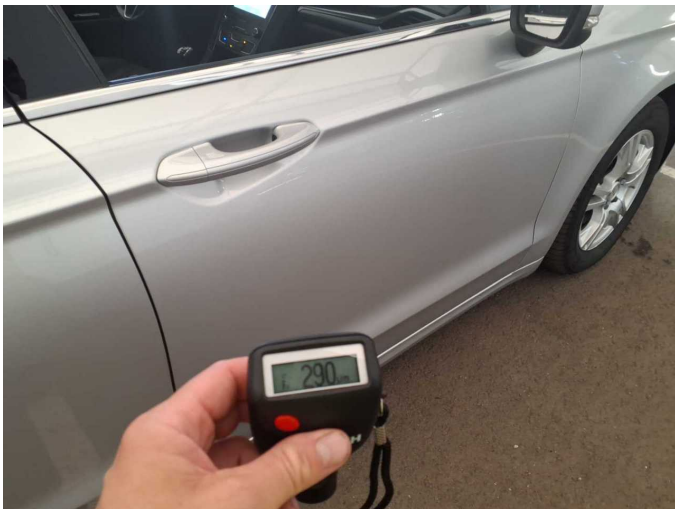
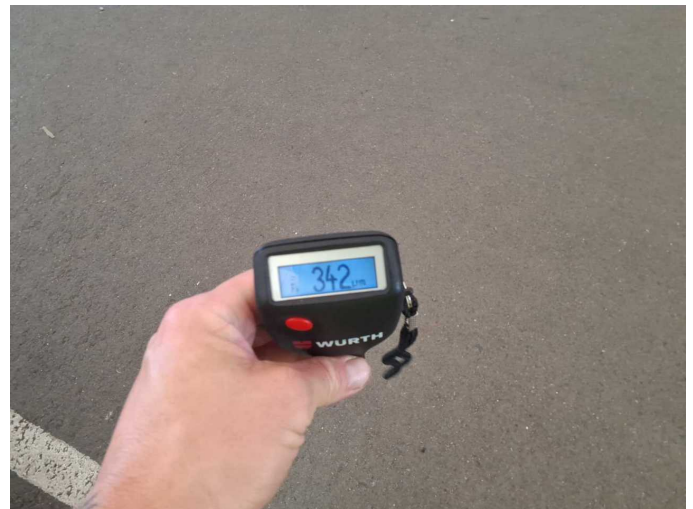
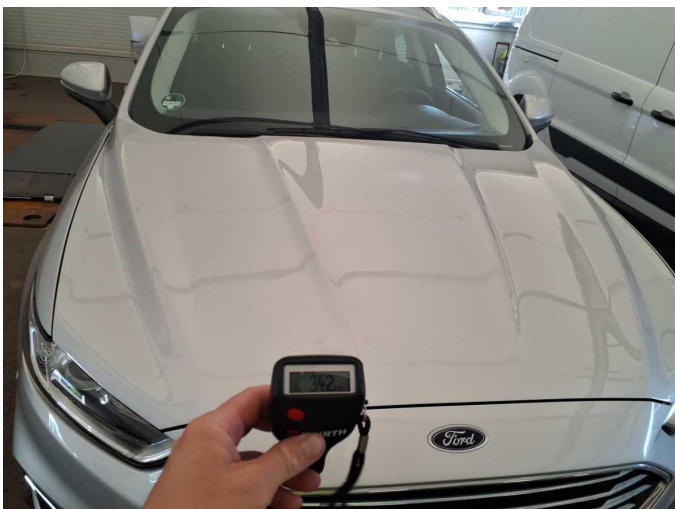
No.	Repainting
1	Bonnet, Side panel - rear right side, Door - front right side, Professionally carried out, Invoice of repair done

Bonnet	342 µm	Side panel - rear right side	239 µm
Door - front right side	290 µm

Repainting 1: Bonnet, Side panel - rear right side, Door - front right side
