Expertise

Protocol number: 46408214  
Order No. / Reference: 26521630  
Inspection date: 8 Jul 2026

Manufacturer: Volkswagen

Model: Passat Variant 1.4 TSI Plug-In-Hybrid DSG GTE

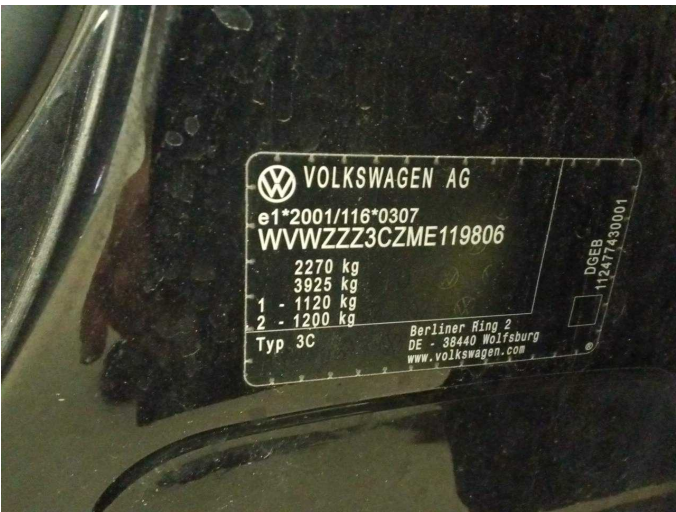
Figure 11: VIN

| VIN comparison | The vehicle identification number (VIN) was read from the vehicle and its conformity with the submitted documents was confirmed by the undersigned during the inspection. |

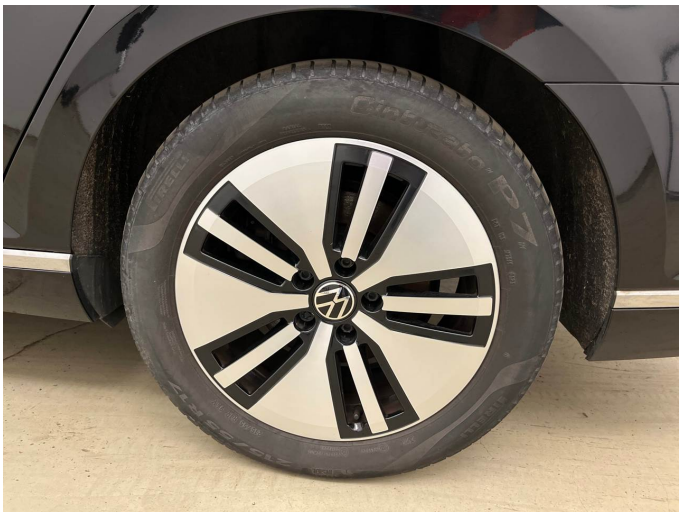
Figure 12: Mounted tyres

| Tyres | | | | |
|---|---|---|---|---|
| 1) | 215/55 R17 94V | Summer tires (with run-flat tires) on Light alloy | Pirelli | 5mm / 5mm |
| 2) | 215/55 R17 94V | Summer tires (with run-flat tires) on Light alloy | Pirelli | 4mm / 4mm |

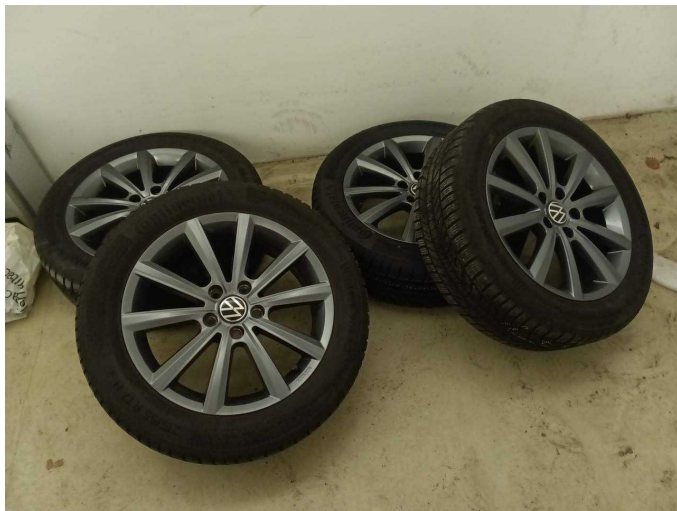
Figure 15: Additional tyres

| Tyres | | | | |
|---|---|---|---|---|
| 1) | 215/55 R17 94H | Winter tyres on Light alloy | Continental | 6mm / 6mm |
| 2) | 215/55 R17 94H | Winter tyres on Light alloy | Continental | 8mm / 8mm |

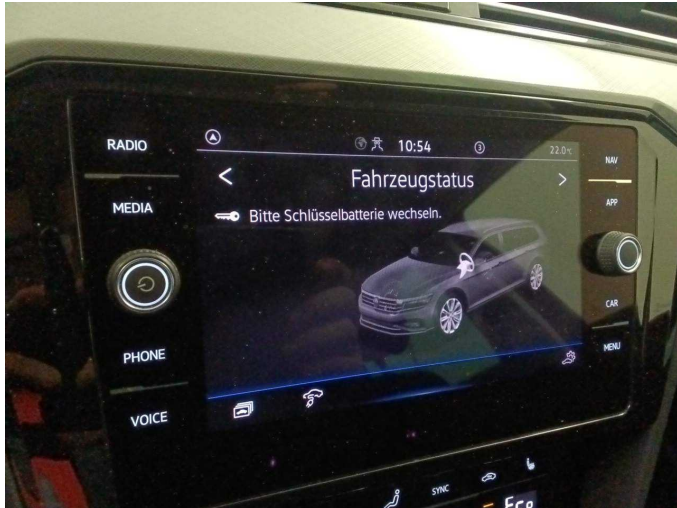
**Damage 1:** Equipment: Other keys (Batterie) - Empty - Replace

| No. | Component group | Description |
|---|---|---|
| 1 | Equipment | Other keys (Batterie) - Empty - Replace |

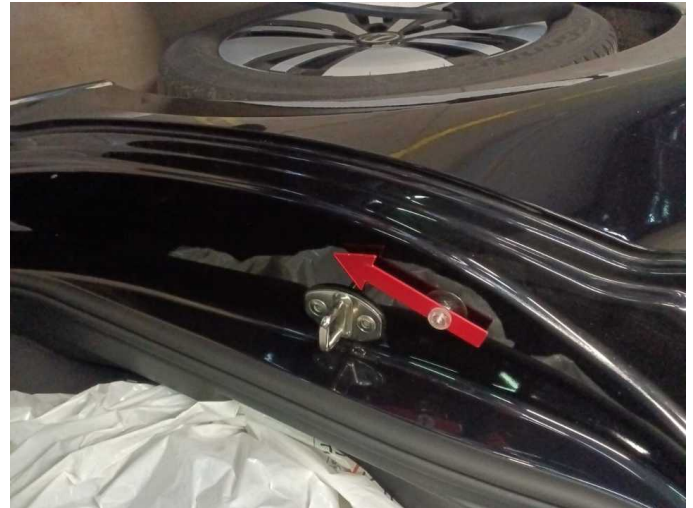
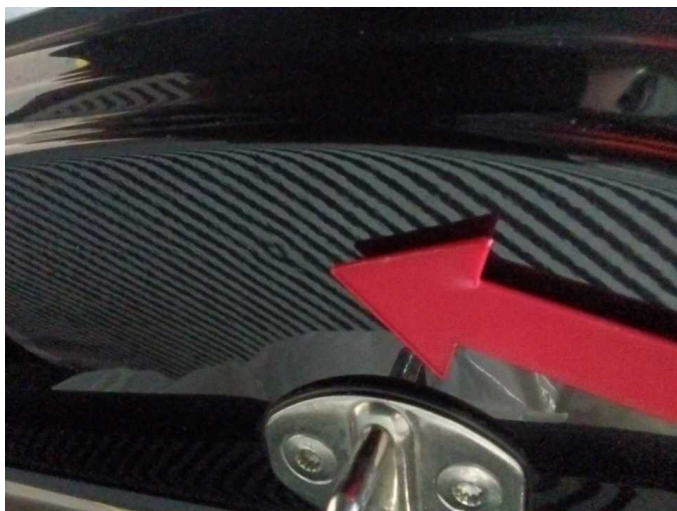
**Damage 2:** Side panel - rear right side: Sill - dent(s) - Smooth repair work

| No. | Component group | Description |
|---|---|---|
| 2 | Side panel - rear right side | Sill - dent(s) - Smooth repair work |

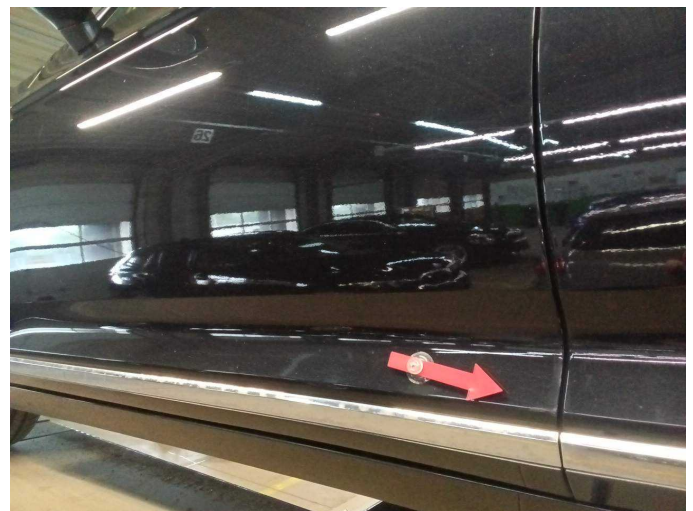
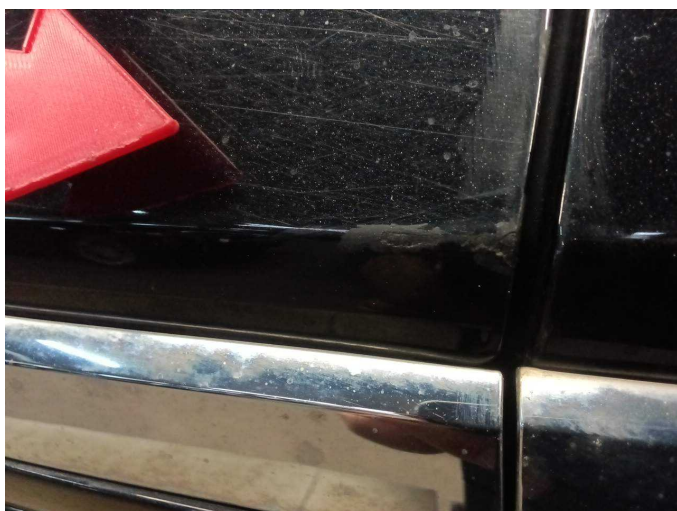
**Damage 3:** Door - front left side: Door - Scratch(es) - Smart repair

| No. | Component group | Description |
|---|---|---|
| 3 | Door - front left side | Door - Scratch(es) - Smart repair |

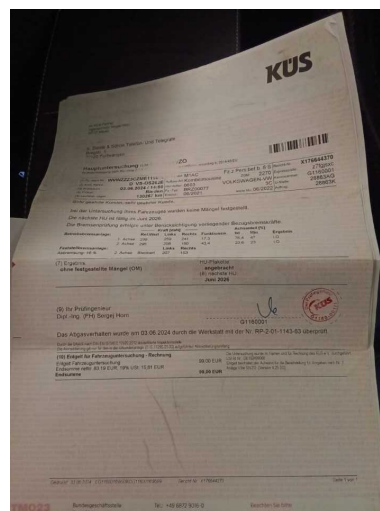
**Damage 4:** Misc.: Main inspection - Due - Perform

| No. | Component group | Description |
|---|---|---|
| 4 | Misc. | Main inspection - Due - Perform |

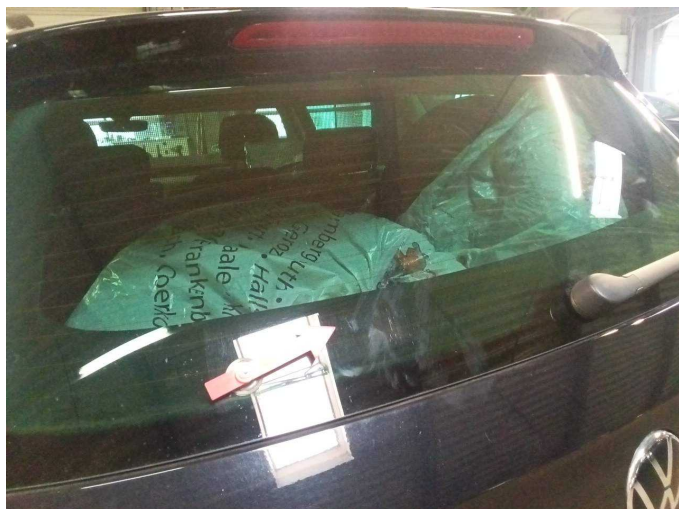
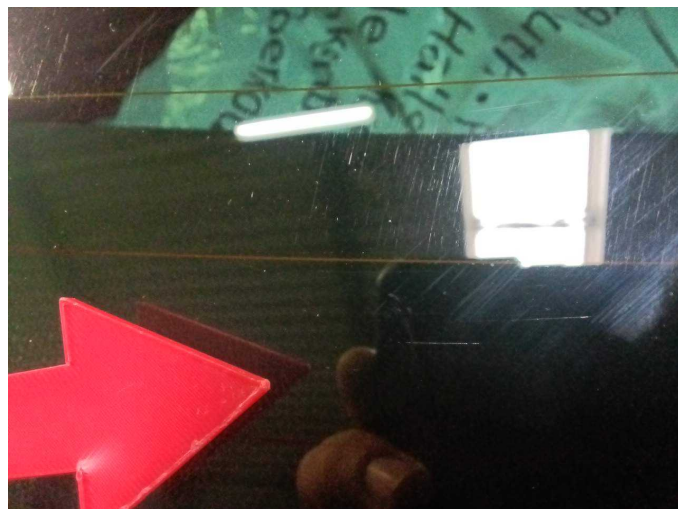
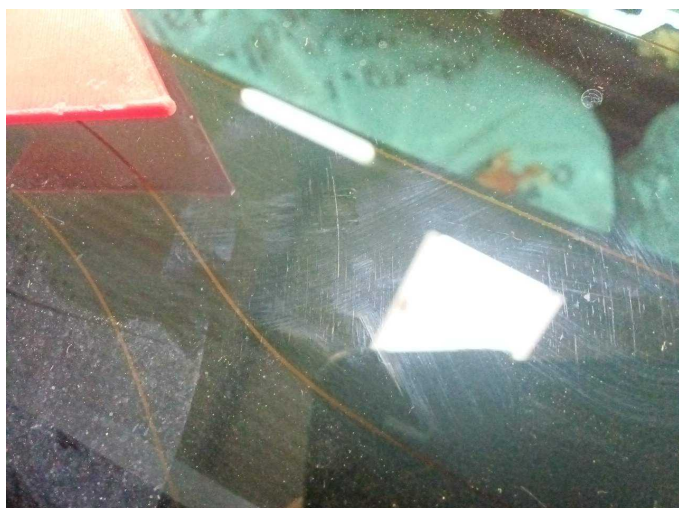
**Damage 5:** Vehicle glazing: Rear window - Scratch(es) - Loss in value

| No. | Component group | Description |
|---|---|---|
| 5 | Vehicle glazing | Rear window - Scratch(es) - Loss in value |

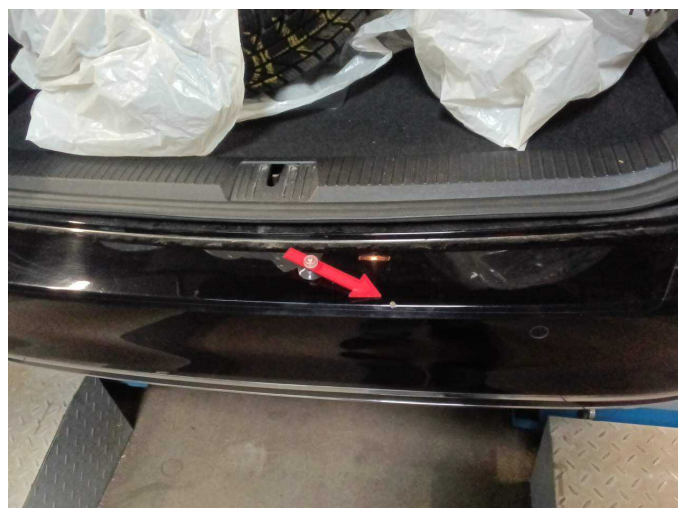
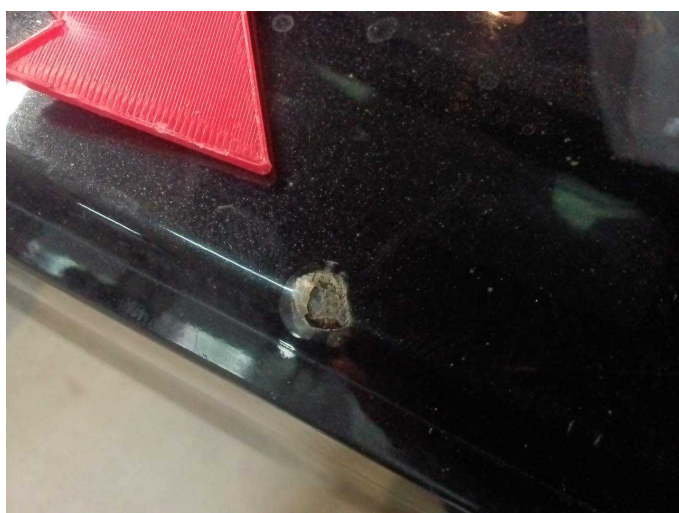
**Damage 6:** Rear bumper: Rear bumper - Scratch(es) - Paint

| No. | Component group | Description |
|---|---|---|
| 6 | Rear bumper | Rear bumper - Scratch(es) - Paint |

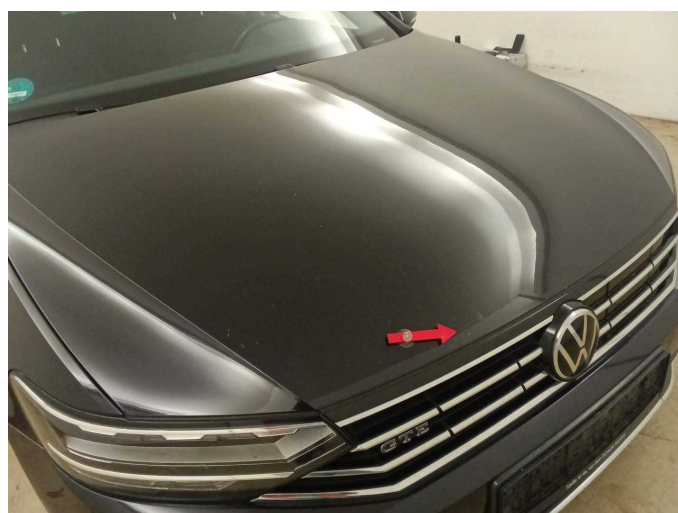
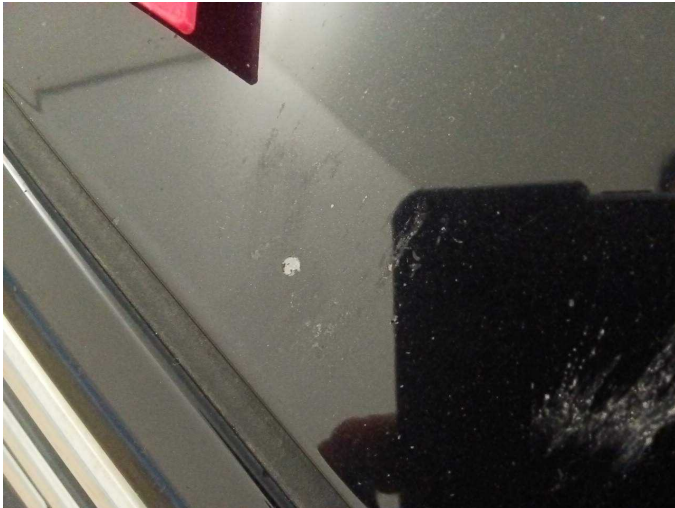
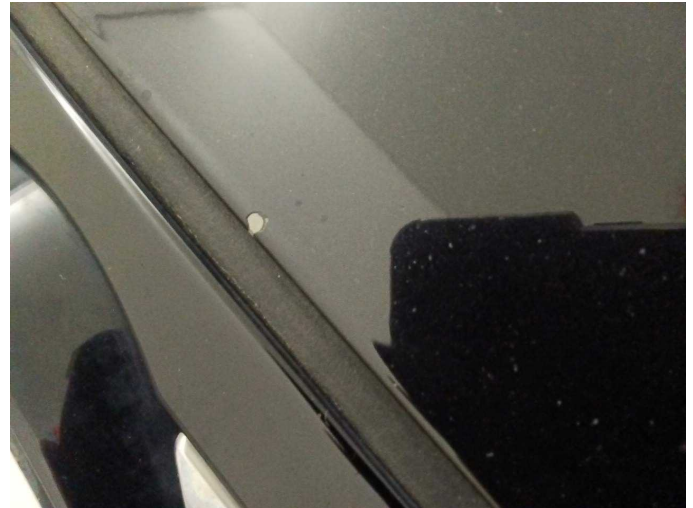
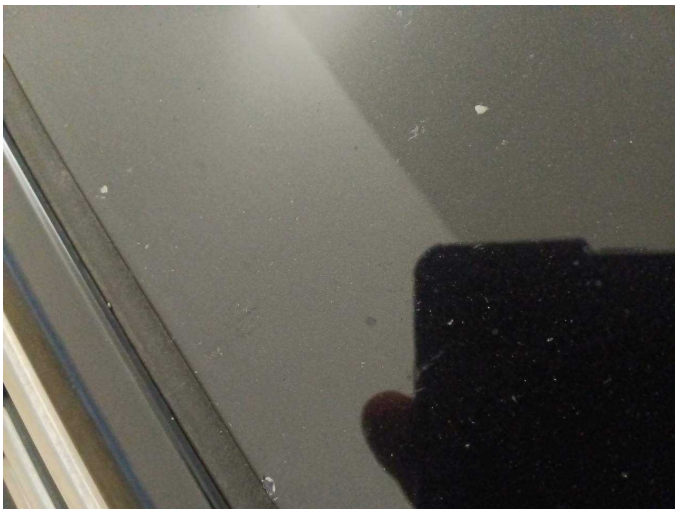
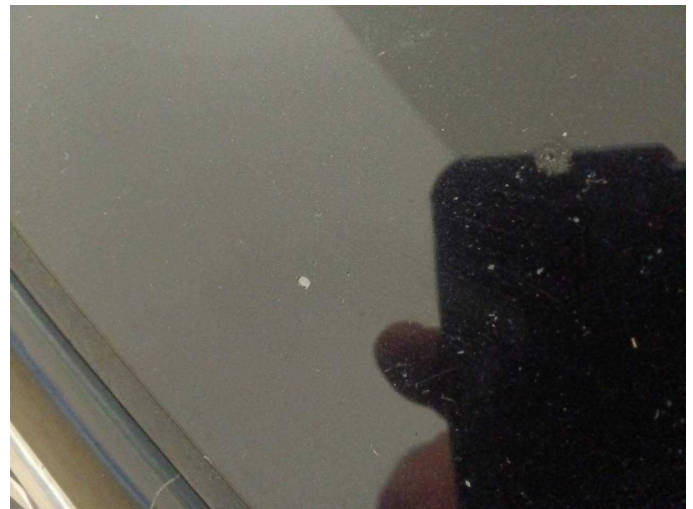
**Damage 7:** Bonnet: Bonnet - Stone chips - Paint

| No. | Component group | Description |
|---|---|---|
| 7 | Bonnet | Bonnet - Stone chips - Paint |

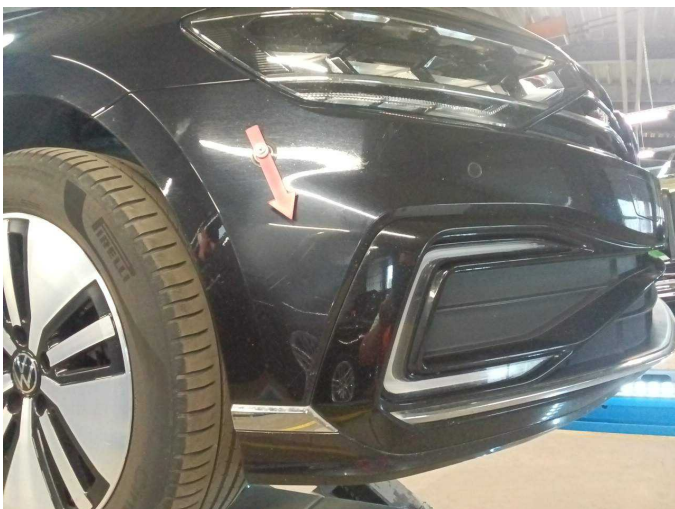
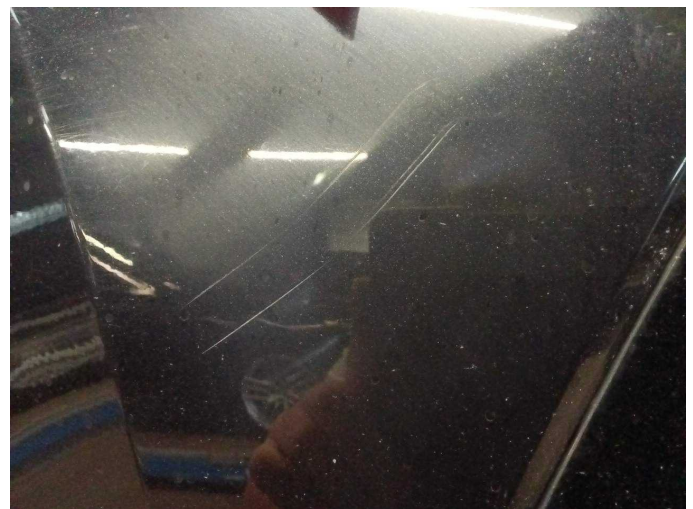
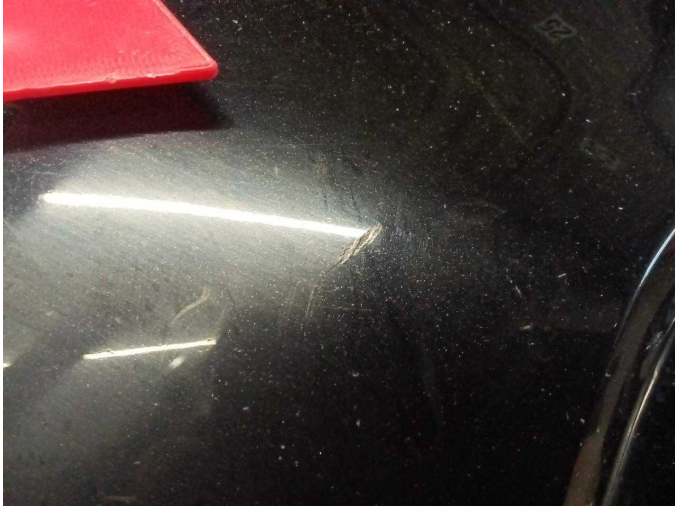
**Damage 8:** Front bumper: Front bumper - Scratch(es) - Paint

| No. | Component group | Description |
|---|---|---|
| 8 | Front bumper | Front bumper - Scratch(es) - Paint |

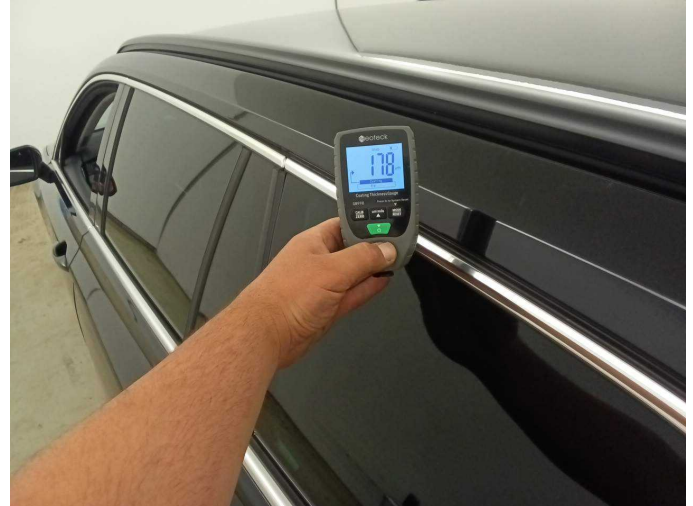
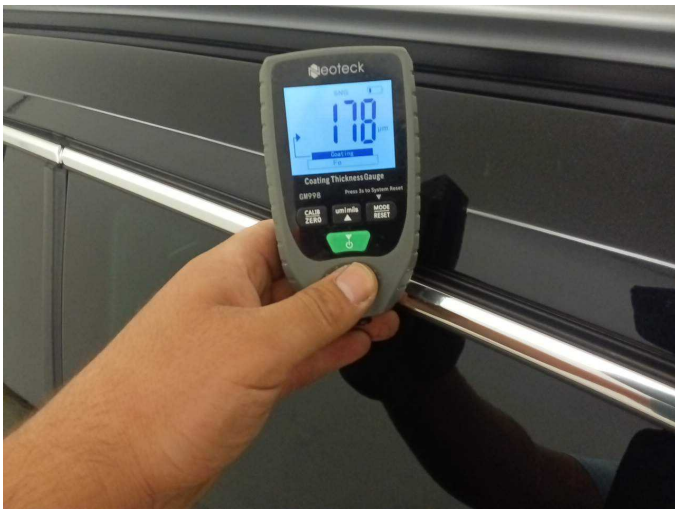
**Roof rail - left side:** 178 µm

- 1 Roof rail - left side, Mudguard - left side, Side panel - rear left side, Door - rear left side, Door - front left side, Professionally carried out, Invoice of repair done Non-existent

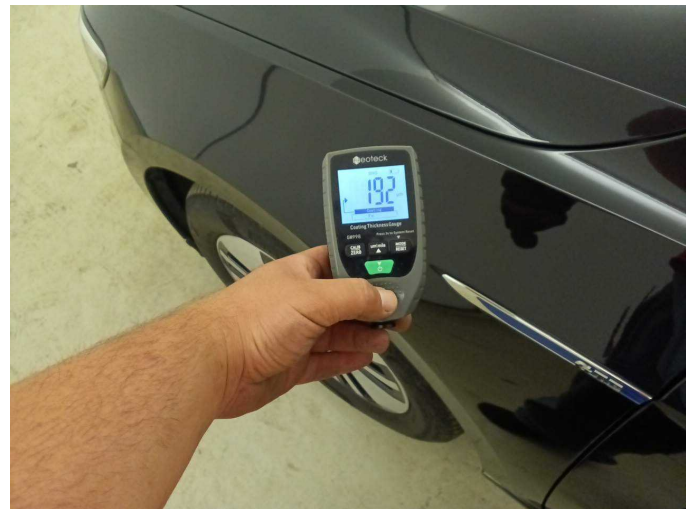
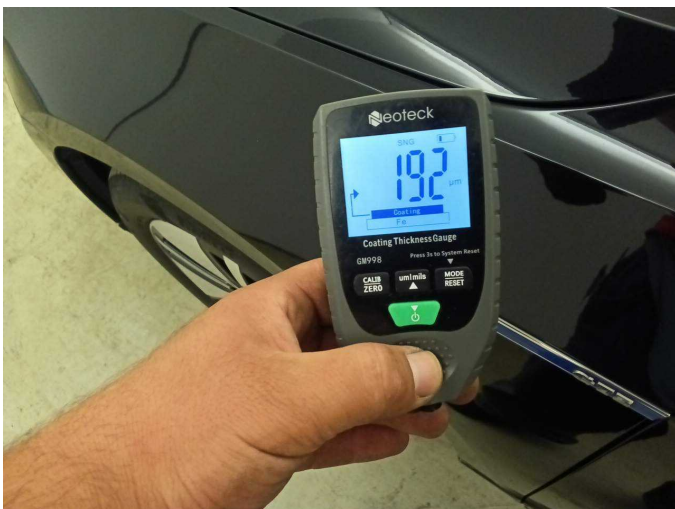
**Mudguard - left side:** 192 µm

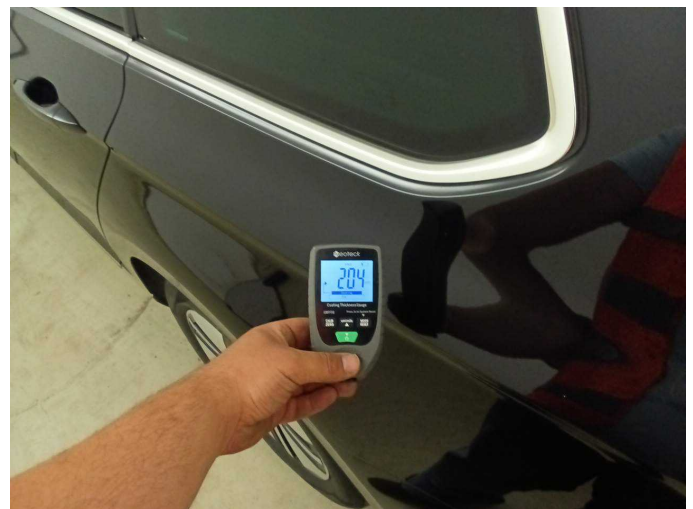
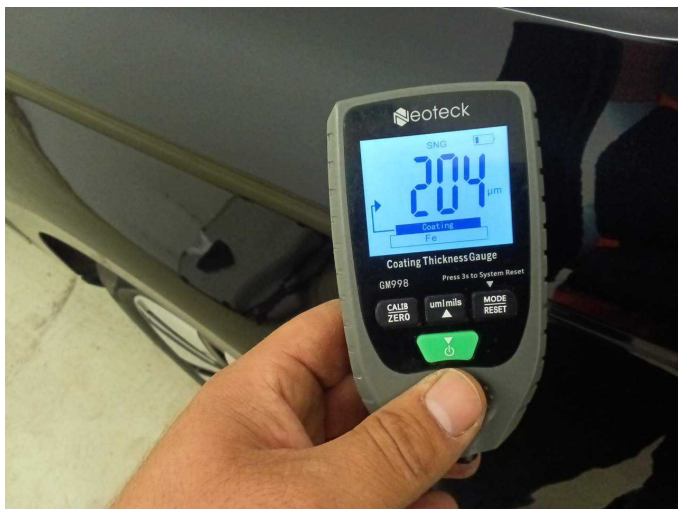
**Side panel - rear left side:** 204 µm

Side panel - rear left side: 204 µm

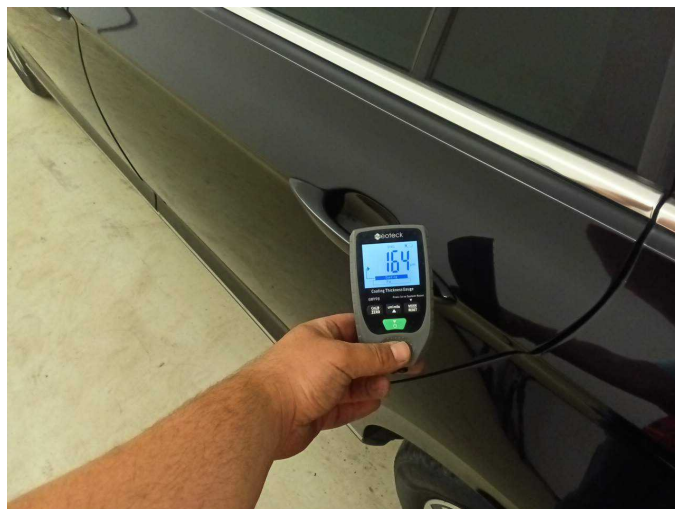
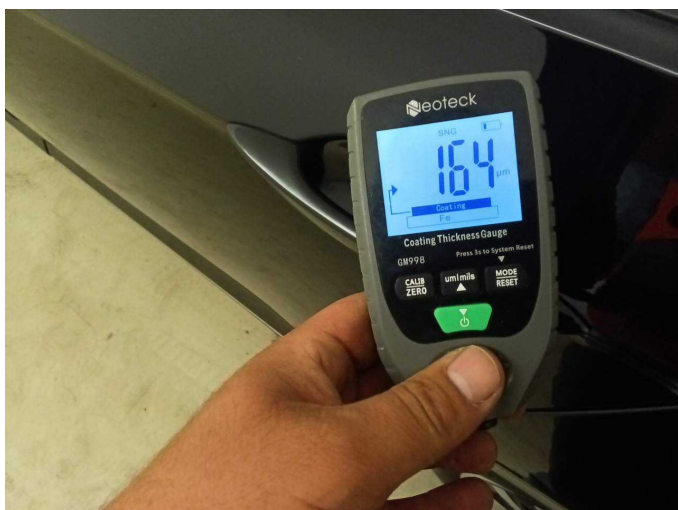
Door - rear left side: 164 µm

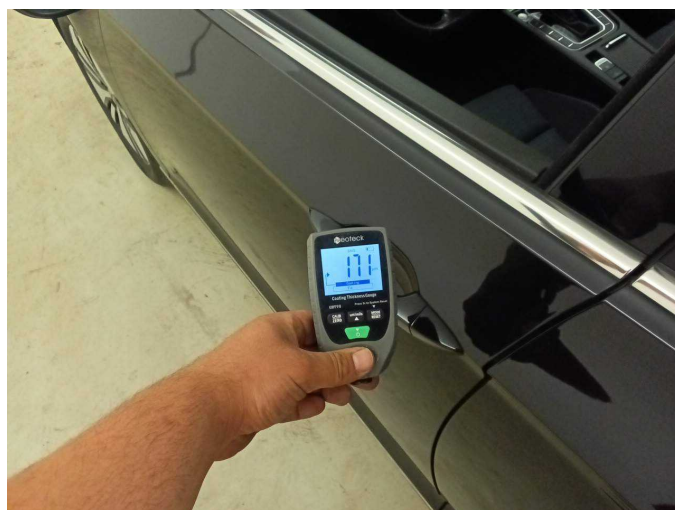
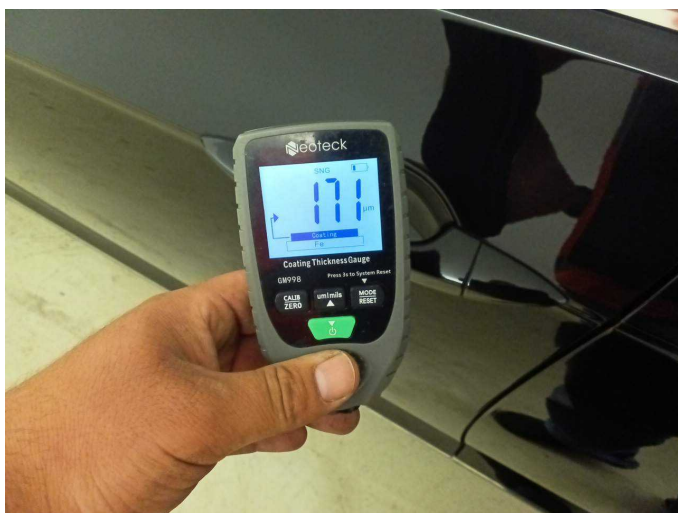
Door - front left side: 171 µm
