Expertise

Protocol number: 46347225  
Order No. / Reference: 26597639  
Inspection date: 6 Jul 2026

Manufacturer: Volkswagen

Model: Touran 2.0 TDI SCR DSG Comfortline

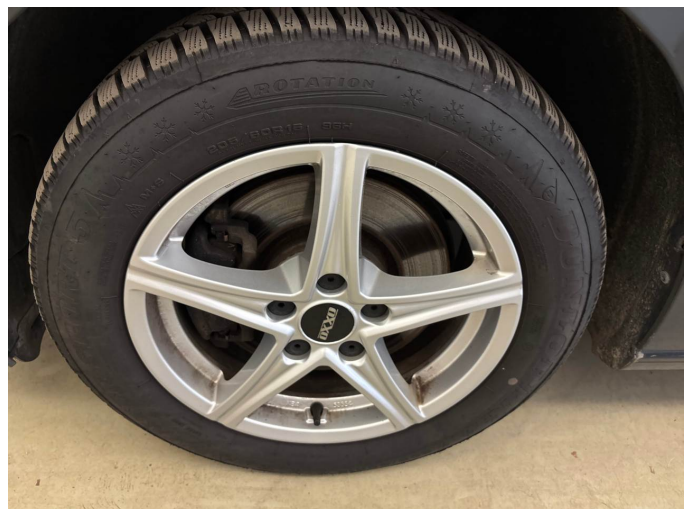
| # | Tyre size | Type of tyre | Manufacturer | Tread depth |
|---|---|---|---|---|
| 1) | 205/60 R16 96H | Winter tyres on Light alloy | Dunlop | 5mm / 5mm |
| 2) | 205/60 R16 96H | Winter tyres on Light alloy | Dunlop | 5mm / 5mm |

Figure 12: Mounted tyres

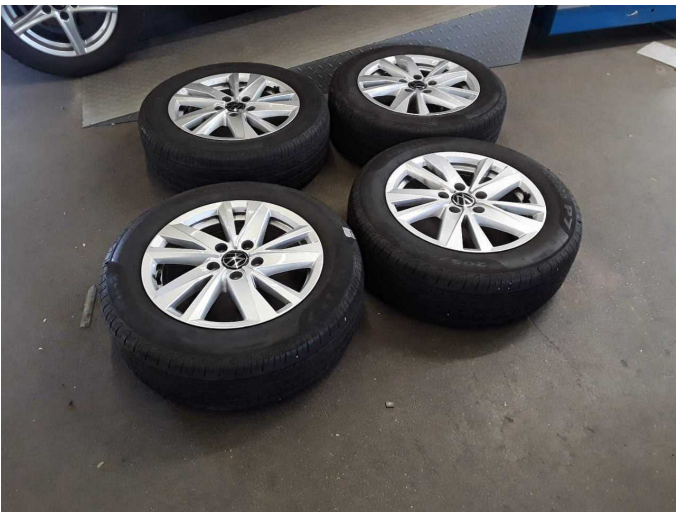
| # | Tyre size | Type of tyre | Manufacturer | Tread depth |
|---|---|---|---|---|
| 1) | 205/60 R16 96V | Summer tyres on Light alloy | Pirelli | 4mm / 4mm |
| 2) | 205/60 R16 96V | Summer tyres on Light alloy | Pirelli | 4mm / 4mm |

Figure 17: Additional tyres

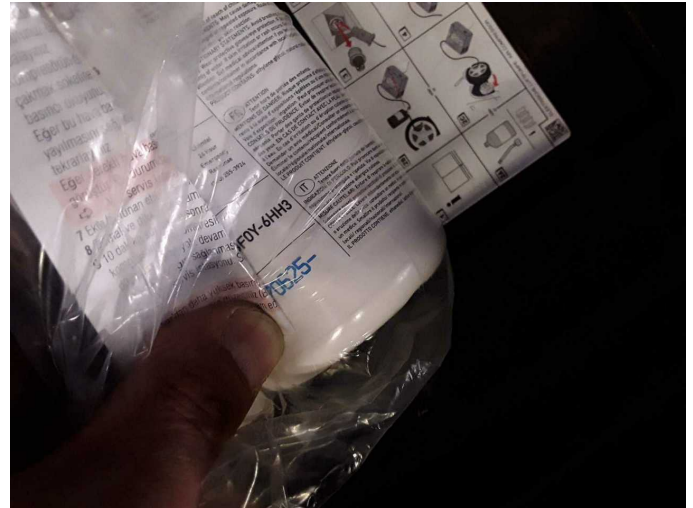
| No. | Component group | Description |
|---|---|---|
| 1 | Equipment | Tirefit filler - Expired - Replace |

**Damage 1:** Equipment: Tirefit filler - Expired - Replace

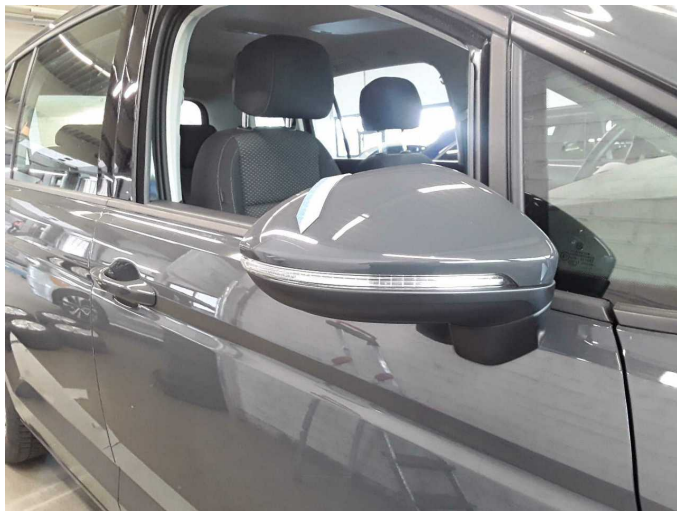
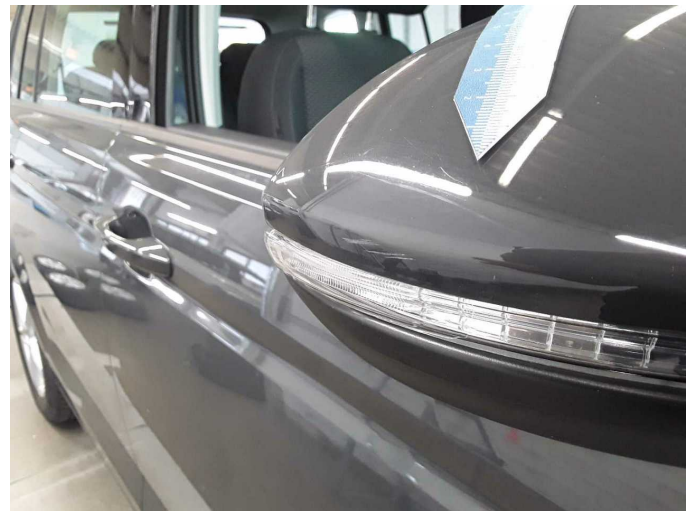
| No. | Component group | Description |
|---|---|---|
| 2 | Wing mirror - right side | Cap - Scratch(es) - Smart repair |

**Damage 2:** Wing mirror - right side: Cap - Scratch(es) - Smart repair

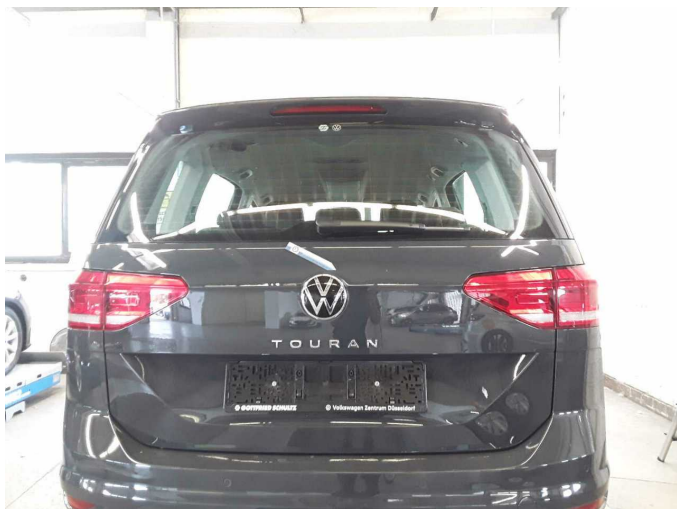
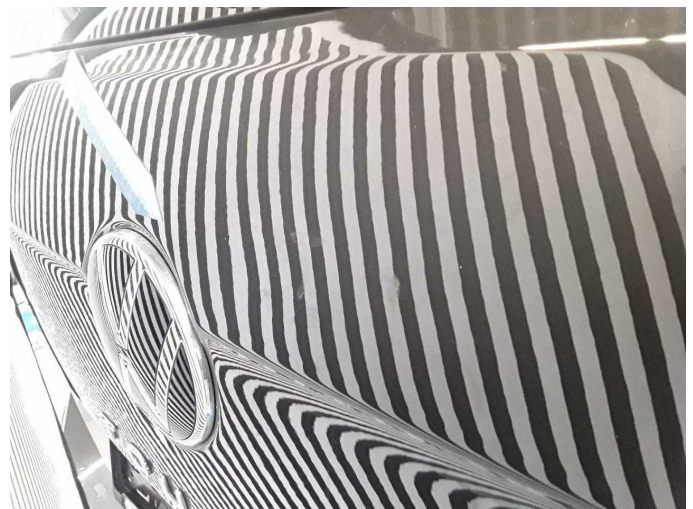
| No. | Component group | Description |
|---|---|---|
| 3 | Boot lid / rear door | Boot lid - dent(s) - Smooth repair work |

**Damage 3:** Boot lid / rear door: Boot lid - dent(s) - Smooth repair work

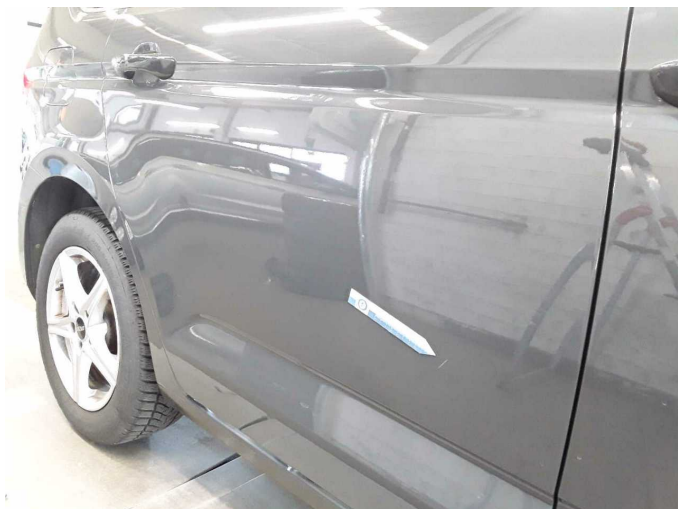
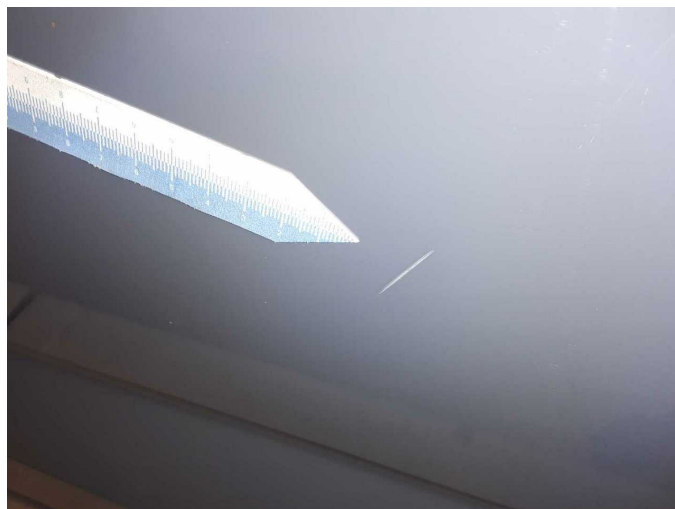
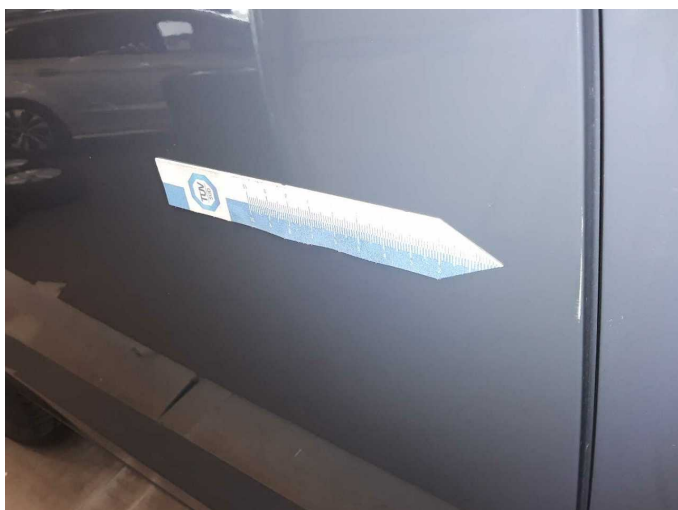
| No. | Component group | Description |
|---|---|---|
| 4 | Door - rear right side | Door - Scratch(es) - Paint |

**Damage 4:** Door - rear right side: Door - Scratch(es) - Paint

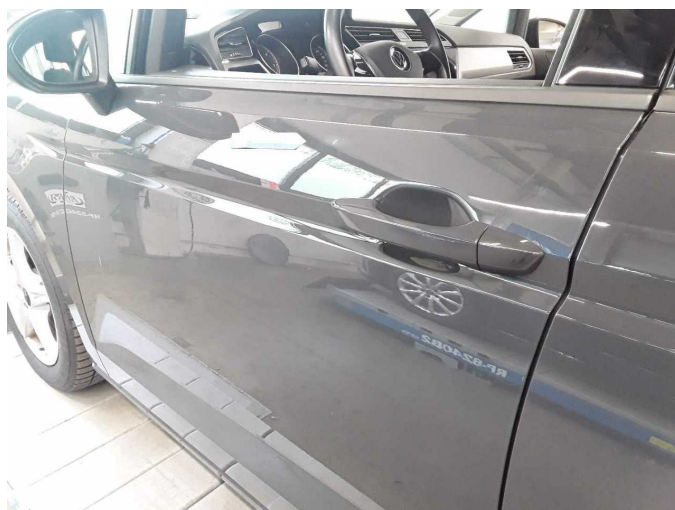
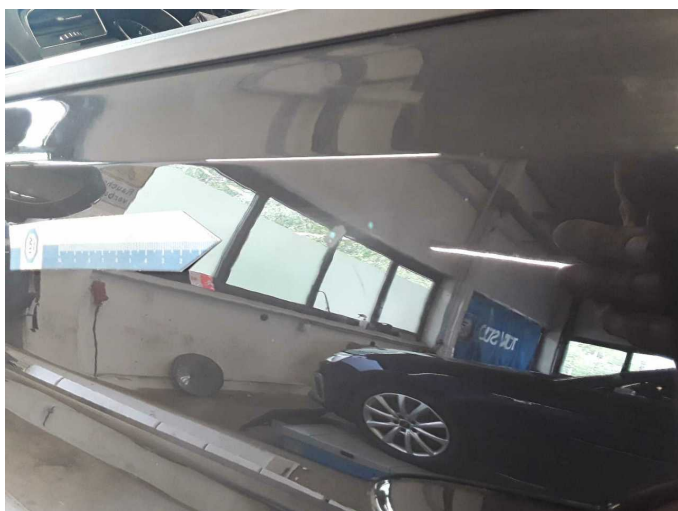
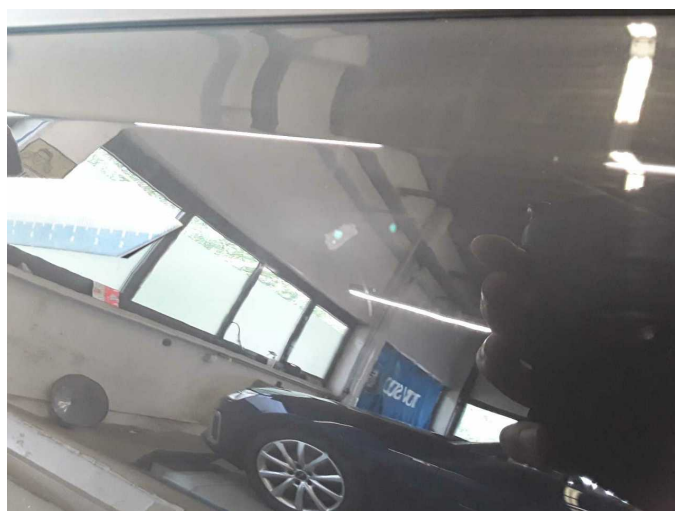
| No. | Component group | Description |
|---|---|---|
| 5 | Door - front left side | Door (Klarlack abgeblättert) - Paint defect - Paint |

**Damage 5:** Door - front left side: Door (Klarlack abgeblättert) - Paint defect - Paint

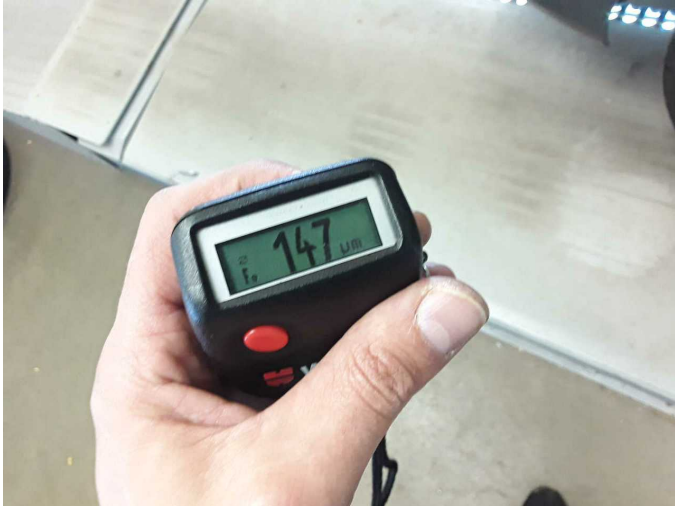
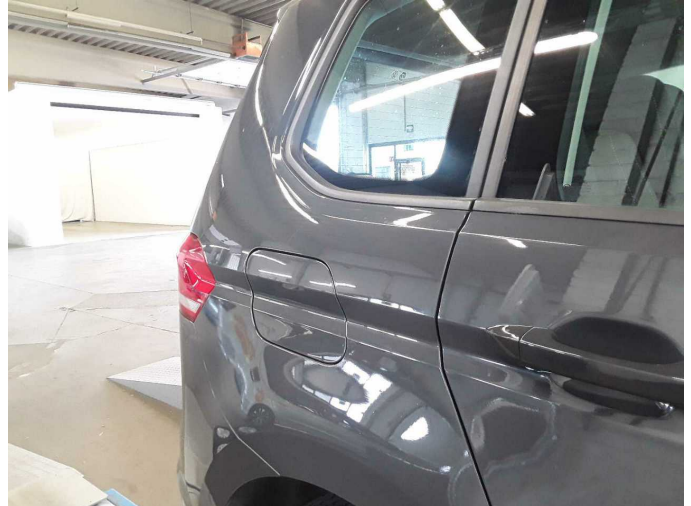
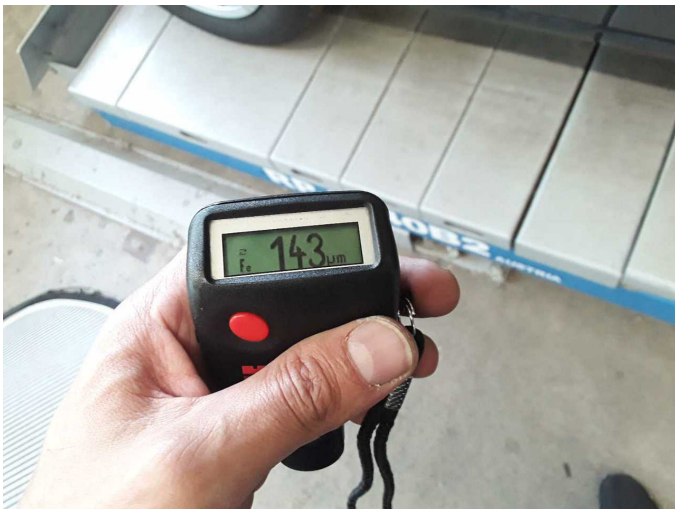
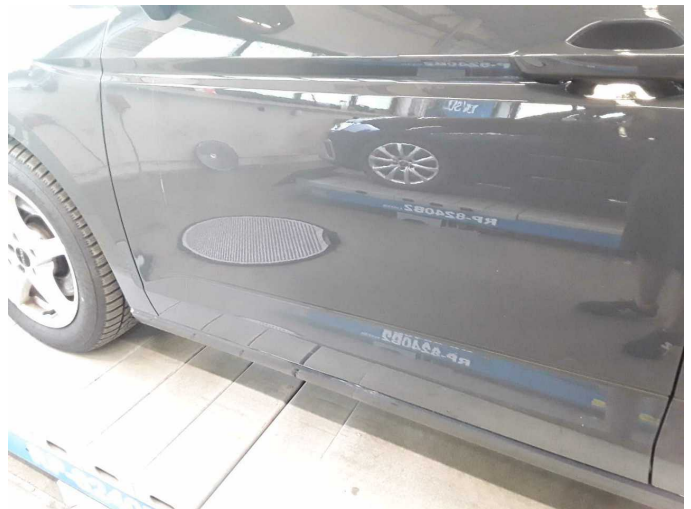
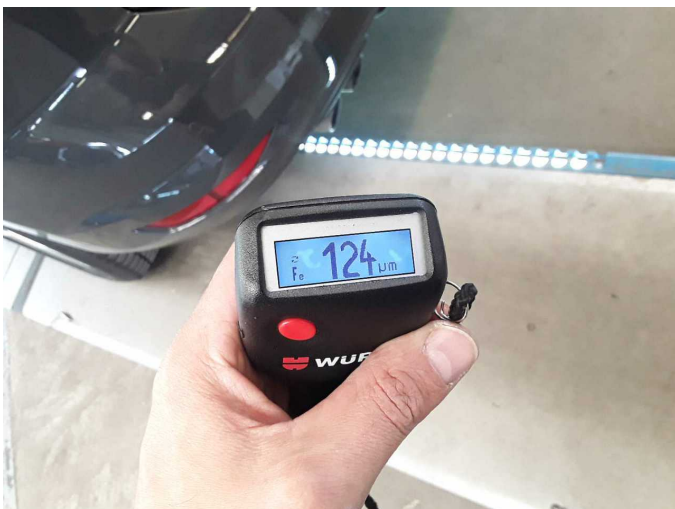
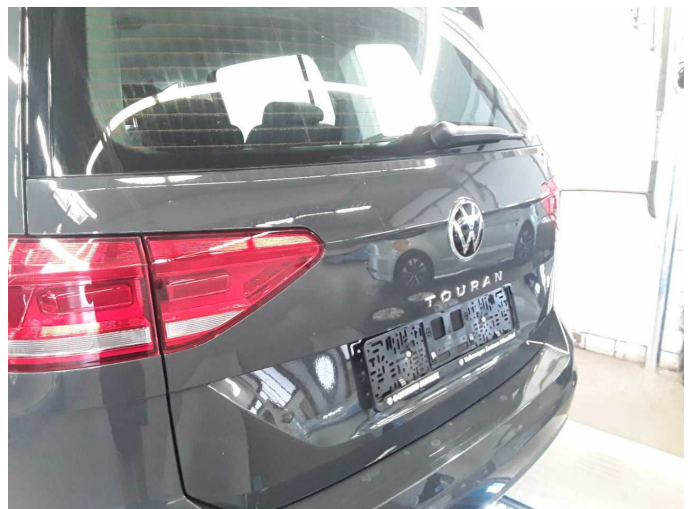
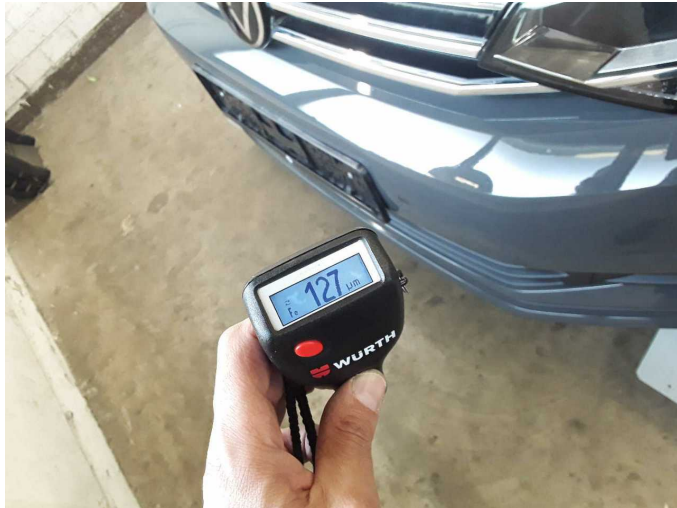
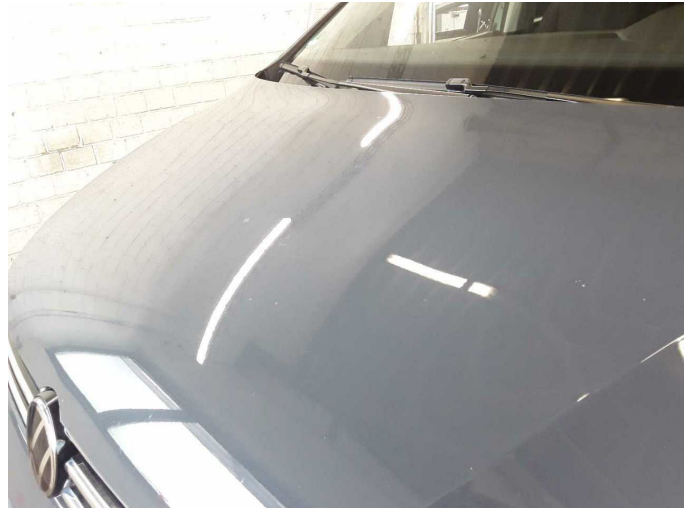
| No. | Repainting |
|---|---|
| 1 | Boot lid / rear door, Bonnet, Side panel - rear right side, Door - front left side, Professionally carried out, Invoice of repair done Non-existent |

**Repainting 1:** Boot lid / rear door, Bonnet, Side panel - rear right side,  
Door - front left side
