Expertise

Protocol number: 46447384  
Order No. / Reference: 26655695  
Inspection date: 10 Jul 2026

Manufacturer: Opel

Model: Grandland 1.5 D Automatik Elegance

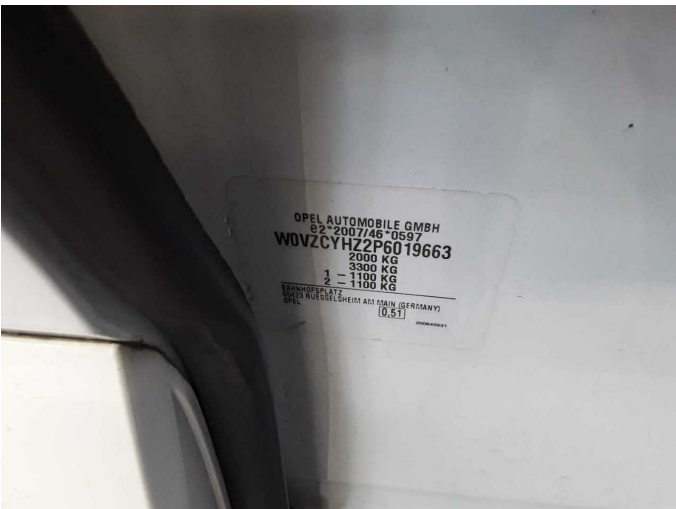
Figure 11: VIN

| VIN comparison | The vehicle identification number (VIN) was read from the vehicle and its conformity with the submitted documents was confirmed by the undersigned during the inspection. |

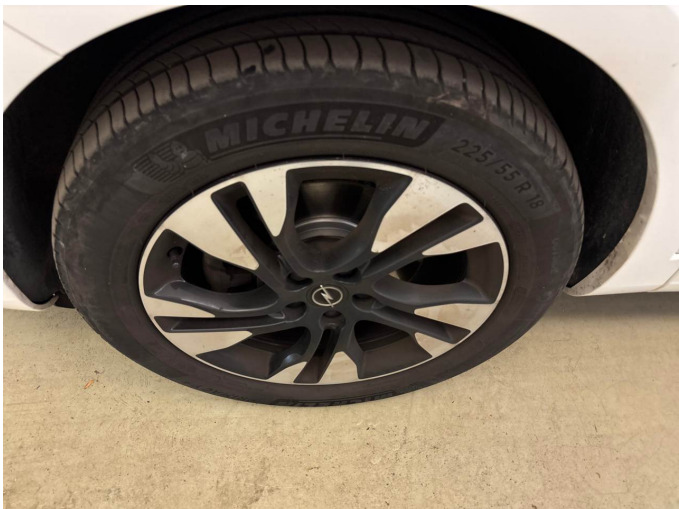
Figure 12: Mounted tyres

| # | Tyre size | Type of tyre | Manufacturer | Tread depth |
|---|---|---|---|---|
| 1) | 225/55 R18 102V | Summer tyres on Light alloy | Michelin | 4mm / 4mm |
| 2) | 225/55 R18 102V | Summer tyres on Light alloy | Michelin | 4mm / 4mm |

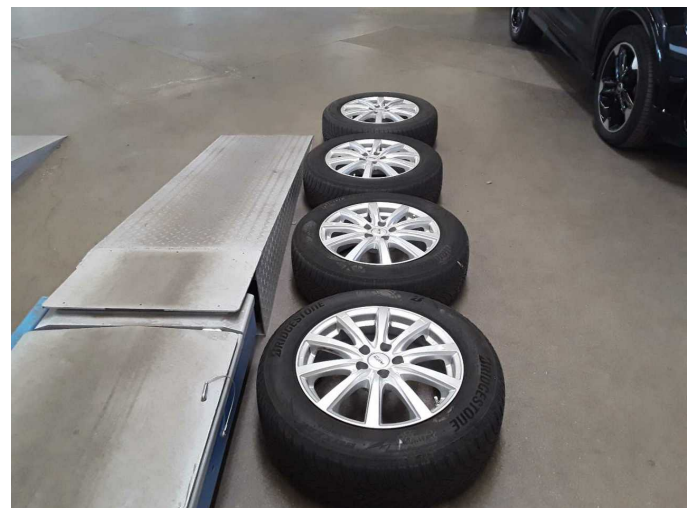
Figure 16: Additional tyres

| # | Tyre size | Type of tyre | Manufacturer | Tread depth |
|---|---|---|---|---|
| 1) | 215/65 R17 103H | Winter tyres on Light alloy | Bridgestone | 4mm / 4mm |
| 2) | 215/65 R17 103H | Winter tyres on Light alloy | Bridgestone | 4mm / 4mm |

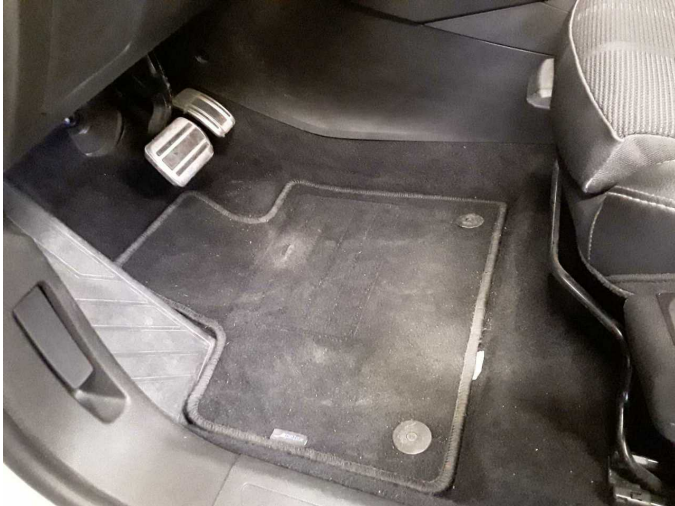
| No. | Component group | Description |
|---|---|---|
| 1 | Trim / covers | Floor mats - Damaged - Replace |

**Damage 1:** Trim / covers: Floor mats - Damaged - Replace

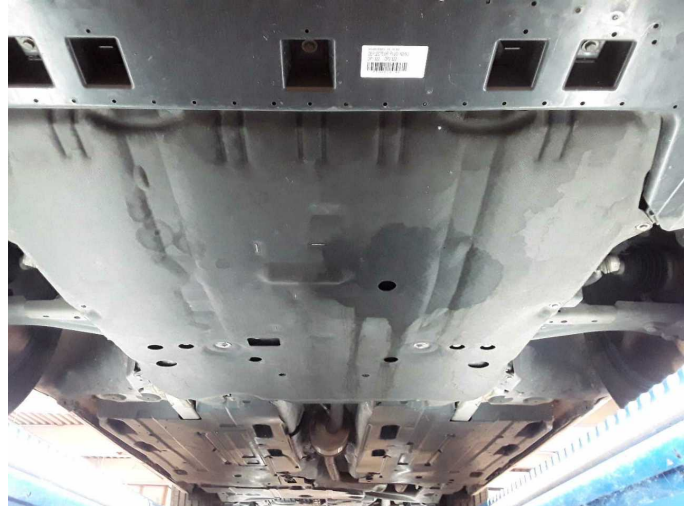
| No. | Component group | Description |
|---|---|---|
| 2 | Engine | Engine - Leaking - Perform diagnosis |

**Damage 2:** Engine: Engine - Leaking - Perform diagnosis

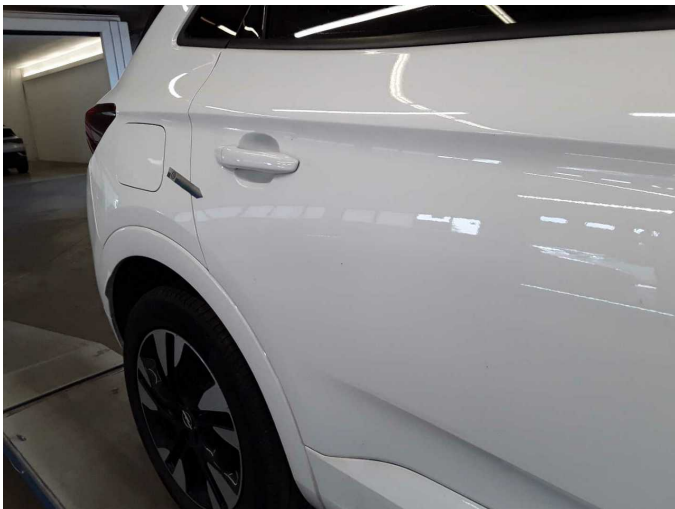
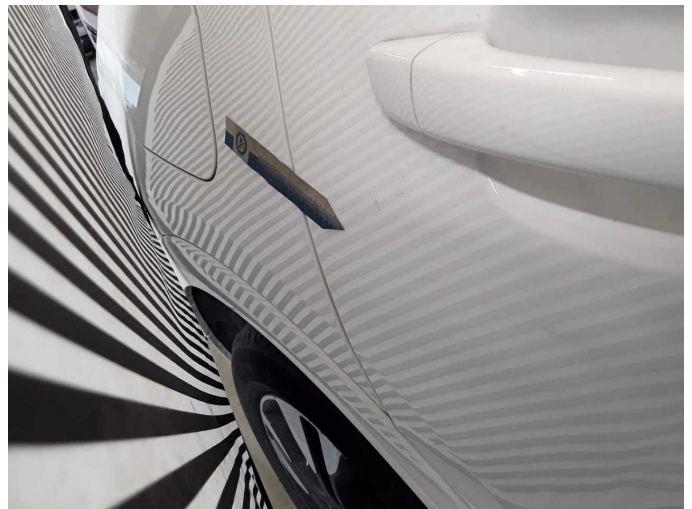
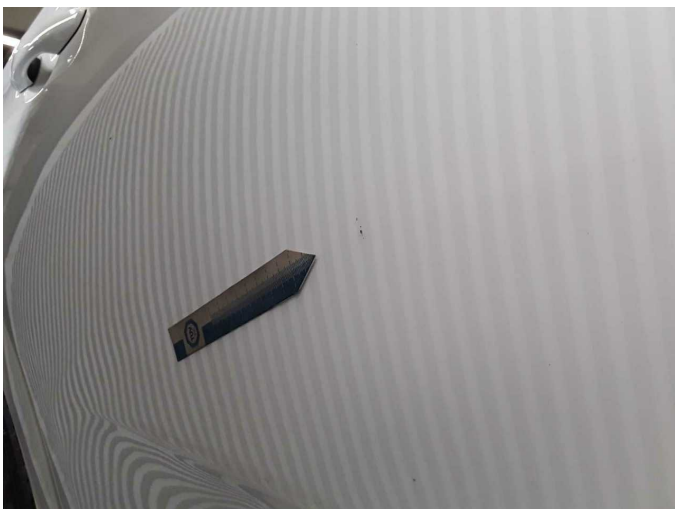
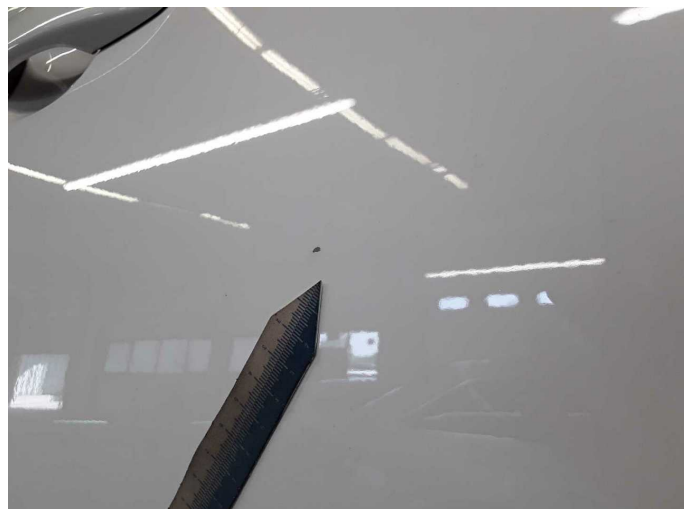
| No. | Component group | Description |
|---|---|---|
| 4 | Door - rear right side | Door - Dent / paintcoat damage - Smart repair |

**Damage 4:** Door - rear right side: Door - Dent / paintcoat damage - Smart repair
