Expertise

Protocol number: 45913286
Order No. / Reference: 26361935
Inspection date: 12 Jun 2026

Model: Octavia Combi 2.0 TDI DSG Style

VIN: TMBJJ0NXXMY192056

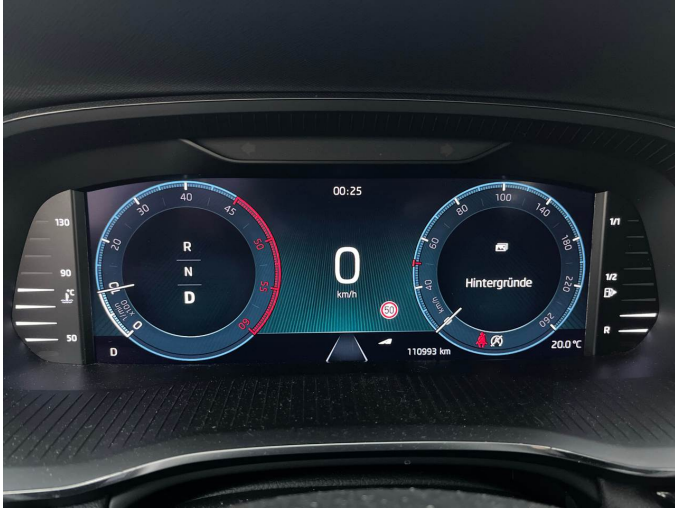
Figure 7: Instrument cluster

Mileage (Read) 110,993 km

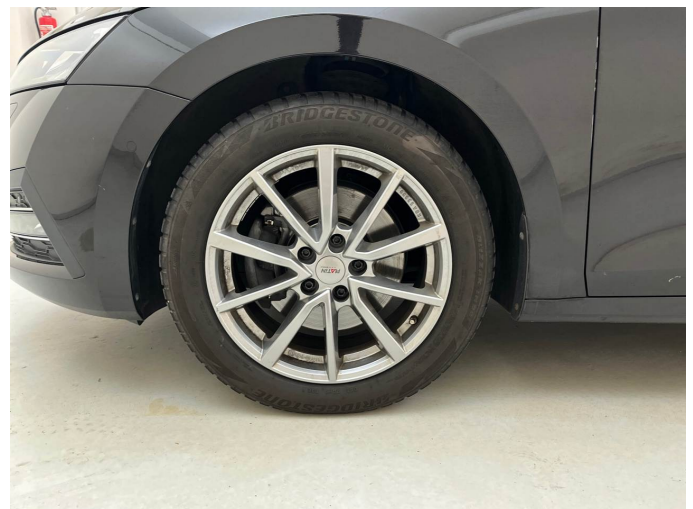
Figure 12: Mounted tyres

| Mounted tyres | | | | |
|---|---|---|---|---|
| 1) | 205/55 R17 91H | Winter tyres on Light alloy | Bridgestone | 4mm / 4mm |
| 2) | 205/55 R17 91H | Winter tyres on Light alloy | Bridgestone | 6mm / 6mm |

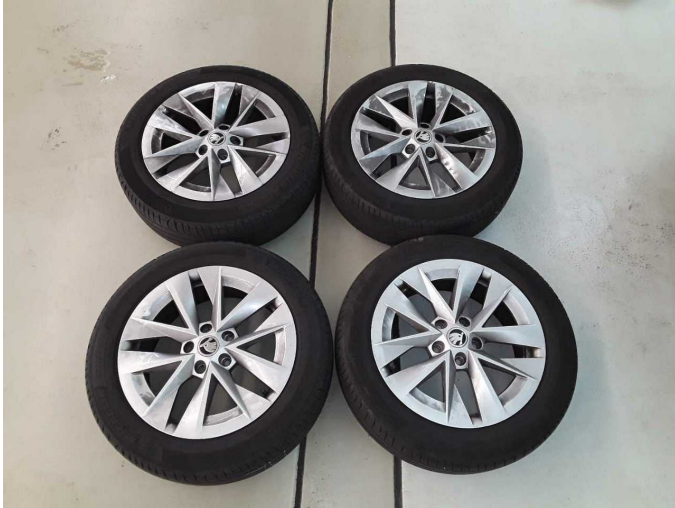
Figure 19: Additional tyres

| Additional tyres | | | | |
|---|---|---|---|---|
| 1) | 205/55 R17 91V | Summer tyres on Light alloy | Michelin | 5mm / 5mm |
| 2) | 205/55 R17 91V | Summer tyres on Light alloy | Michelin | 5mm / 5mm |

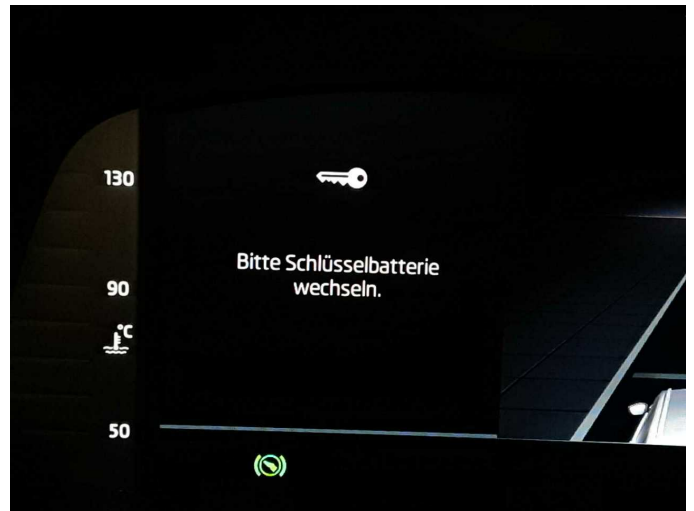
Damage 1: Equipment: Vehicle key - Empty - Replace

| No. | Component group | Description |
|---|---|---|
| 1 | Equipment | Vehicle key - Empty - Replace |

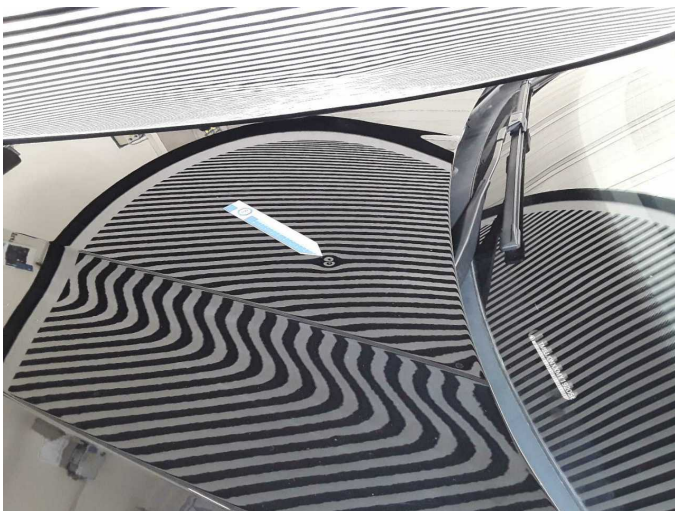
Damage 2: Bonnet: Bonnet - dent(s) - Smart repair

| No. | Component group | Description |
|---|---|---|
| 2 | Bonnet | Bonnet - dent(s) - Smart repair |

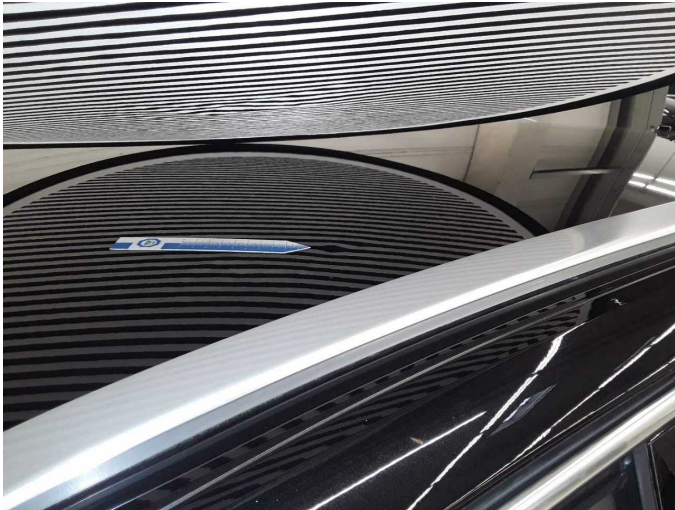
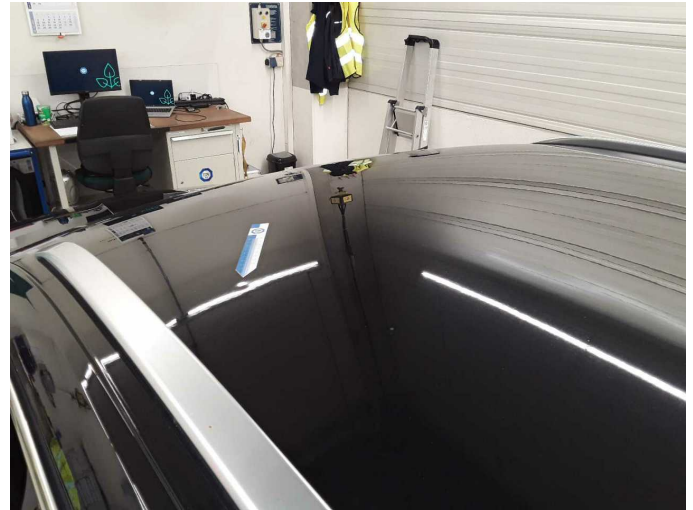
Damage 3: Roof: Roof - dent(s) - Smart repair

| No. | Component group | Description |
|---|---|---|
| 3 | Roof | Roof - dent(s) - Smart repair |

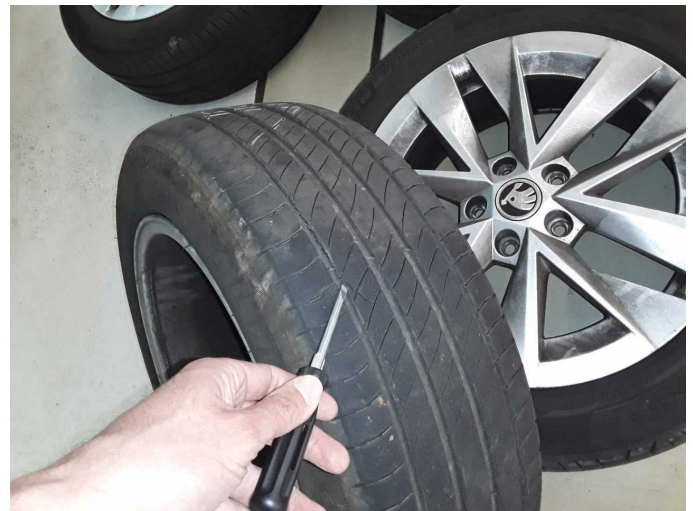
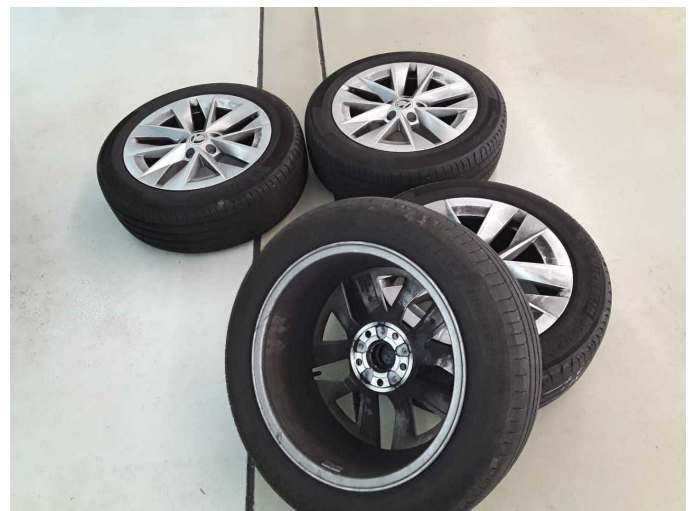
Damage 4: 2nd wheel set: 1 tyre - Broken / torn - Replace

| No. | Component group | Description |
|---|---|---|
| 4 | 2nd wheel set | 1 tyre - Broken / torn - Replace |

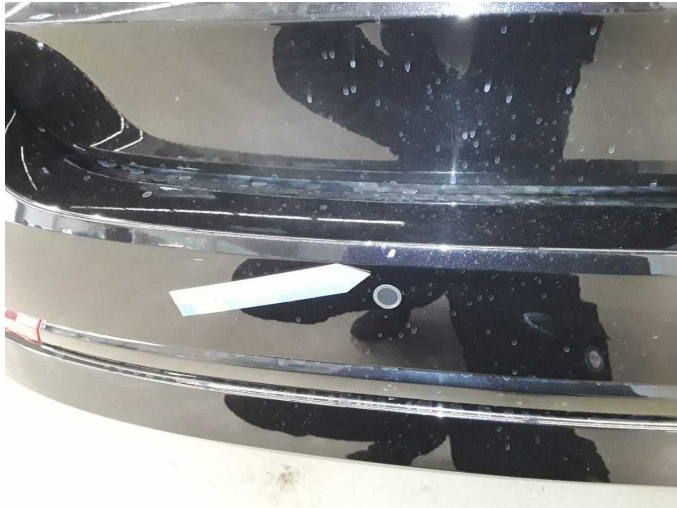
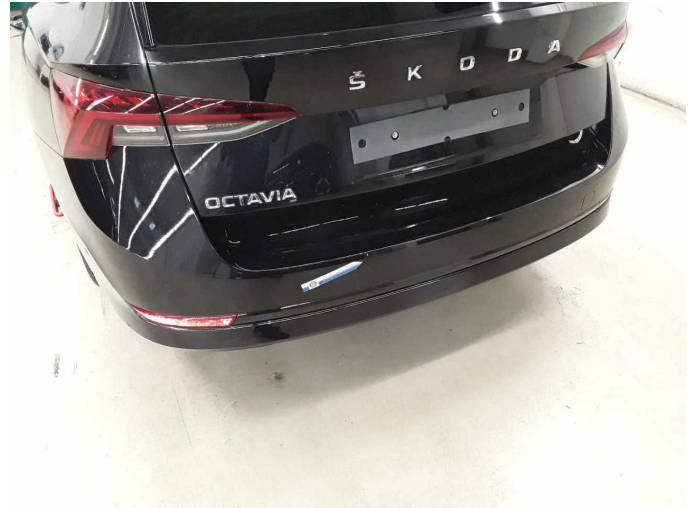
Damage 6: Rear bumper: Rear bumper - Scratch(es) - Smart repair

| No. | Component group | Description |
|---|---|---|
| 6 | Rear bumper | Rear bumper - Scratch(es) - Smart repair |

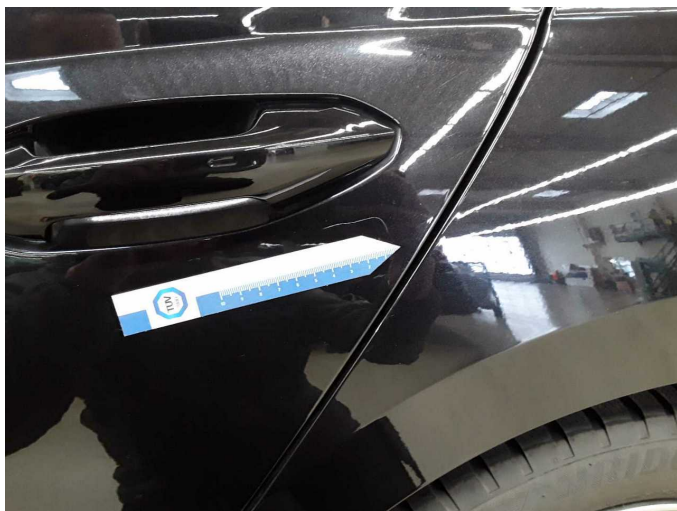
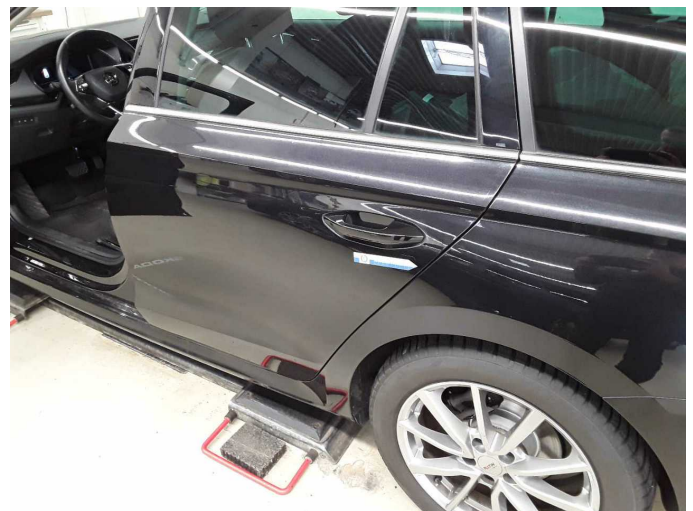
Damage 7: Door - rear left side: Door - Scratch(es) - Smart repair

| No. | Component group | Description |
|---|---|---|
| 7 | Door - rear left side | Door - Scratch(es) - Smart repair |

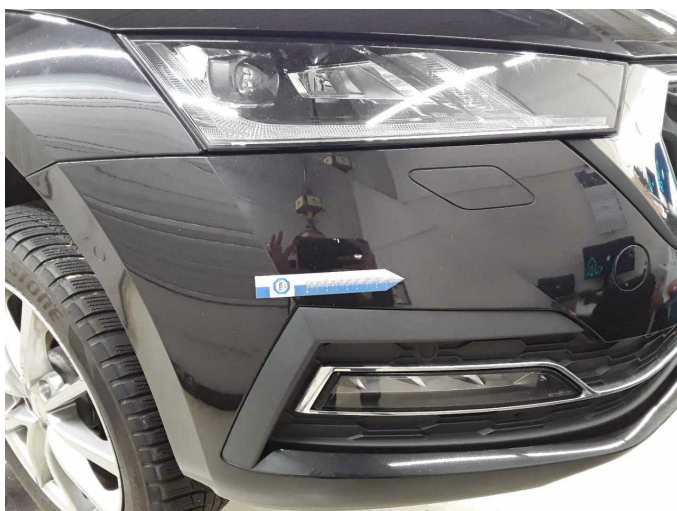
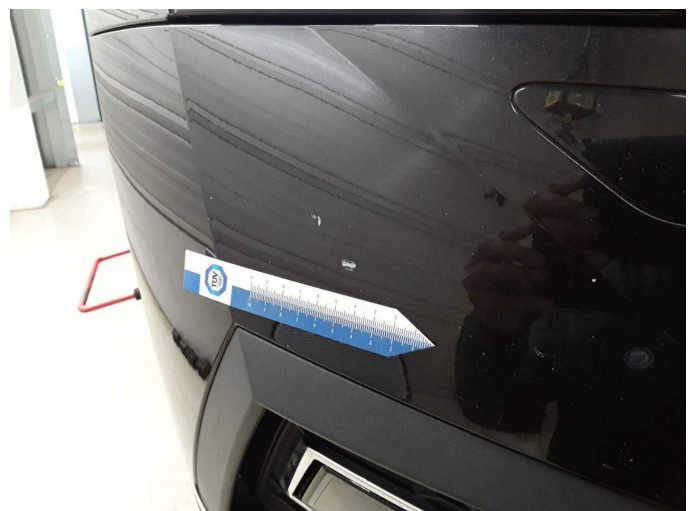
Damage 8: Front bumper: Front bumper - Scratch(es) - Smart repair

| No. | Component group | Description |
|---|---|---|
| 8 | Front bumper | Front bumper - Scratch(es) - Smart repair |
