Expertise

Protocol number: 46526656  
Order No. / Reference: 26543099  
Inspection date: 9 Jul 2026

Model: C 220 d 4Matic T 9G-TRONIC Avantgarde Advanced

VIN: W1KAH0FBXRF144581

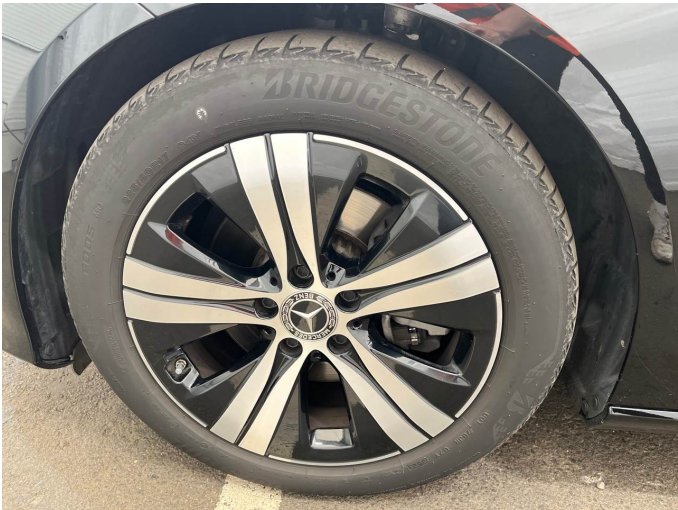
Figure 12: Mounted tyres

| # | Tyre size | Type of tyre | Manufacturer | Tread depth |
|---|---|---|---|---|
| 1) | 225/50 R17 94Y | Summer tyres on Light alloy | Bridgestone | 4mm / 4mm |
| 2) | 225/50 R17 94Y | Summer tyres on Light alloy | Bridgestone | 5mm / 5mm |

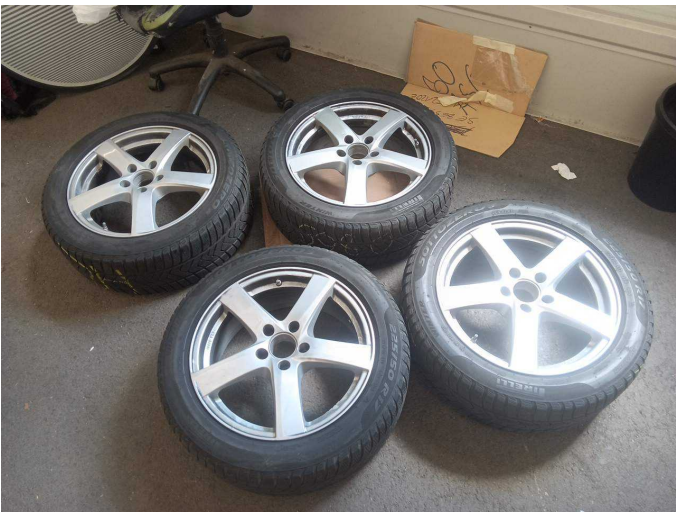
Figure 17: Additional tyres

| # | Tyre size | Type of tyre | Manufacturer | Tread depth |
|---|---|---|---|---|
| 1) | 225/50 R17 98H | Winter tyres on Light alloy | Sonstige | 4mm / 4mm |
| 2) | 225/50 R17 98H | Winter tyres on Light alloy | Sonstige | 4mm / 4mm |

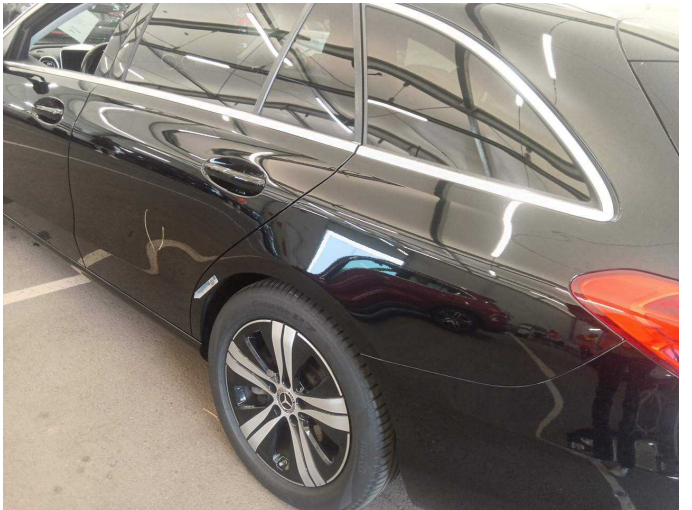
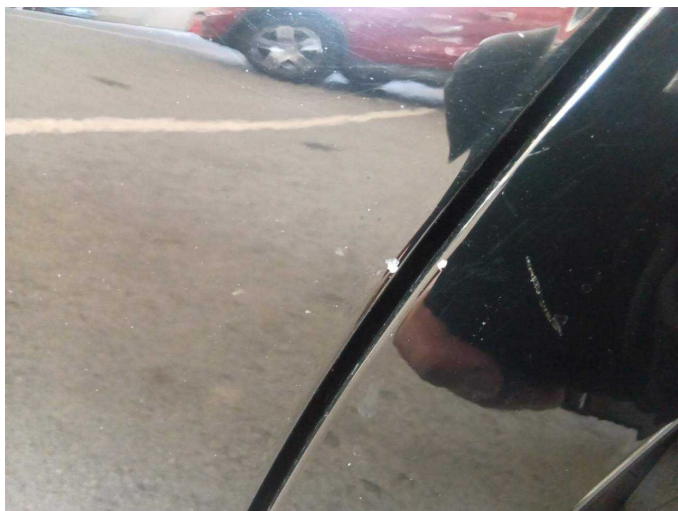
| No. | Component group | Description |
|---|---|---|
| 1 | Side panel - rear left side | Mudguard - rear left side - Scratch(es) - Smart repair |

Damage 1: Side panel - rear left side: Mudguard - rear left side - Scratch(es) - Smart repair

**Damage 1:** Side panel - rear left side: Mudguard - rear left side - Scratch(es) - Smart repair

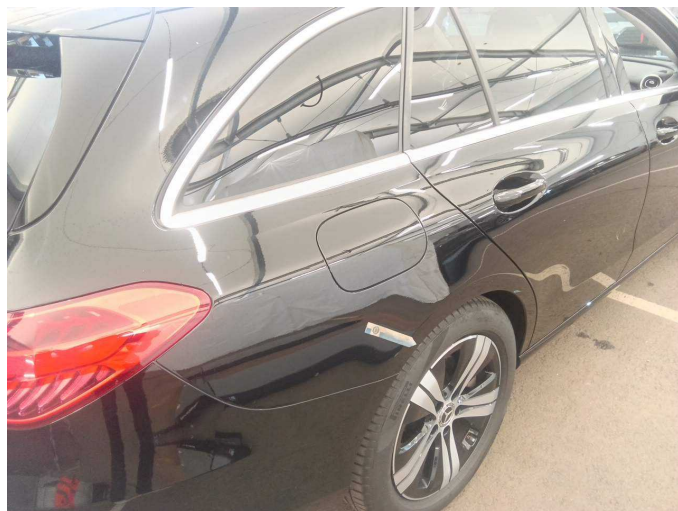
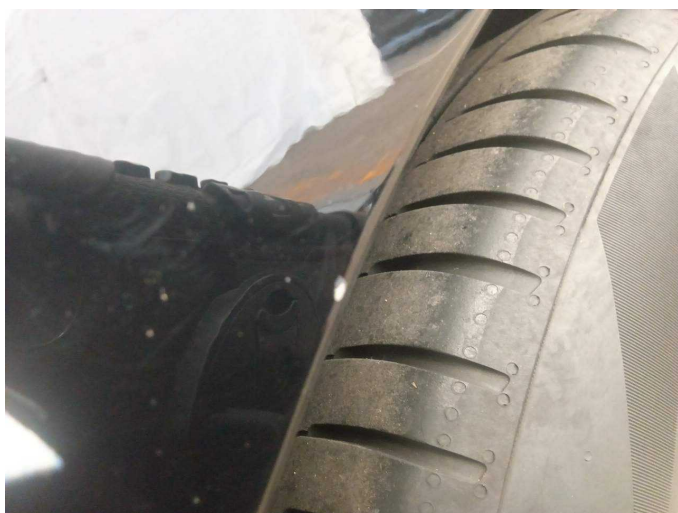
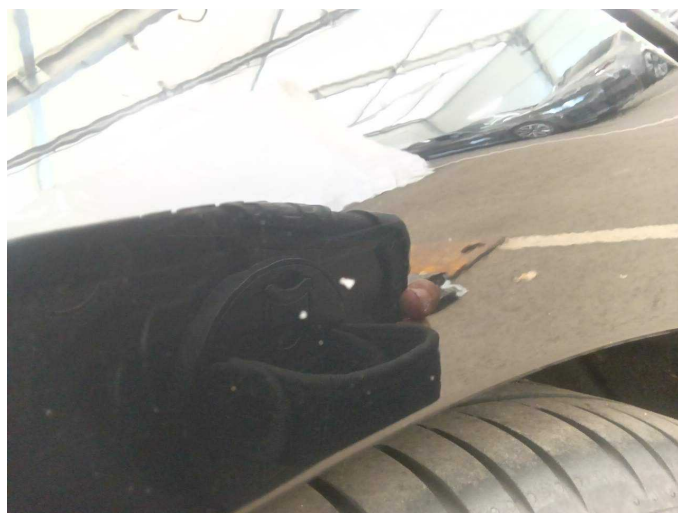
| No. | Component group | Description |
|---|---|---|
| 2 | Side panel - rear right side | Mudguard - rear right side - Scratch(es) - Smart repair |

**Damage 2:** Side panel - rear right side: Mudguard - rear right side - Scratch(es) - Smart repair

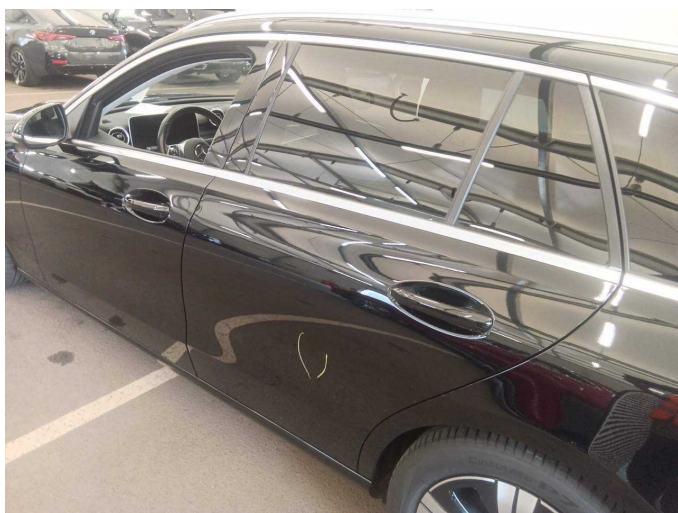
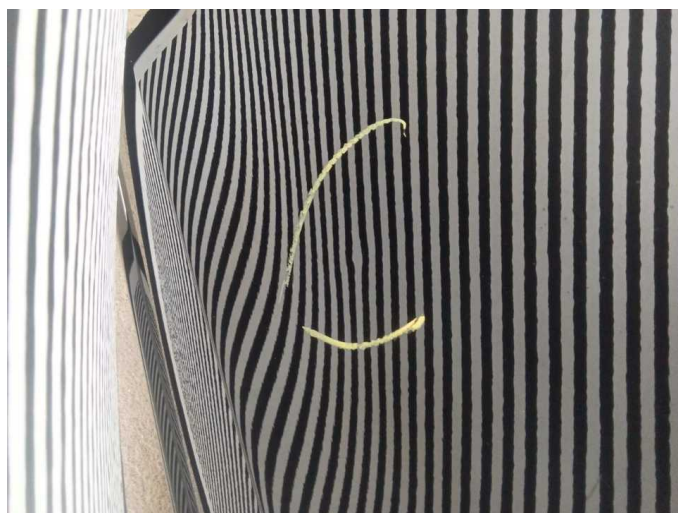
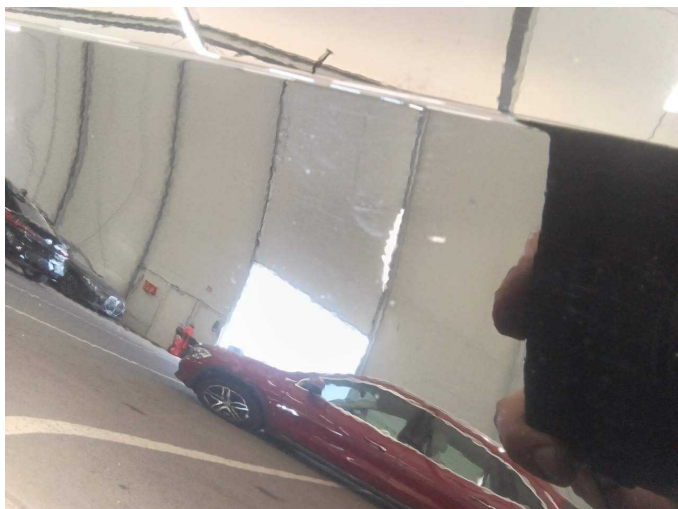
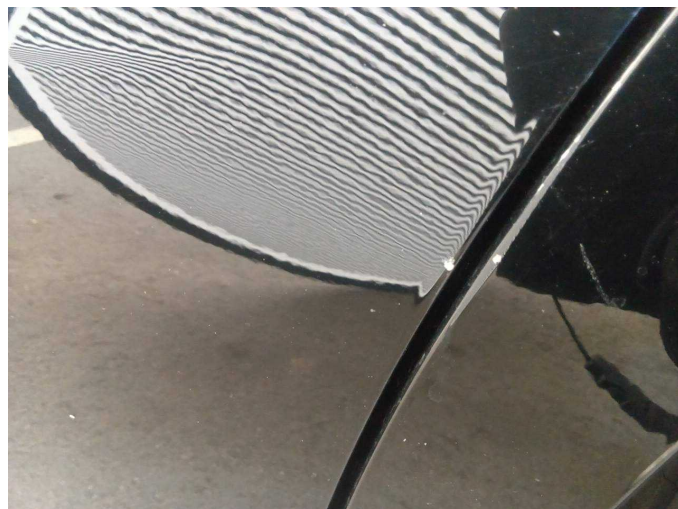
| No. | Component group | Description |
|---|---|---|
| 3 | Door - rear left side | Door edge - Scratch(es) - Smart repair |

**Damage 3:** Door - rear left side: Door edge - Scratch(es) - Smart repair

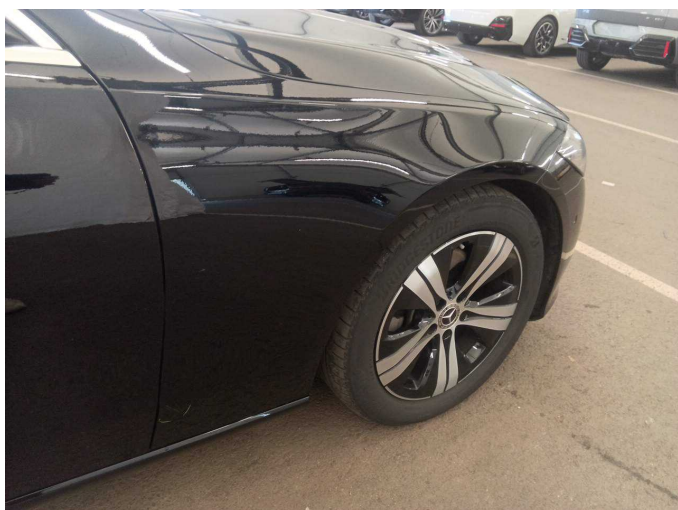
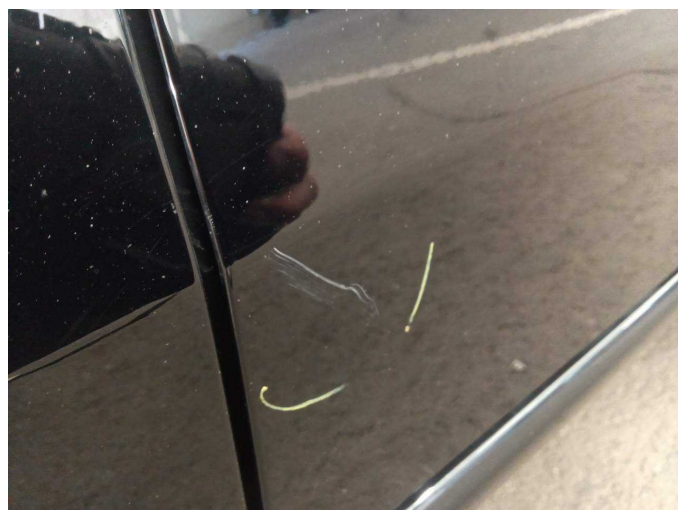
| No. | Component group | Description |
|---|---|---|
| 4 | Mudguard - right side | Mudguard - right side - Scratch(es) - Paint |

**Damage 4:** Mudguard - right side: Mudguard - right side - Scratch(es) - Paint

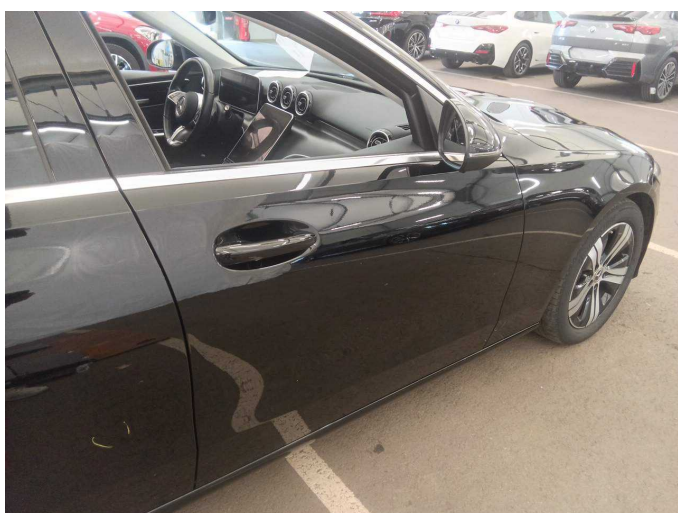
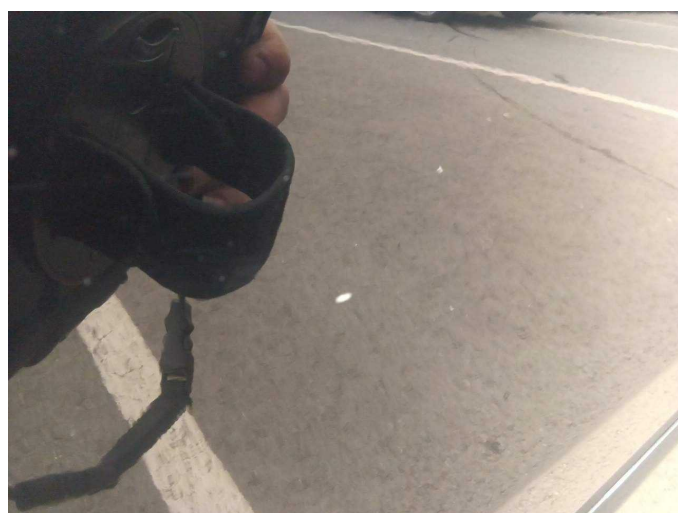
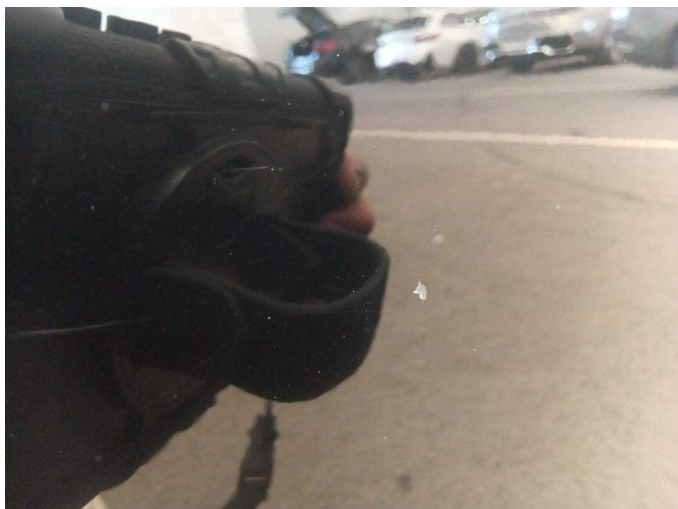
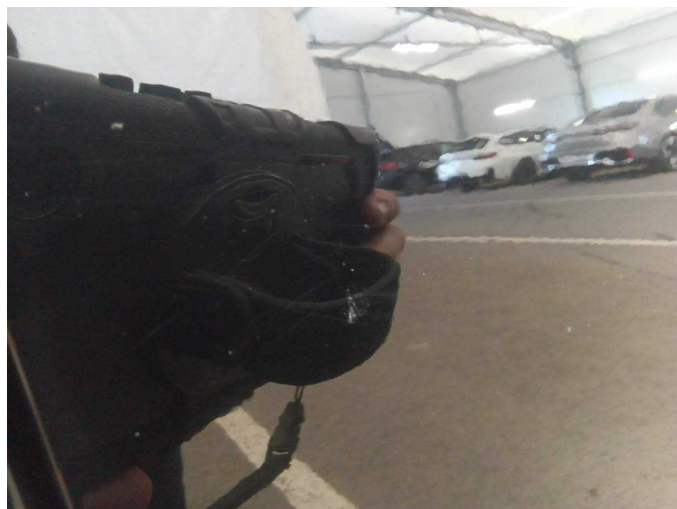
| No. | Component group | Description |
|---|---|---|
| 5 | Door - front right side | Door - Scratch(es) - Paint |

**Damage 5:** Door - front right side: Door - Scratch(es) - Paint

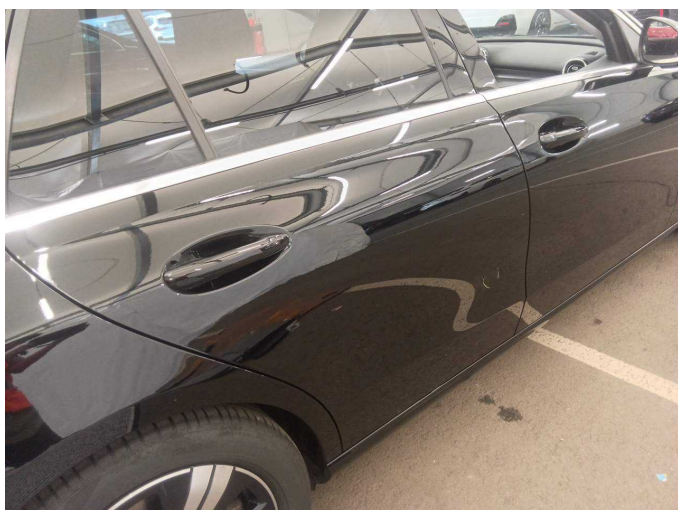
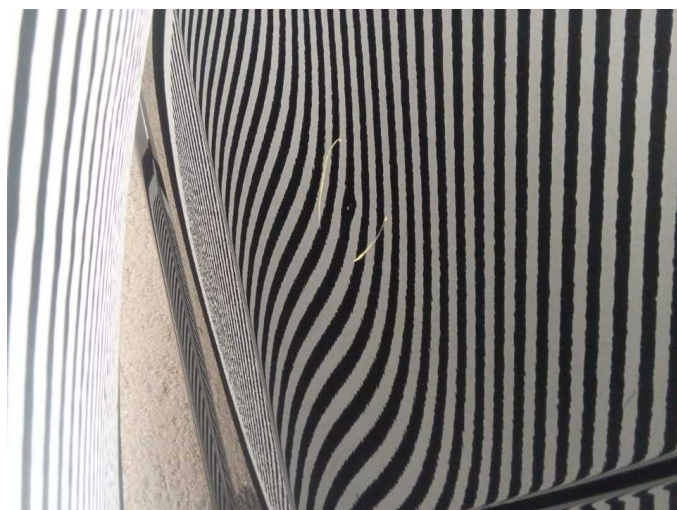
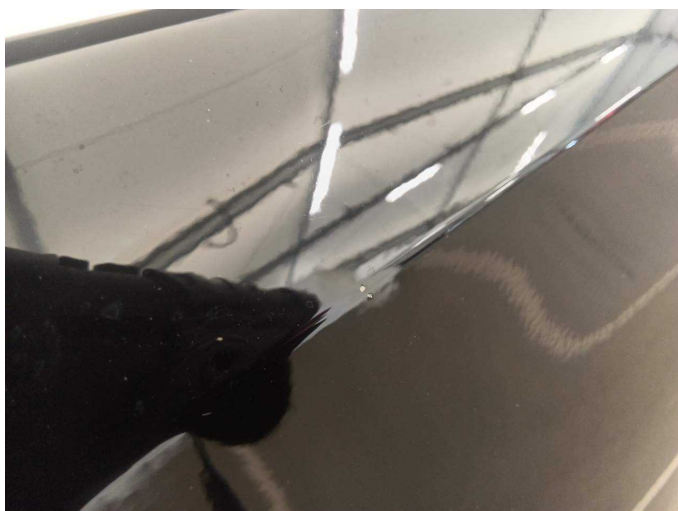
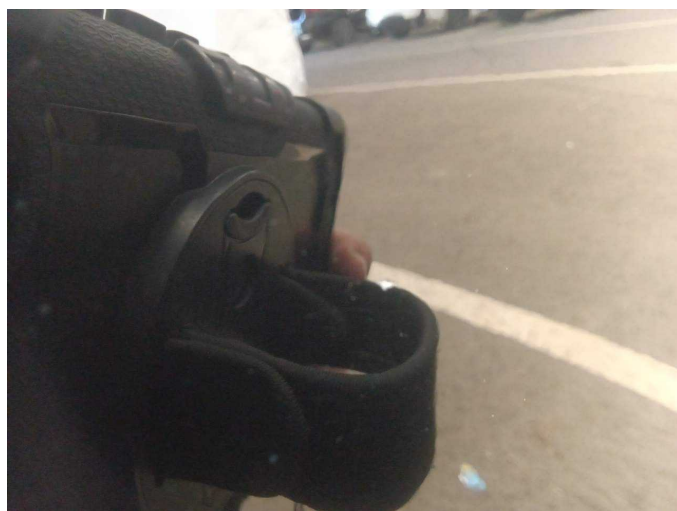
| No. | Component group | Description |
|---|---|---|
| 6 | Door - rear right side | Door - Dent / paintcoat damage - Repair and paint |

**Damage 6:** Door - rear right side: Door - Dent / paintcoat damage - Repair and paint

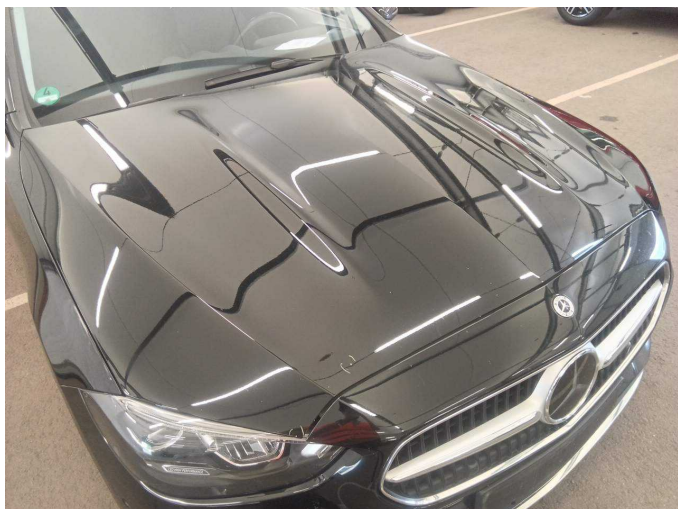
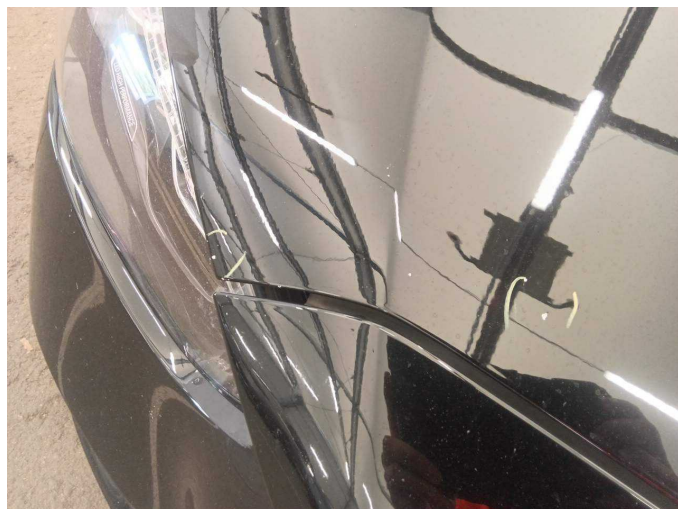
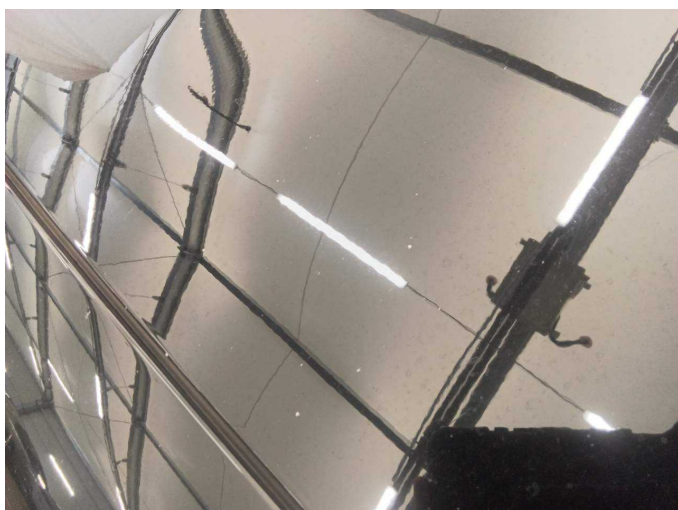
| No. | Component group | Description |
|---|---|---|
| 7 | Bonnet | Bonnet (Übermäßige Steinschläge) - Stone chips - Paint |

**Damage 7:** Bonnet: Bonnet (Übermäßige Steinschläge) - Stone chips - Paint

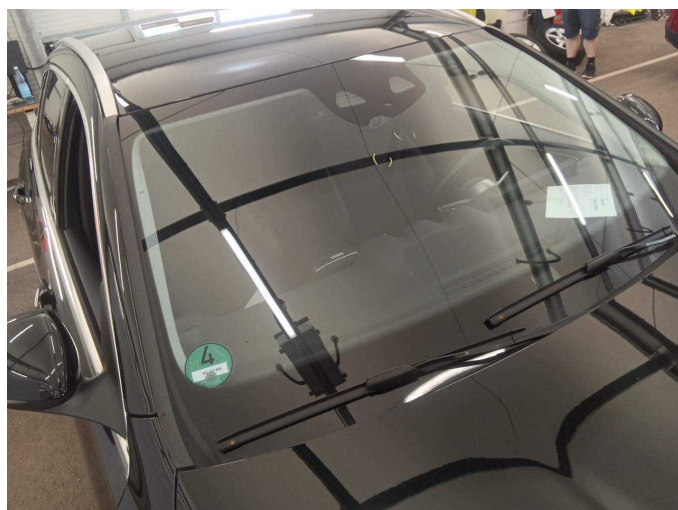
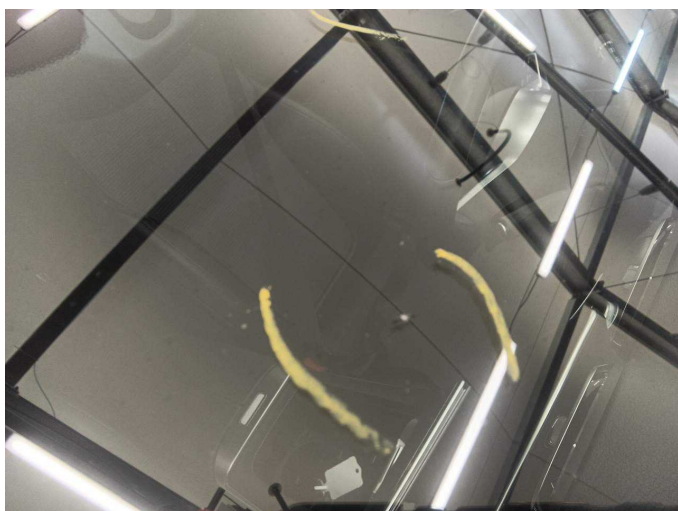
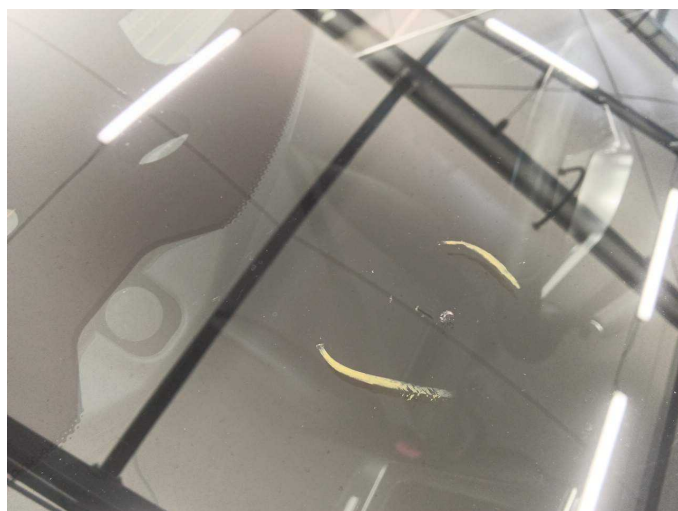
| No. | Component group | Description |
|---|---|---|
| 8 | Vehicle glazing | Windscreen (Mit Rissbildung) - Stone chips - Replace |

**Damage 8:** Vehicle glazing: Windscreen (Mit Rissbildung) - Stone chips - Replace

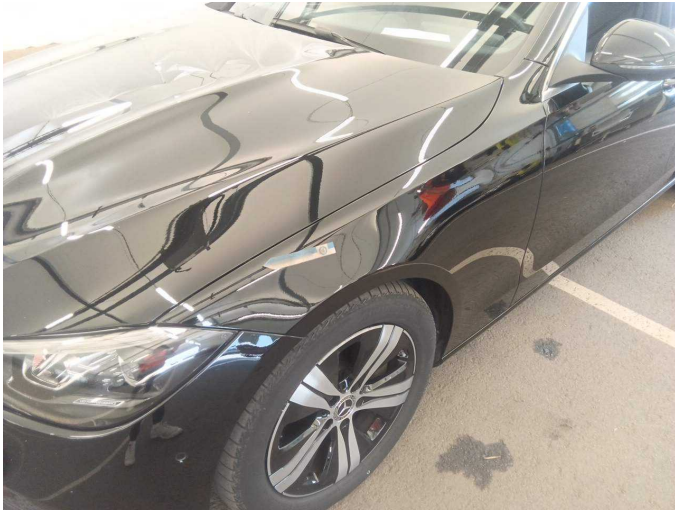
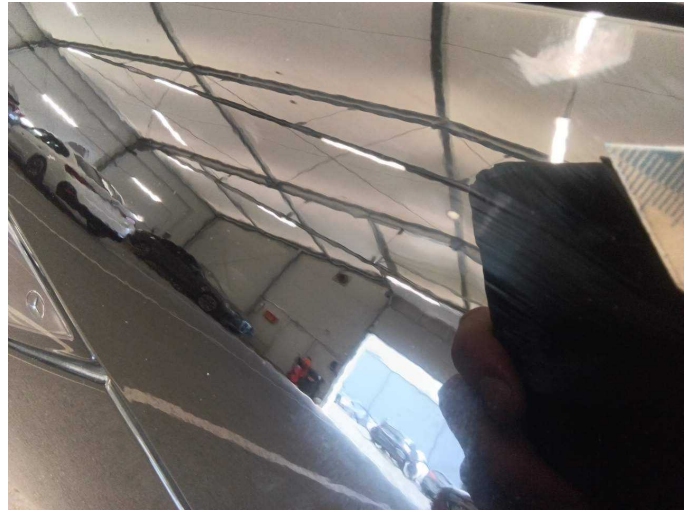
| No. | Component group | Description |
|---|---|---|
| 1 | Mudguard - left side | Mudguard - left side - Stone chips - No deduction |

**Wear and tear 1:** Mudguard - left side: Mudguard - left side - Stone chips  
- No deduction
