Expertise

Protocol number: 46820956  
Order No. / Reference: 26781739  
Inspection date: 31 Jul 2026

Manufacturer: Volvo

Model: XC40 Recharge 82 kWh Single M. Extended Range RWD  
Ultimate

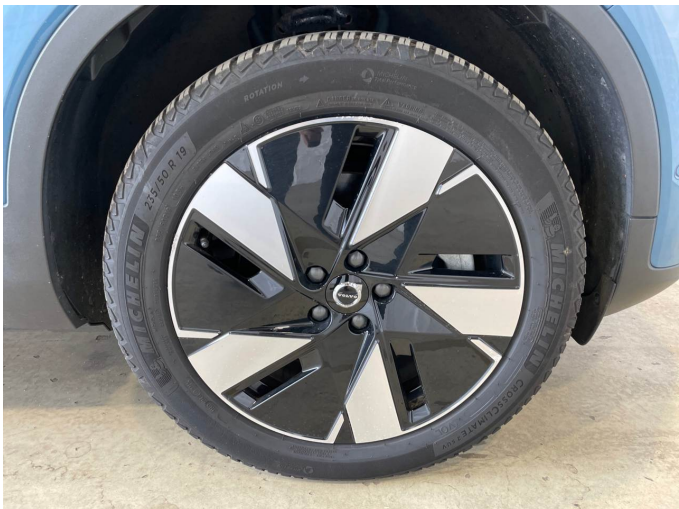
Figure 12: Mounted tyres

| Tyres | | | |
|---|---|---|---|
| 1) | 235/50 R19 103H | All-season tyres on Light alloy | 6mm / 6mm |
| 2) | 235/50 R19 103H | All-season tyres on Light alloy | 6mm / 6mm |

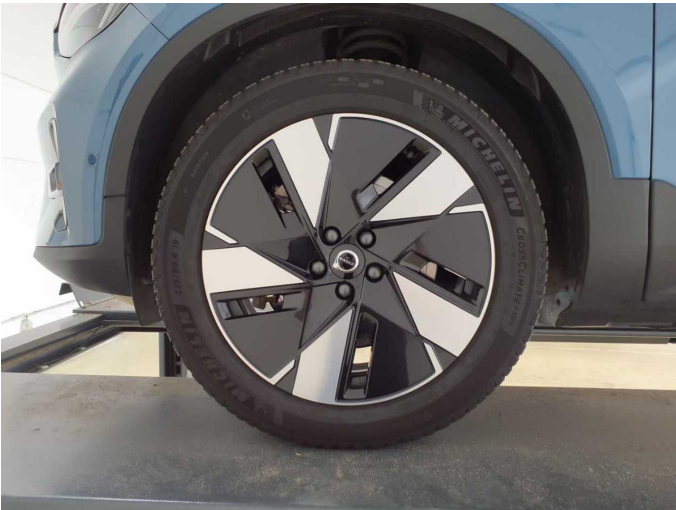
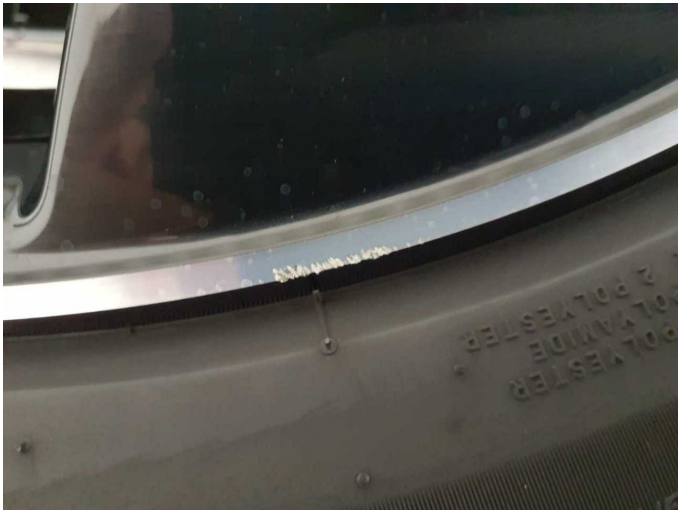
| No. | Component group | Description |
|---|---|---|
| 1 | Wheel / tyres | Alloy rim - front left side - Scratch(es) - Loss in value |

Damage 1: Wheel / tyres: Alloy rim - front left side - Scratch(es) - Loss in value

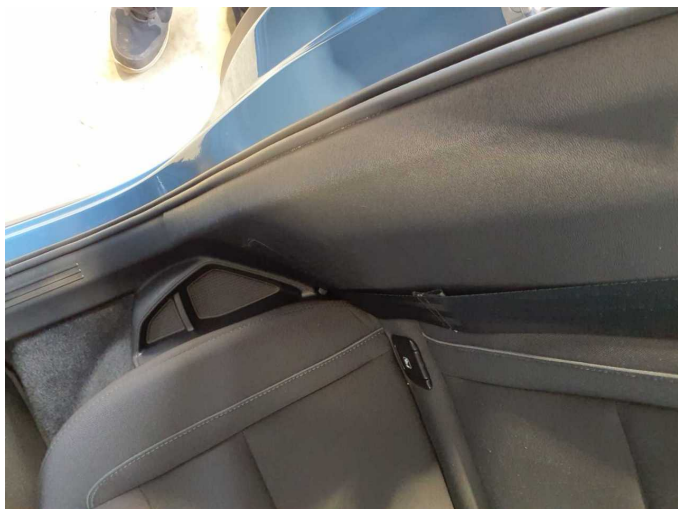
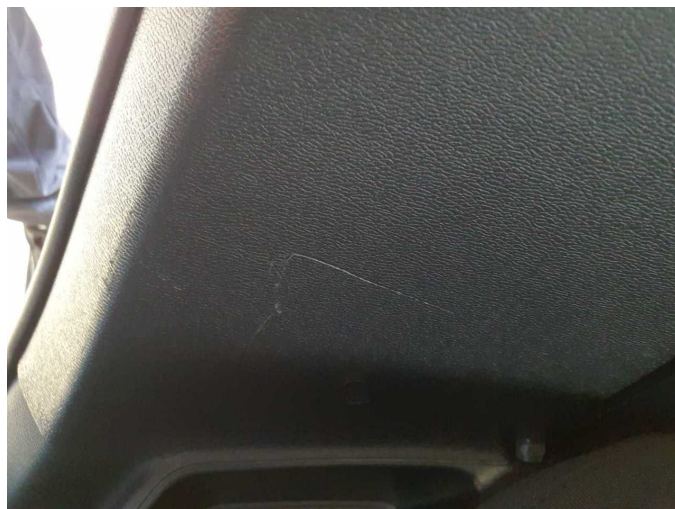
| No. | Component group | Description |
|---|---|---|
| 2 | Side panel - rear right side | Interior trim - Scratch(es) - Replace |

**Damage 2:** Side panel - rear right side: Interior trim - Scratch(es) - Replace

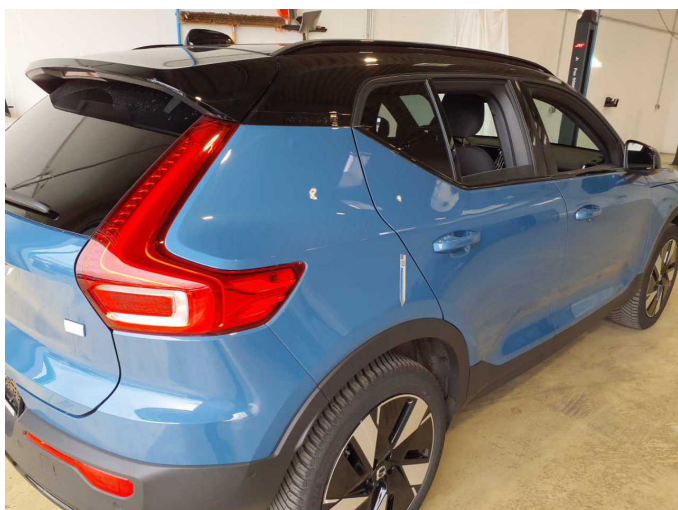
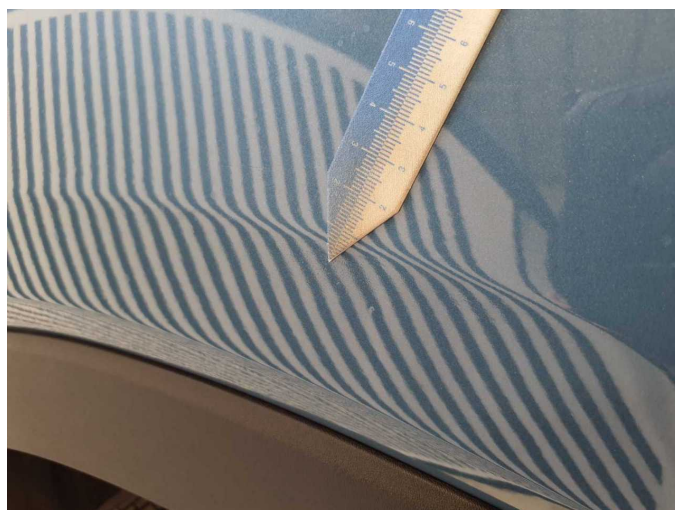
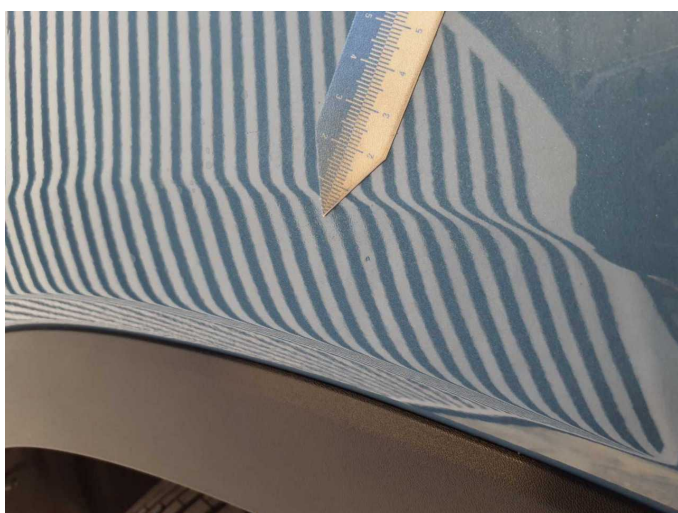
| No. | Component group | Description |
|---|---|---|
| 3 | Side panel - rear right side | Side panel (Spachtelmasse eingefallen und Einschluss) - Unprofessionally repaired - Repair and paint |

- 1 Door - rear right side, Professionally carried out, Invoice of repair done Non-existent
- 2 Side panel - rear right side, Unprofessionally carried out

| Side panel - rear right side | 175 µm | Door - rear right side | 181 µm |

**Damage 3:** Side panel - rear right side: Side panel (Spachtelmasse eingefallen und Einschluss) - Unprofessionally repaired - Repair and paint

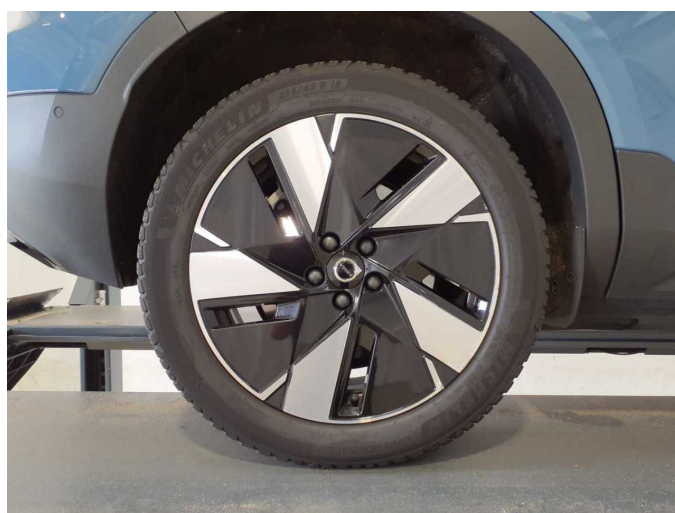
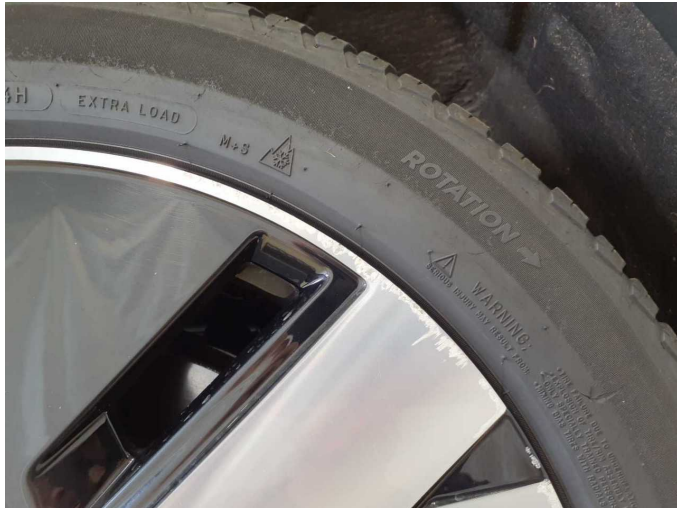
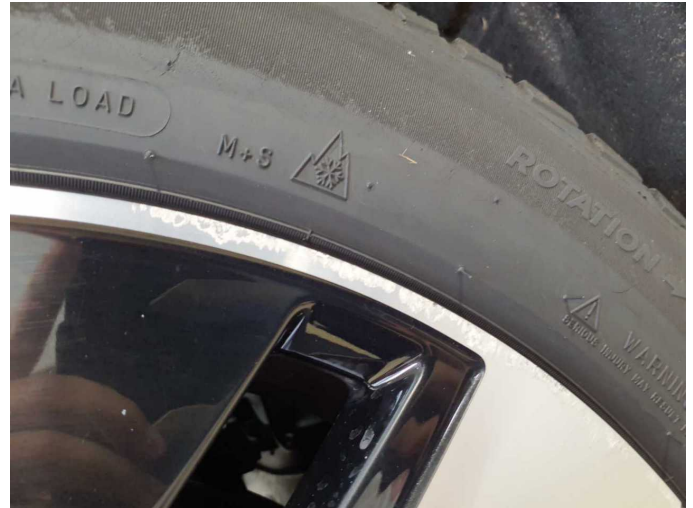
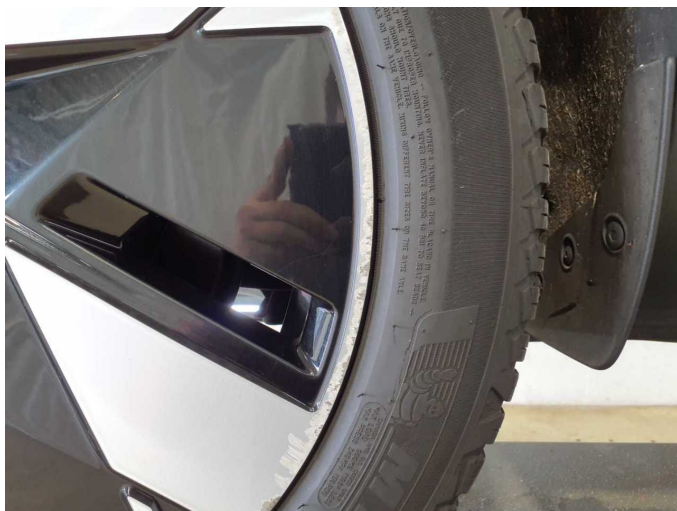
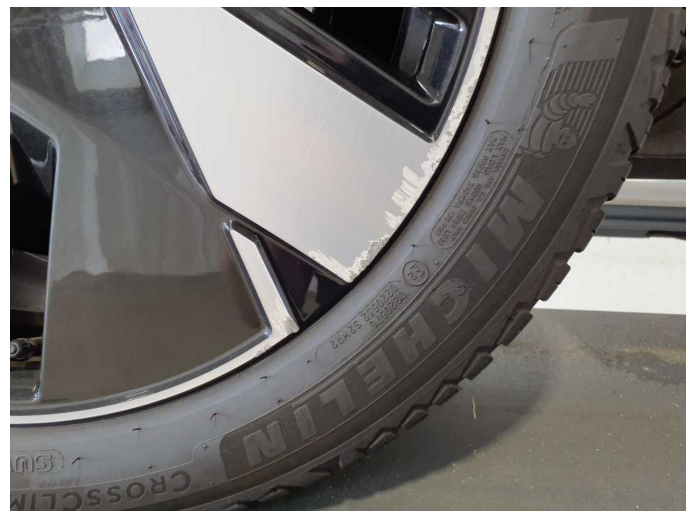
| No. | Component group | Description |
|---|---|---|
| 4 | Wheel / tyres | Alloy rim - rear right side - Scratch(es) - Replace |

**Damage 4:** Wheel / tyres: Alloy rim - rear right side - Scratch(es) - Replace

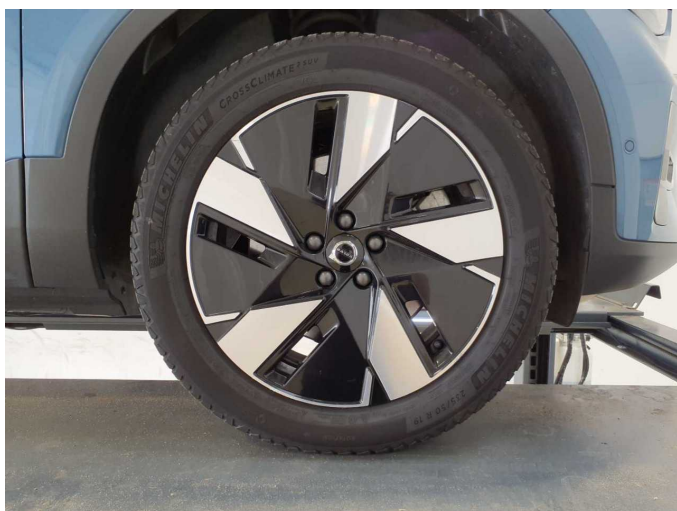
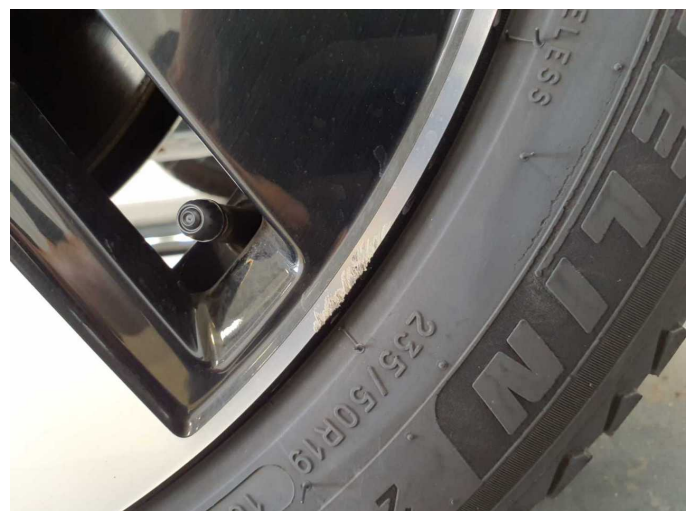
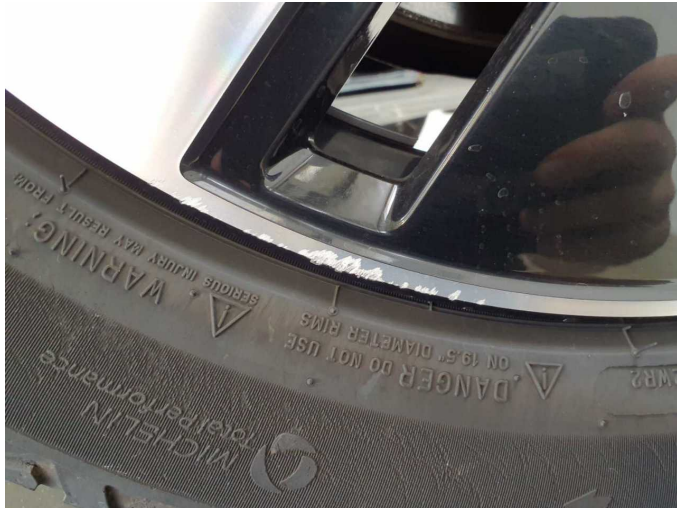
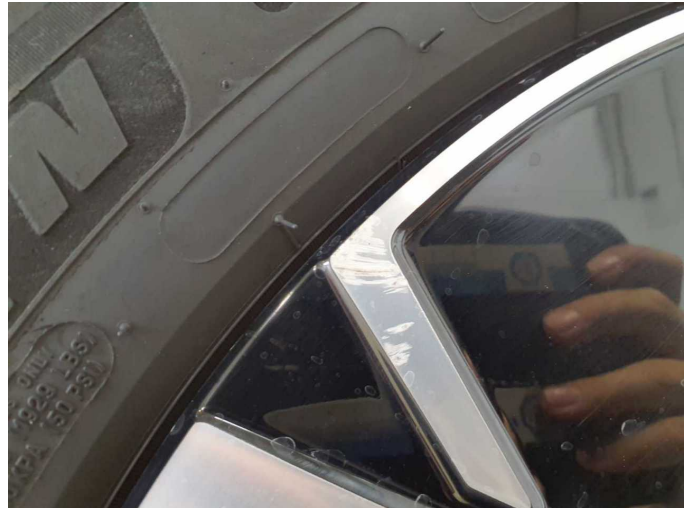
| No. | Component group | Description |
|---|---|---|
| 5 | Wheel / tyres | Alloy rim - front right side - Scratch(es) - Replace |

**Damage 5:** Wheel / tyres: Alloy rim - front right side - Scratch(es) - Replace

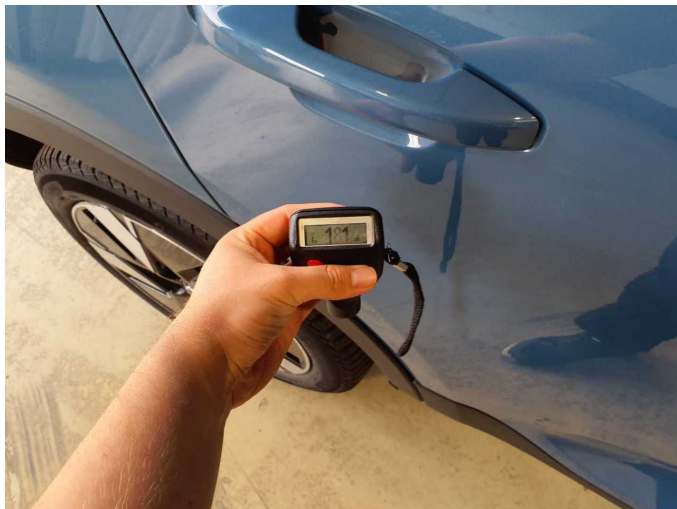
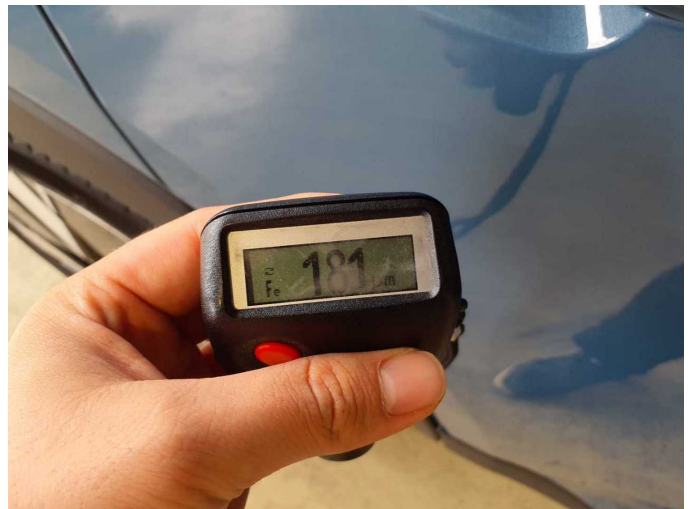
**Repainting 1:** Door - rear right side

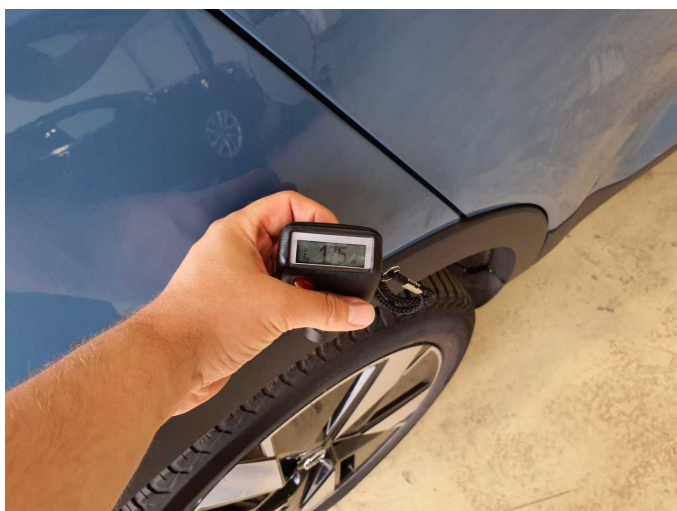
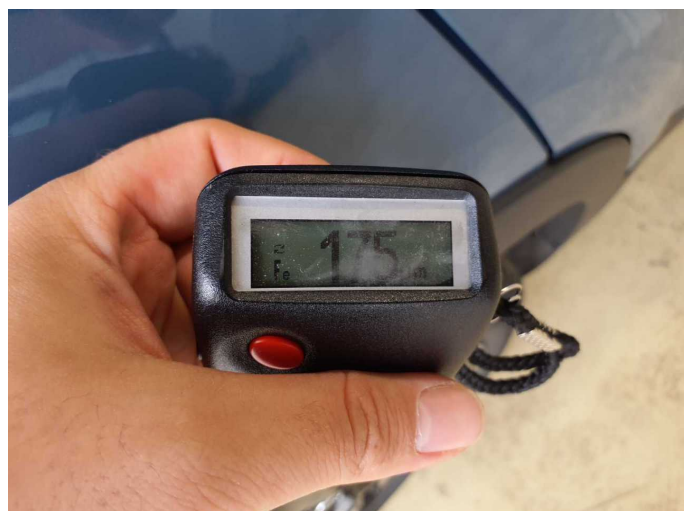
**Repainting 2:** Side panel - rear right side
