Expertise

Protocol number: 46506058  
Order No. / Reference: 26382758  
Inspection date: 8 Jul 2026

Manufacturer: Ford

Model: Kuga 2.5 Duratec PHEV ST-LINE X

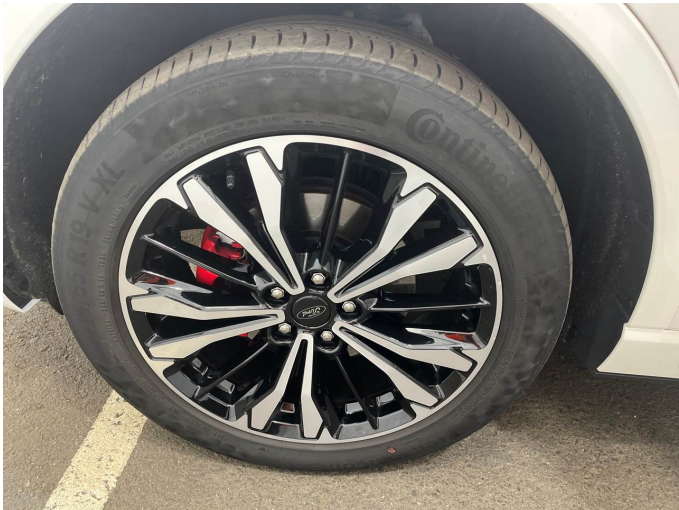
| # | Tyre size | Type of tyre | Manufacturer | Tread depth |
|---|---|---|---|---|
| 1) | 225/55 R19 103V | Summer tyres on Light alloy | Continental | 3mm / 3mm |
| 2) | 225/55 R19 103V | Summer tyres on Light alloy | Continental | 4mm / 4mm |

Figure 12: Mounted tyres

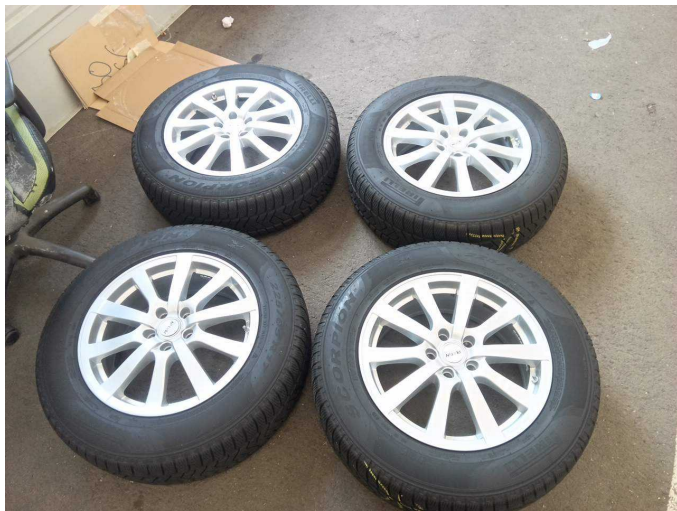
| # | Tyre size | Type of tyre | Manufacturer | Tread depth |
|---|---|---|---|---|
| 1) | 225/65 R17 106H | Winter tyres on Light alloy | Pirelli | 5mm / 5mm |
| 2) | 225/65 R17 106H | Winter tyres on Light alloy | Pirelli | 6mm / 6mm |

Figure 15: Additional tyres

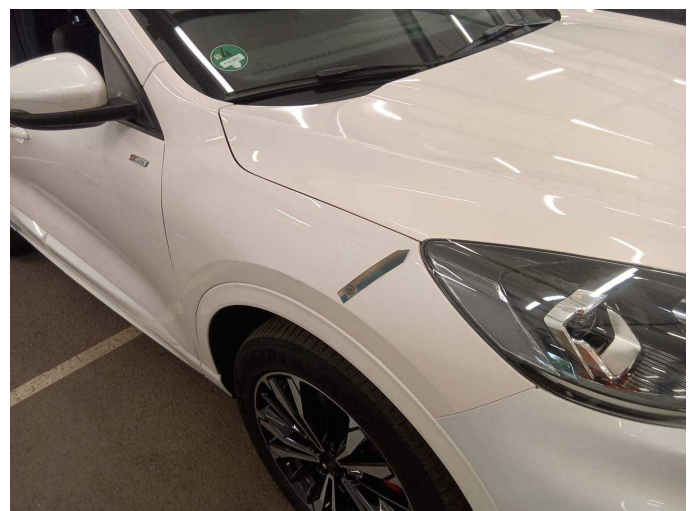
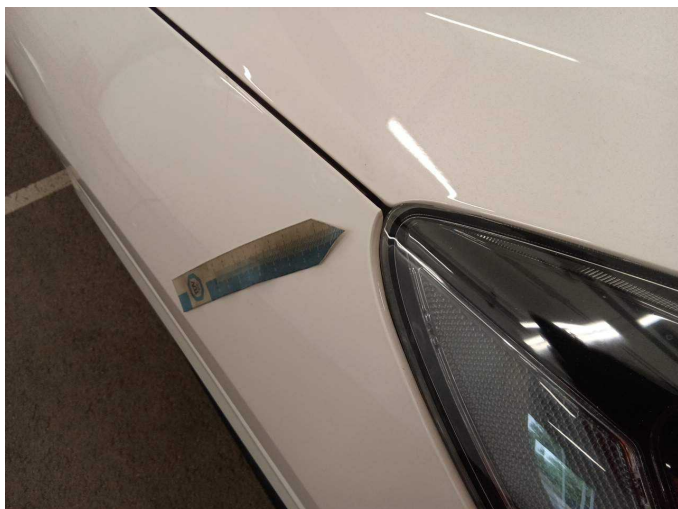
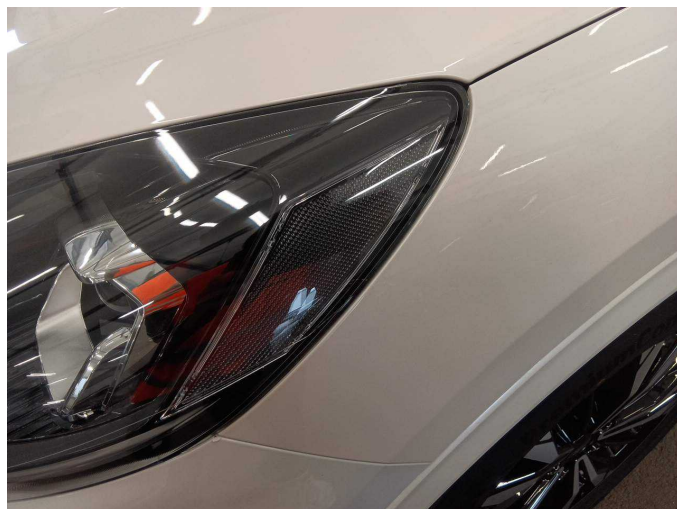
| No. | Component group | Description |
|---|---|---|
| 1 | Mudguard - right side | Mudguard - right side (Spaltmaße nicht passend) - Malposition - Un- / install |

**Damage 1:** Mudguard - right side: Mudguard - right side (Spaltmaße nicht passend) - Malposition - Un- / install

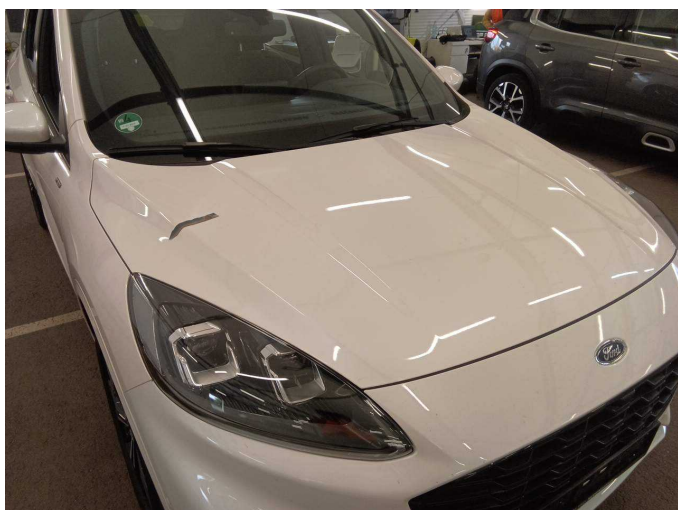
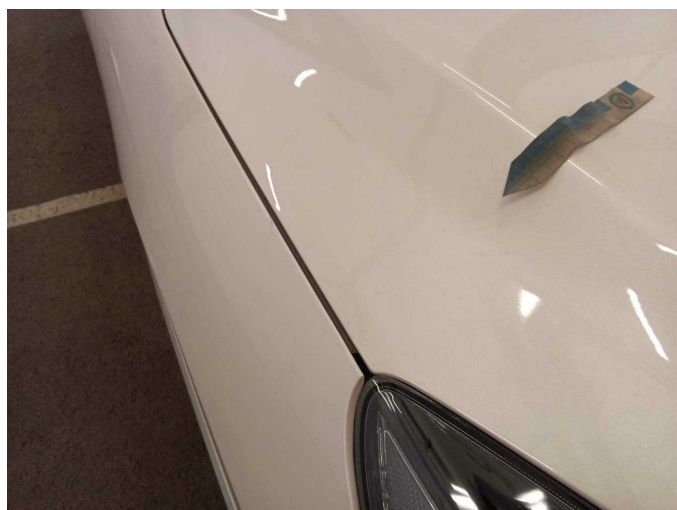
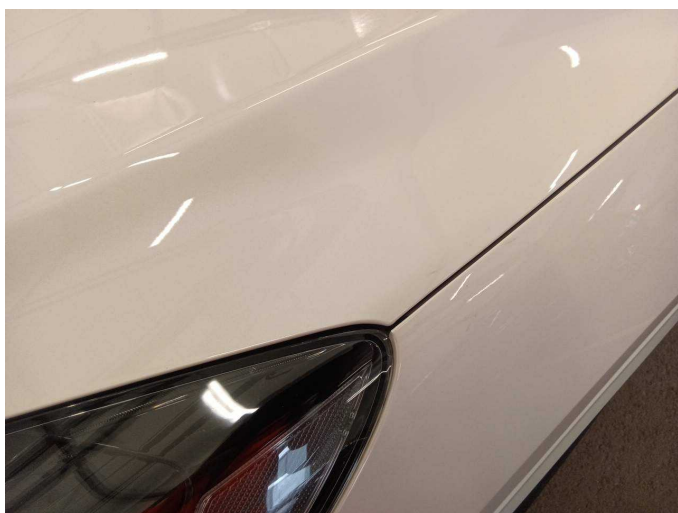
| No. | Component group | Description |
|---|---|---|
| 2 | Bonnet | Bonnet (Spaltmaße nicht passend) - Malposition - Un- / install |

**Damage 2:** Bonnet: Bonnet (Spaltmaße nicht passend) - Malposition - Un- / install

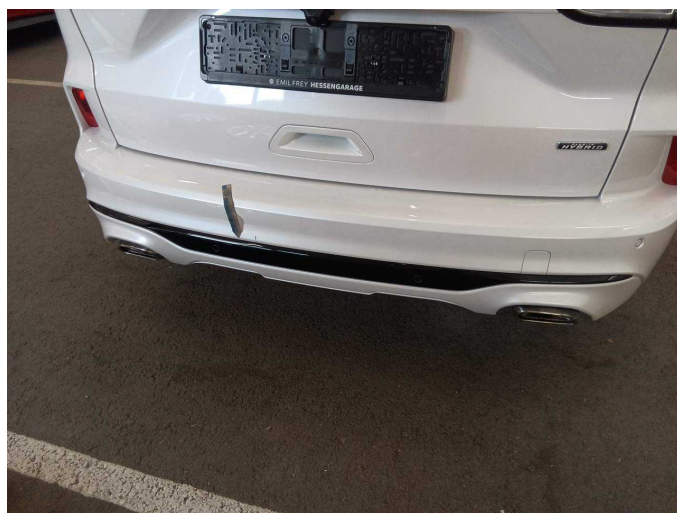
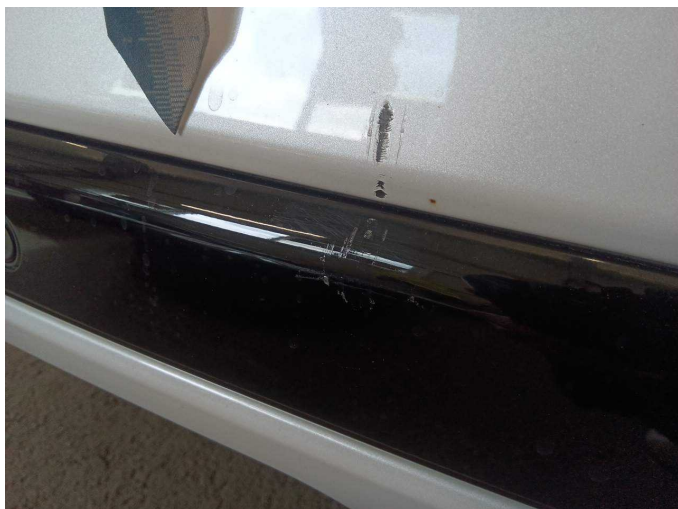
| No. | Component group | Description |
|---|---|---|
| 3 | Rear bumper | Protection strip - centre - Scratch(es) - Replace |

**Damage 3:** Rear bumper: Protection strip - centre - Scratch(es) - Replace

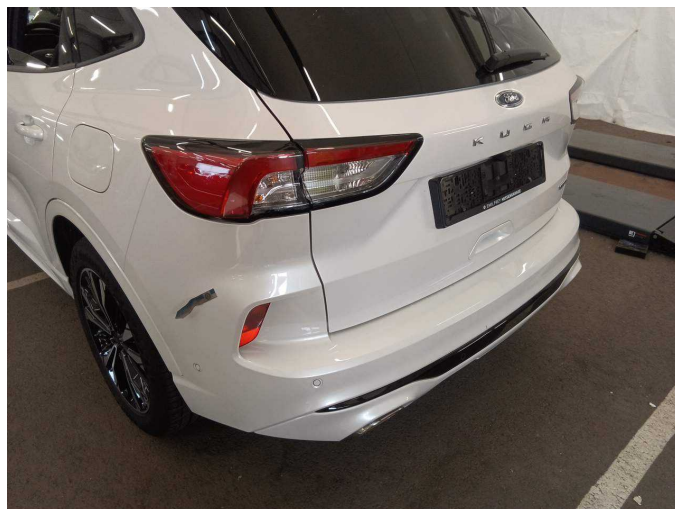
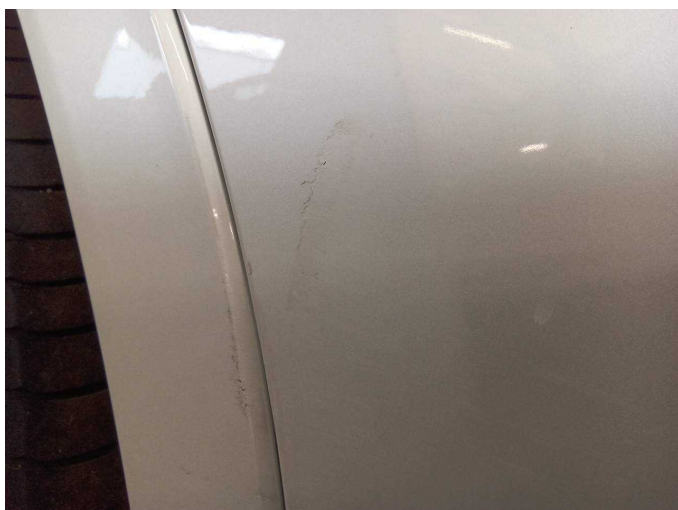
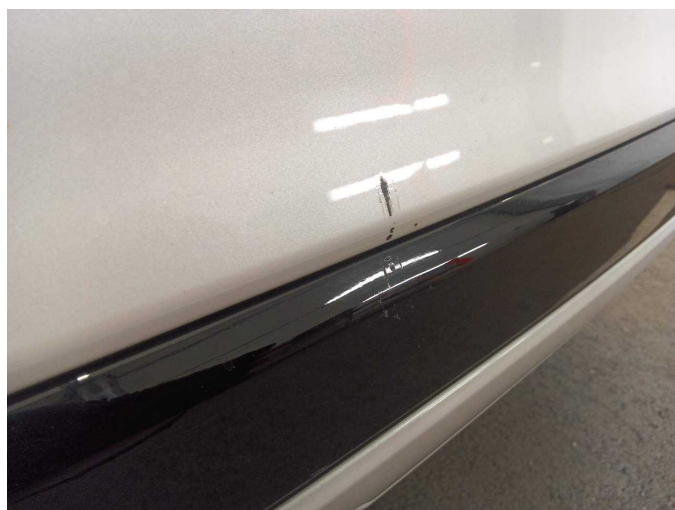
| No. | Component group | Description |
|---|---|---|
| 4 | Rear bumper | Rear bumper - Scratch(es) - Paint |

**Damage 4:** Rear bumper: Rear bumper - Scratch(es) - Paint

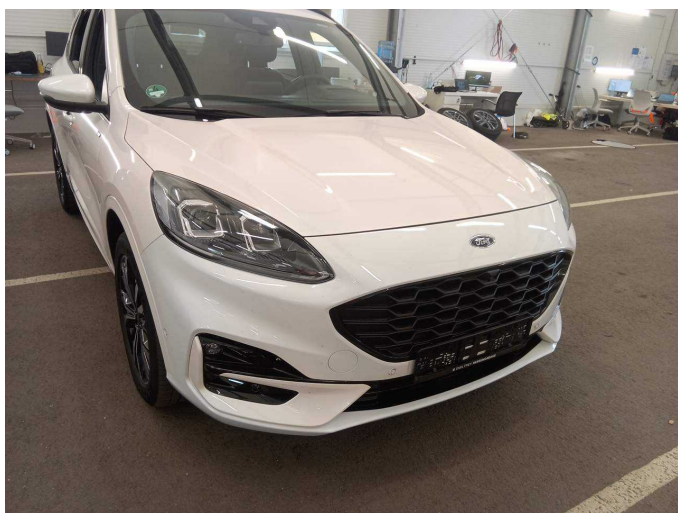
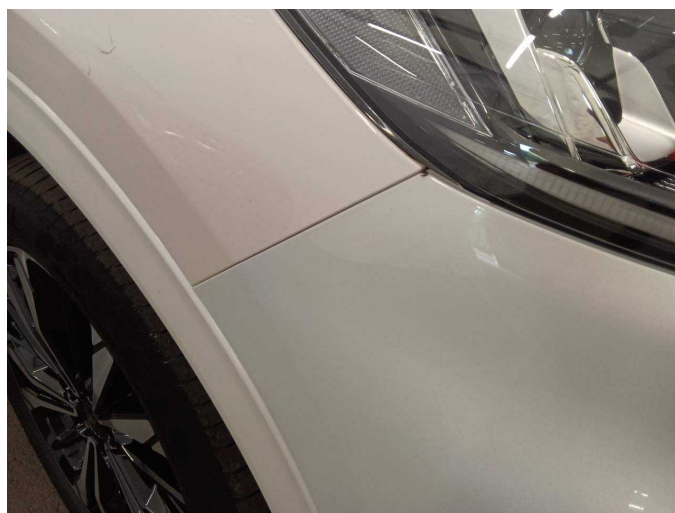
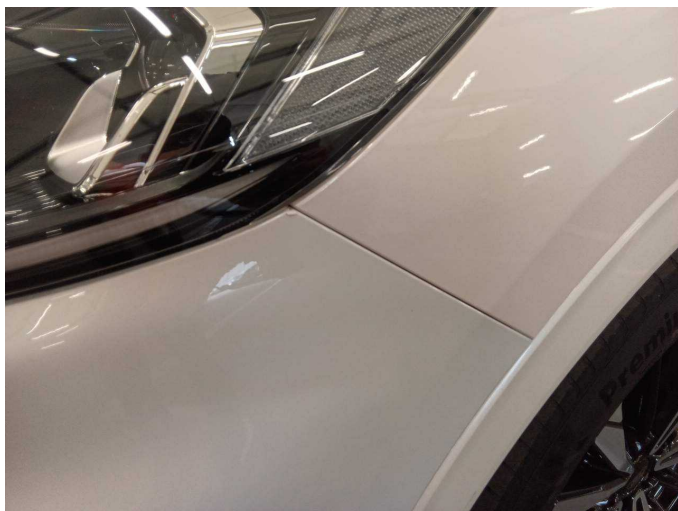
| No. | Component group | Description |
|---|---|---|
| 5 | Front bumper | Front bumper (Farbunterschied feststellbar, Anbauteile in Originalfarbe) - Unprofessionally repaired - Paint |

- 1 Bumper front, Unprofessionally carried out, Invoice of repair done Non-existent

**Damage 5:** Front bumper: Front bumper (Farbunterschied feststellbar, Anbauteile in Originalfarbe) - Unprofessionally repaired - Paint

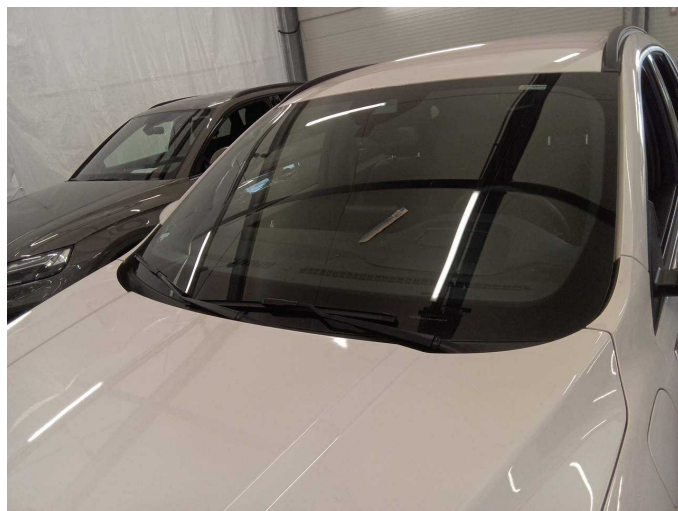
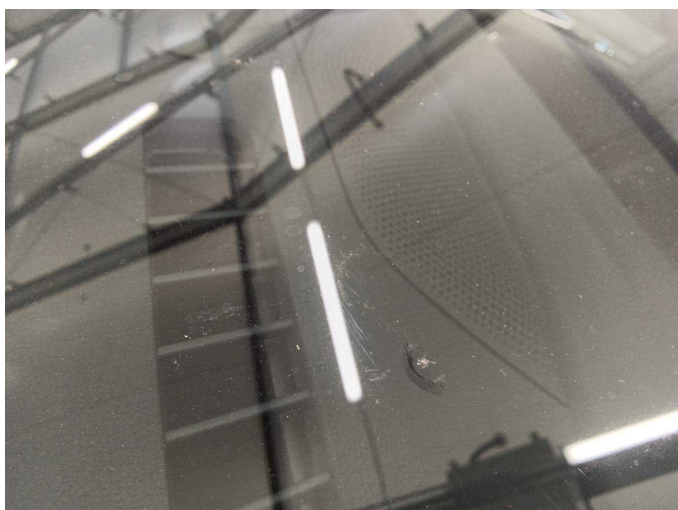
| No. | Component group | Description |
|---|---|---|
| 6 | Vehicle glazing | Windscreen (Mit Rissbildung) - Stone chips - Replace |

**Damage 6:** Vehicle glazing: Windscreen (Mit Rissbildung) - Stone chips - Replace

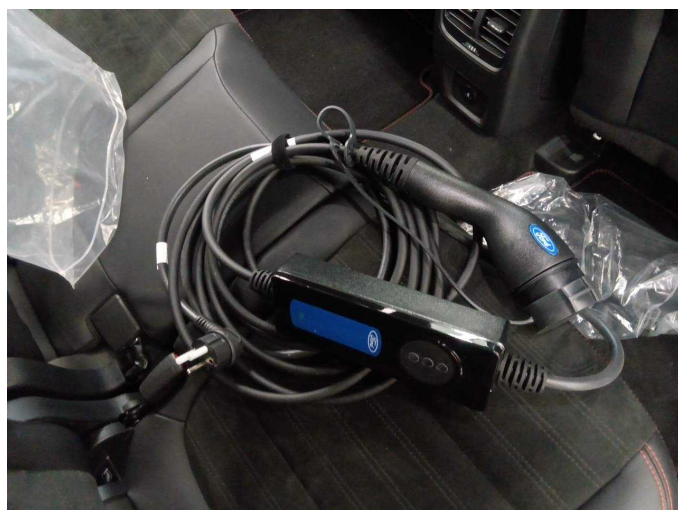
Equipment - charging cable (Für öffentliche Ladestationen)

**Missing part 1:** Equipment: charging cable (Für öffentliche Ladestationen) - Missing - Replace
