Expertise

Protocol number: 46571695  
Order No. / Reference: 26653087  
Inspection date: 15 Jul 2026

Manufacturer: Mercedes-Benz

Model: C 200 d T 9G-TRONIC

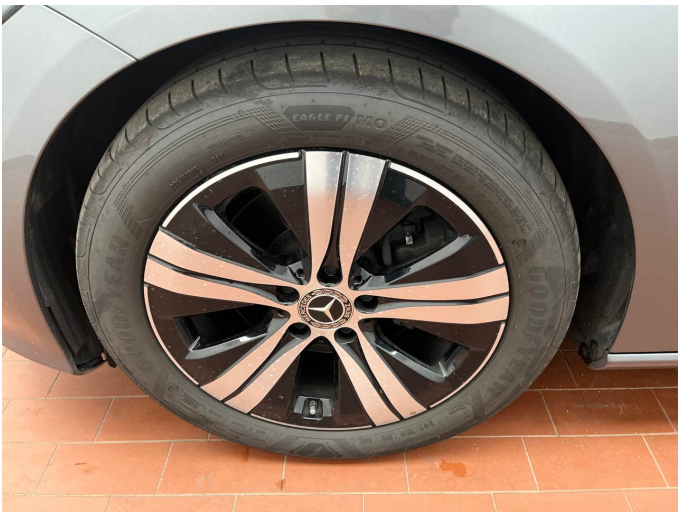
Figure 12: Mounted tyres

| # | Tyre size | Type of tyre | Manufacturer | Tread depth |
|---|---|---|---|---|
| 1) | 225/50 R17 94Y | Summer tyres on Light alloy | Goodyear | 5mm / 5mm |
| 2) | 225/50 R17 94Y | Summer tyres on Light alloy | Goodyear | 5mm / 5mm |

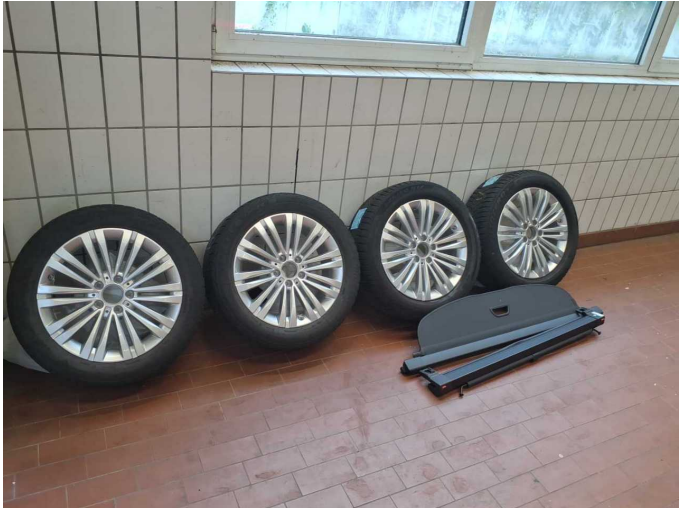
Figure 16: Additional tyres

| # | Tyre size | Type of tyre | Manufacturer | Tread depth |
|---|---|---|---|---|
| 1) | 225/50 R17 94H | Winter tyres on Light alloy | Pirelli | 6mm / 6mm |
| 2) | 225/50 R17 94H | Winter tyres on Light alloy | Bridgestone | 3mm / 3mm |

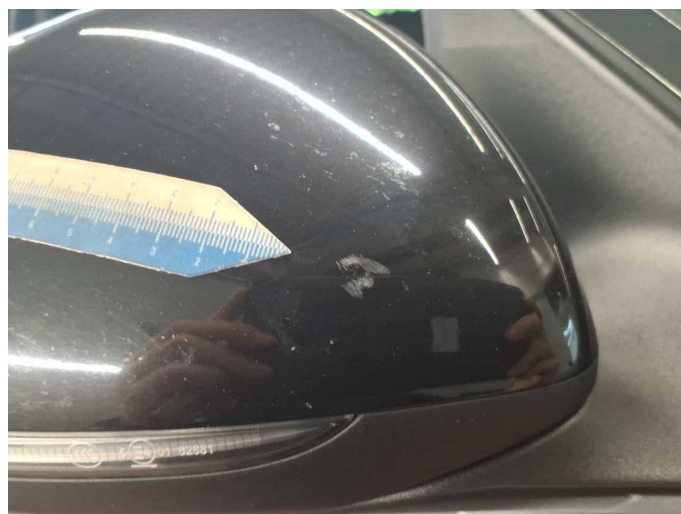
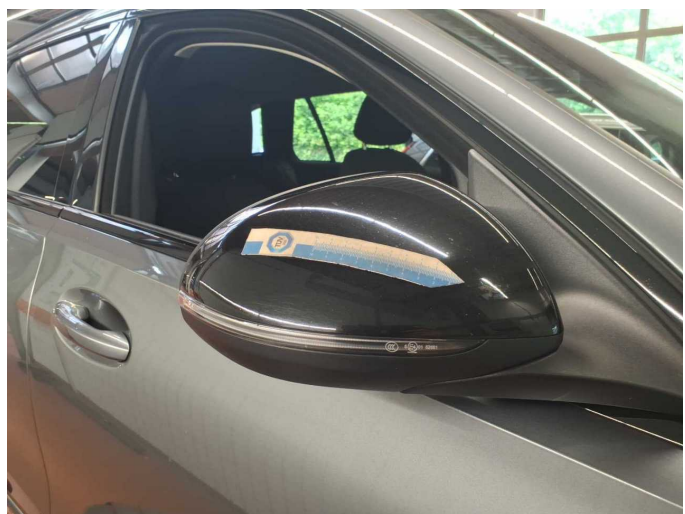
| No. | Component group | Description |
|---|---|---|
| 1 | Wing mirror - right side | Cap - Scratch(es) - Smart repair |

Damage 1: Wing mirror - right side: Cap - Scratch(es) - Smart repair

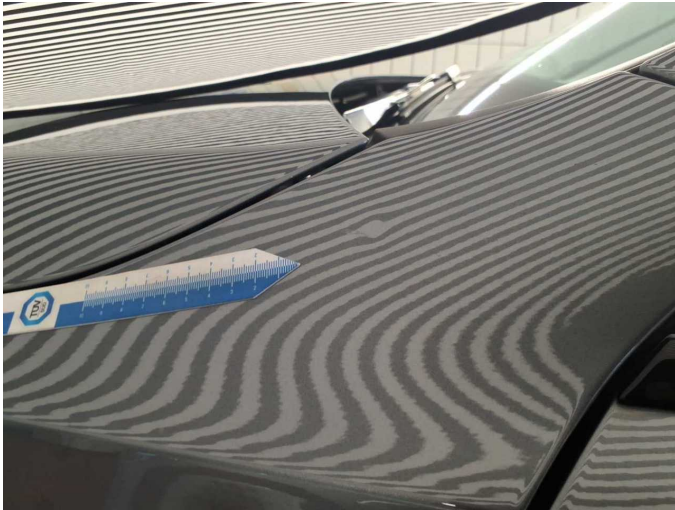
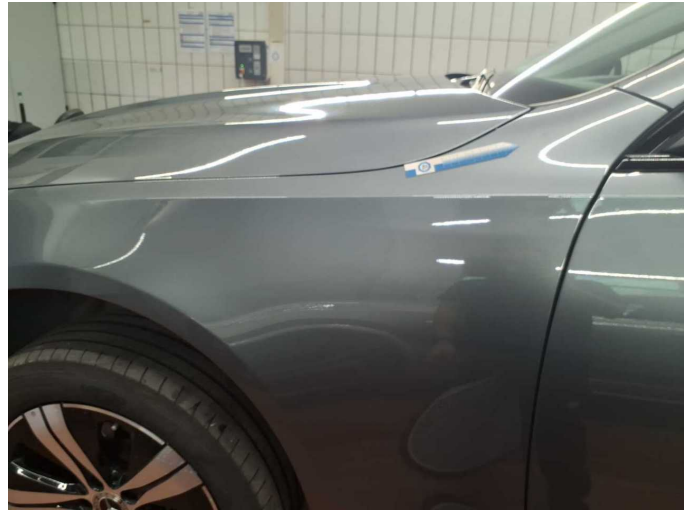
| No. | Component group | Description |
|---|---|---|
| 2 | Mudguard - left side | Mudguard - left side - dent(s) - Smooth repair work |

**Damage 2:** Mudguard - left side: Mudguard - left side - dent(s) - Smooth repair work

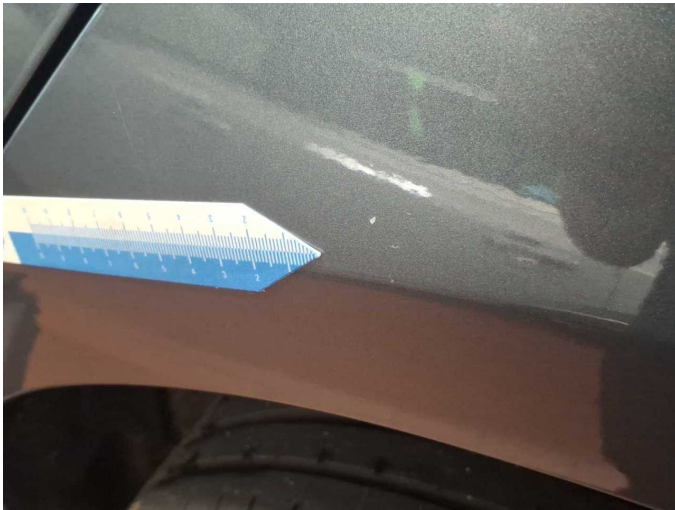
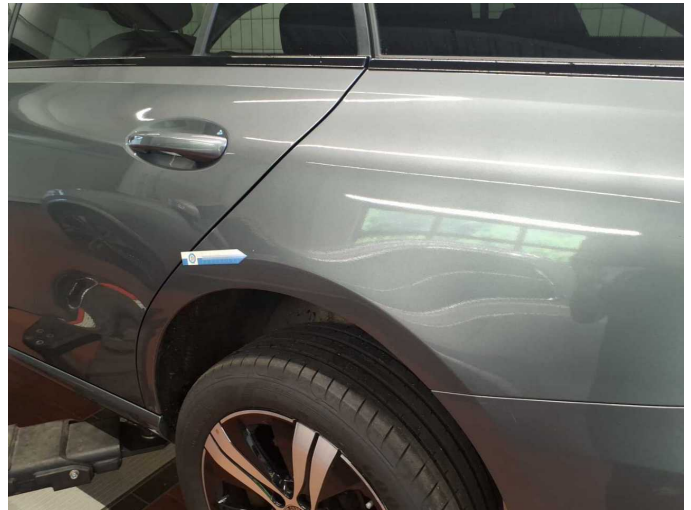
| No. | Component group | Description |
|---|---|---|
| 3 | Side panel - rear left side | Side panel - Scratch(es) - Smart repair |

**Damage 3:** Side panel - rear left side: Side panel - Scratch(es) - Smart repair

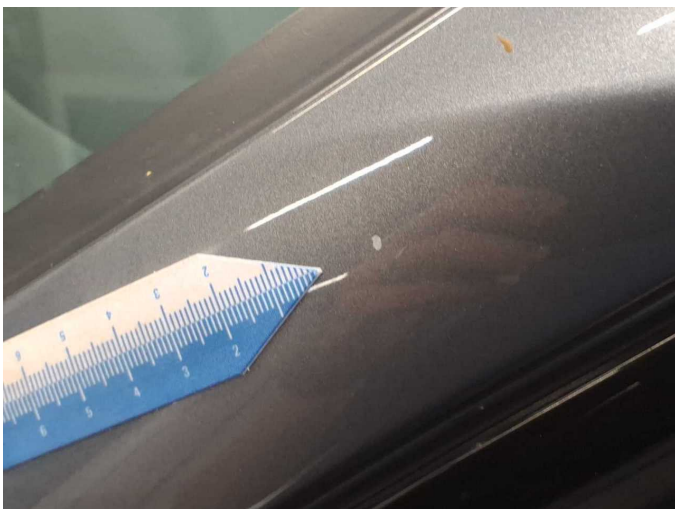
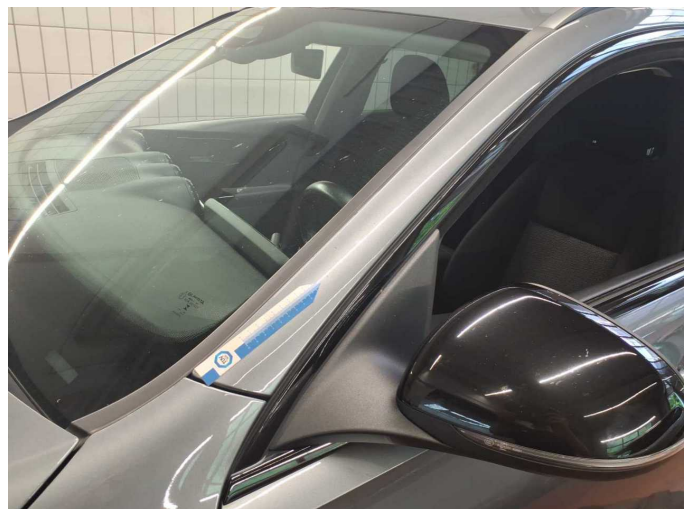
| No. | Component group | Description |
|---|---|---|
| 4 | Roof | Roof rail - left side - Stone chips - Smart repair |

**Damage 4:** Roof: Roof rail - left side - Stone chips - Smart repair

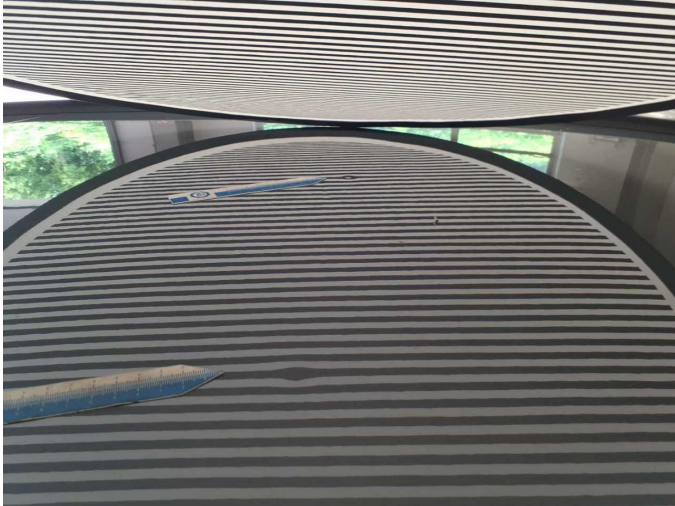
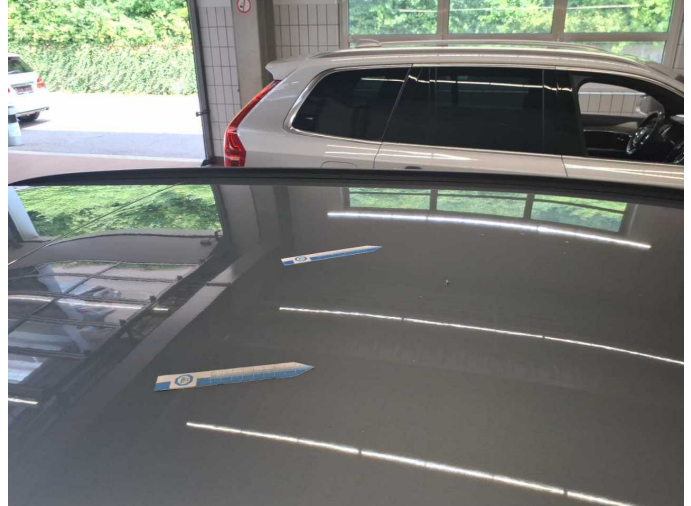
| No. | Component group | Description |
|---|---|---|
| 5 | Roof | Roof - dent(s) - Smooth repair work |

**Damage 5:** Roof: Roof - dent(s) - Smooth repair work

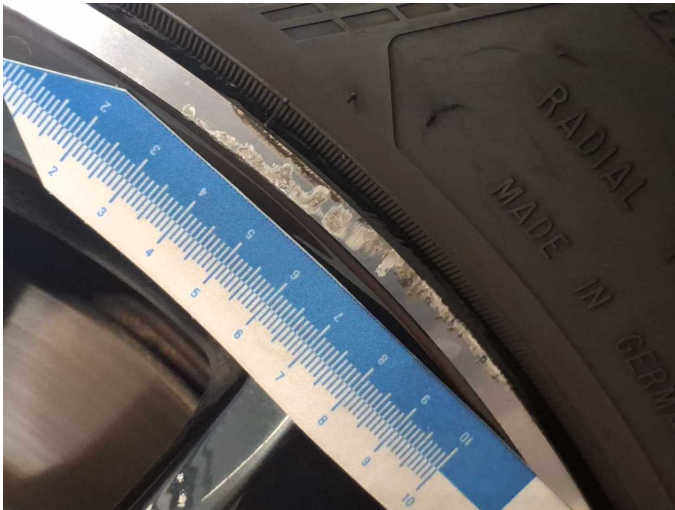
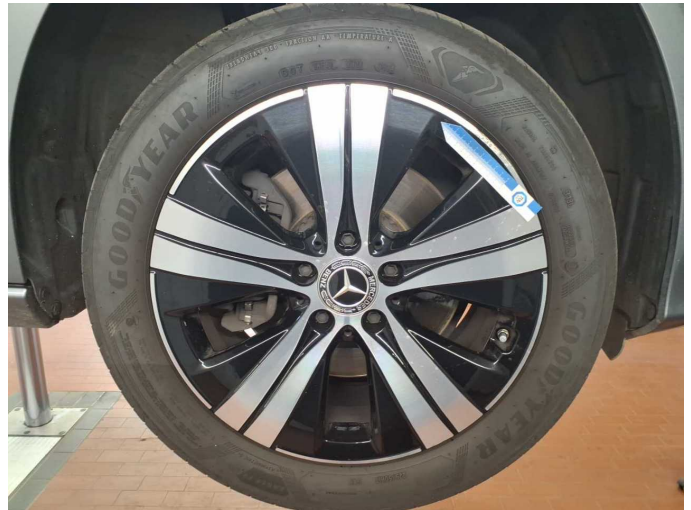
| No. | Component group | Description |
|---|---|---|
| 6 | Wheel / tyres | Alloy rim - front right side - Scratch(es) - Loss in value |

**Damage 6:** Wheel / tyres: Alloy rim - front right side - Scratch(es) - Loss in value

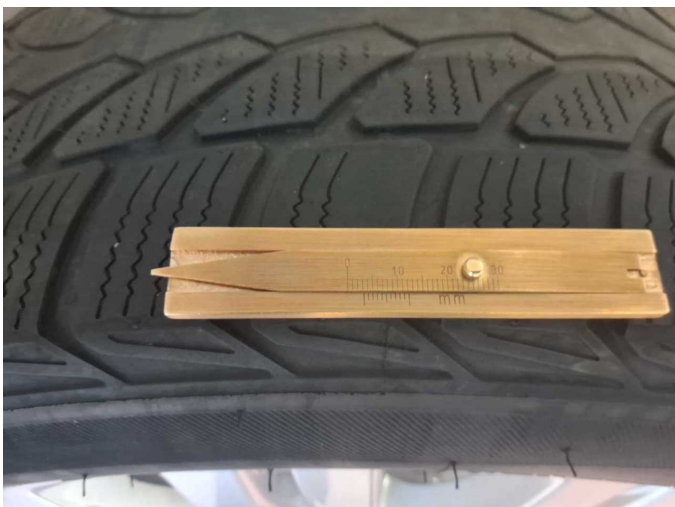
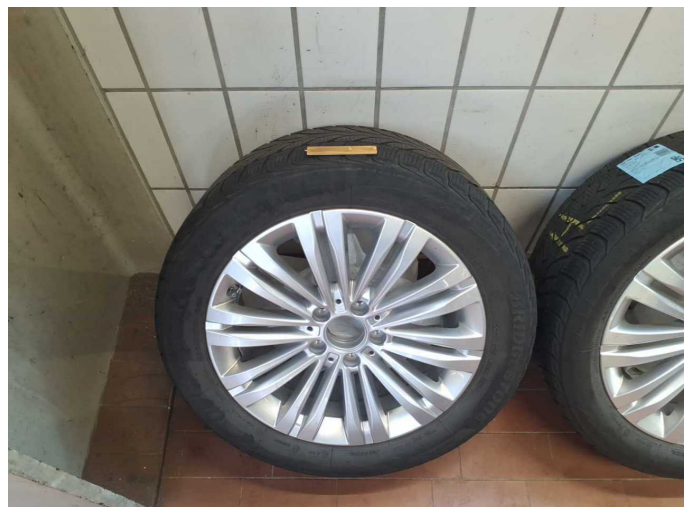
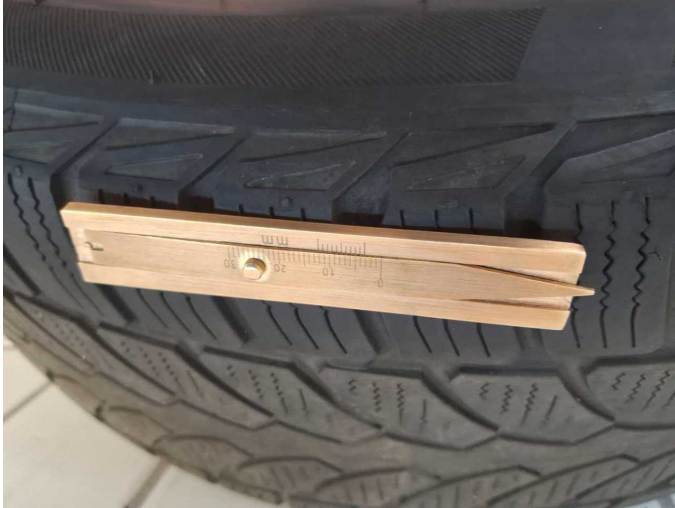
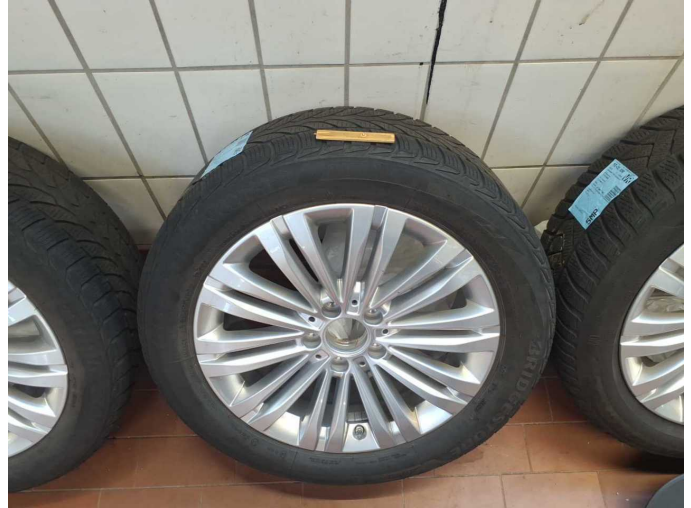
| No. | Component group | Description |
|---|---|---|
| 7 | 2nd wheel set | 2 tyres (3mm/ Hinterachse) - Does not meet the leasing specifications - Replace |

**Damage 7:** 2nd wheel set: 2 tyres (3mm/ Hinterachse) - Does not meet the leasing specifications - Replace

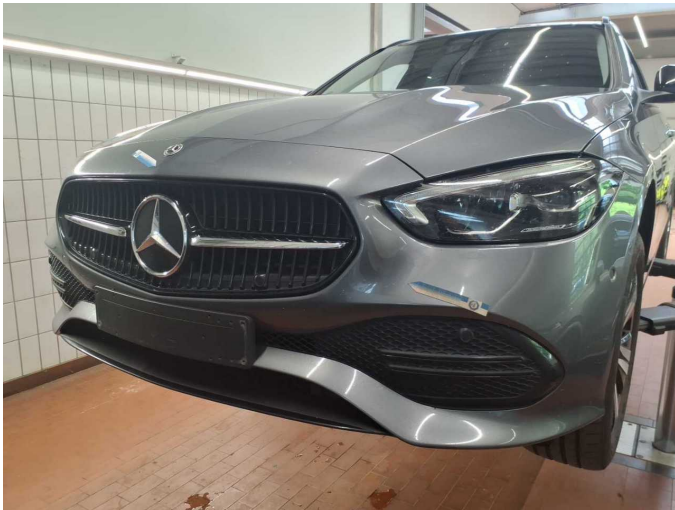
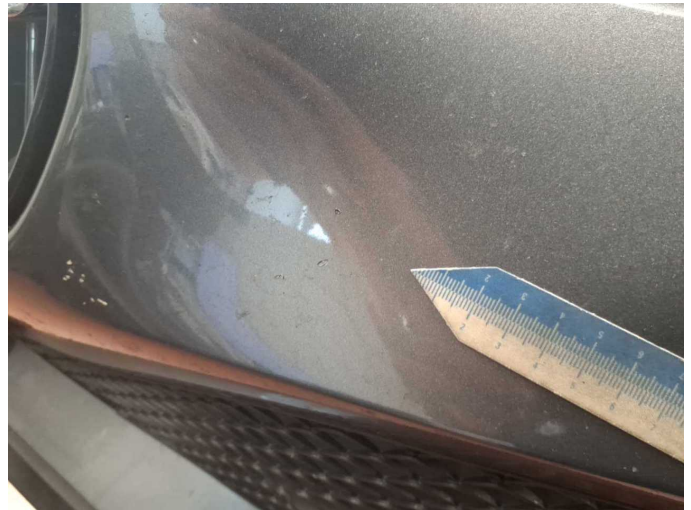
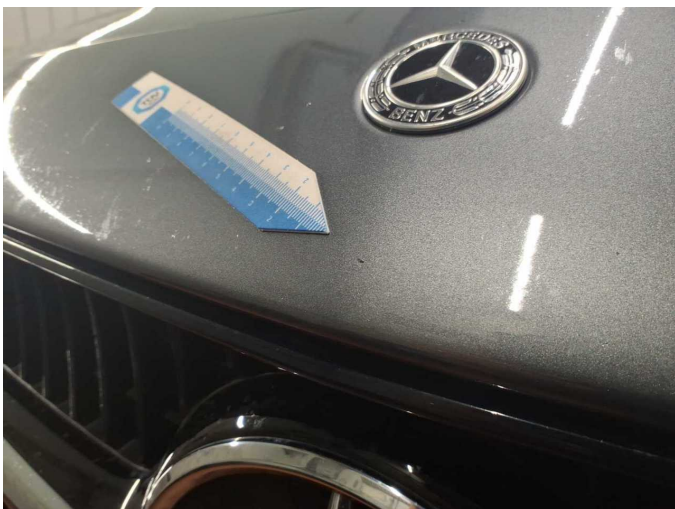
| No. | Component group | Description |
|---|---|---|
| 8 | Front bumper | Front bumper - Stone chips - Paint |

**Damage 8:** Front bumper: Front bumper - Stone chips - Paint

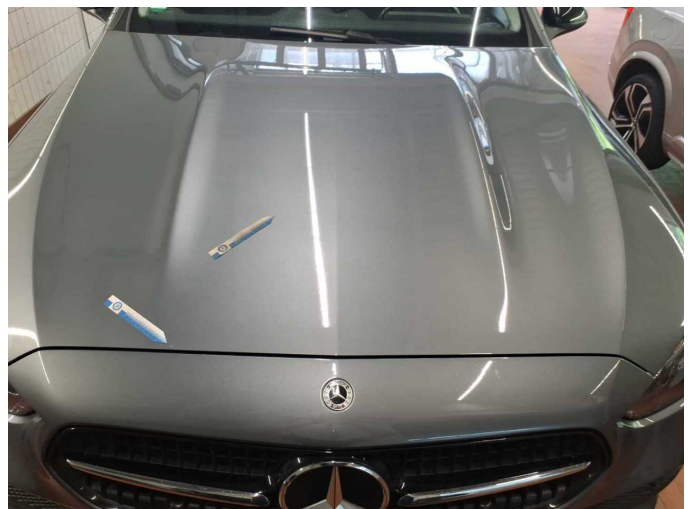
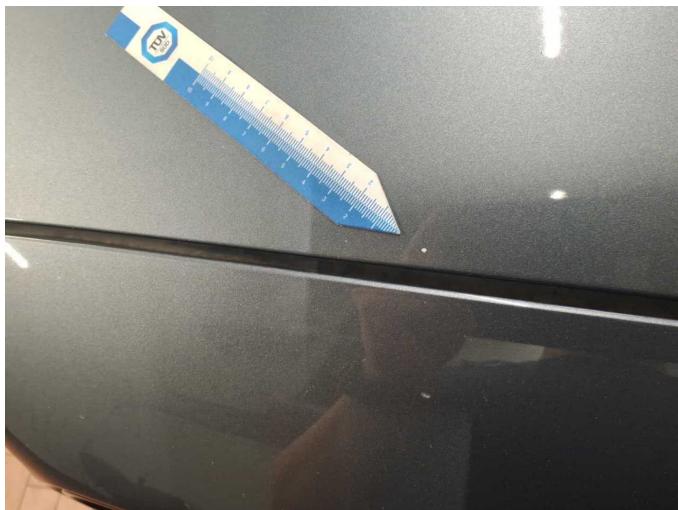
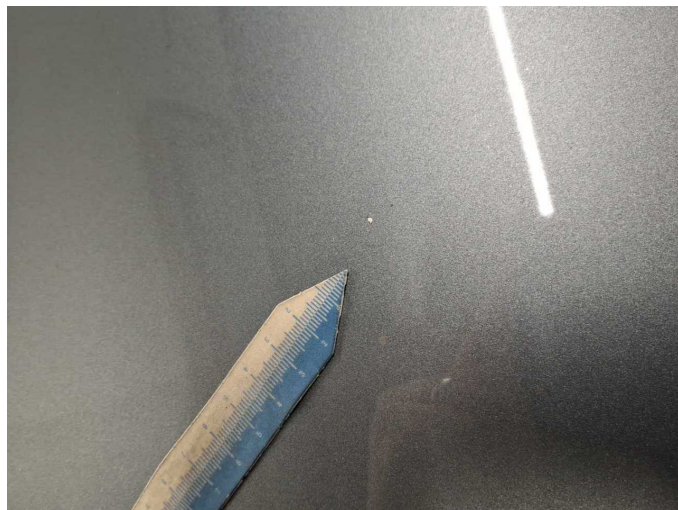
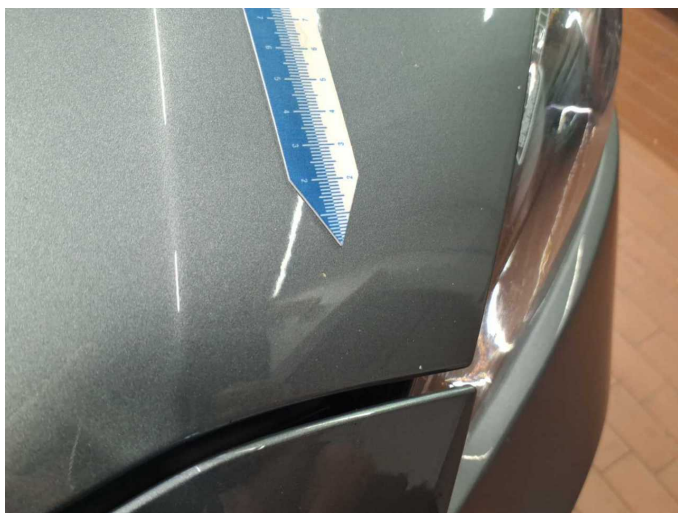
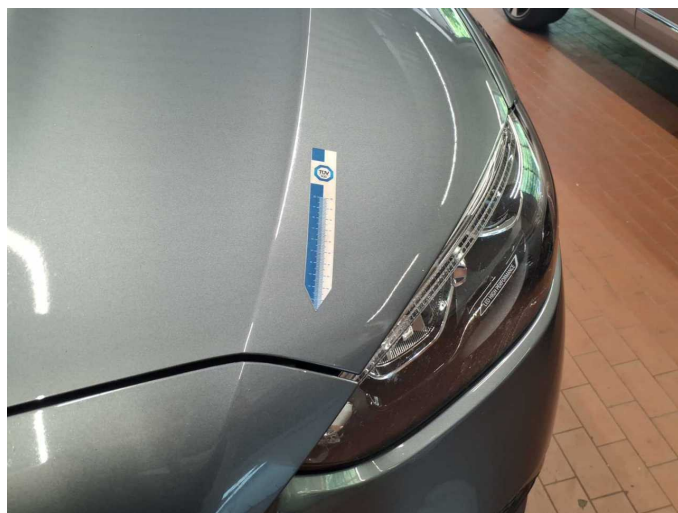
| No. | Component group | Description |
|---|---|---|
| 2 | Bonnet | Bonnet - Stone chips - No deduction |

**Wear and tear 2:** Bonnet: Bonnet - Stone chips - No deduction

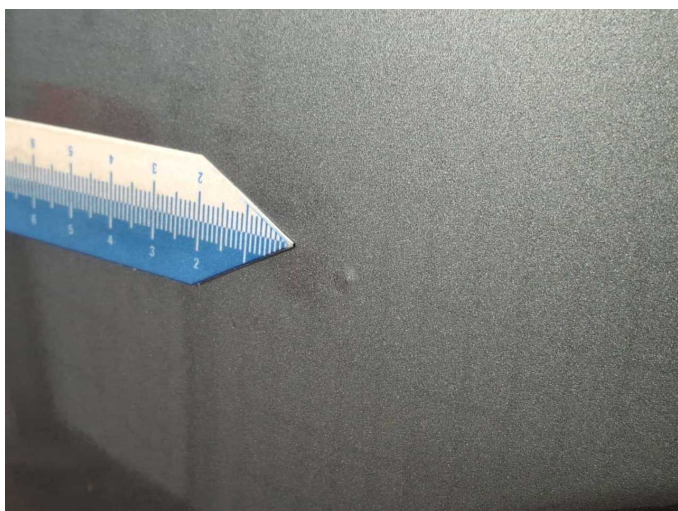
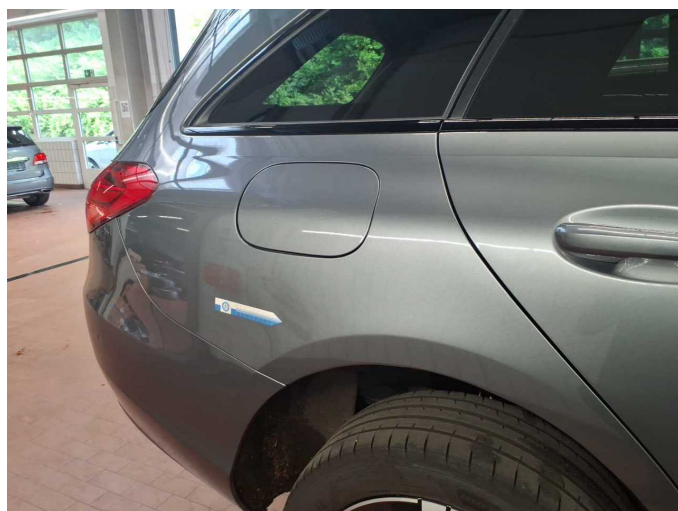
| No. | Component group | Description |
|---|---|---|
| 3 | Side panel - rear right side | Side panel (Lackpickel) - Paint defect - No deduction |

**Wear and tear 3:** Side panel - rear right side: Side panel (Lackpickel) - Paint defect - No deduction

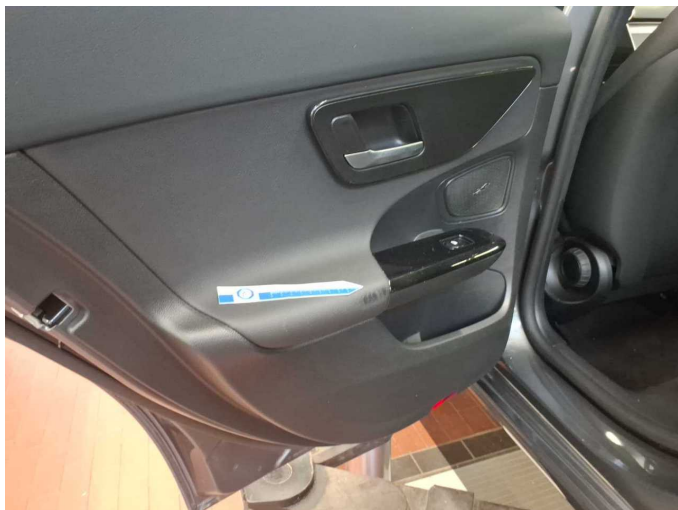
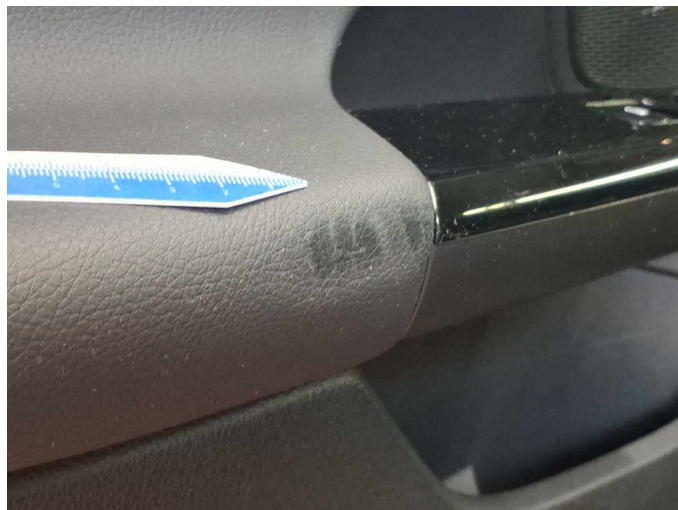
| No. | Component group | Description |
|---|---|---|
| 5 | Trim / covers | Door trim - rear left side - dent(s) - No deduction |

**Wear and tear 5:** Trim / covers: Door trim - rear left side - dent(s) - No deduction
