Expertise

Protocol number: 46887899  
Order No. / Reference: 26750386  
Inspection date: 5 Aug 2026

Manufacturer: Skoda  
VIN: TMBEK6PJXP4082534

Model: Fabia 1.5 TSI DSG Style

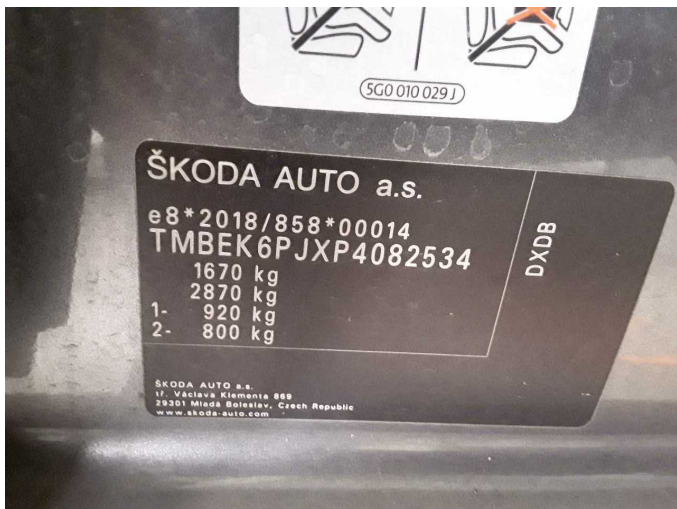
| VIN comparison | The vehicle identification number (VIN) was read from the vehicle and its conformity with the submitted documents was confirmed by the undersigned during the inspection. |

Figure 11: VIN

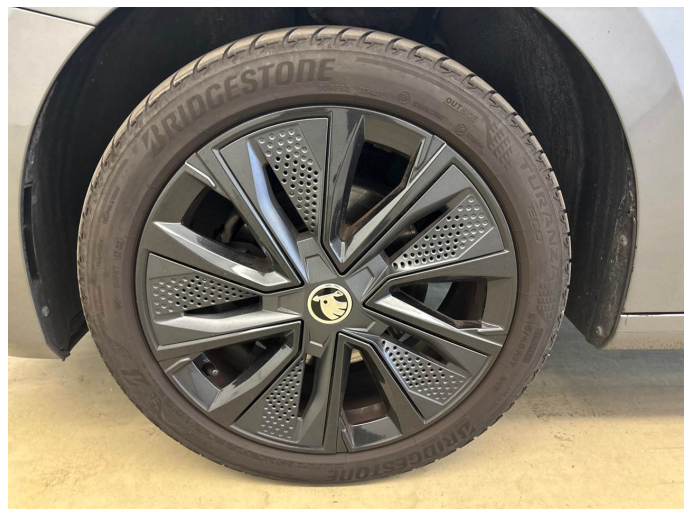
| # | Tyre size | Type of tyre | Manufacturer | Tread depth |
|---|---|---|---|---|
| 1) | 215/45 R17 91V | Summer tyres on Light alloy | Bridgestone | 4mm / 4mm |
| 2) | 215/45 R17 91V | Summer tyres on Light alloy | Bridgestone | 5mm / 5mm |

Figure 12: Mounted tyres

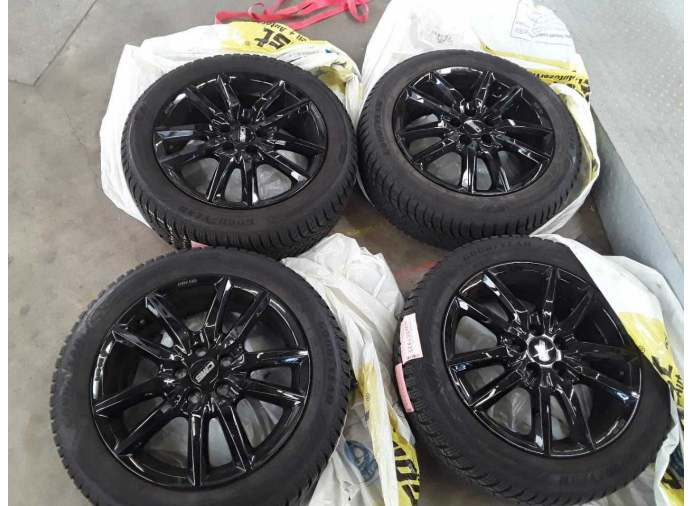
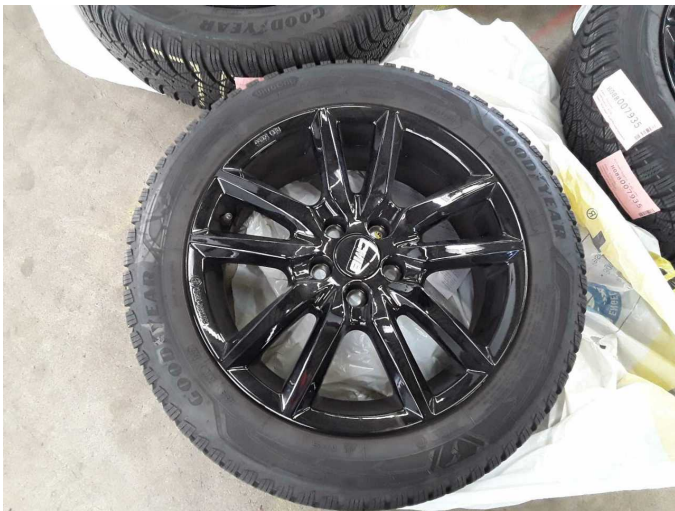
| # | Tyre size | Type of tyre | Manufacturer | Tread depth |
|---|---|---|---|---|
| 1) | 195/55 R16 91H | Winter tyres on Light alloy | Goodyear | 6mm / 6mm |
| 2) | 195/55 R16 91H | Winter tyres on Light alloy | Goodyear | 7mm / 7mm |

Figure 14: Additional tyres

Figure 15: Additional tyres

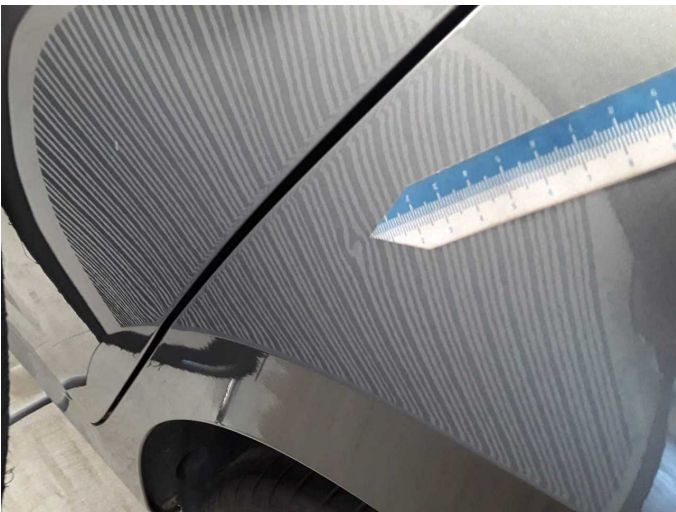
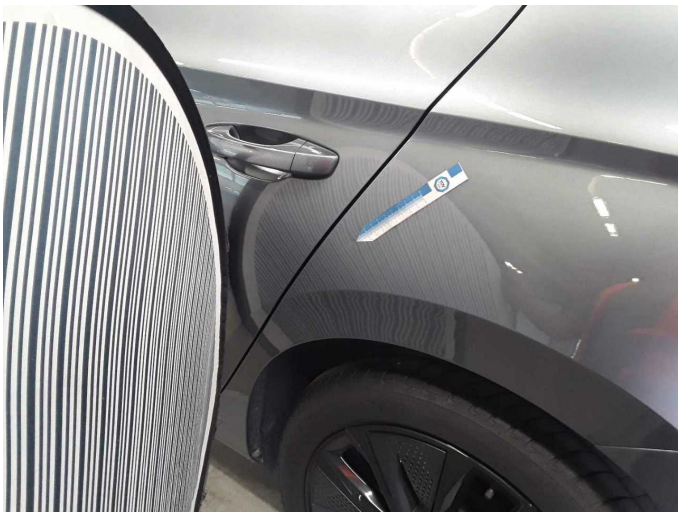
| No. | Component group | Description |
|---|---|---|
| 1 | Side panel - rear left side | Side panel - dent(s) - Smooth repair work |

Damage 1: Side panel - rear left side: Side panel - dent(s) - Smooth repair work

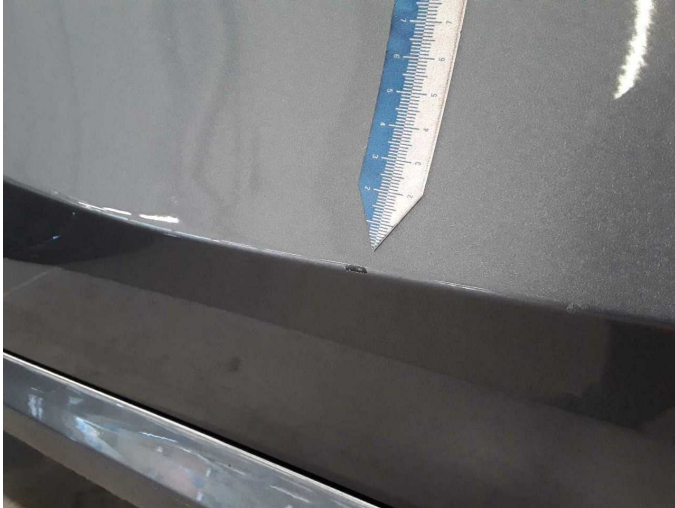
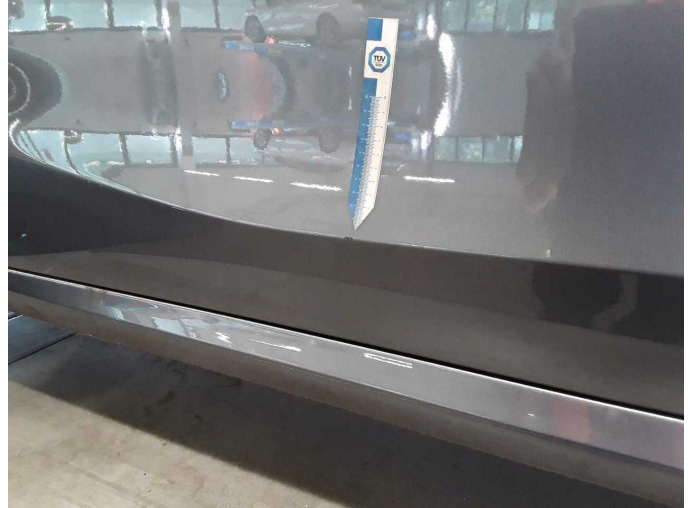
| No. | Component group | Description |
|---|---|---|
| 2 | Door - front left side | Door - Scratch(es) - Smart repair |

**Damage 2:** Door - front left side: Door - Scratch(es) - Smart repair

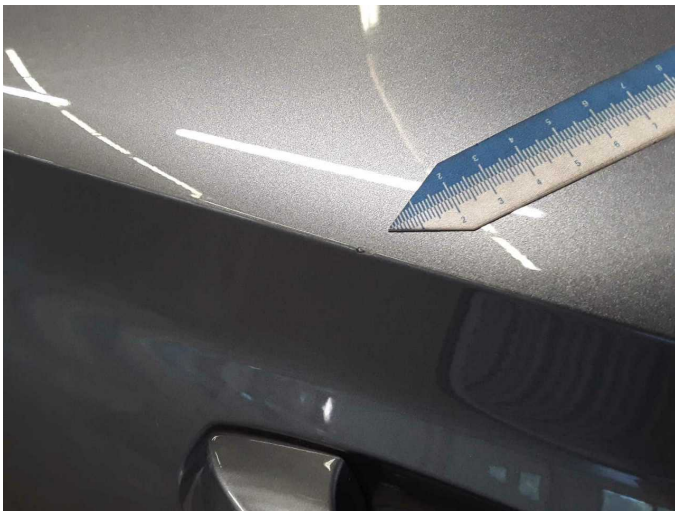
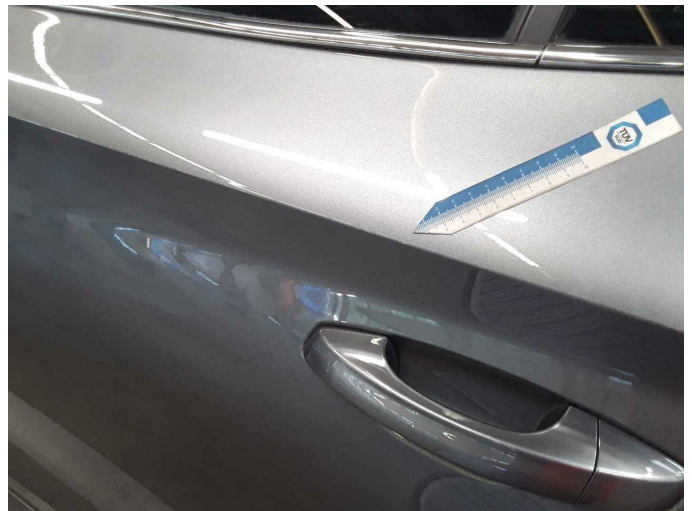
| No. | Component group | Description |
|---|---|---|
| 3 | Door - rear left side | Door - Scratch(es) - Smart repair |

**Damage 3:** Door - rear left side: Door - Scratch(es) - Smart repair

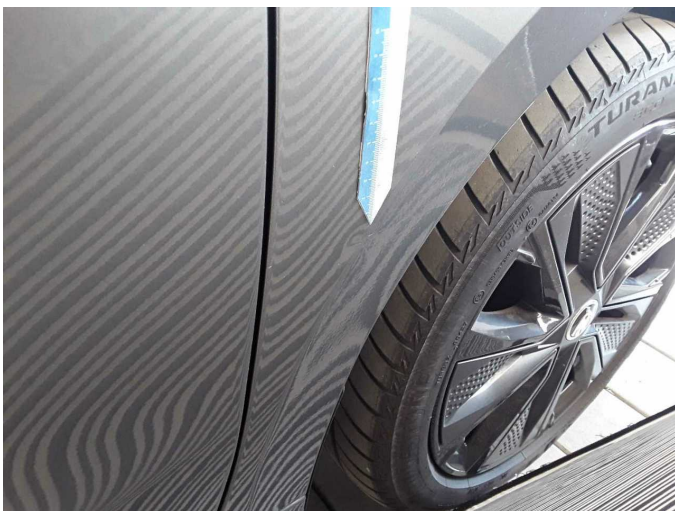
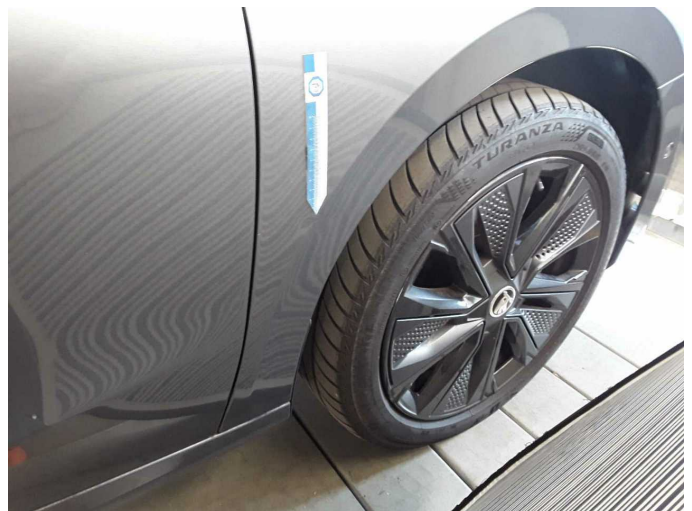
| No. | Component group | Description |
|---|---|---|
| 4 | Mudguard - right side | Mudguard - right side - Dent / paintcoat damage - Repair and paint |

**Damage 4:** Mudguard - right side: Mudguard - right side - Dent / paintcoat damage - Repair and paint

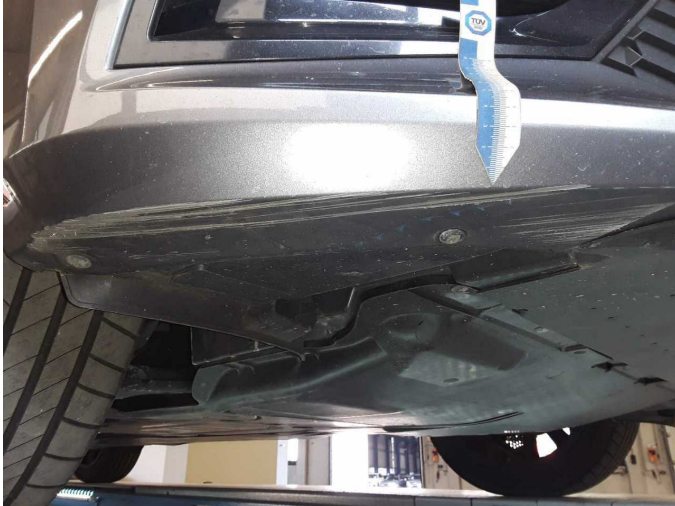
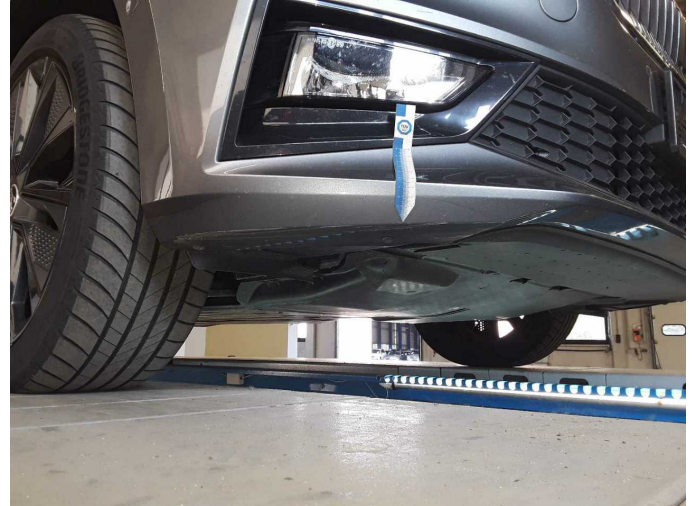
| No. | Component group | Description |
|---|---|---|
| 5 | Front bumper | Front bumper - Scratched - Paint |

**Damage 5:** Front bumper: Front bumper - Scratched - Paint

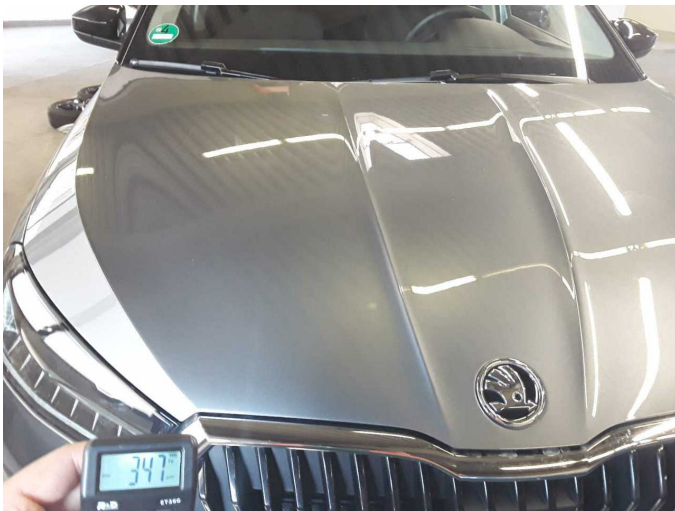
| No. | Repainting |
|---|---|
| 1 | Bonnet, Professionally carried out |

Bonnet

347 µm |

**Bonnet:** 347 µm
