Expertise

Protocol number: 46397691  
Order No. / Reference: 26574168-1  
Inspection date: 30 Jun 2026

Manufacturer: Ford

Model: Kuga 2.5 Duratec PHEV TITANIUM

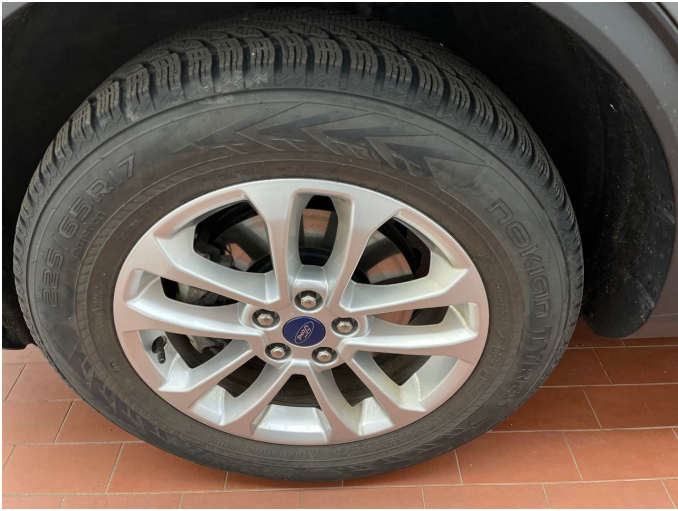
Figure 12: Mounted tyres

| # | Tyre size | Type of tyre | Manufacturer | Tread depth |
|---|---|---|---|---|
| 1) | 225/65 R17 106H | Winter tyres on Light alloy | Nokian | 5mm / 5mm |
| 2) | 225/65 R17 106H | Winter tyres on Light alloy | Nokian | 3mm / 3mm |

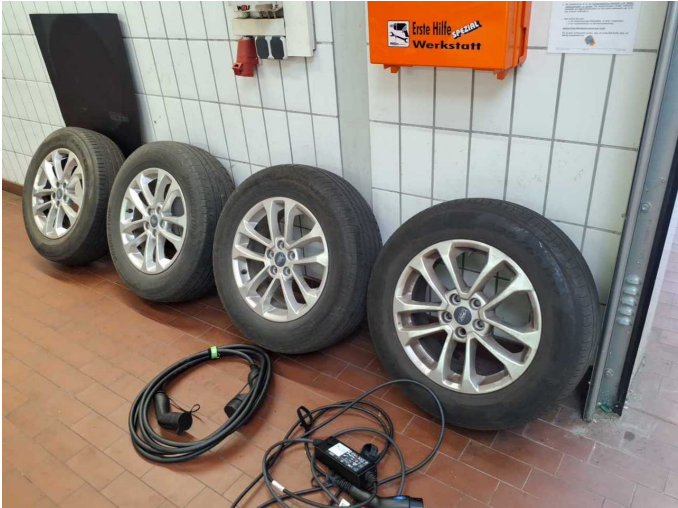
Figure 16: Additional tyres

| # | Tyre size | Type of tyre | Manufacturer | Tread depth |
|---|---|---|---|---|
| 1) | 225/65 R17 102V | Summer tyres on Light alloy | Bridgestone | 5mm / 5mm |
| 2) | 225/65 R17 102V | Summer tyres on Light alloy | Bridgestone | 5mm / 5mm |

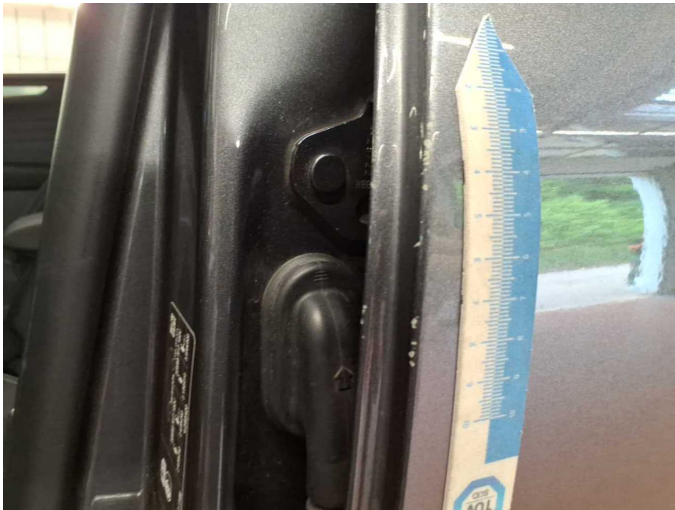
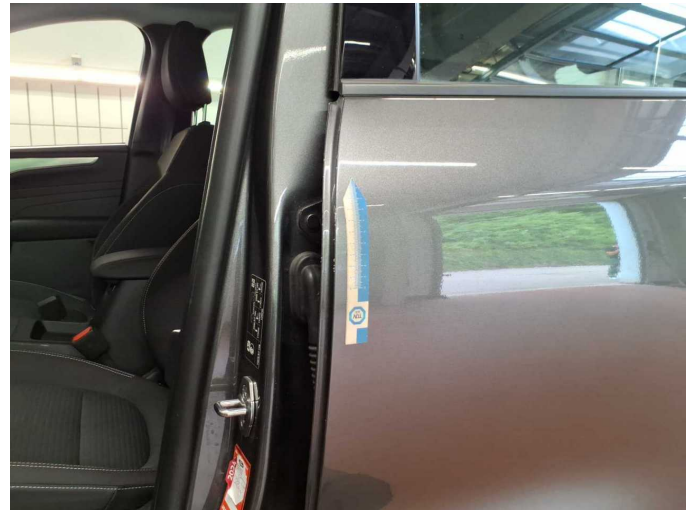
| No. | Component group | Description |
|---|---|---|
| 1 | Door - rear left side | Door edge - Scratch(es) - Smart repair |

**Damage 1:** Door - rear left side: Door edge - Scratch(es) - Smart repair

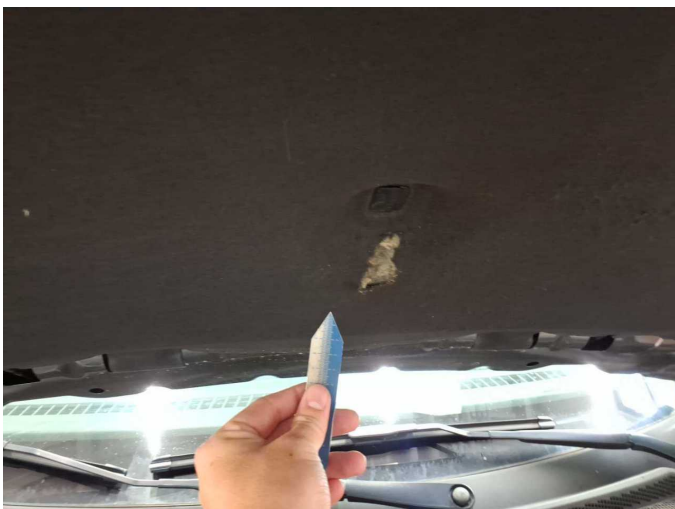
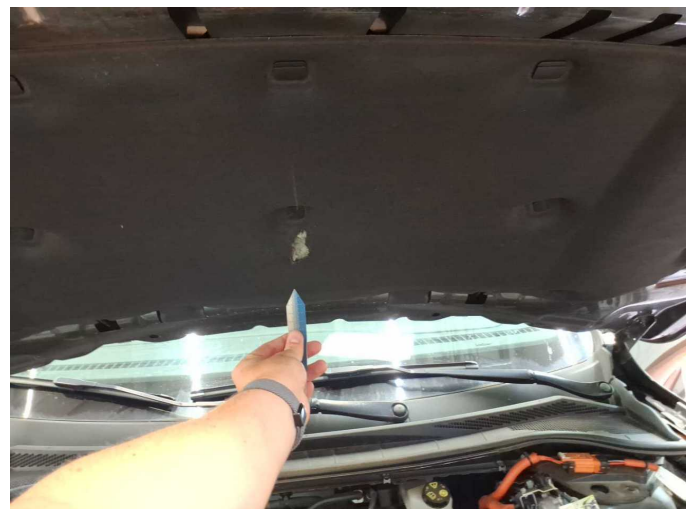
| No. | Component group | Description |
|---|---|---|
| 2 | Bonnet | Insulation lining - Broken / torn - Replace |

**Damage 2:** Bonnet: Insulation lining - Broken / torn - Replace

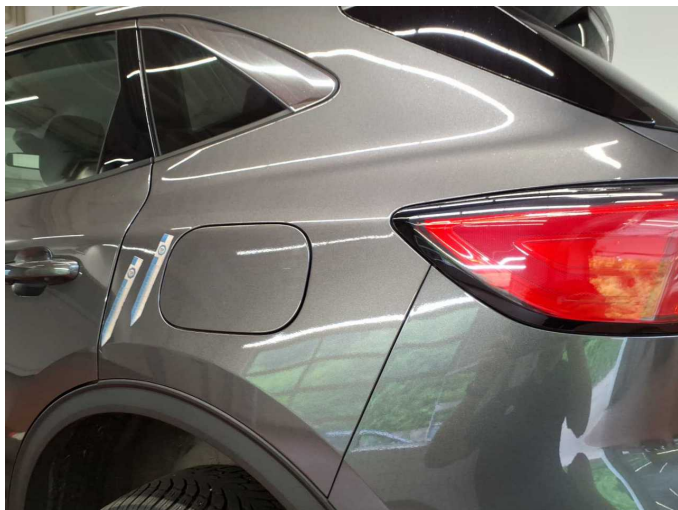
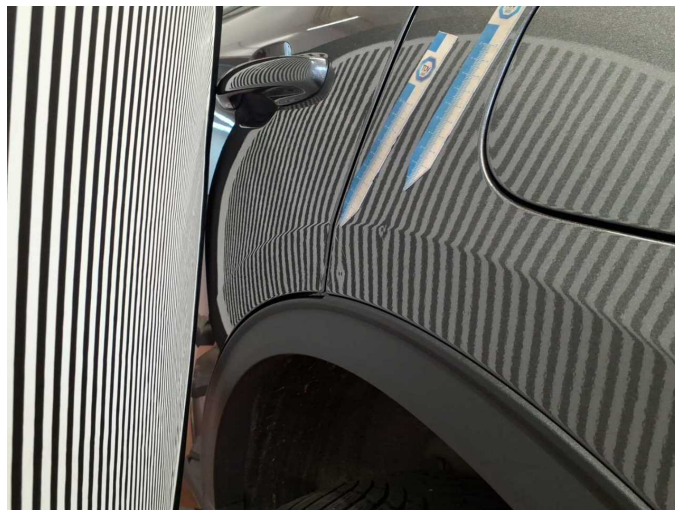
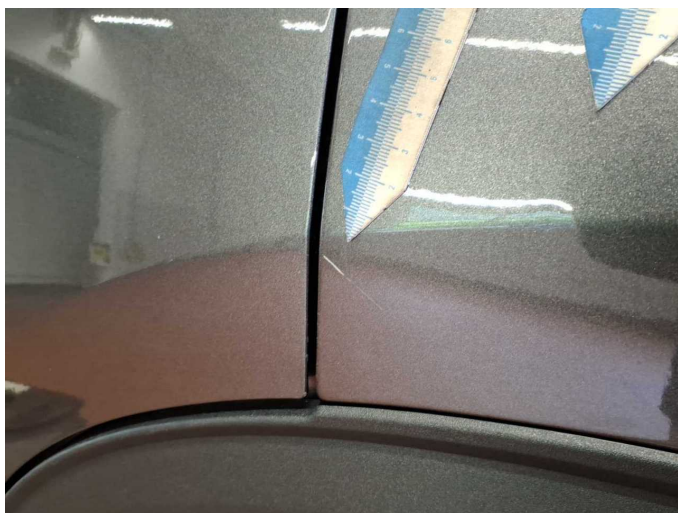
| No. | Component group | Description |
|---|---|---|
| 3 | Side panel - rear left side | Side panel - Dent / paintcoat damage - Smart repair |

**Damage 3:** Side panel - rear left side: Side panel - Dent / paintcoat damage - Smart repair

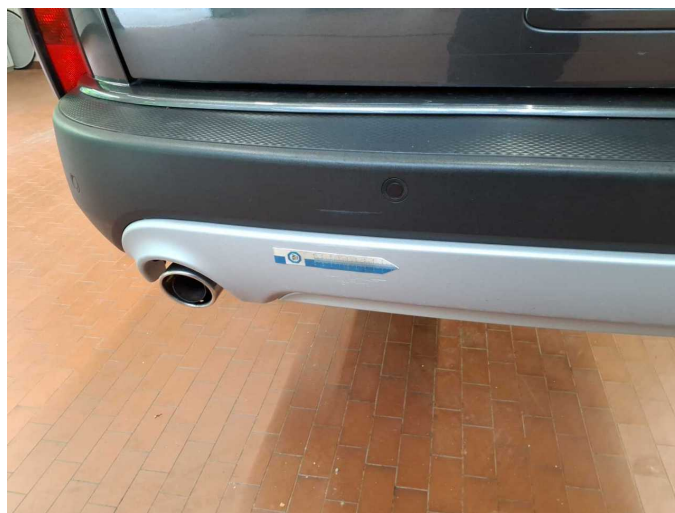
| No. | Component group | Description |
|---|---|---|
| 4 | Rear bumper | Spoiler - Scratch(es) - Replace |

**Damage 4:** Rear bumper: Spoiler - Scratch(es) - Replace

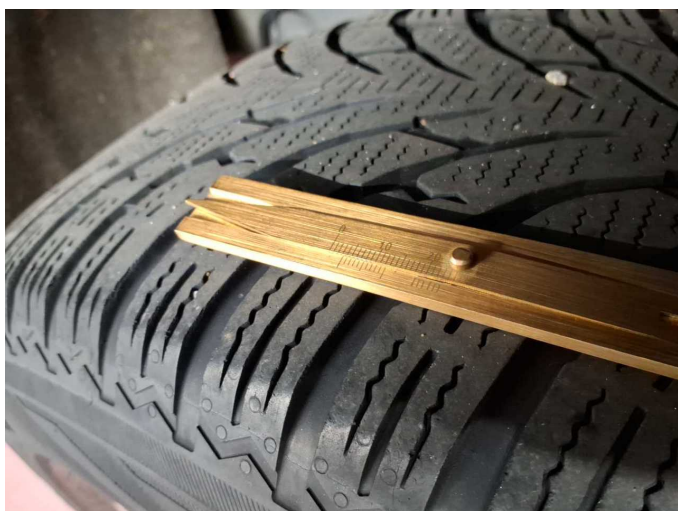
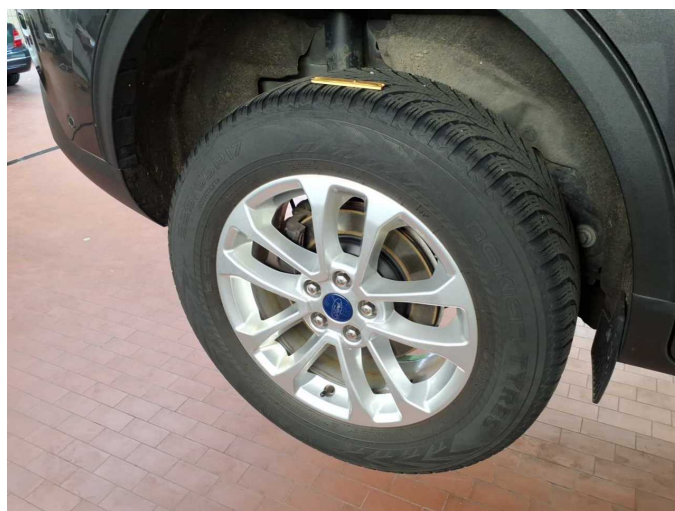
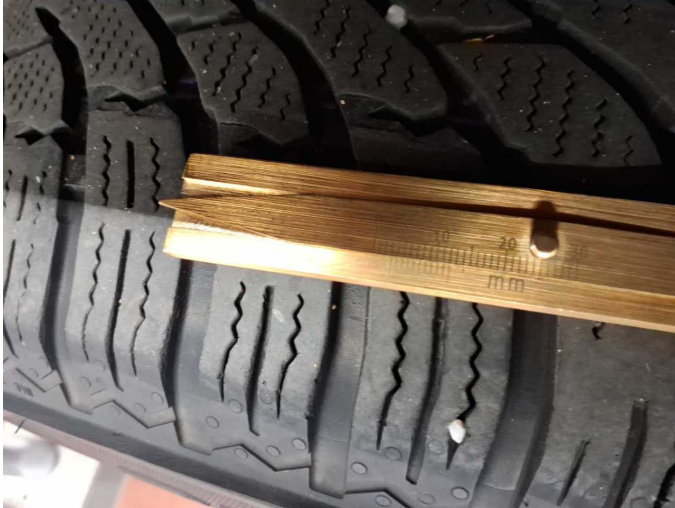
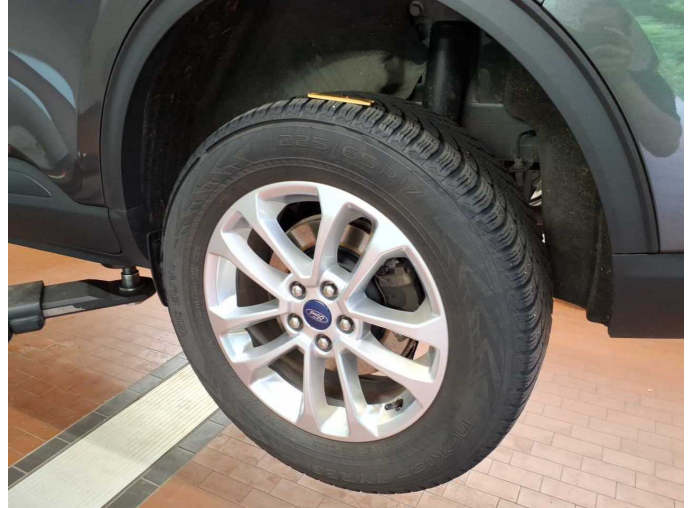
| No. | Component group | Description |
|---|---|---|
| 5 | Wheel / tyres | Tyre - right (3mm Profil) - Does not meet the leasing specifications - Replace |

**Damage 5:** Wheel / tyres: Tyre - right (3mm Profil) - Does not meet the leasing specifications - Replace

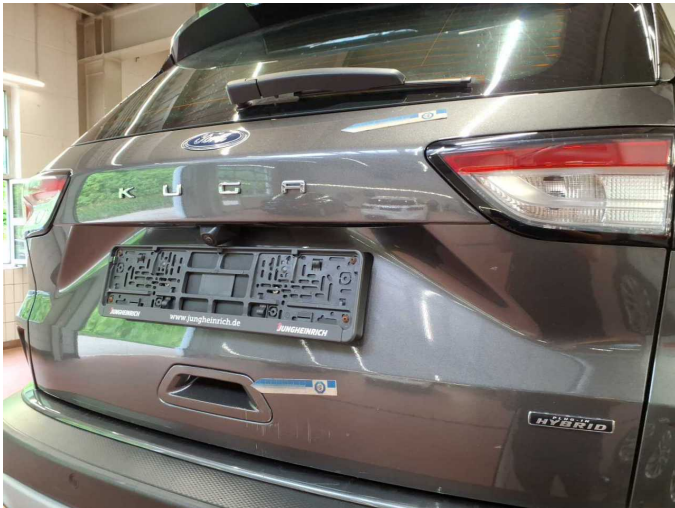
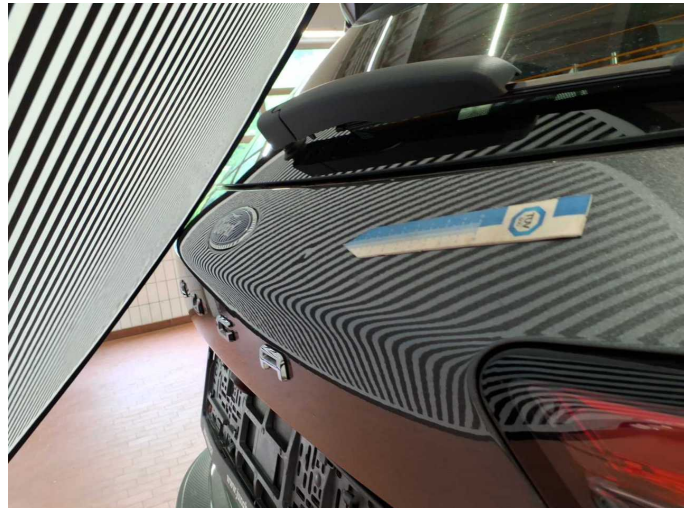
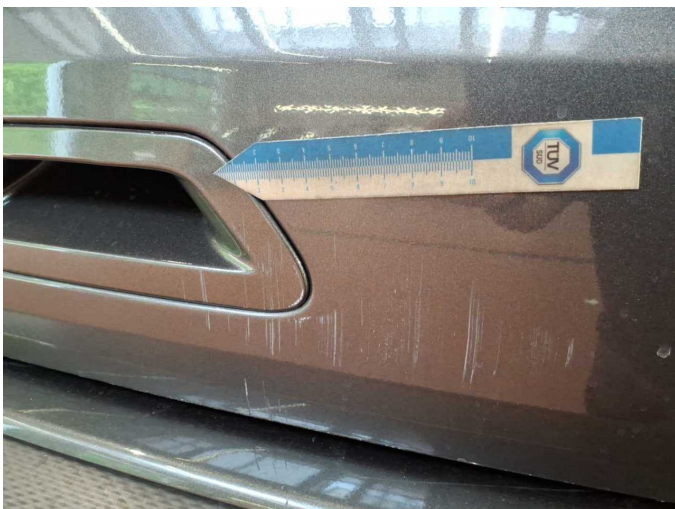
| No. | Component group | Description |
|---|---|---|
| 6 | Boot lid / rear door | Boot lid - Dent / paintcoat damage - Paint |

**Damage 6:** Boot lid / rear door: Boot lid - Dent / paintcoat damage - Paint

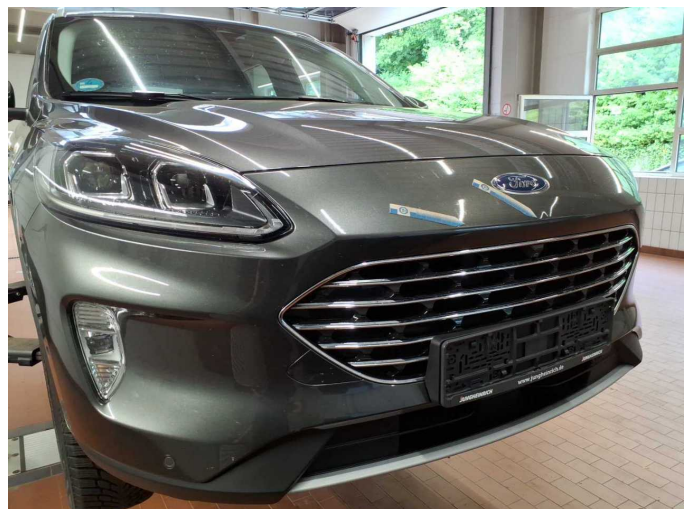
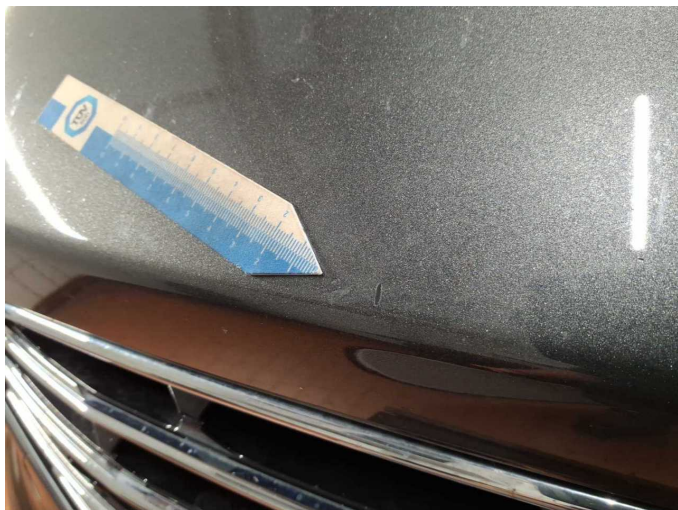
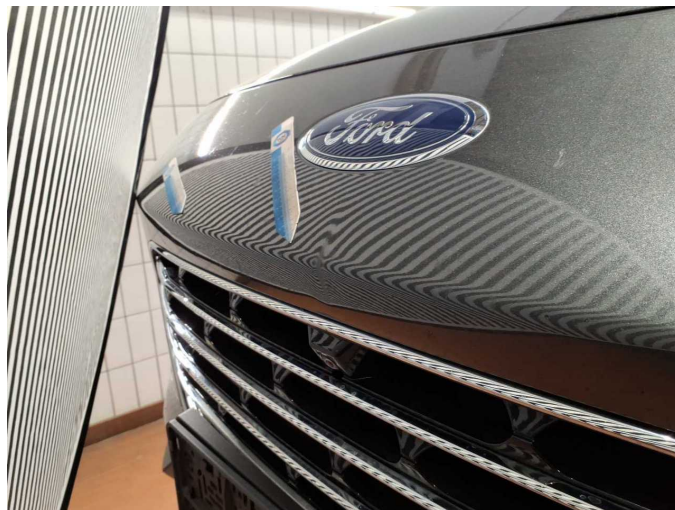
| No. | Component group | Description |
|---|---|---|
| 7 | Front bumper | Front bumper - Dent / paintcoat damage - Paint |

**Damage 7:** Front bumper: Front bumper - Dent / paintcoat damage - Paint

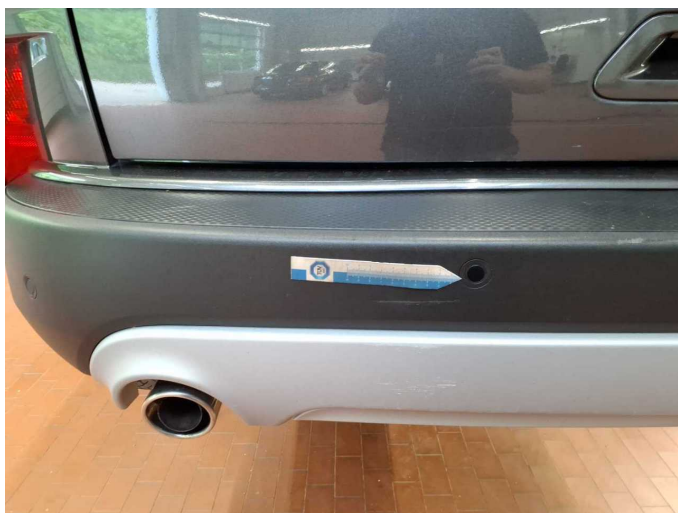
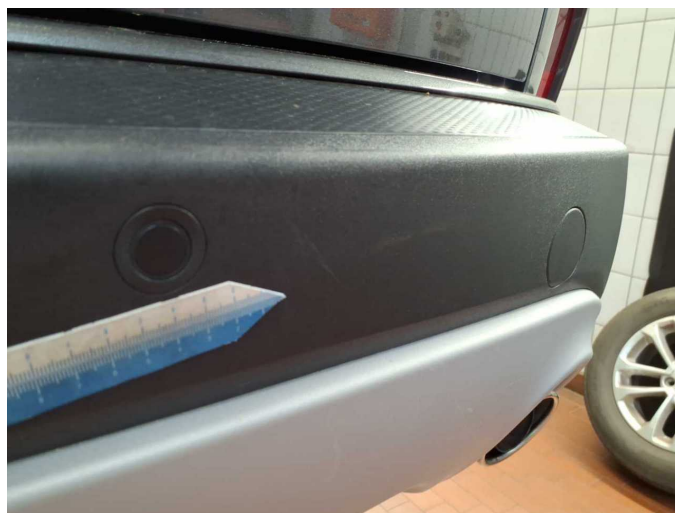
| No. | Component group | Description |
|---|---|---|
| 1 | Rear bumper | Rear bumper - Scratch(es) - No deduction |

**Wear and tear 1:** Rear bumper: Rear bumper - Scratch(es) - No deduction

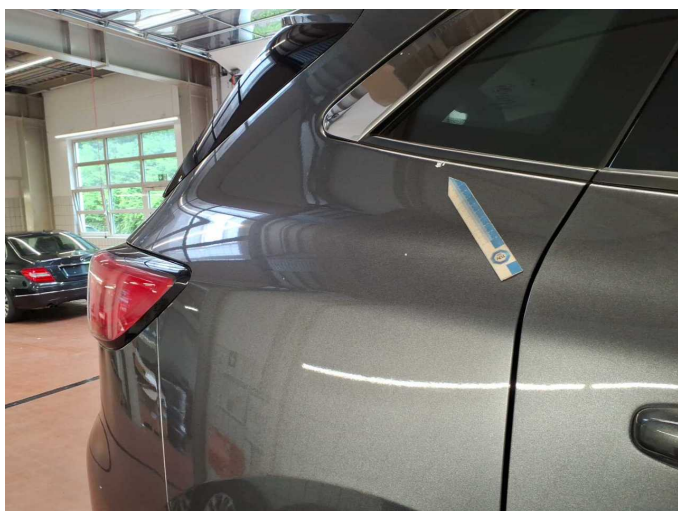
| No. | Component group | Description |
|---|---|---|
| 3 | Side panel - rear right side | Side panel - Soiled - No deduction |

**Wear and tear 3:** Side panel - rear right side: Side panel - Soiled - No deduction
