Expertise

Protocol number: 46547019  
Order No. / Reference: 26681055  
Inspection date: 16 Jul 2026

Manufacturer: Volkswagen

Model: Caddy 2.0 TDI BMT (5-Si.) DSG Style

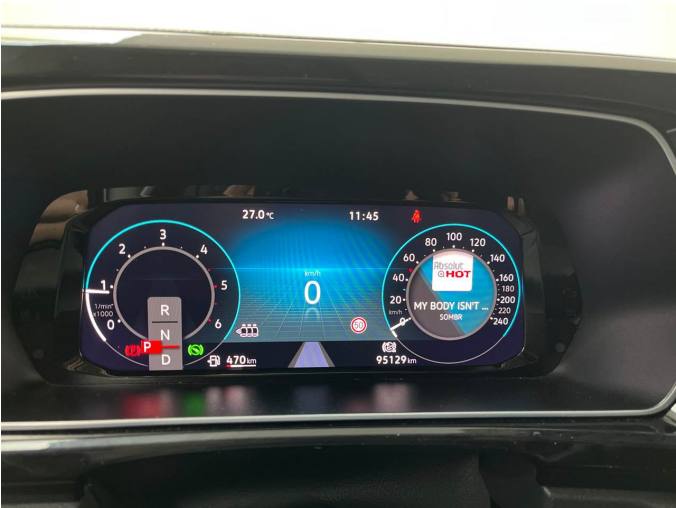
| Vehicle details | |
|---|---|
| Mileage (Read) | 95,129 km |

Figure 7: Instrument cluster

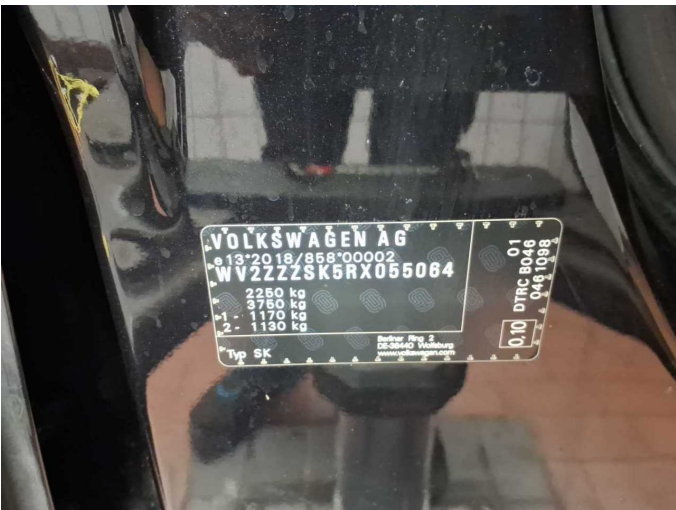
| VIN comparison | The vehicle identification number (VIN) was read from the vehicle and its conformity with the submitted documents was confirmed by the undersigned during the inspection. |

Figure 11: VIN

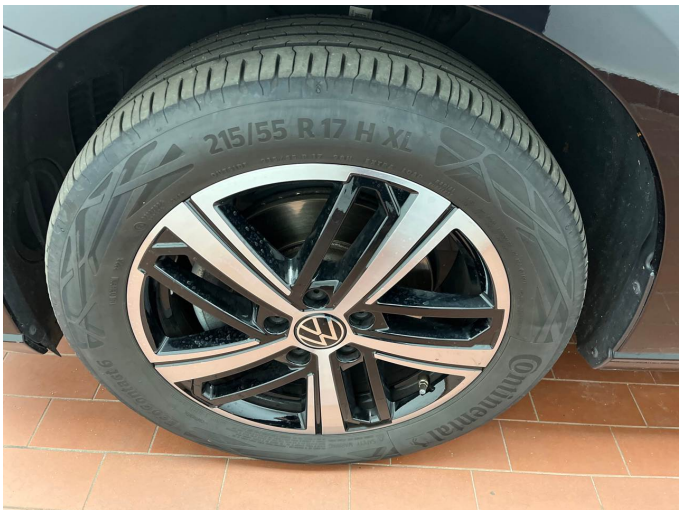
| # | Tyre size | Type of tyre | Manufacturer | Tread depth |
|---|---|---|---|---|
| 1) | 215/55 R17 98H | Summer tyres on Light alloy | Continental | 4mm / 4mm |
| 2) | 215/55 R17 98H | Summer tyres on Light alloy | Continental | 5mm / 5mm |

Figure 12: Mounted tyres

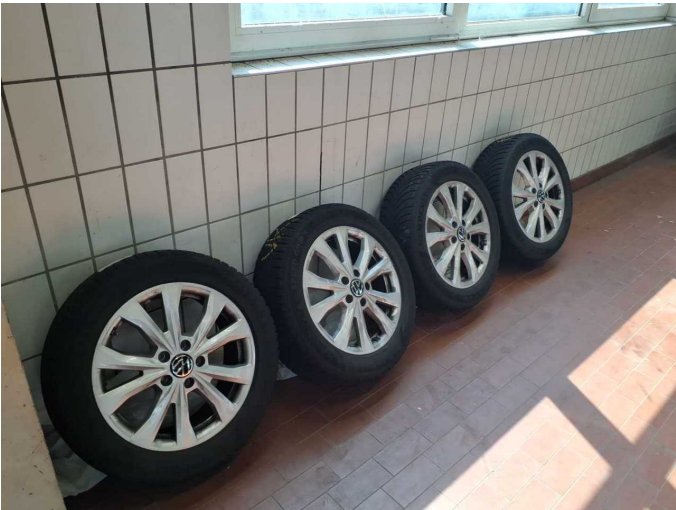
| # | Tyre size | Type of tyre | Manufacturer | Tread depth |
|---|---|---|---|---|
| 1) | 215/55 R17 98V | Winter tyres on Light alloy | Semperit | 4mm / 4mm |
| 2) | 215/55 R17 98V | Winter tyres on Light alloy | Semperit | 4mm / 4mm |

Figure 15: Additional tyres

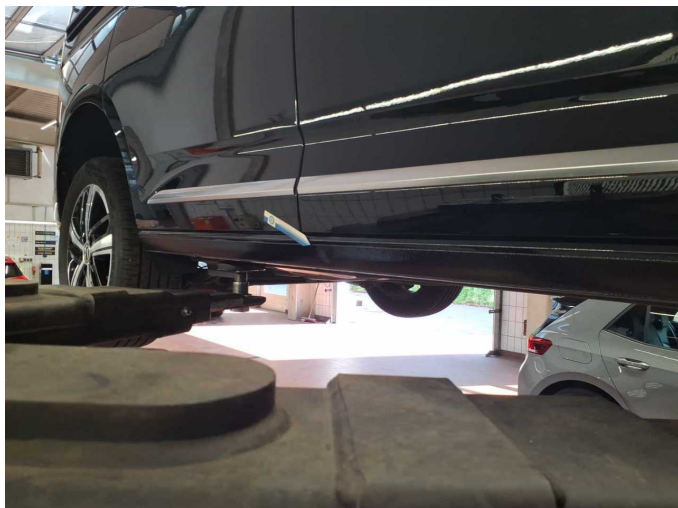
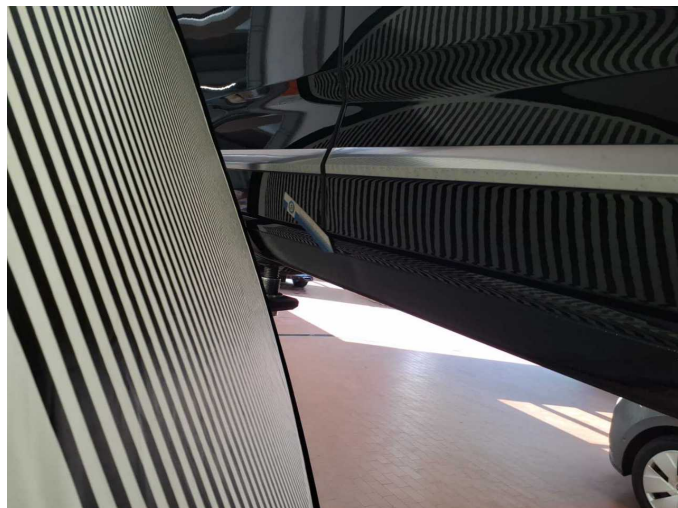
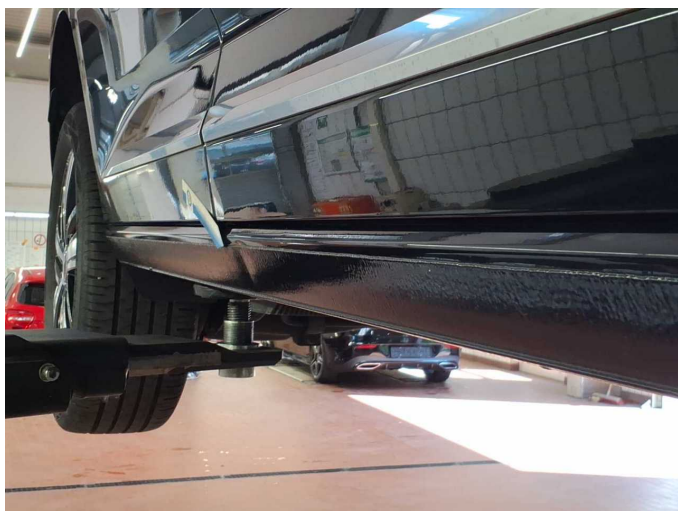
| No. | Component group | Description |
|---|---|---|
| 1 | Sill - right side | Sill - dent(s) - Smooth repair work |

**Damage 1:** Sill - right side: Sill - dent(s) - Smooth repair work

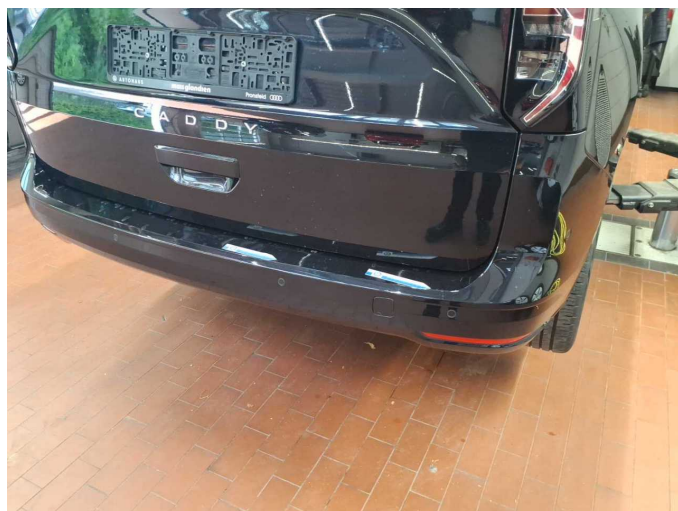
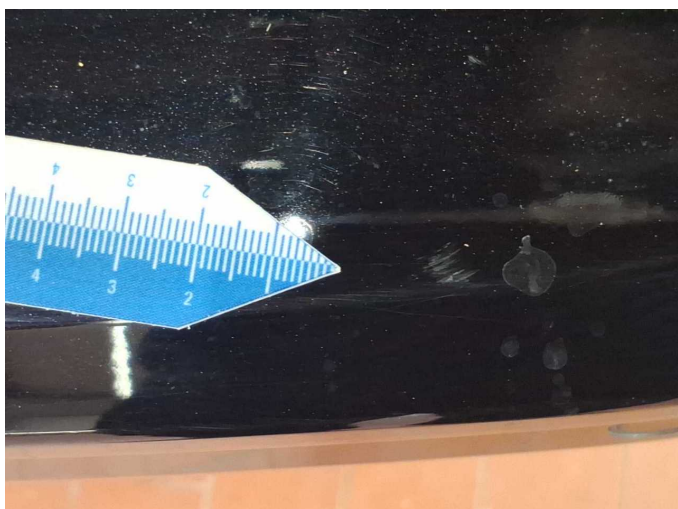
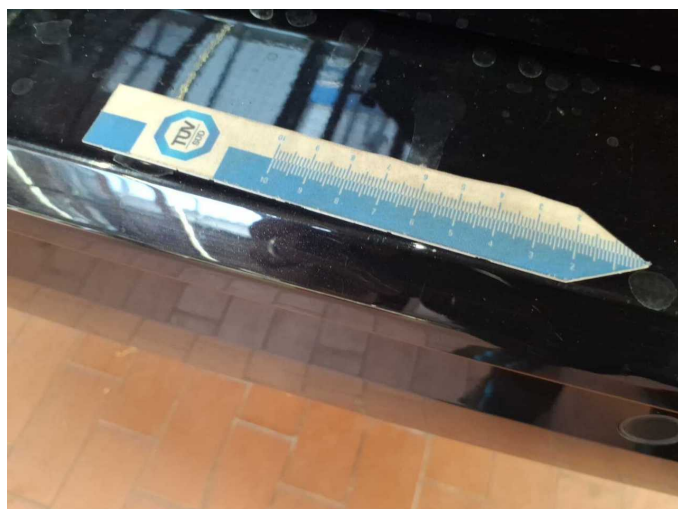
| No. | Component group | Description |
|---|---|---|
| 2 | Rear bumper | Rear bumper - Scratch(es) - Smart repair |

**Damage 2:** Rear bumper: Rear bumper - Scratch(es) - Smart repair

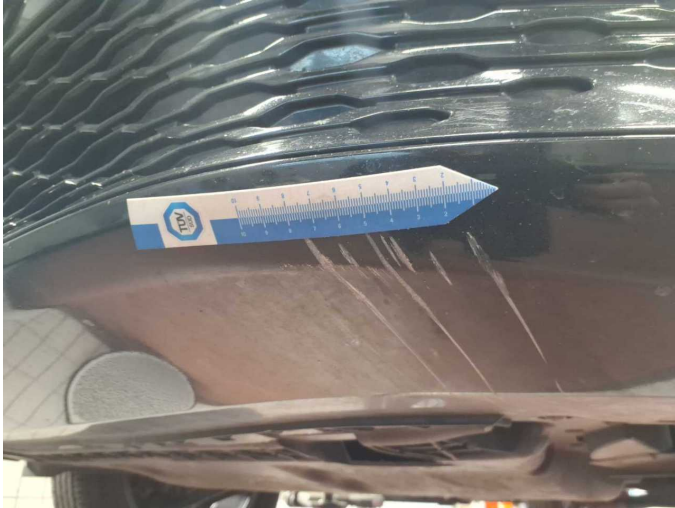
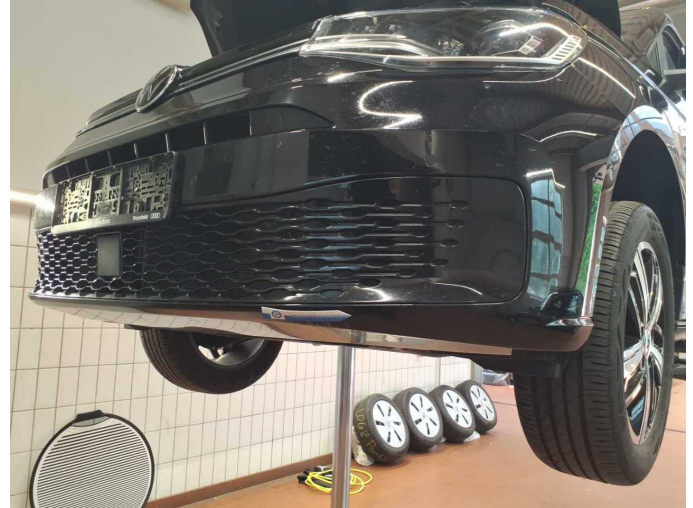
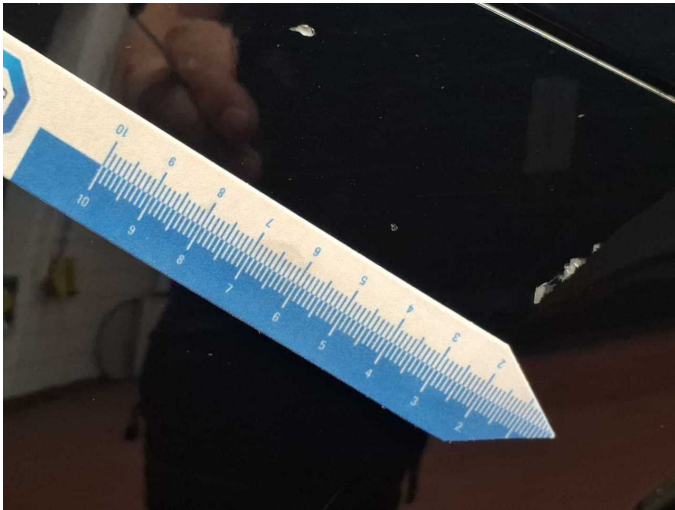
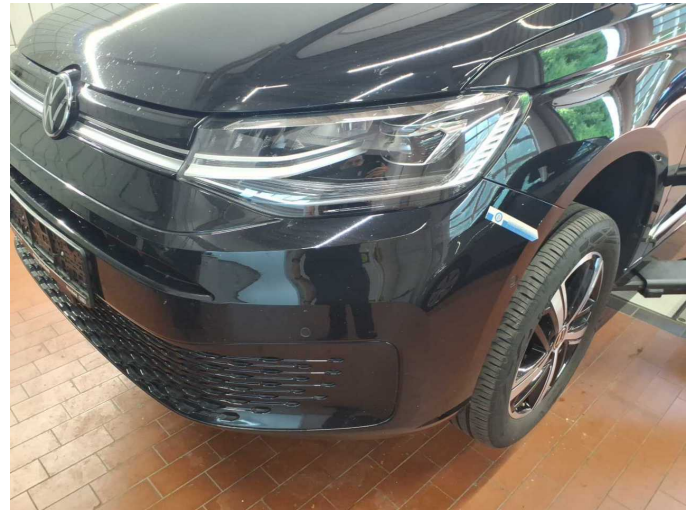
| No. | Component group | Description |
|---|---|---|
| 3 | Front bumper | Front bumper - Scratched - Paint |

**Damage 3:** Front bumper: Front bumper - Scratched - Paint

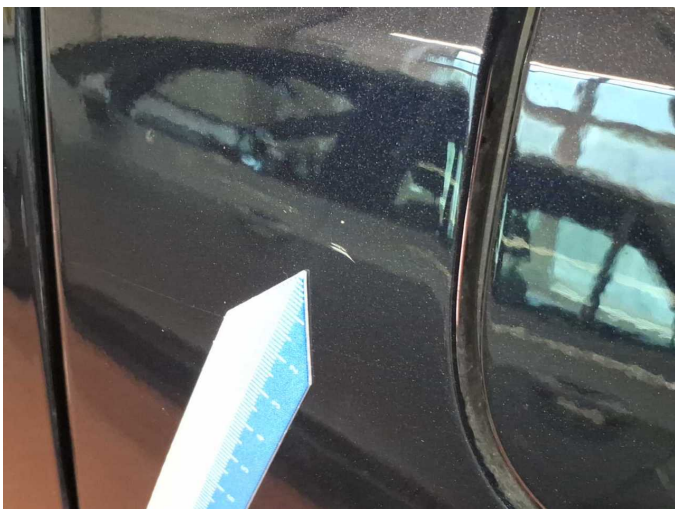
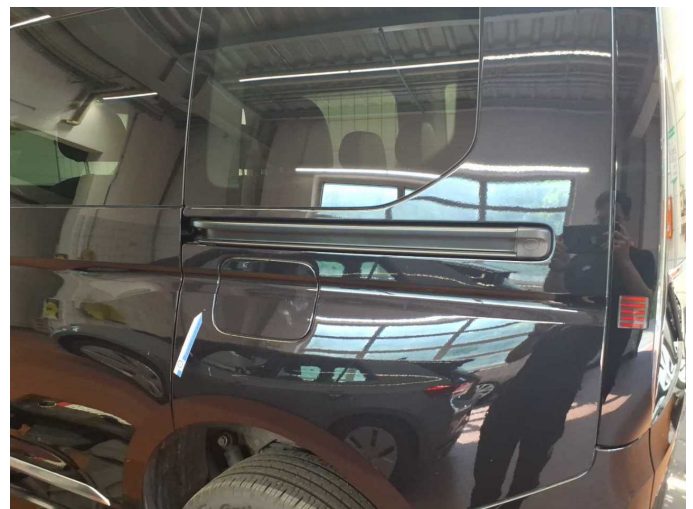
| No. | Component group | Description |
|---|---|---|
| 1 | Side panel - rear left side | Side panel - Scratch(es) - No deduction |

**Wear and tear 1:** Side panel - rear left side: Side panel - Scratch(es) - No deduction

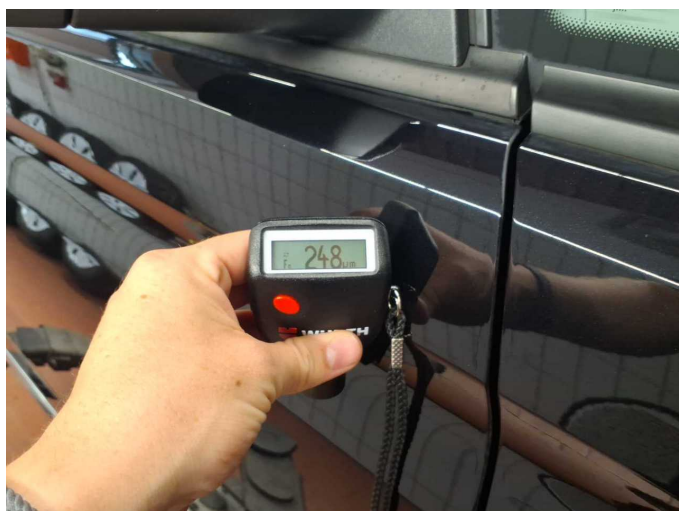
| No. | Repainting |
|---|---|
| 1 | Door - front right side, Professionally carried out, Invoice of repair done Non-existent |

| Door - front right side | 248 µm |

**Repainting 1:** Door - front right side
