Expertise

Protocol number: 46214043  
Order No. / Reference: 26456370  
Inspection date: 30 Jun 2026

Manufacturer: Volvo

Model: XC60 B4 D Core

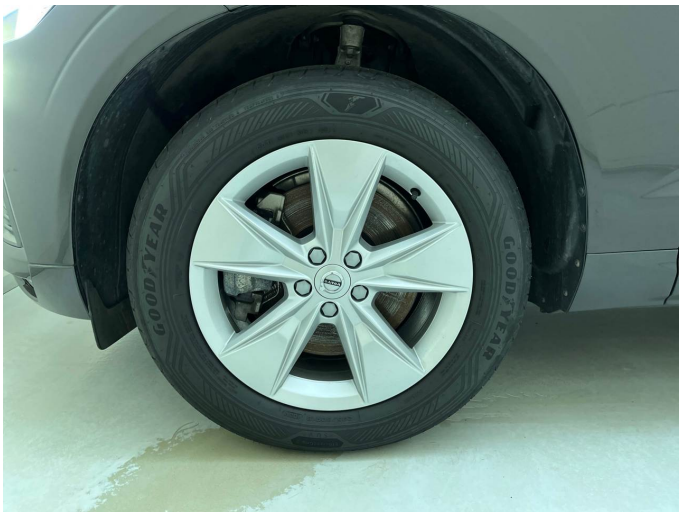
Figure 12: Mounted tyres

| # | Tyre size | Type of tyre | Manufacturer | Tread depth |
|---|---|---|---|---|
| 1) | 235/60 R18 103V | Summer tyres on Light alloy | Goodyear | 5mm / 5mm |
| 2) | 235/60 R18 103V | Summer tyres on Light alloy | Goodyear | 6mm / 6mm |

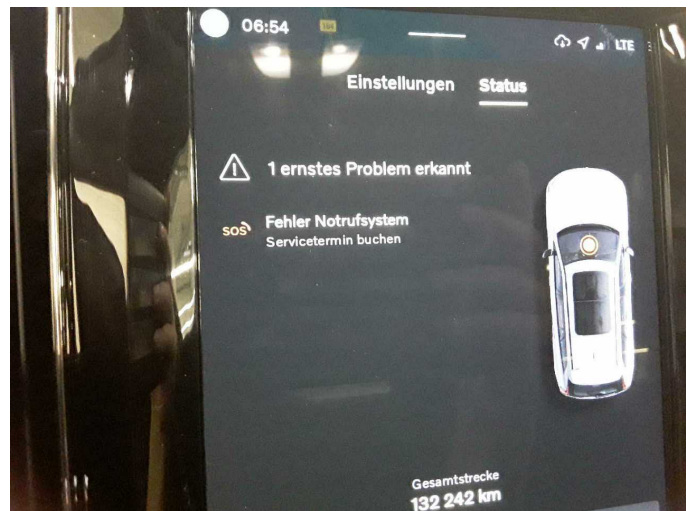
| No. | Component group | Description |
|---|---|---|
| 1 | Electronic systems | Electronic systems (Notrufsystem, Zusatzkosten können entstehen) - Electrical fault - Perform diagnosis |

**Damage 1:** Electronic systems: Electronic systems (Notrufsystem, Zusatzkosten können entstehen) - Electrical fault - Perform diagnosis

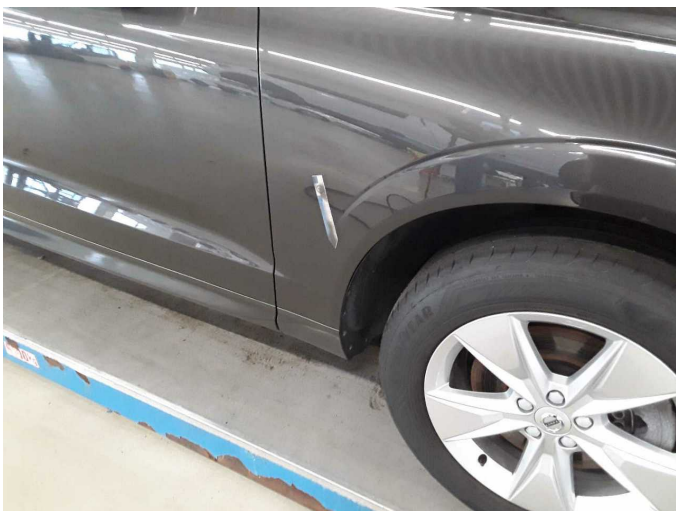
| No. | Component group | Description |
|---|---|---|
| 3 | Mudguard - right side | Mudguard - right side - dent(s) - Paint |

**Damage 3:** Mudguard - right side: Mudguard - right side - dent(s) - Paint

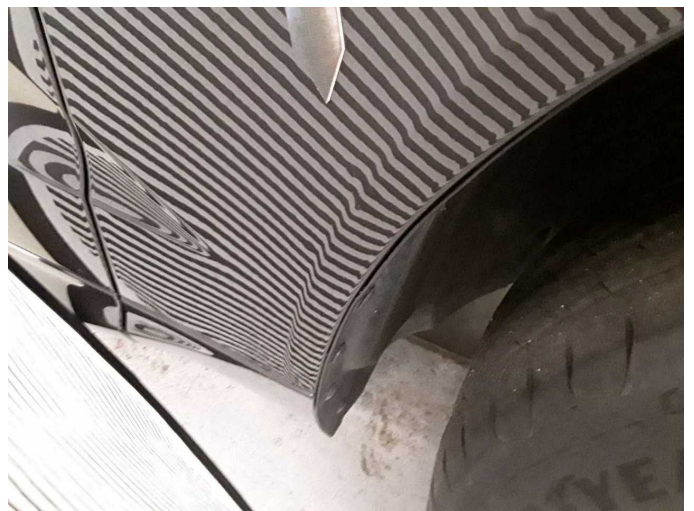
**Damage 3:** Mudguard - right side: Mudguard - right side - dent(s) - Paint
