Expertise

Protocol number: 46107473
Order No. / Reference: 26460668
Inspection date: 23 Jun 2026

Model: Mondeo Turnier 2.0 EcoBlue Titanium

VIN: WF0FXXWPCFNY70369

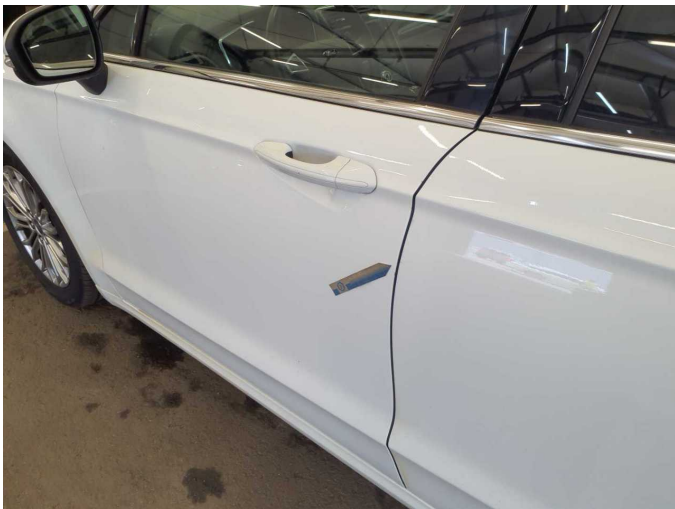
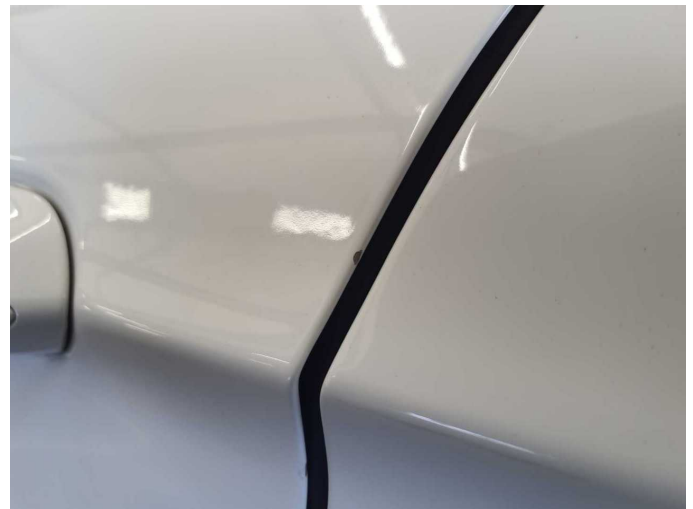
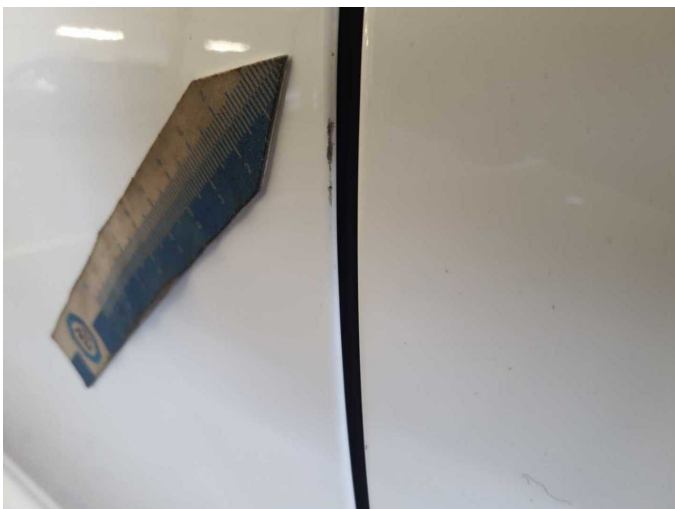
| No. | Component group | Description |
|---|---|--|
| 1 | Door - front left side | Door edge - Scratch(es) - Smart repair |

Damage 1: Door - front left side: Door edge - Scratch(es) - Smart repair

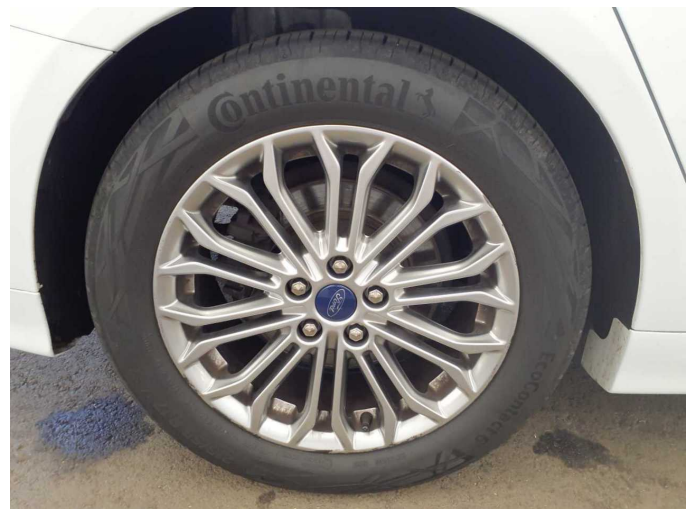
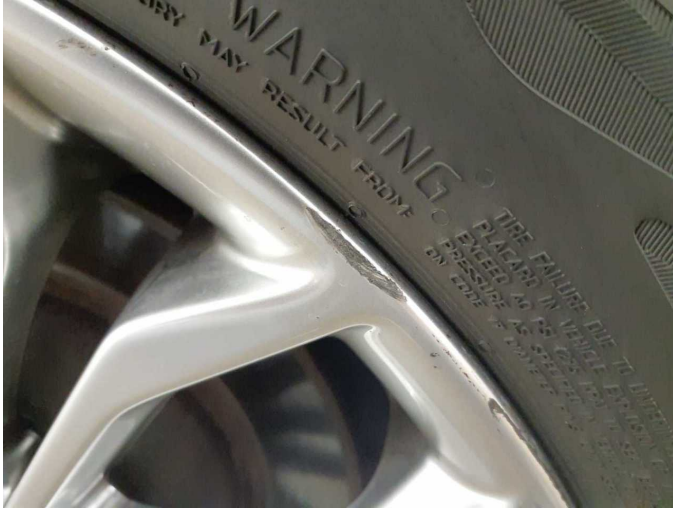
| No. | Component group | Description |
|---|---|--|
| 2 | Wheel / tyres | Alloy rim - rear right side - Scratch(es) - Loss in value |

Damage 2: Wheel / tyres: Alloy rim - rear right side - Scratch(es) - Loss in value

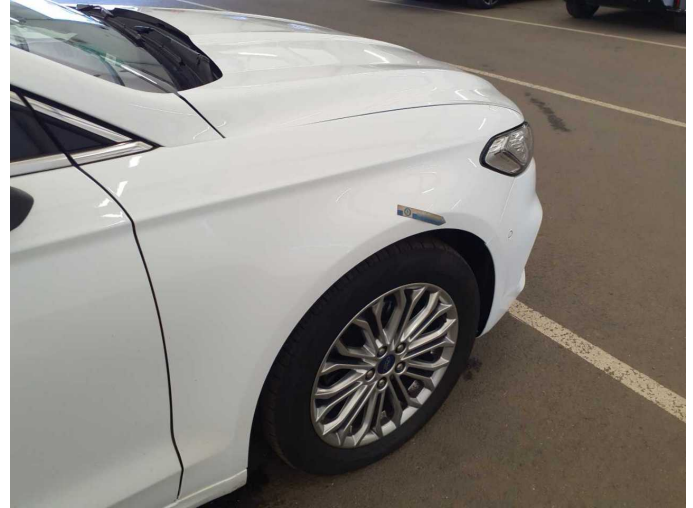
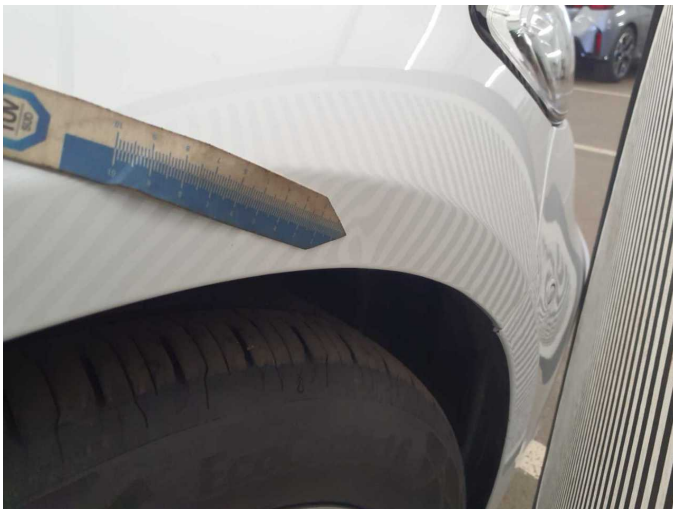
| No. | Component group | Description |
|---|---|--|
| 3 | Mudguard - right side | Mudguard - right side - dent(s) - Smart repair |

Damage 3: Mudguard - right side: Mudguard - right side - dent(s) - Smart repair

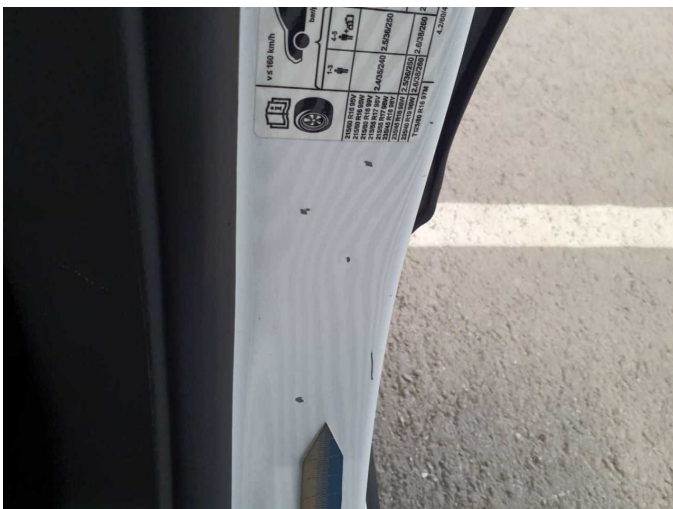
| No. | Component group | Description |
|---|---|--|
| 4 | Body | B-pillar - left side - Dent / paintcoat damage - Smart repair |

Damage 4: Body: B-pillar - left side - Dent / paintcoat damage - Smart repair

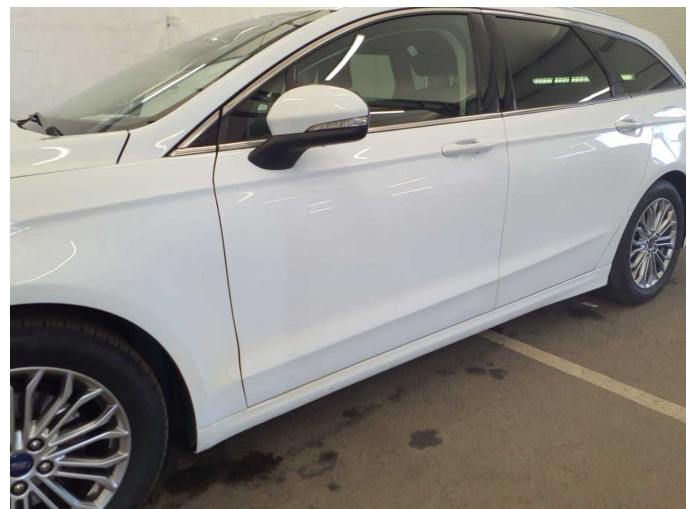
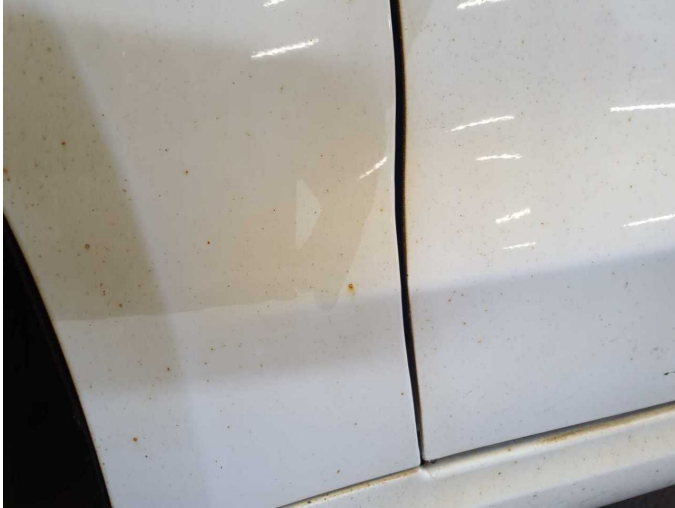
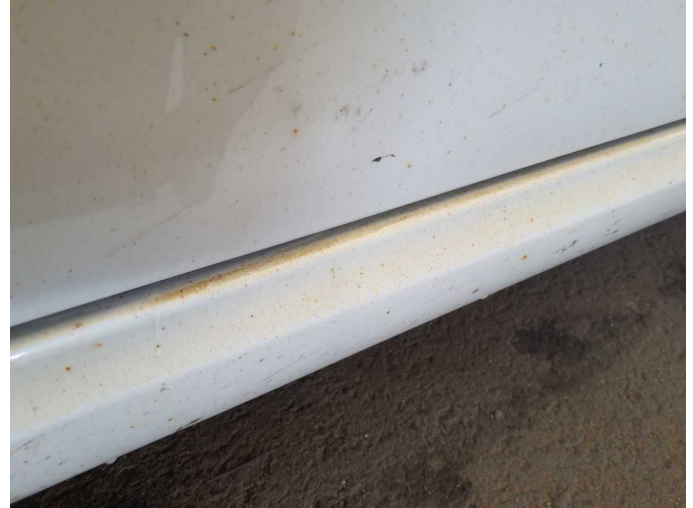
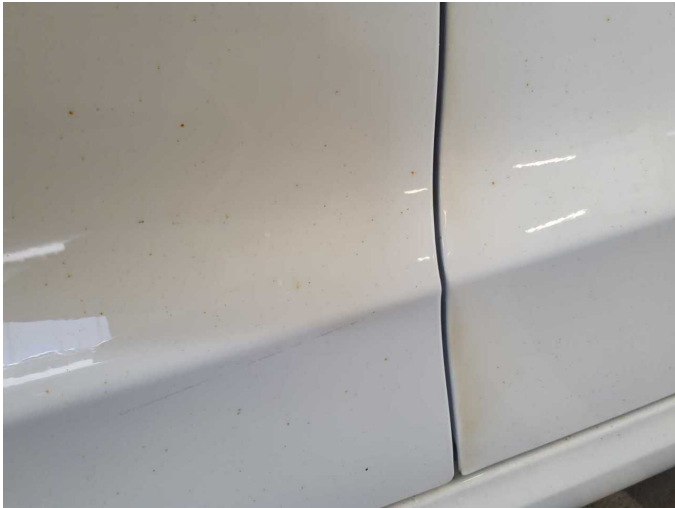
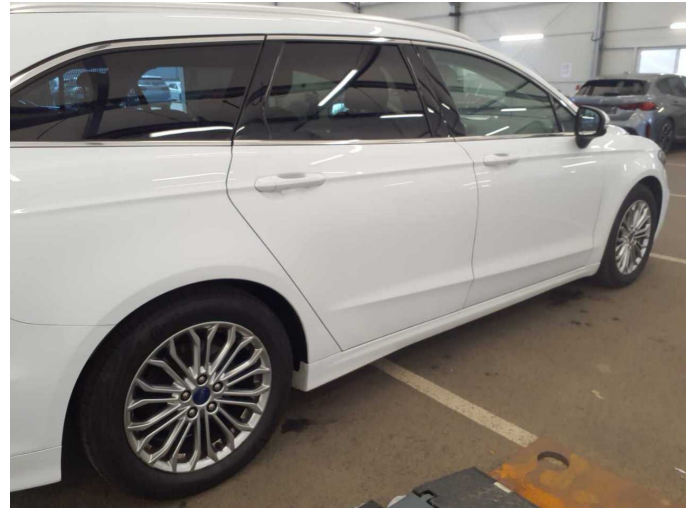
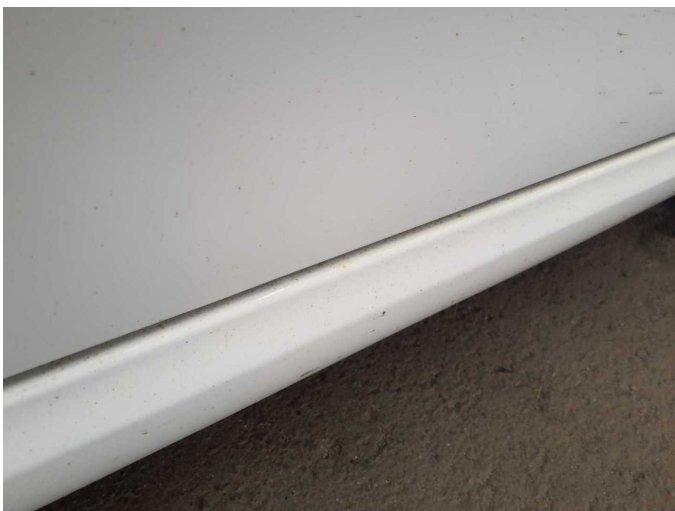
| No. | Component group | Description |
|---|---|--|
| 5 | Body | Body (Flugrost - Mehrkosten können entstehen) - Soiled - Clean |

Damage 5: Body: Body (Flugrost - Mehrkosten können entstehen) - Soiled - Clean

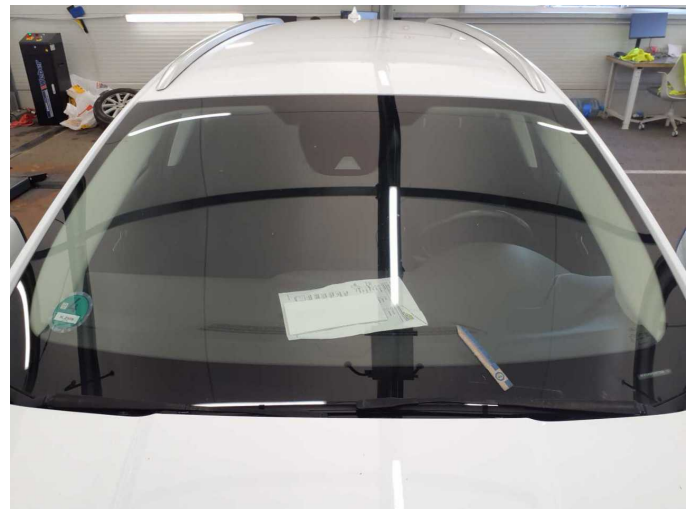
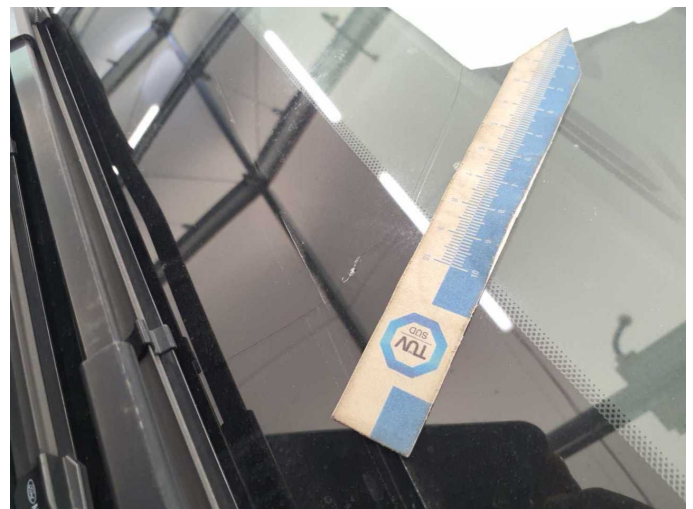
| No. | Component group | Description |
|---|---|--|
| 6 | Vehicle glazing | Windscreen with lane departure assistant - Broken / torn - Replace |

Damage 6: Vehicle glazing: Windscreen with lane departure assistant - Broken / torn - Replace

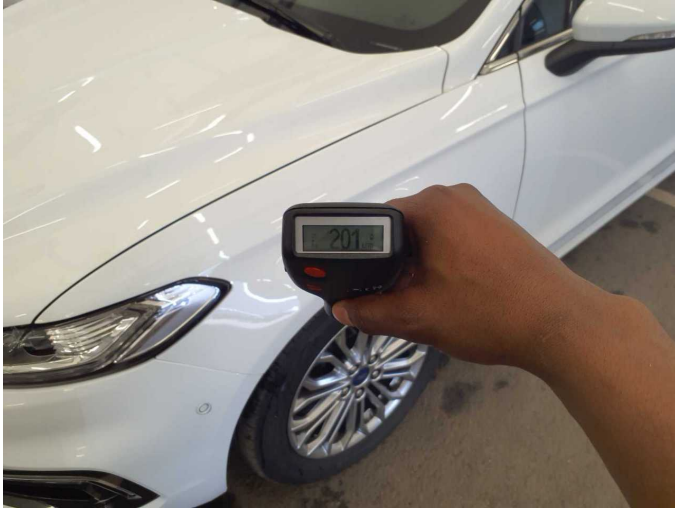
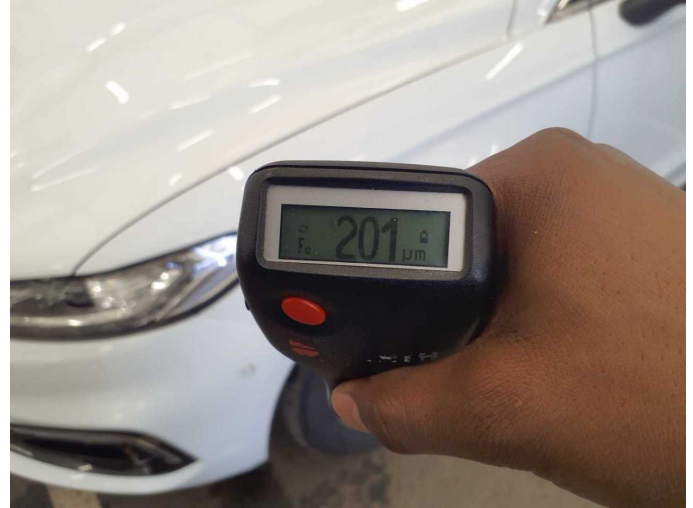
Repainting 1: Mudguard - left side

- 1 Mudguard - left side, Professionally carried out, Invoice of repair done Non-existent
- 2 Mudguard - right side, Professionally carried out, Invoice of repair done Non-existent
- 3 Door - front right side, Professionally carried out, Invoice of repair done Non-existent

Mudguard - left side

201 µm

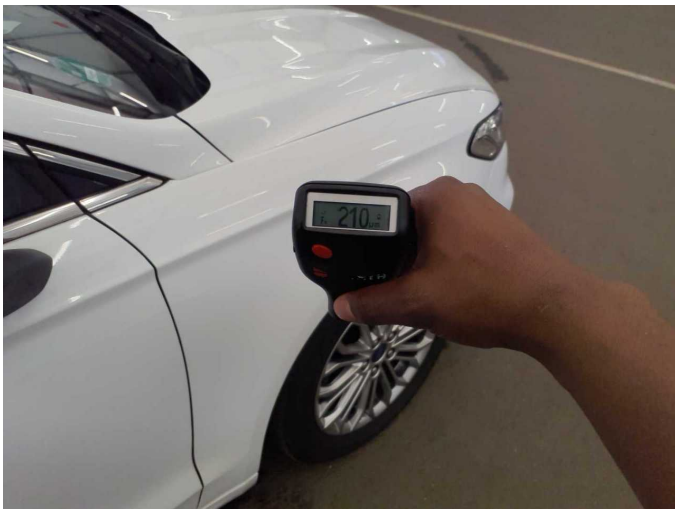
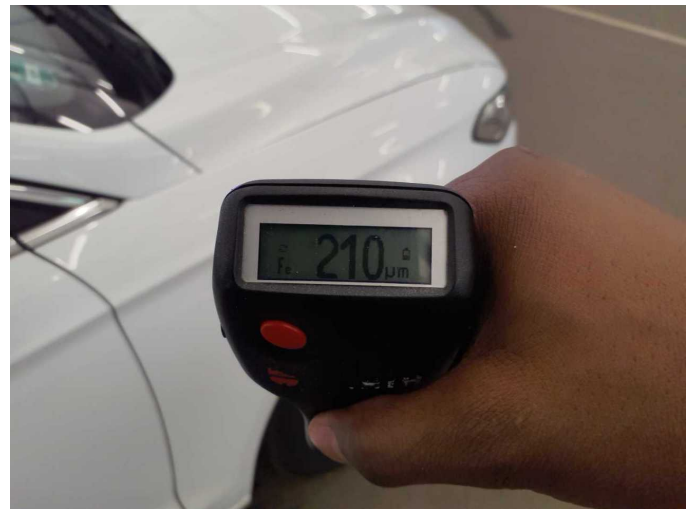
Repainting 2: Mudguard - right side

Mudguard - right side

210 µm
