Expertise

Protocol number: 45898587  
Order No. / Reference: 26362448  
Inspection date: 11 Jun 2026

Manufacturer: Mercedes-Benz  
VIN: W1KAH5EB0PF108362

Model: C 300 e T 9G-TRONIC AMG Line

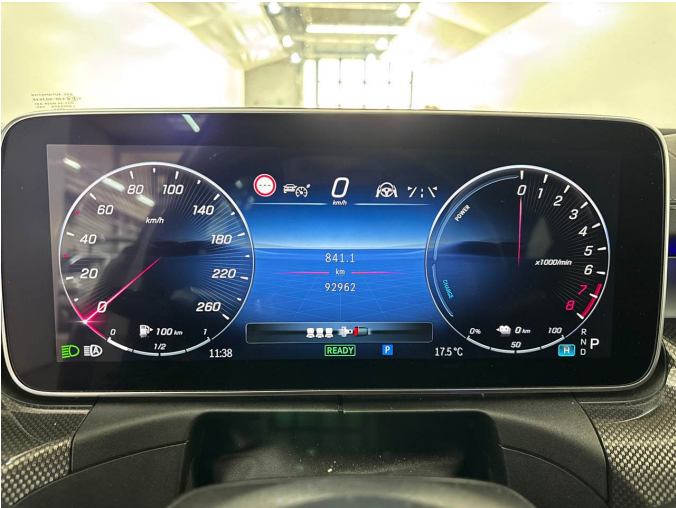
| Vehicle details | |
|---|---|
| Mileage (Read) | 92,962 km |

Figure 7: Instrument cluster

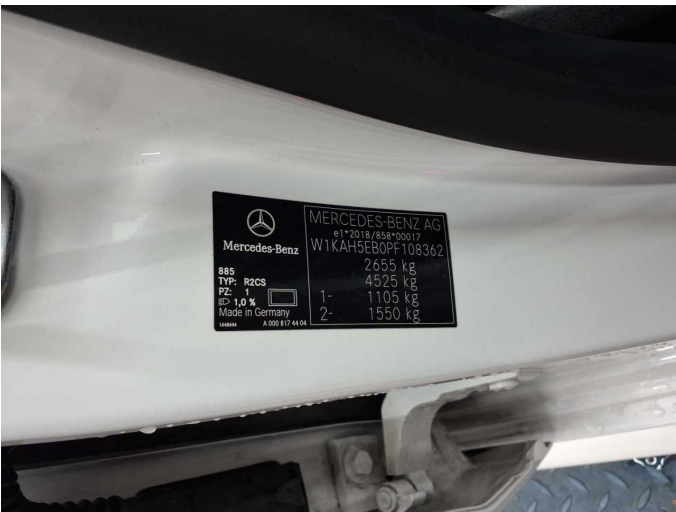
Figure 11: VIN

| VIN comparison | The vehicle identification number (VIN) was read from the vehicle and its conformity with the submitted documents was confirmed by the undersigned during the inspection. |

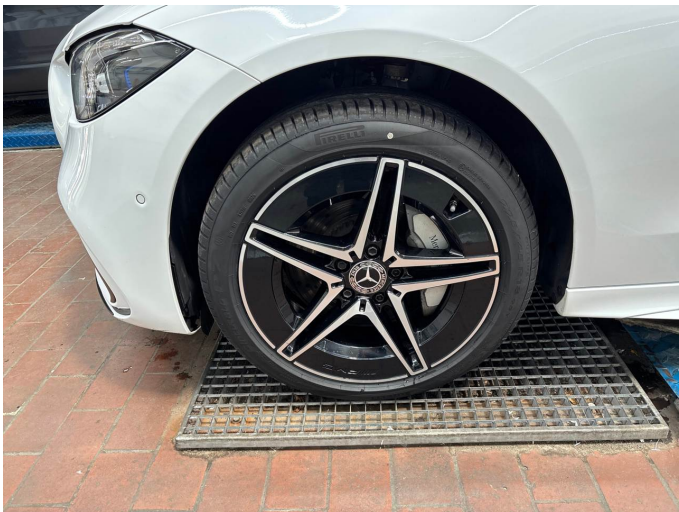
| # | Tyre size | Type of tyre | Manufacturer | Tread depth |
|---|---|---|---|---|
| 1) | 225/45 R18 95Y | Summer tyres on Light alloy | Pirelli | 7mm / 7mm |
| 2) | 255/40 R18 99Y | Summer tyres on Light alloy | Pirelli | 4mm / 4mm |

Figure 12: Mounted tyres

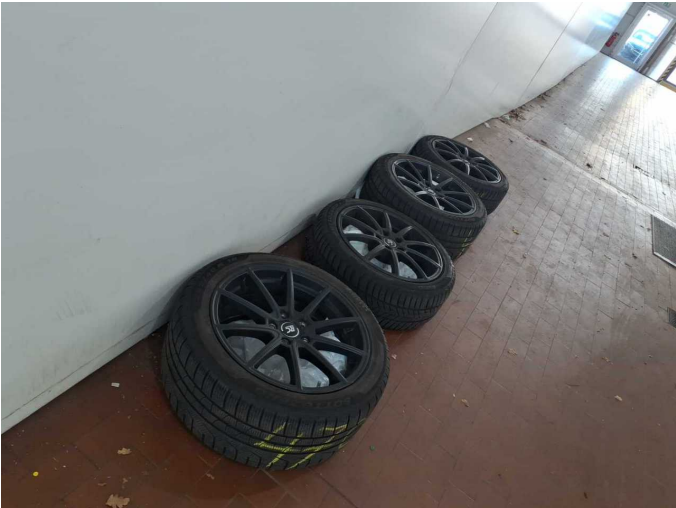
| # | Tyre size | Type of tyre | Manufacturer | Tread depth |
|---|---|---|---|---|
| 1) | 225/45 R18 95V | Winter tyres on Light alloy | Pirelli | 6mm / 6mm |
| 2) | 255/40 R18 99V | Winter tyres on Light alloy | Pirelli | 6mm / 6mm |

Figure 15: Additional tyres

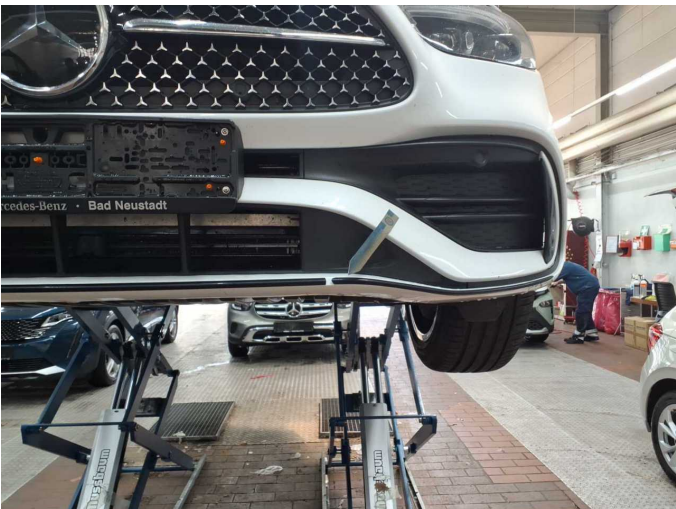
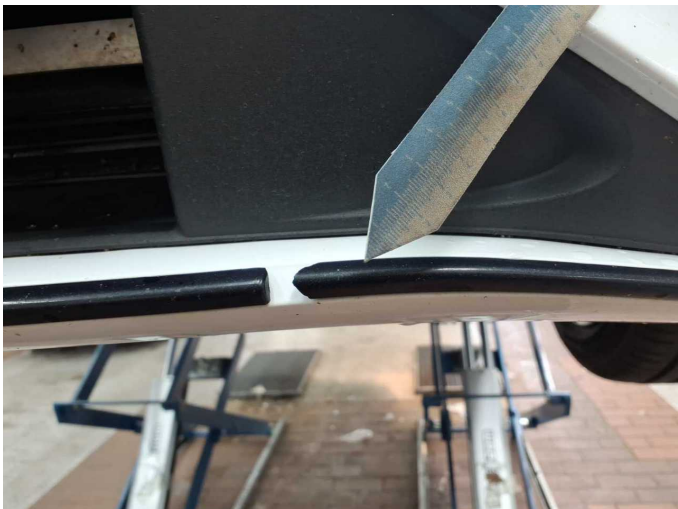
| No. | Component group | Description |
|---|---|---|
| 1 | Front bumper | Spoiler - Broken / torn - Replace |

Damage 1: Front bumper: Spoiler - Broken / torn - Replace

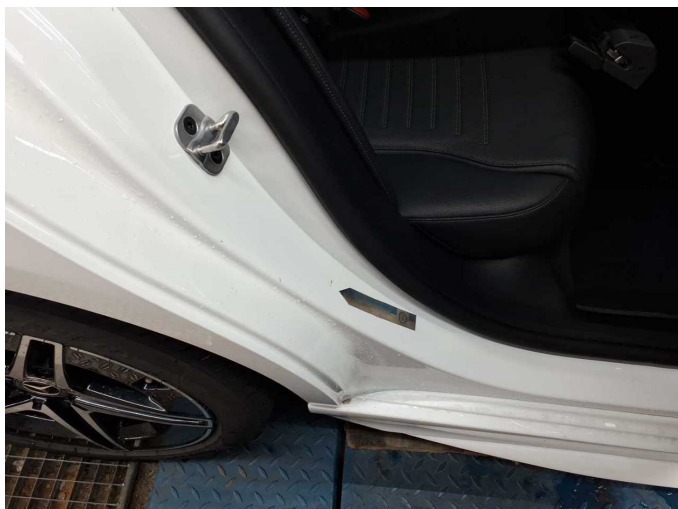
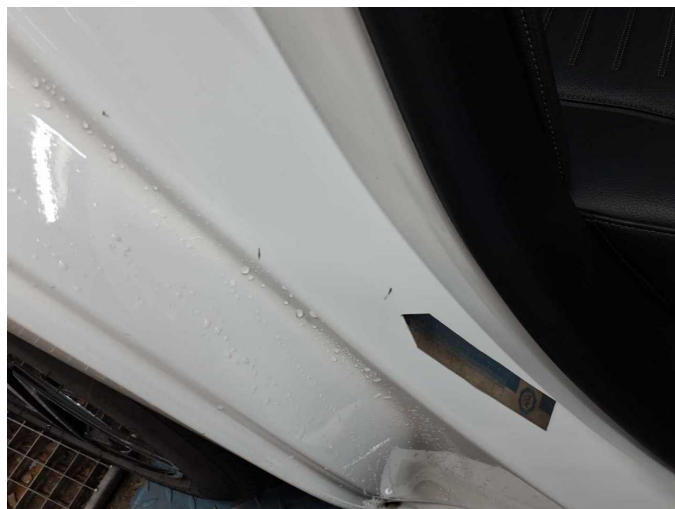
| No. | Component group | Description |
|---|---|---|
| 2 | Side panel - rear right side | Sill - Scratch(es) - Smart repair |

**Damage 2:** Side panel - rear right side: Sill - Scratch(es) - Smart repair

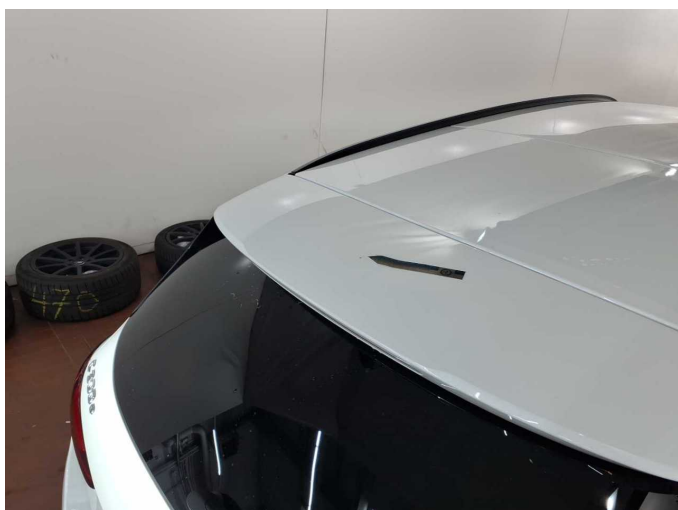
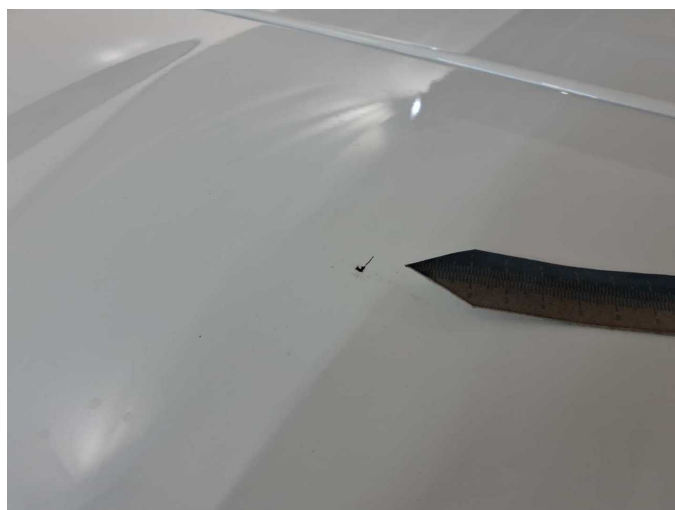
| No. | Component group | Description |
|---|---|---|
| 3 | Boot lid / rear door | Rear spoiler - Scratch(es) - Smart repair |

**Damage 3:** Boot lid / rear door: Rear spoiler - Scratch(es) - Smart repair

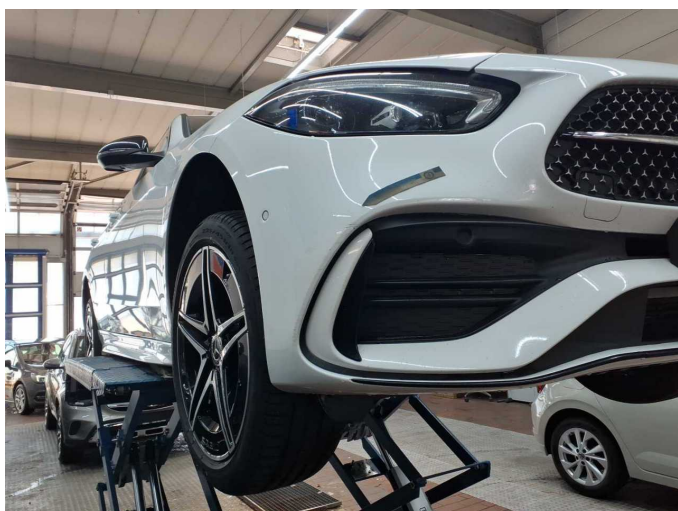
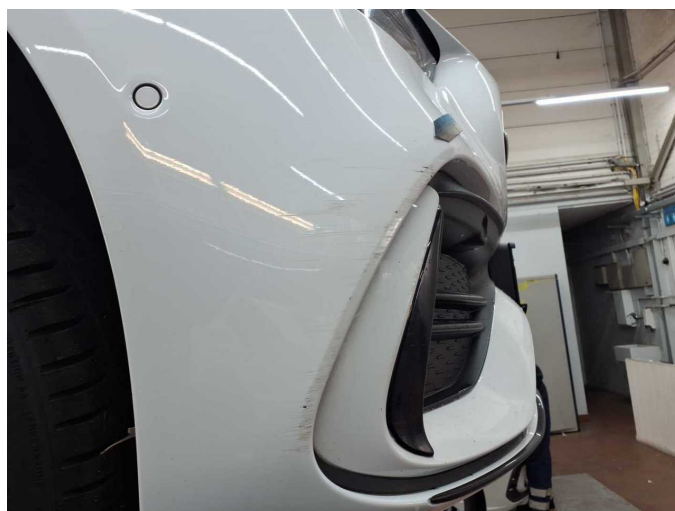
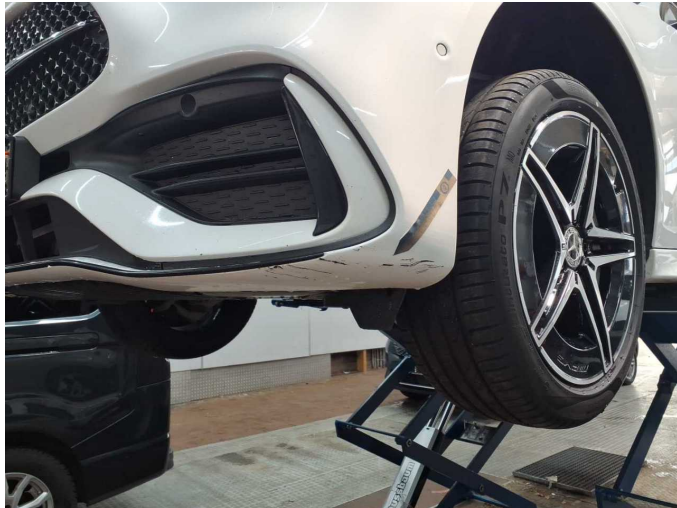
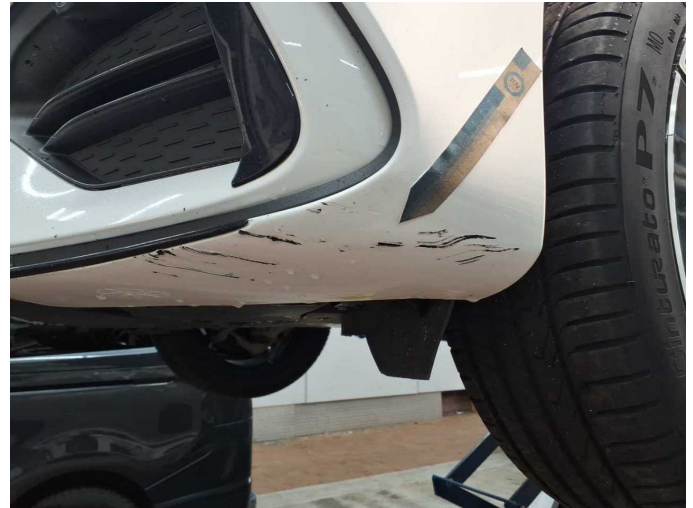
| No. | Component group | Description |
|---|---|---|
| 4 | Front bumper | Front bumper - Scratch(es) - Paint |

**Damage 4:** Front bumper: Front bumper - Scratch(es) - Paint

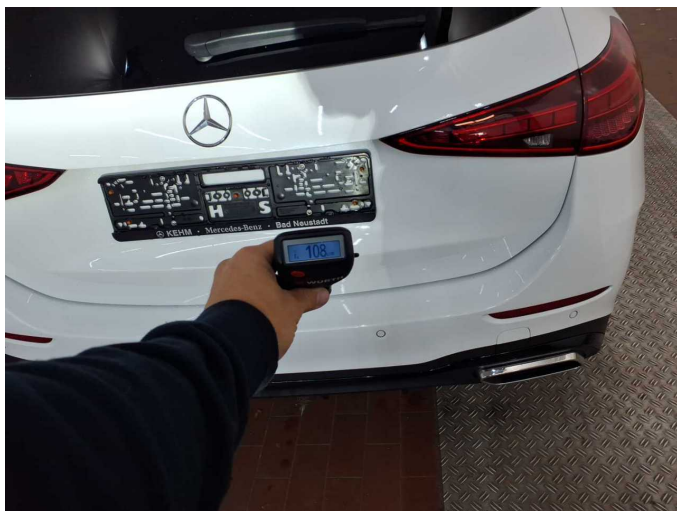
| No. | Previous damage | Extent of damage (Net) |
|---|---|---|
| 1 | Rear, Provided by user / customer, from 6 Nov 2023 | 2.266,93 € |

According to available information previous damages were repaired at the vehicle. Traces of repairs, which allow conclusions about the area of repair, were not recognizable during the inspection.

**Previous damage 1:** Rear
