Expertise

Protocol number: 46096337  
Order No. / Reference: 26528376  
Inspection date: 18 Jun 2026

| Manufacturer: Ford | Model: Focus 1.5 EcoBlue Start-Stopp-System Aut. TITANIUM X |
| VIN: WF0NXXGCHNPD64354 | |

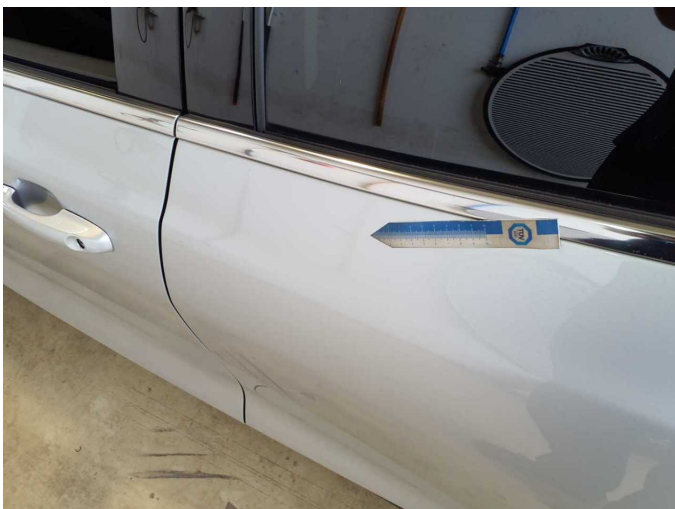
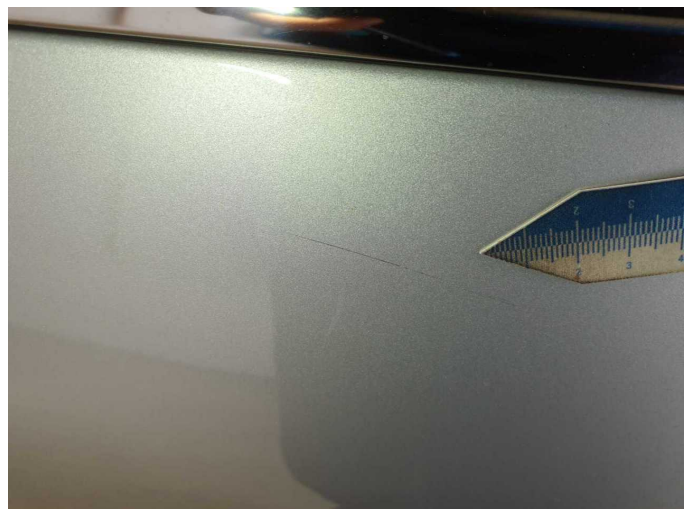
| No. | Component group | Description |
|---|---|---|
| 1 | Door - rear left side | Door - Scratch(es) - Smart repair |

**Damage 1:** Door - rear left side: Door - Scratch(es) - Smart repair

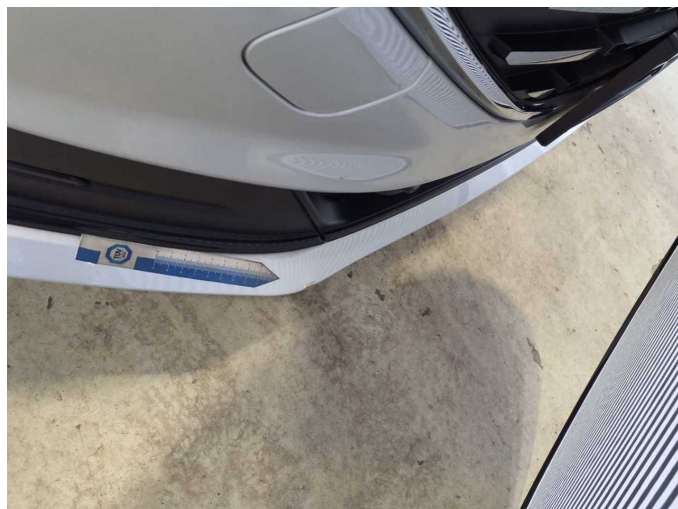
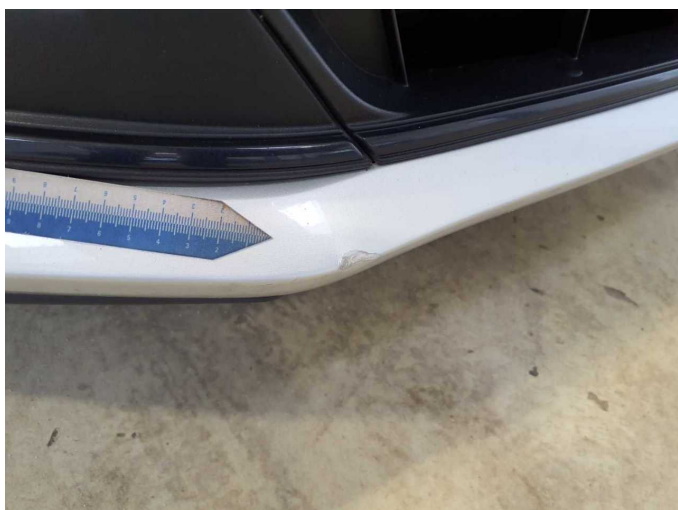
| No. | Component group | Description |
|---|---|---|
| 3 | Front bumper | Front bumper - Dent / paintcoat damage - Repair and paint |

**Damage 3:** Front bumper: Front bumper - Dent / paintcoat damage - Repair and paint

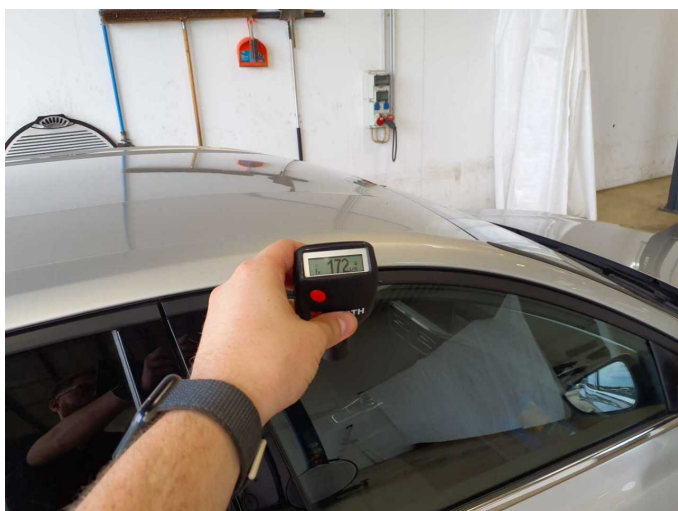
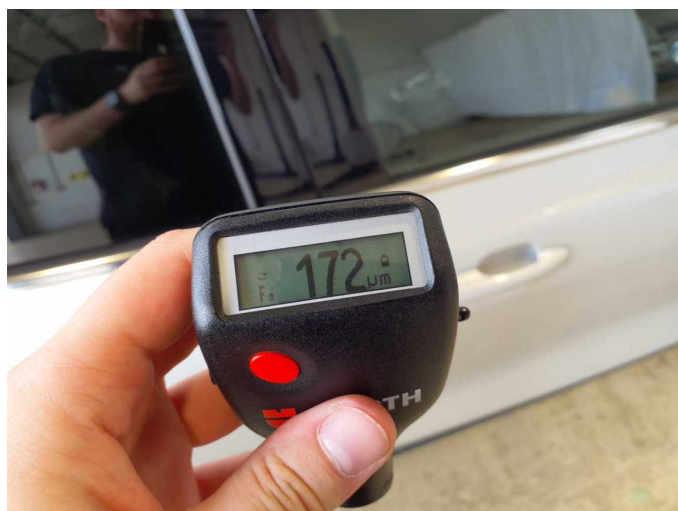
| No. | Repainting |
|---|---|
| 1 | Roof rail - right side, Professionally carried out, Invoice of repair done Non-existent |

| Roof rail - right side | 172 µm | Mudguard - right side | 170 µm |

**Repainting 1:** Roof rail - right side

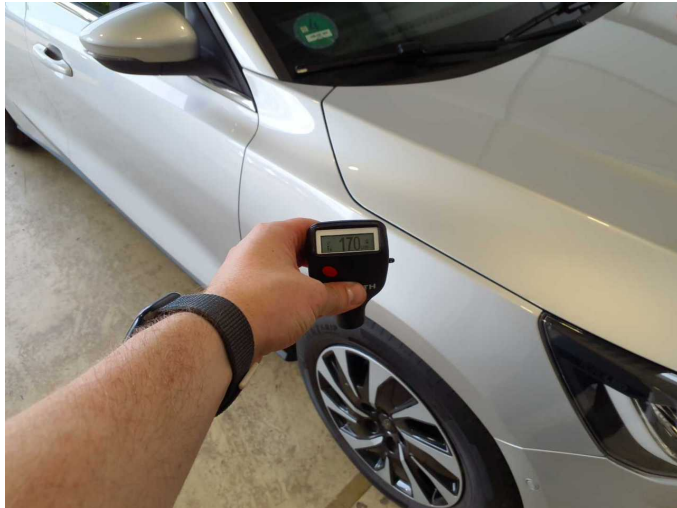
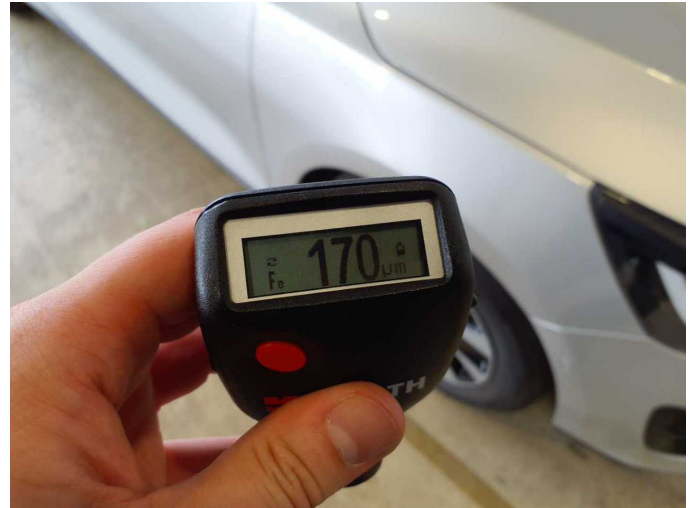
| No. | Repainting |
|---|---|
| 2 | Mudguard - right side, Professionally carried out, Invoice of repair done Non-existent |

**Repainting 2:** Mudguard - right side

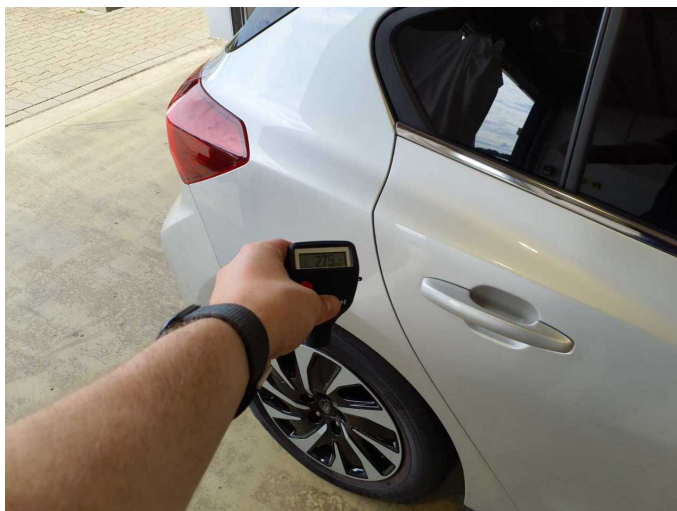
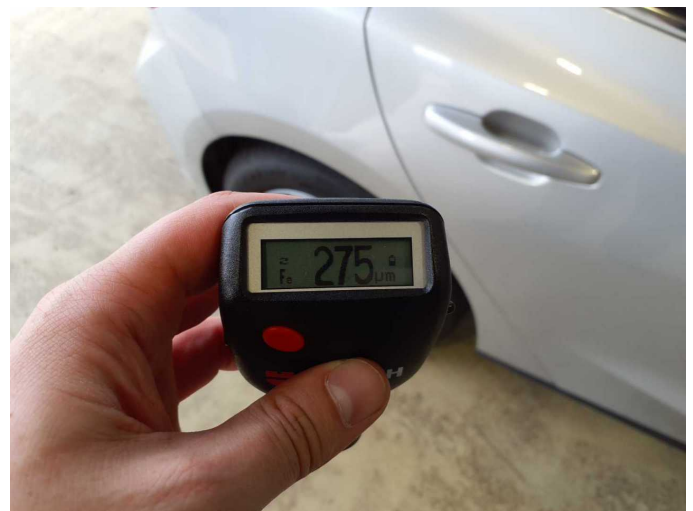
| No. | Repainting |
|---|---|
| 3 | Side panel - rear right side, Professionally carried out, Invoice of repair done Non-existent |

| Side panel - rear right side | 275 µm | | |

**Repainting 3:** Side panel - rear right side
