Expertise

Protocol number: 46338687  
Order No. / Reference: 26302329  
Inspection date: 6 Jul 2026

Manufacturer: Ford

Model: Transit Connect 210 L2 S&S Trend

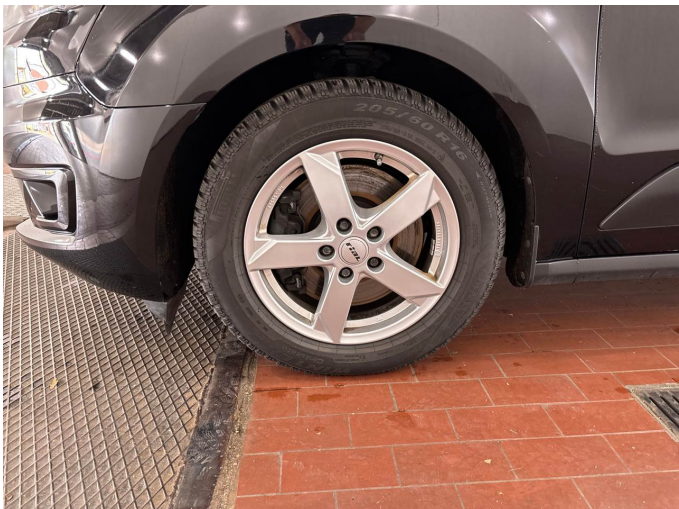
Figure 12: Mounted tyres

| # | Tyre size | Type of tyre | Manufacturer | Tread depth |
|---|---|---|---|---|
| 1) | 205/60 R16 96H | Winter tyres on Light alloy | Pirelli | 5mm / 5mm |

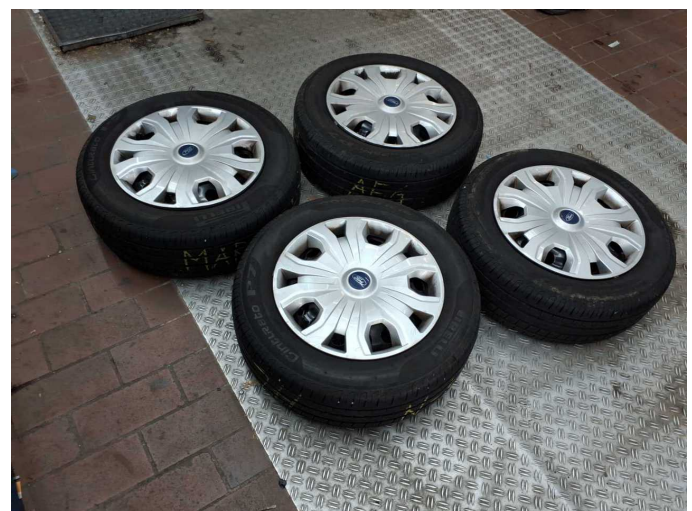
Figure 18: Additional tyres

| # | Tyre size | Type of tyre | Manufacturer | Tread depth |
|---|---|---|---|---|
| 1) | 205/60 R16 96V | Summer tyres on Steel rim with wheel cover | Pirelli | 6mm / 6mm |

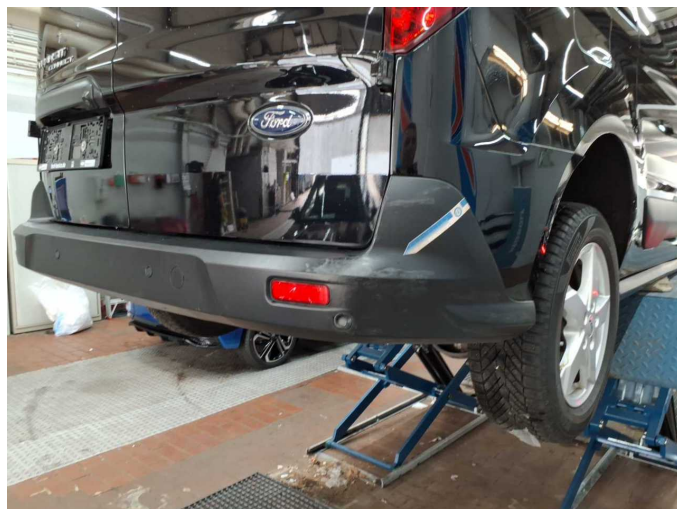
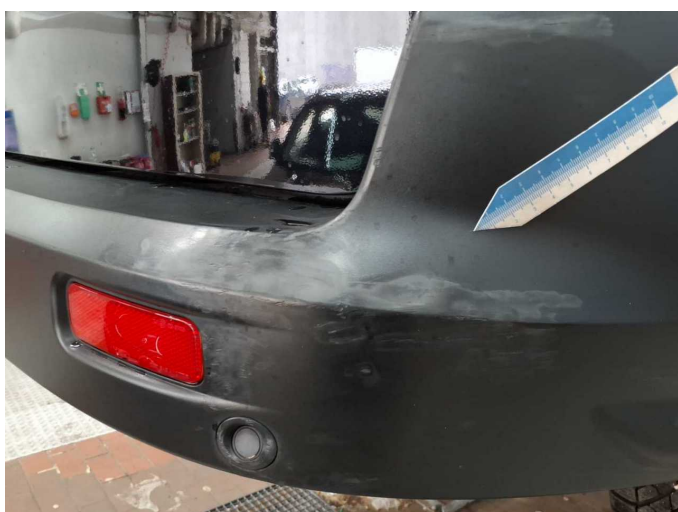
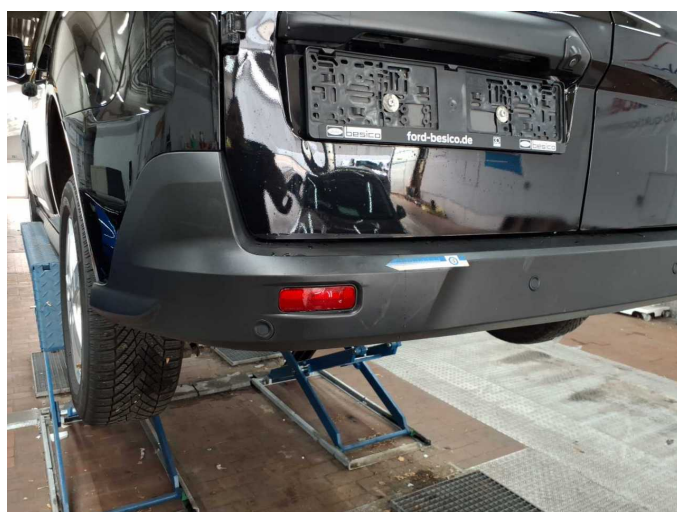
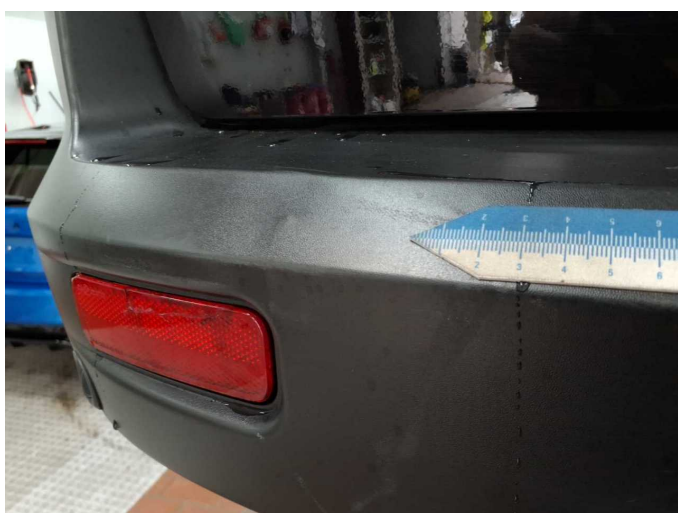
| No. | Component group | Description |
|---|---|---|
| 1 | Rear bumper | Rear bumper - Scratched - Loss in value |

**Damage 1:** Rear bumper: Rear bumper - Scratched - Loss in value

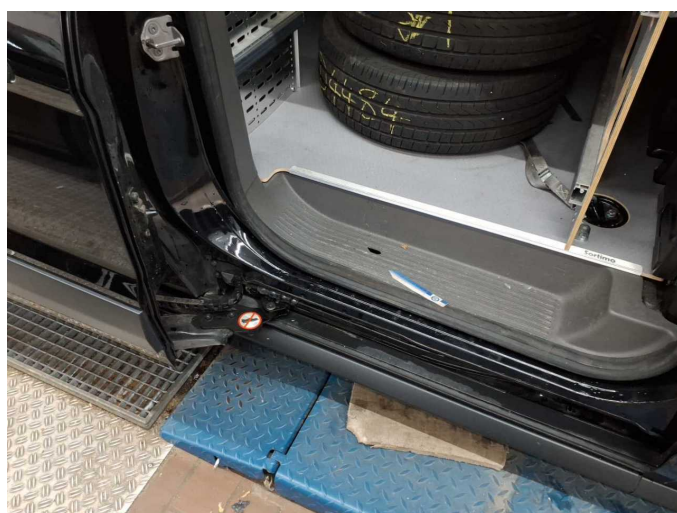
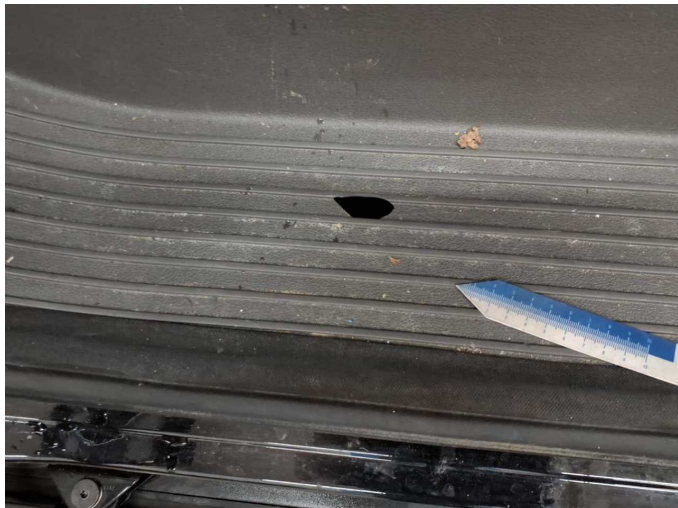
| No. | Component group | Description |
|---|---|---|
| 2 | Trim / covers | Entrance sliding door - right side - Broken / torn - Loss in value |

**Damage 2:** Trim / covers: Entrance sliding door - right side - Broken / torn - Loss in value

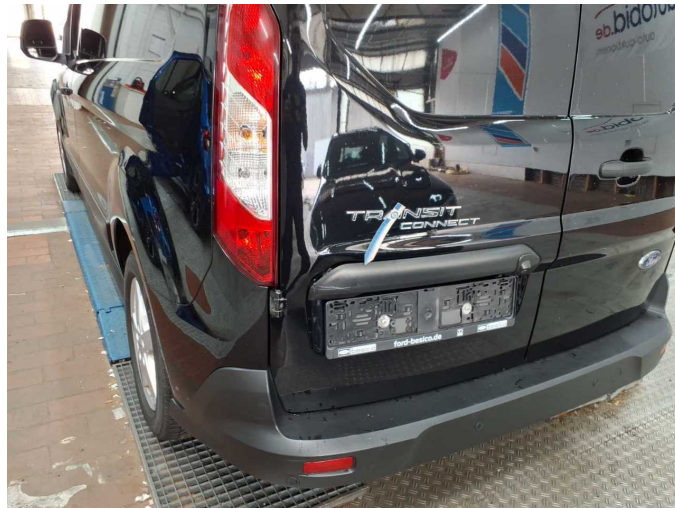
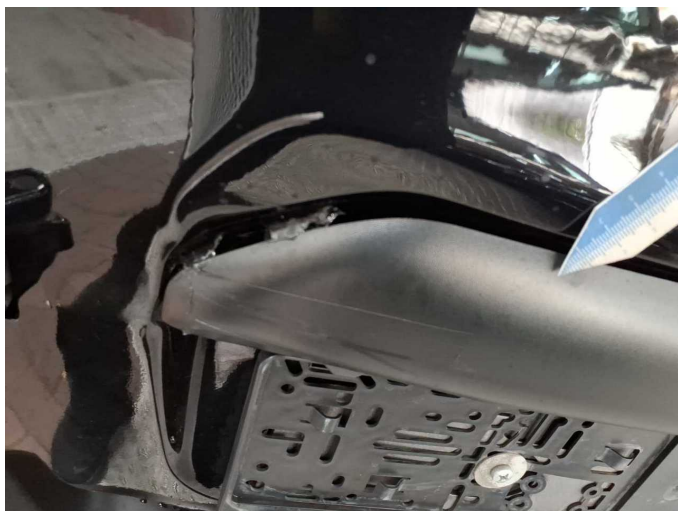
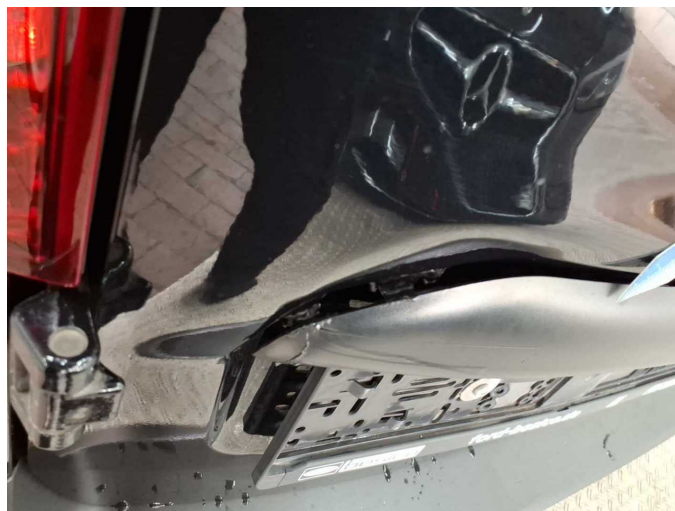
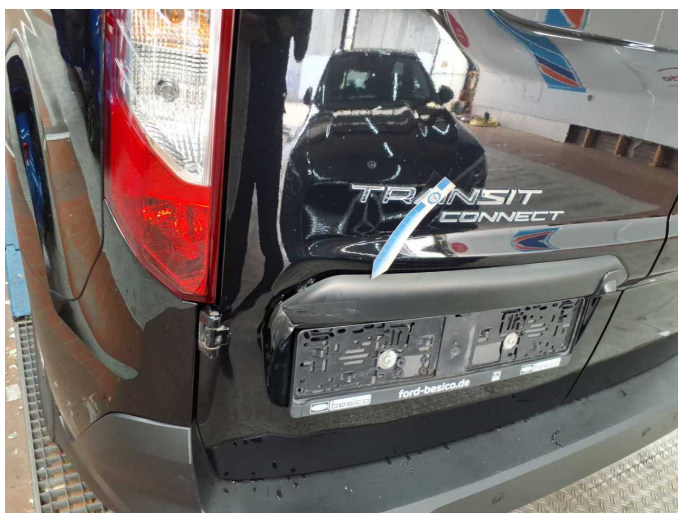
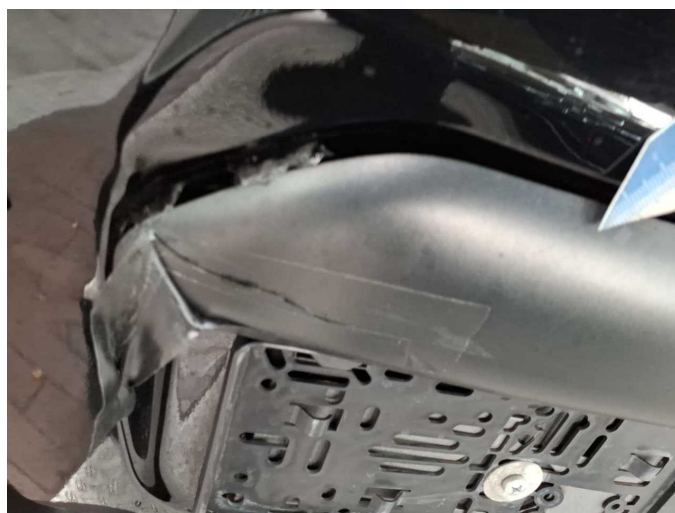
| No. | Component group | Description |
|---|---|---|
| 3 | Boot lid / rear door | Rear door - left side (Blende Kennzeichenleuchte) - Broken / torn - Replace |

**Damage 3:** Boot lid / rear door: Rear door - left side (Blende Kennzeichenleuchte) - Broken / torn - Replace
