## Expertise

Protocol number: 45183887  
Order No. / Reference: 26139194  
Inspection date: 28 Apr 2026

Model: Octavia Combi 2.0 TDI DSG Style

VIN: TMBJJ7NX0NY037610

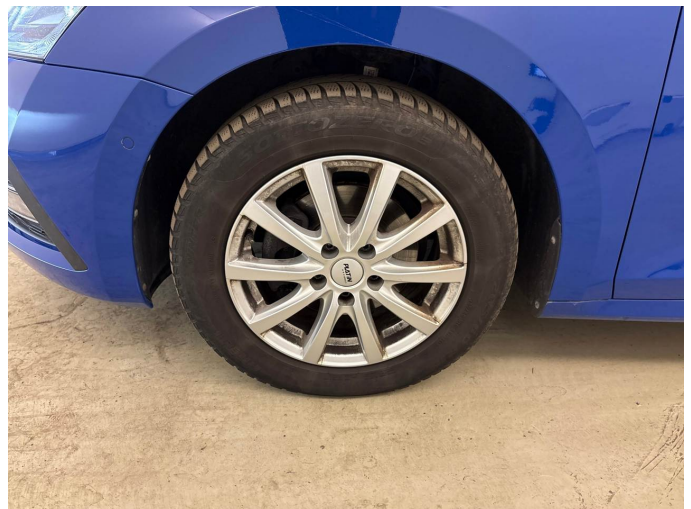
Figure 12: Mounted tyres

#	Tyre size	Type of tyre	Manufacturer	Tread depth
1)	205/60 R16 96H	Winter tyres on Light alloy	Pirelli	3mm / 3mm
2)	205/60 R16 96H	Winter tyres on Light alloy	Pirelli	5mm / 5mm

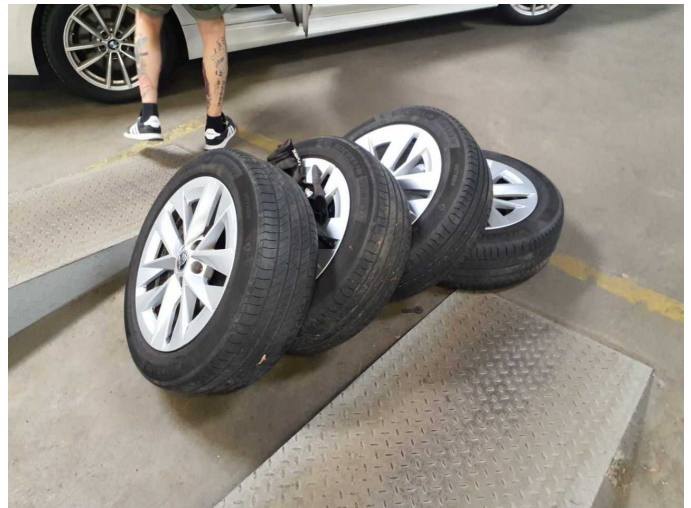
Figure 14: Additional tyres

#	Tyre size	Type of tyre	Manufacturer	Tread depth
1)	205/55 R17 91V	Summer tyres on Light alloy	Michelin	5mm / 5mm
2)	205/55 R17 91V	Summer tyres on Light alloy	Michelin	4mm / 4mm

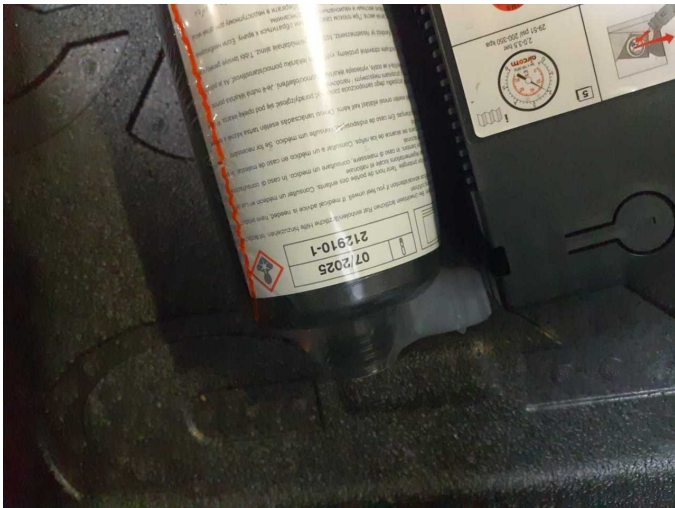
**Damage 1:** Equipment: Tirefit filler - Expired - Replace

No.	Component group	Description
1	Equipment	Tirefit filler - Expired - Replace
2	2nd wheel set	1 alloy rim - Scratch(es) - Loss in value

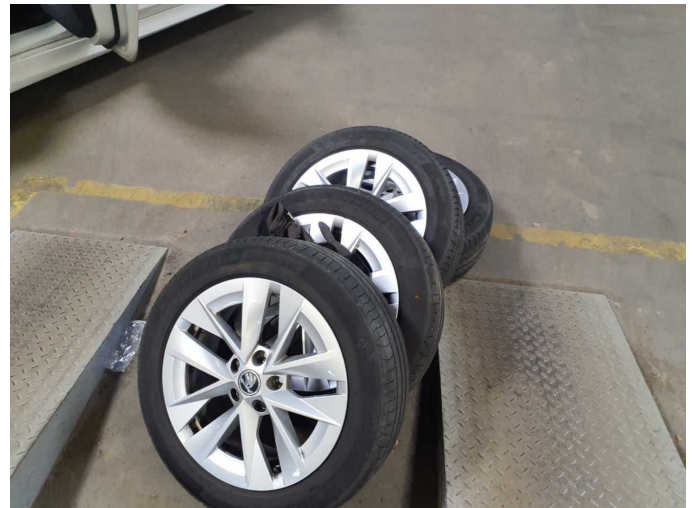
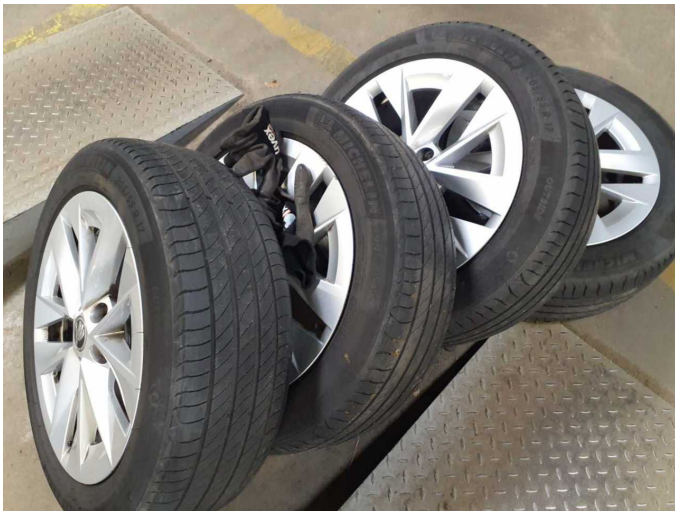
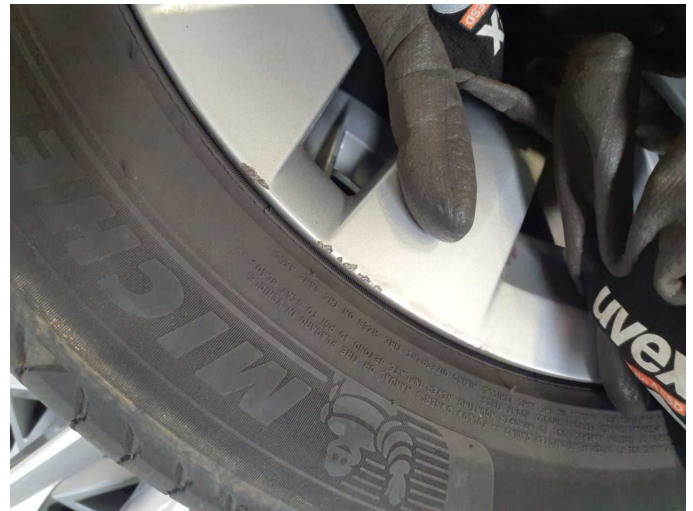
**Damage 2:** 2nd wheel set: 1 alloy rim - Scratch(es) - Loss in value

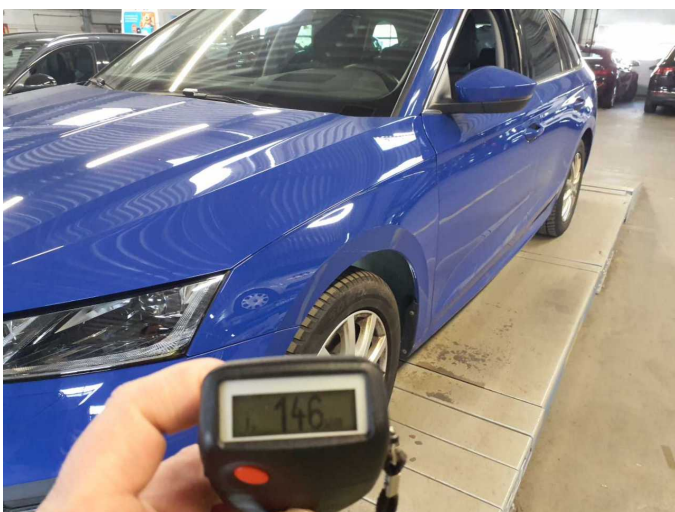
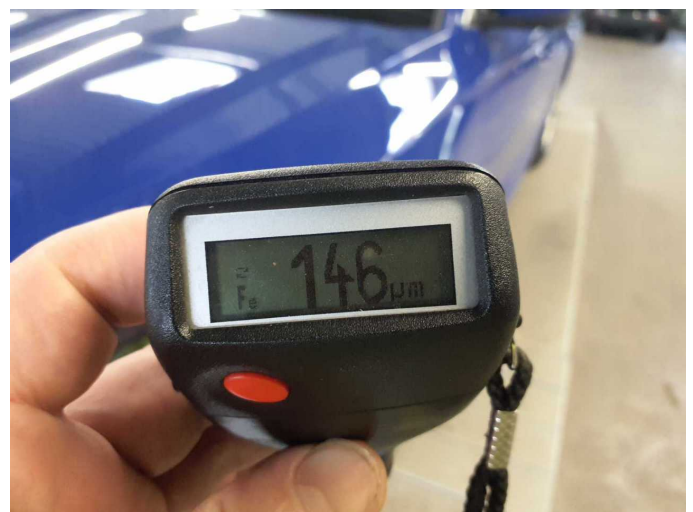
**Repainting 1:** Mudguard - left side

No.	Repainting
1	Mudguard - left side, Professionally carried out, Invoice of repair done Non-existent
2	Mudguard - right side, Professionally carried out, Invoice of repair done Non-existent

Mudguard - left side 156 µm | Mudguard - right side 195 µm

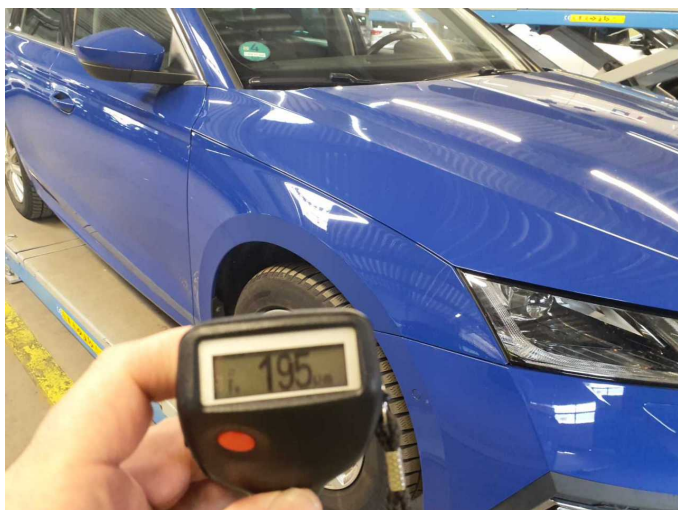
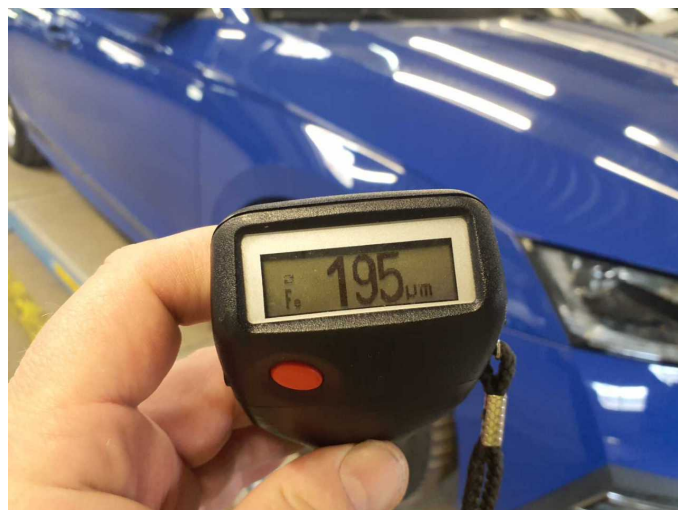
Repainting 2: Mudguard - right side
