Expertise

Protocol number: 45826279
Order No. / Reference: 26343981
Inspection date: 1 Jun 2026

Model: Q3 35 TDI quattro S tronic

VIN: WAUZZZF36P1088069

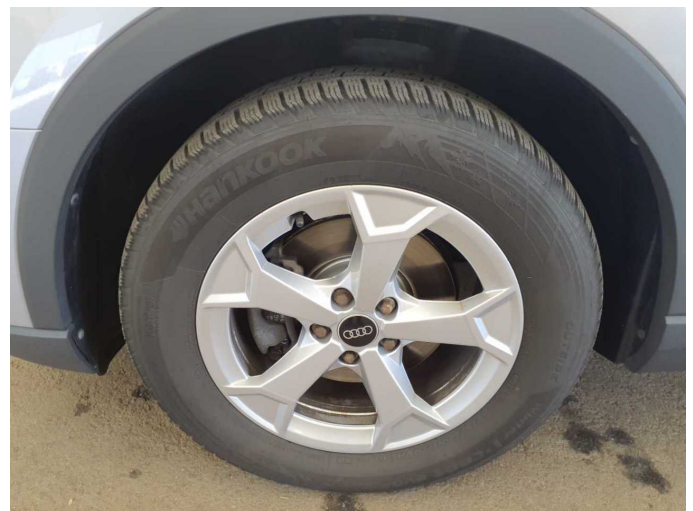
Figure 12: Mounted tyres

#	Tyre size	Type of tyre	Manufacturer	Tread depth
1)	215/65 R17 99H	Winter tyres on Light alloy	Hankook	5mm / 5mm
2)	215/65 R17 99H	Winter tyres on Light alloy	Hankook	5mm / 5mm

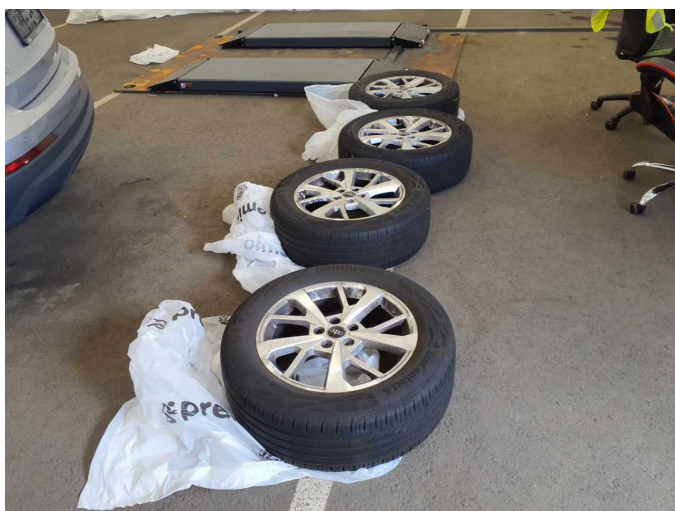
Figure 17: Additional tyres

#	Tyre size	Type of tyre	Manufacturer	Tread depth
1)	235/55 R18 100V	Summer tyres on Light alloy	Continental	5mm / 5mm
2)	235/55 R18 100V	Summer tyres on Light alloy	Continental	3mm / 3mm

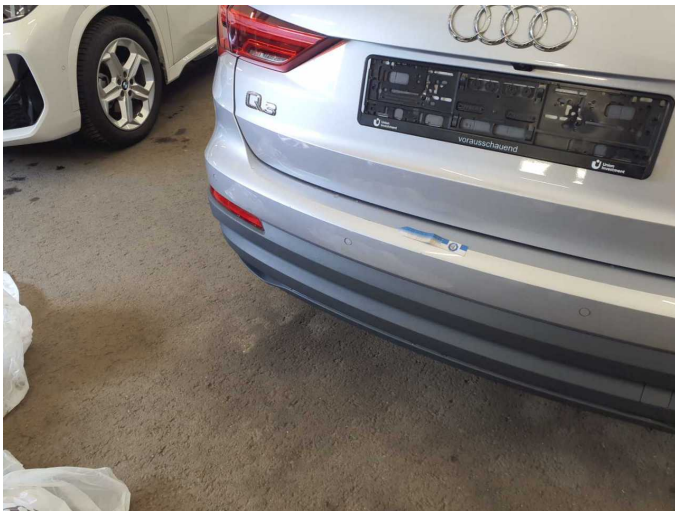
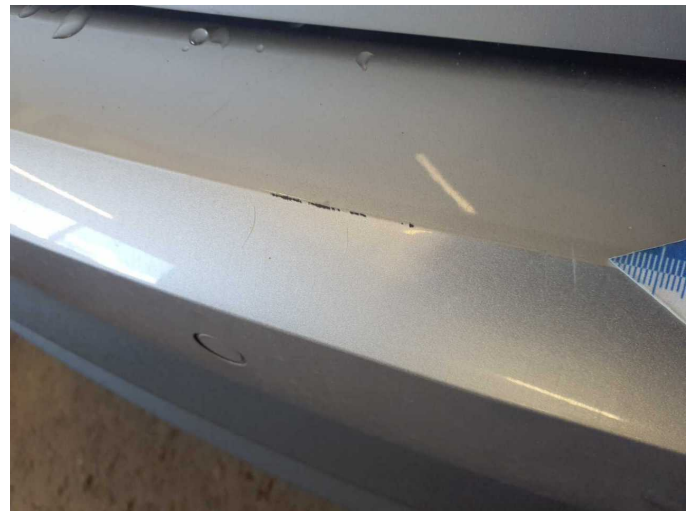
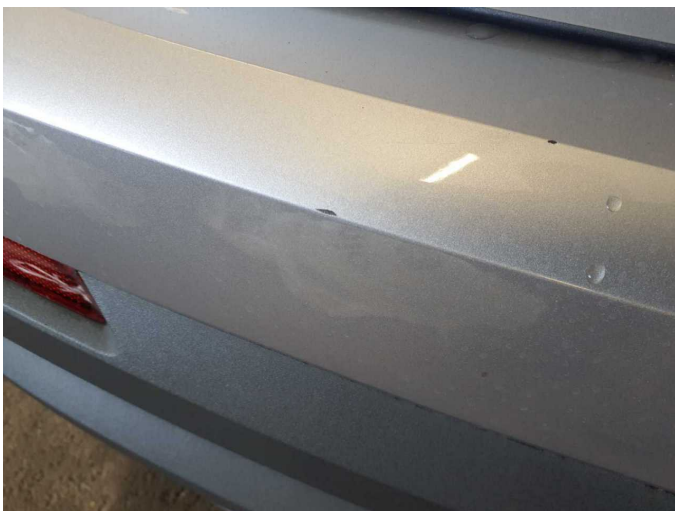
No.	Component group	Description
1	Rear bumper	Rear bumper - Scratched - Repair and paint

Damage 1: Rear bumper: Rear bumper - Scratched - Repair and paint

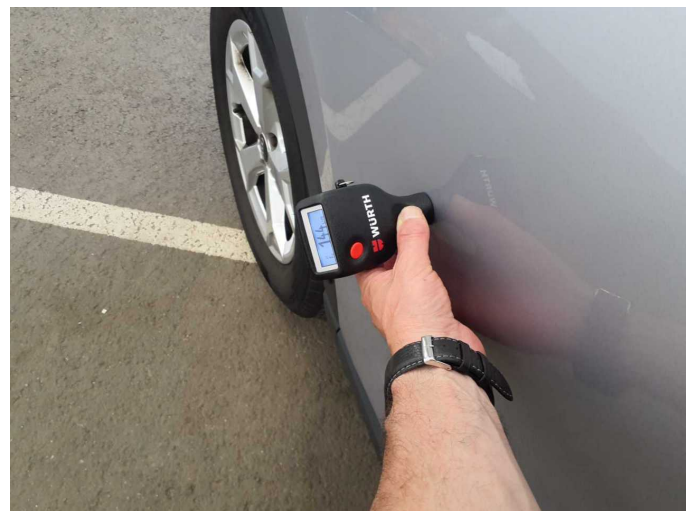
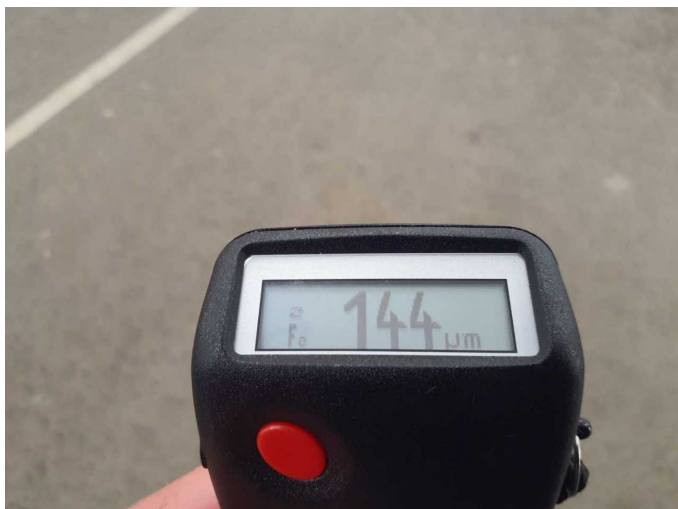
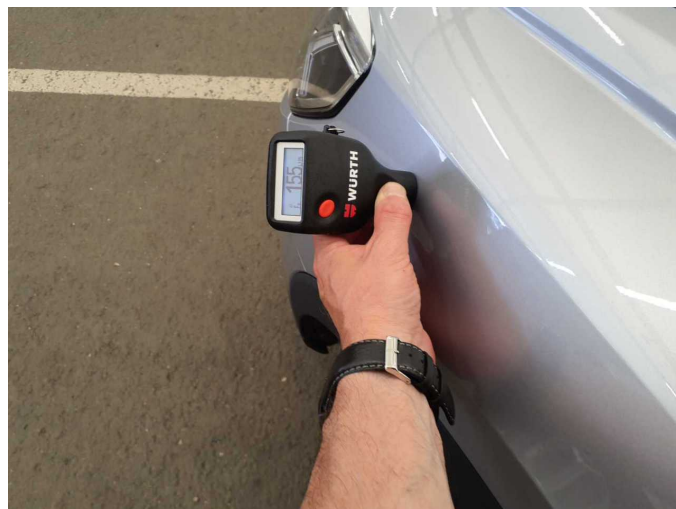
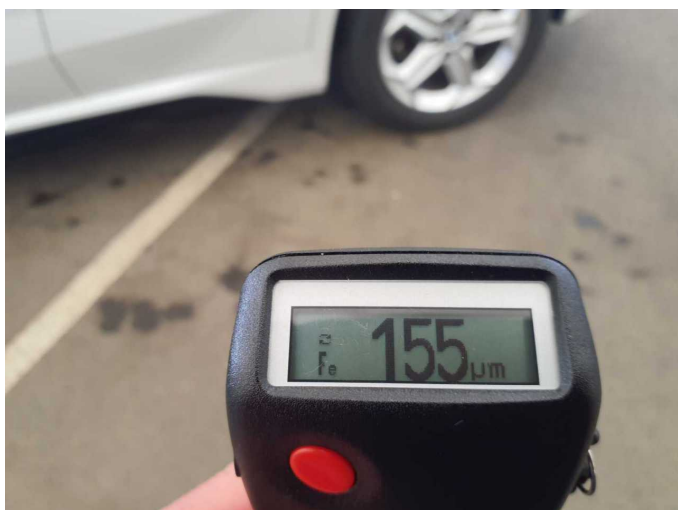
No.	Repainting
1	Mudguard - left side, Door - rear right side, Professionally carried out, Invoice of repair done Non-existent

Mudguard - left side	155 µm	Door - rear right side	144 µm
----------------------	--------	------------------------	--------

Repainting 1: Mudguard - left side, Door - rear right side
