Expertise

Protocol number: 46466053  
Order No. / Reference: 26603398  
Inspection date: 13 Jul 2026

Manufacturer: Mercedes-Benz  
VIN: W1N1673541A607956

Model: GLE-Coupe 350 e 4Matic 9G-TRONIC AMG Line

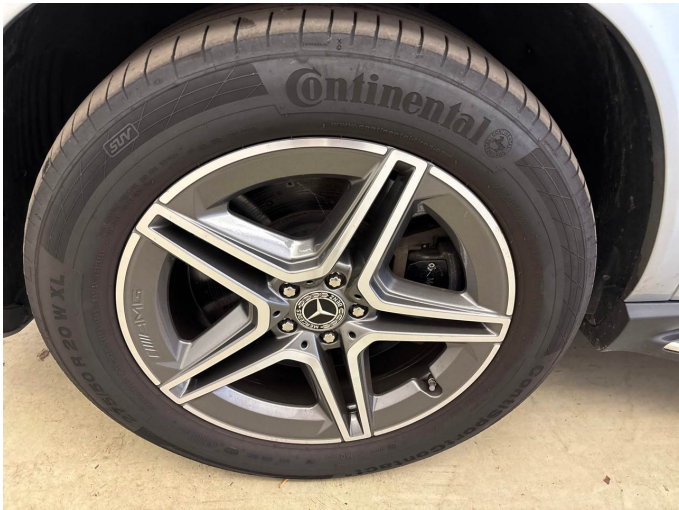
| Tyres | | | | |
|---|---|---|---|---|
| 1) | 275/50 R20 113W | Summer tyres on Light alloy | Continental | 4mm / 4mm |
| 2) | 275/50 R20 113W | Summer tyres on Light alloy | Continental | 4mm / 4mm |

Figure 12: Mounted tyres

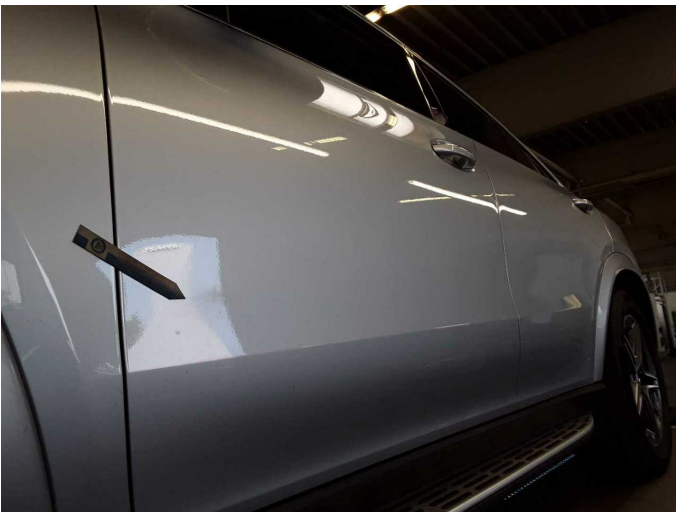
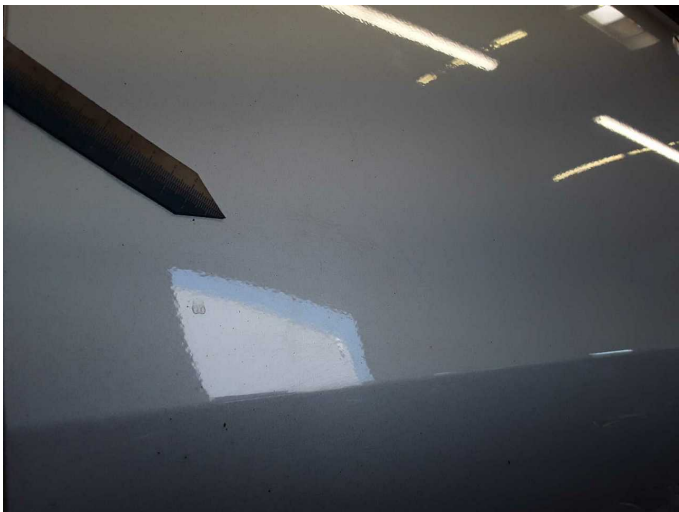
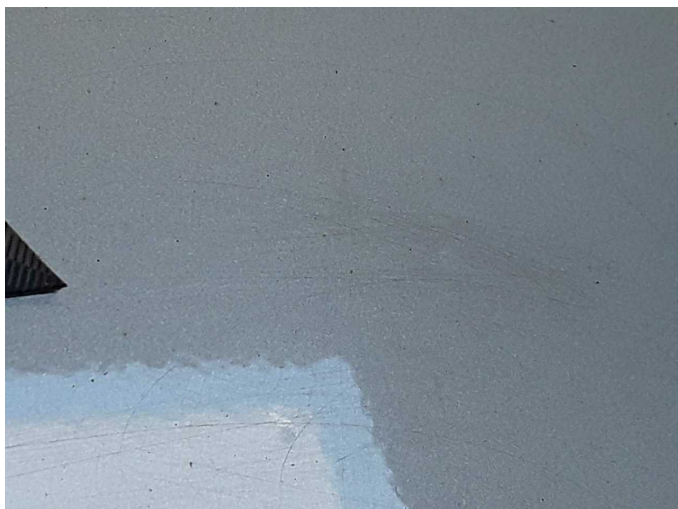
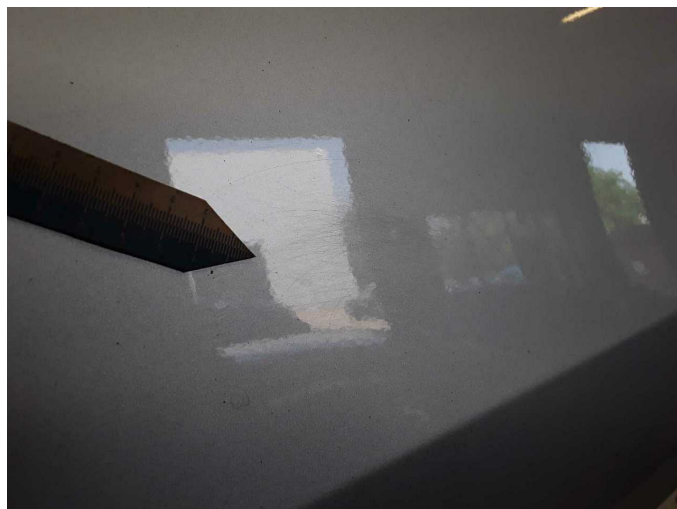
| No. | Component group | Description |
|---|---|---|
| 1 | Door - front left side | Door - Scratched - Paint |

Damage 1: Door - front left side: Door - Scratched - Paint

**Damage 1:** Door - front left side: Door - Scratched - Paint

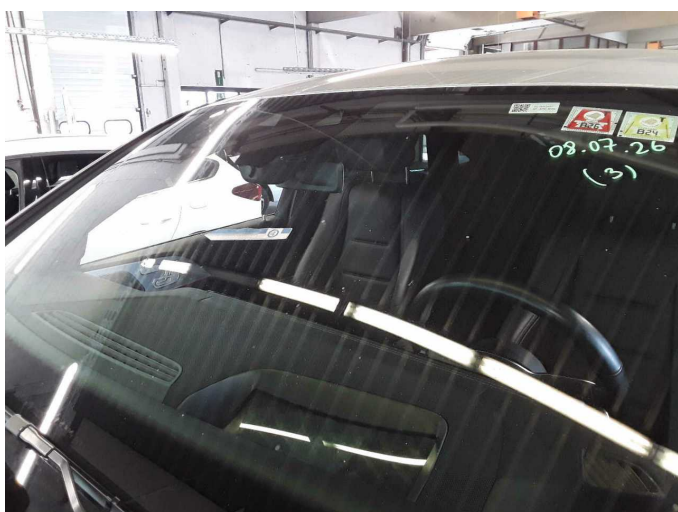
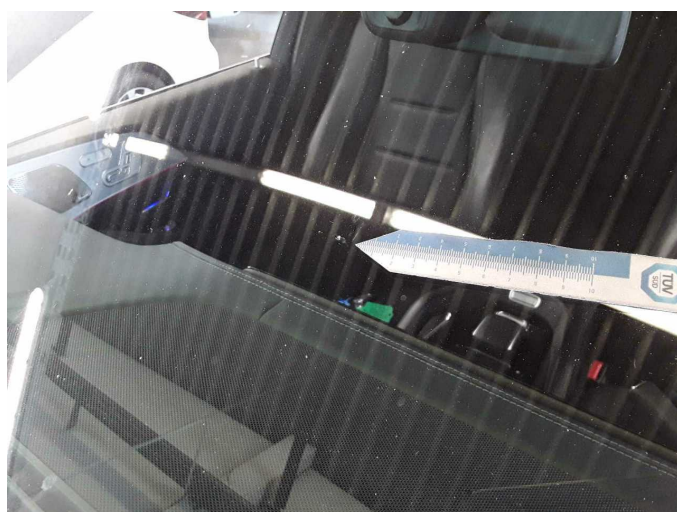
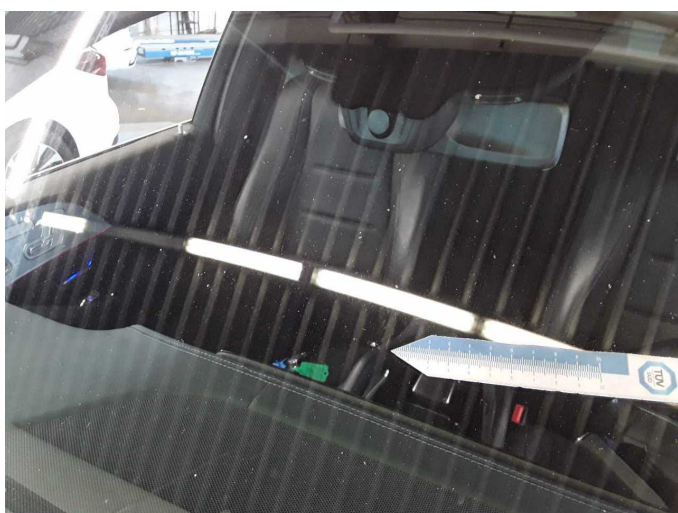
| No. | Component group | Description |
|---|---|---|
| 2 | Vehicle glazing | Windscreen - Stone chips - Replace |

**Damage 2:** Vehicle glazing: Windscreen - Stone chips - Replace

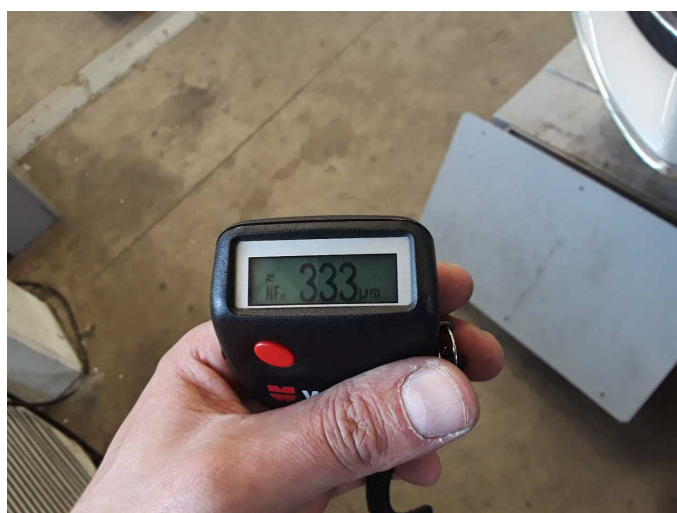
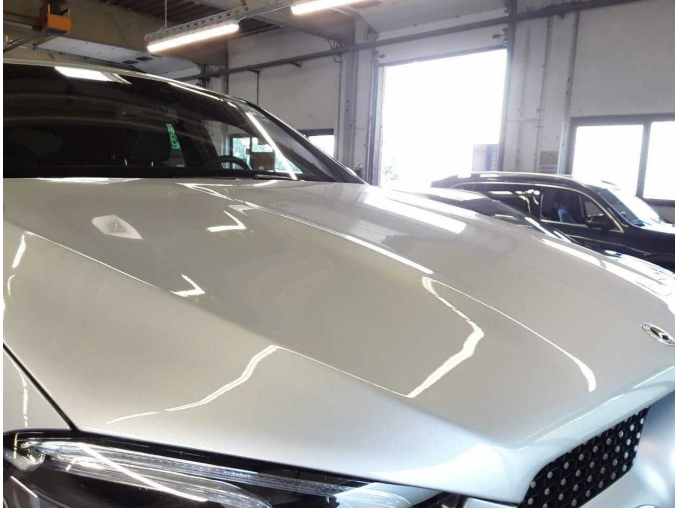
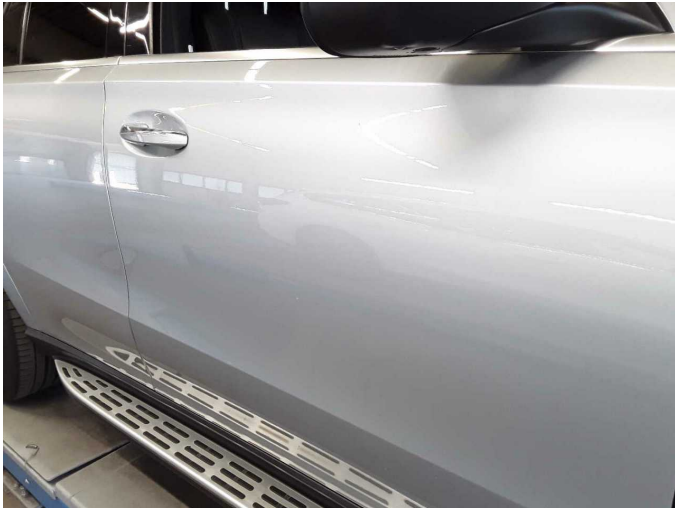
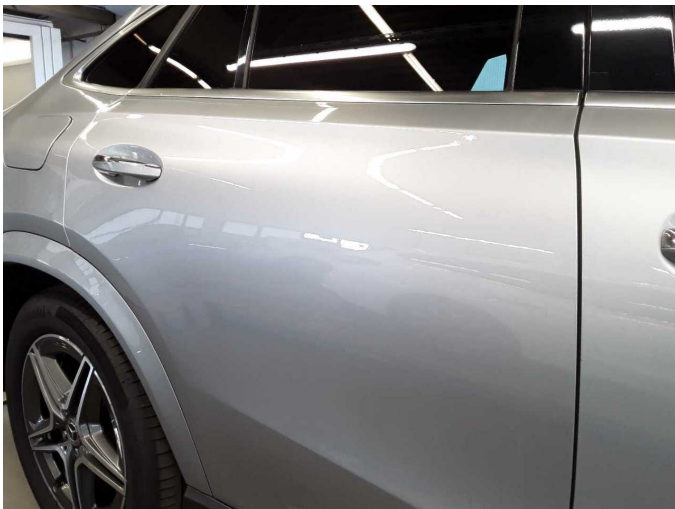
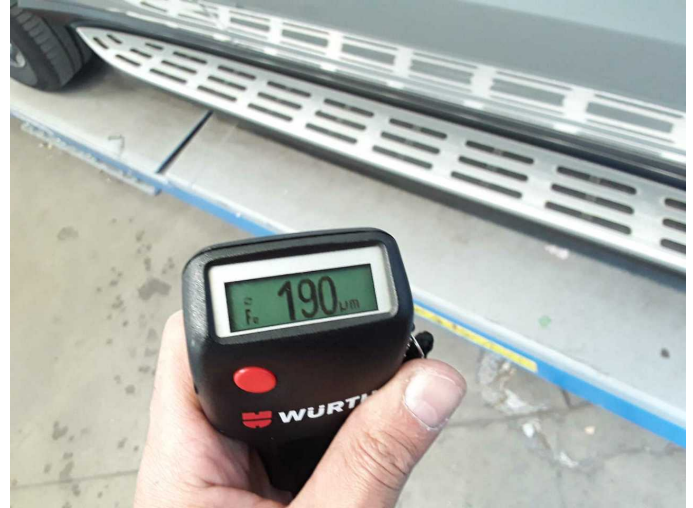
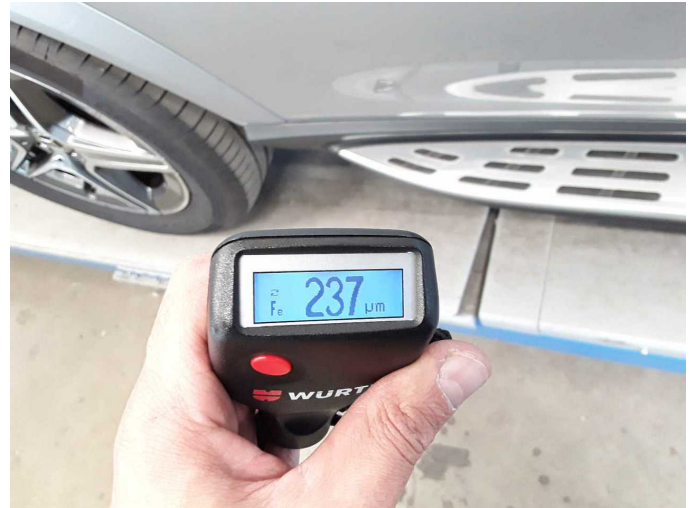
| No. | Repainting |
|---|---|
| 1 | Roof, Boot lid / rear door, Mudguard - left side, Bonnet, Side panel - rear left side, Side panel - rear right side, Door - rear left side, Door - rear right side, Door - front left side, Door - front right side, Professionally carried out, Invoice of repair done Non-existent |

**Repainting 1:** Roof, Boot lid / rear door, Mudguard - left side, Bonnet, Side panel - rear left side, Side panel - rear right side, Door - rear left side, Door - rear right side, Door - front left side, Door - front right side

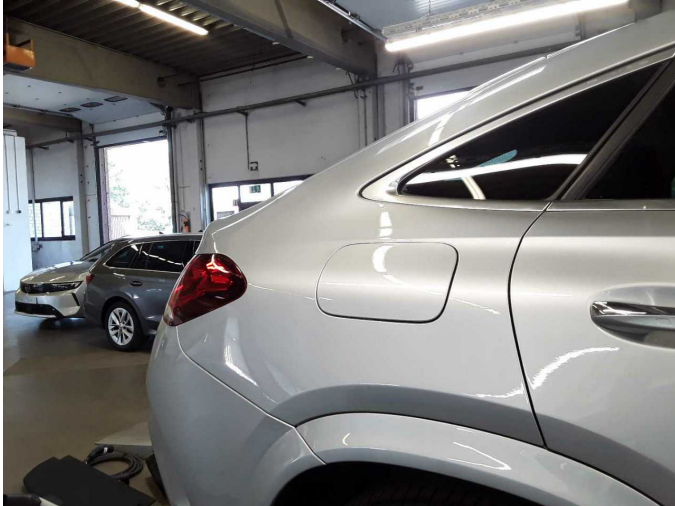
**Repainting 1:** Roof, Boot lid / rear door, Mudguard - left side, Bonnet, Side panel - rear left side, Side panel - rear right side, Door - rear left side, Door - rear right side, Door - front left side, Door - front right side

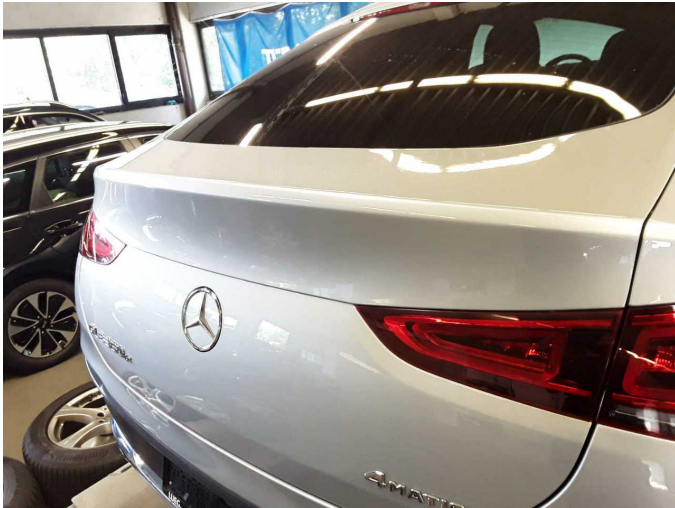
**Repainting 1:** Roof, Boot lid / rear door, Mudguard - left side, Bonnet, Side panel - rear left side, Side panel - rear right side, Door - rear left side, Door - rear right side, Door - front left side, Door - front right side

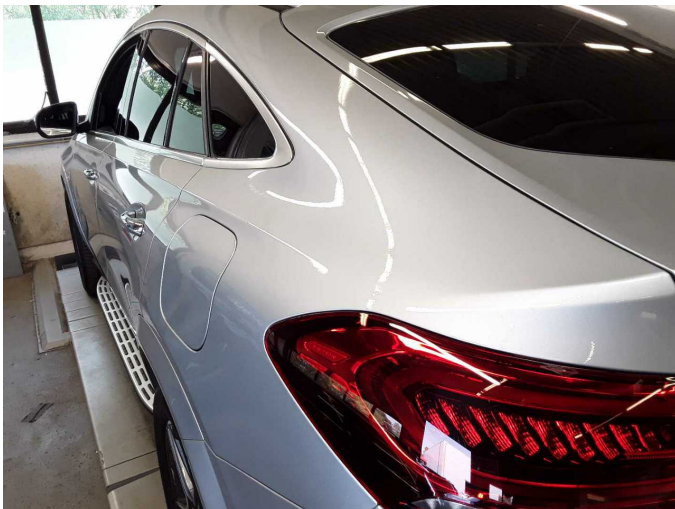
**Repainting 1:** Roof, Boot lid / rear door, Mudguard - left side, Bonnet, Side panel - rear left side, Side panel - rear right side, Door - rear left side, Door - rear right side, Door - front left side, Door - front right side

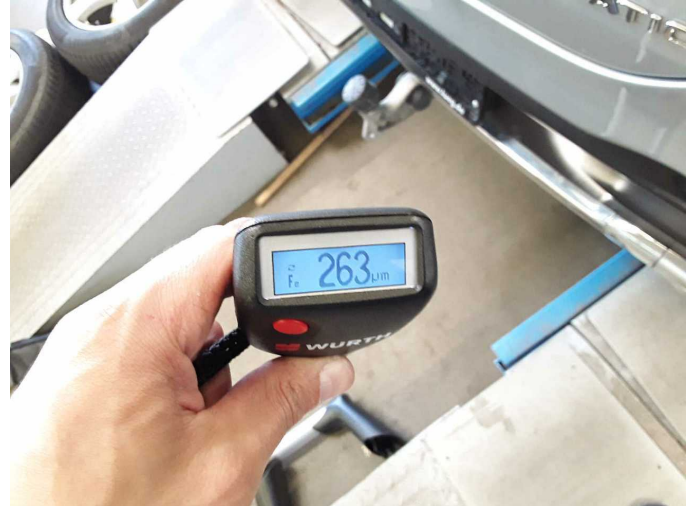
**Repainting 1:** Roof, Boot lid / rear door, Mudguard - left side, Bonnet, Side panel - rear left side, Side panel - rear right side, Door - rear left side, Door - rear right side, Door - front left side, Door - front right side

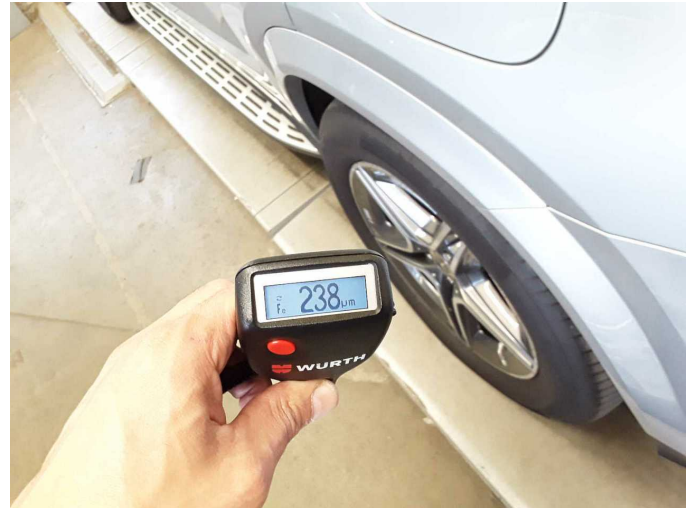
**Repainting 1:** Roof, Boot lid / rear door, Mudguard - left side, Bonnet, Side panel - rear left side, Side panel - rear right side, Door - rear left side, Door - rear right side, Door - front left side, Door - front right side

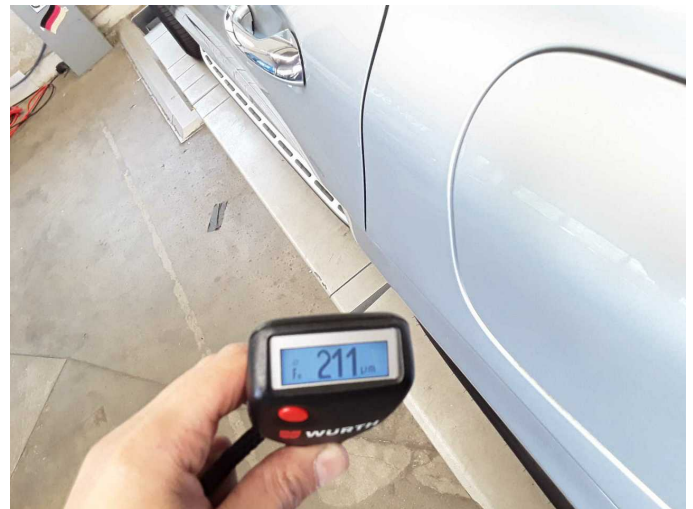
**Repainting 1:** Roof, Boot lid / rear door, Mudguard - left side, Bonnet, Side panel - rear left side, Side panel - rear right side, Door - rear left side, Door - rear right side, Door - front left side, Door - front right side

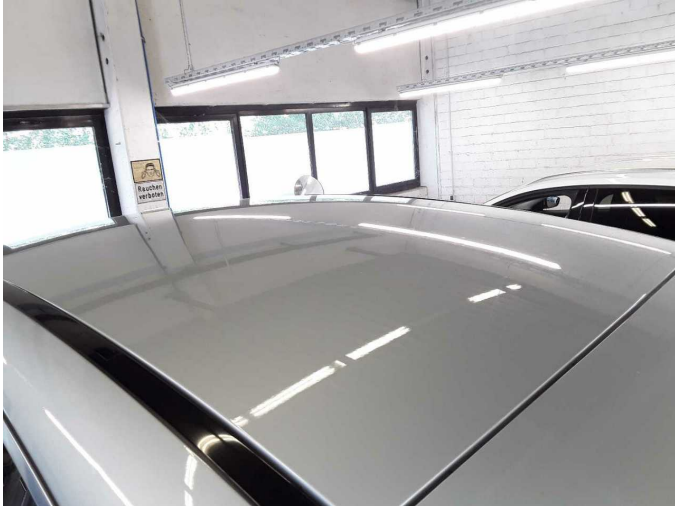
**Repainting 1:** Roof, Boot lid / rear door, Mudguard - left side, Bonnet, Side panel - rear left side, Side panel - rear right side, Door - rear left side, Door - rear right side, Door - front left side, Door - front right side

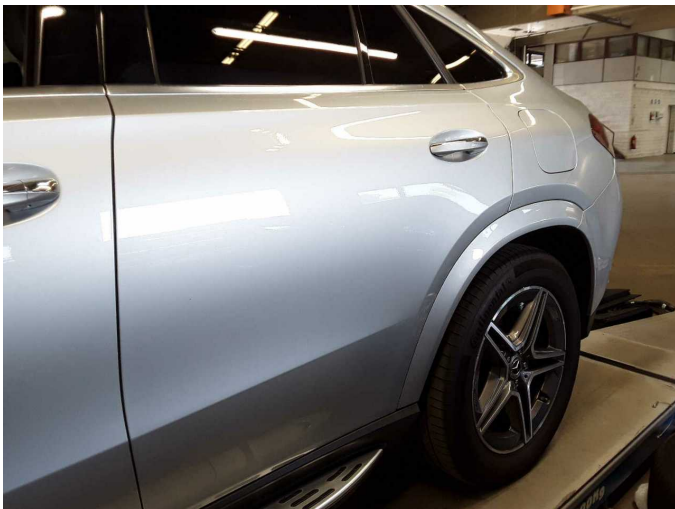
**Repainting 1:** Roof, Boot lid / rear door, Mudguard - left side, Bonnet, Side panel - rear left side, Side panel - rear right side, Door - rear left side, Door - rear right side, Door - front left side, Door - front right side

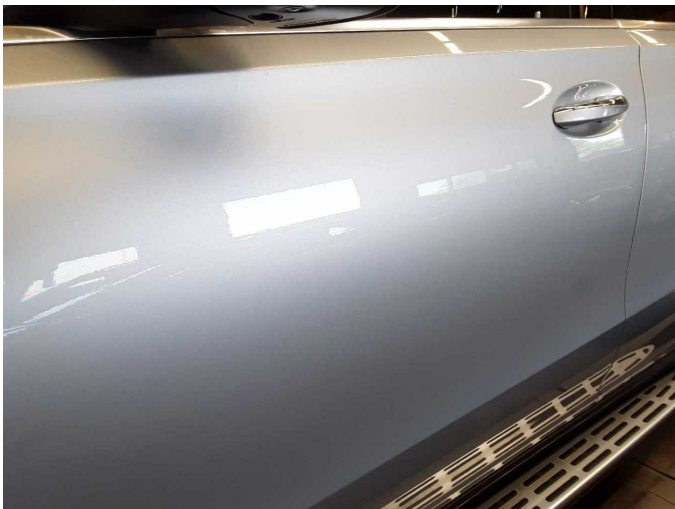
**Repainting 1:** Roof, Boot lid / rear door, Mudguard - left side, Bonnet, Side panel - rear left side, Side panel - rear right side, Door - rear left side, Door - rear right side, Door - front left side, Door - front right side

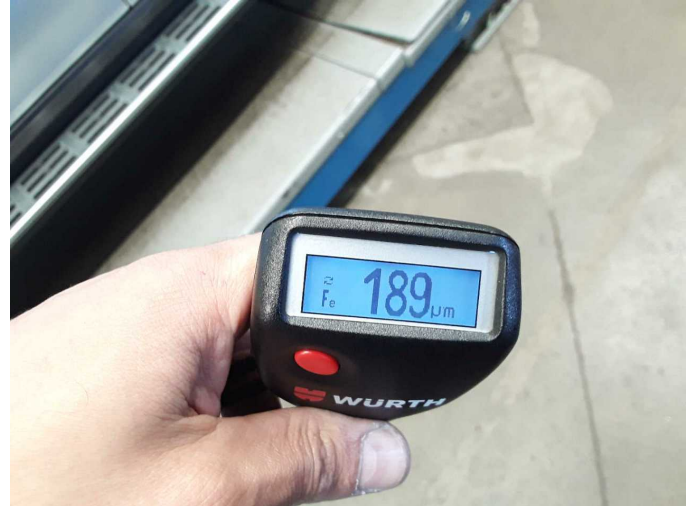
**Repainting 1:** Roof, Boot lid / rear door, Mudguard - left side, Bonnet, Side panel - rear left side, Side panel - rear right side, Door - rear left side, Door - rear right side, Door - front left side, Door - front right side

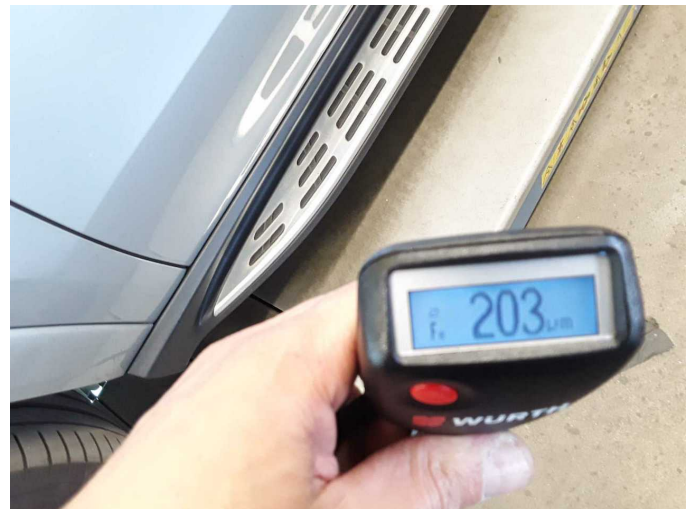
**Repainting 1:** Roof, Boot lid / rear door, Mudguard - left side, Bonnet, Side panel - rear left side, Side panel - rear right side, Door - rear left side, Door - rear right side, Door - front left side, Door - front right side

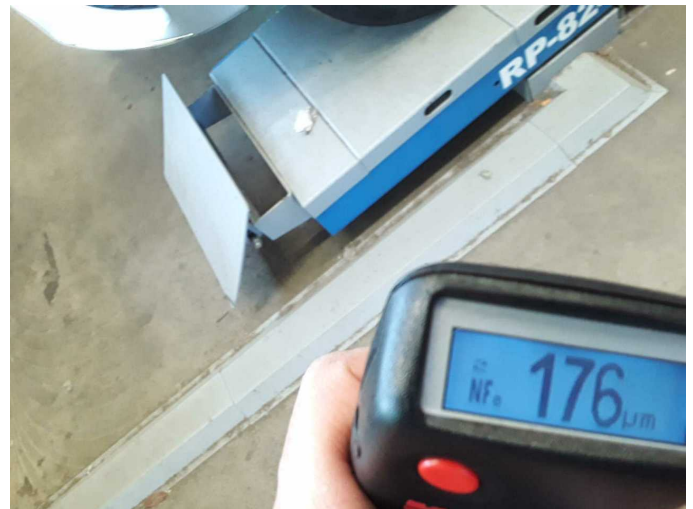
**Repainting 1:** Roof, Boot lid / rear door, Mudguard - left side, Bonnet, Side panel - rear left side, Side panel - rear right side, Door - rear left side, Door - rear right side, Door - front left side, Door - front right side

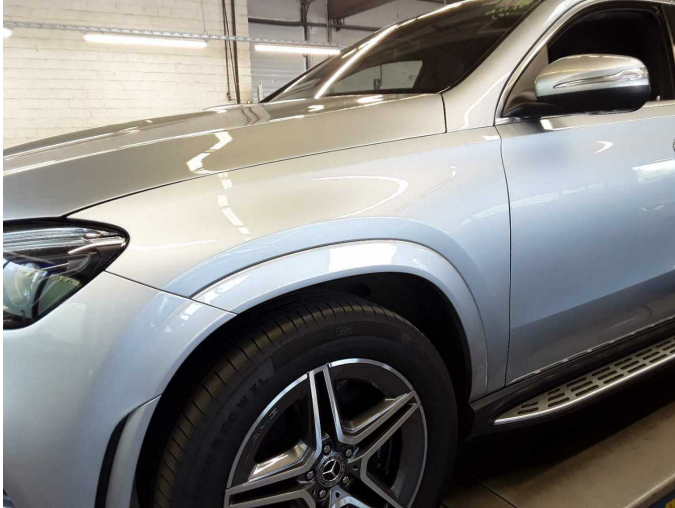
**Repainting 1:** Roof, Boot lid / rear door, Mudguard - left side, Bonnet, Side panel - rear left side, Side panel - rear right side, Door - rear left side, Door - rear right side, Door - front left side, Door - front right side
