## Expertise

Protocol number: 45491779  
Order No. / Reference: 26308054  
Inspection date: 16 May 2026

Model: 5008 BlueHDi 130 EAT8 GT

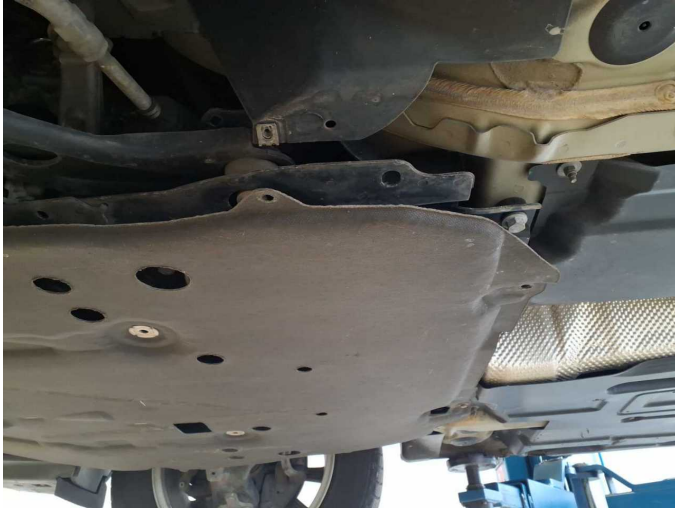
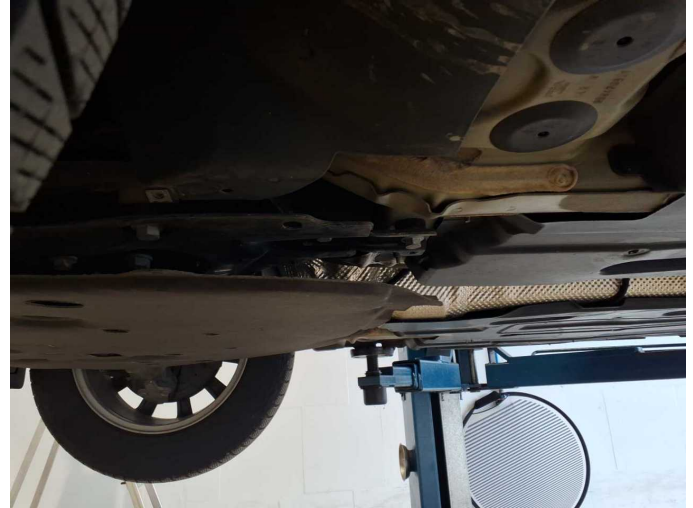
**Damage 1:** Body: Underbody panelling (Schrauben fehlen) - Loose - Replace

| No. | Component group | Description |
|---|---|--|
| 1 | Body | Underbody panelling (Schrauben fehlen) - Loose - Replace |

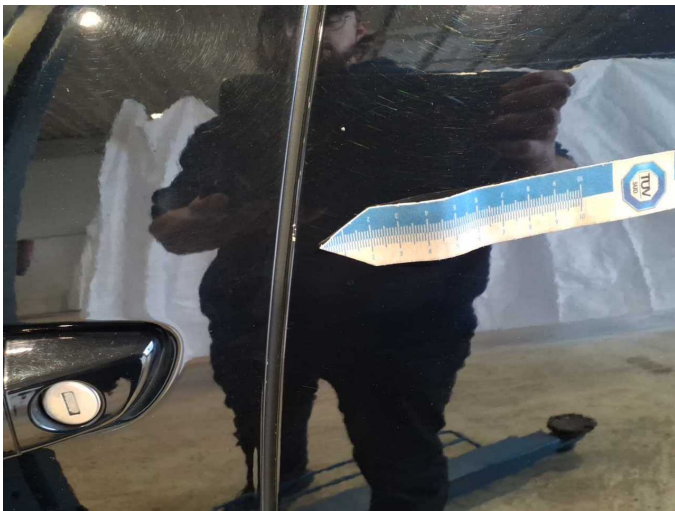
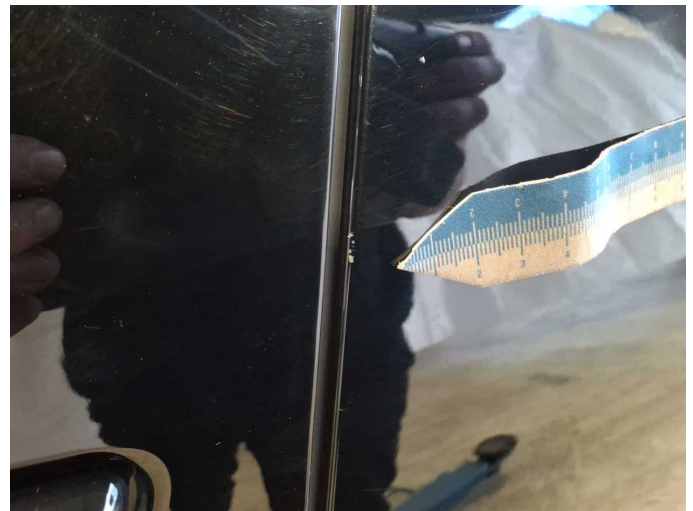
**Damage 2:** Door - front left side: Door - Scratch(es) - Smart repair

| No. | Component group | Description |
|---|---|--|
| 2 | Door - front left side | Door - Scratch(es) - Smart repair |

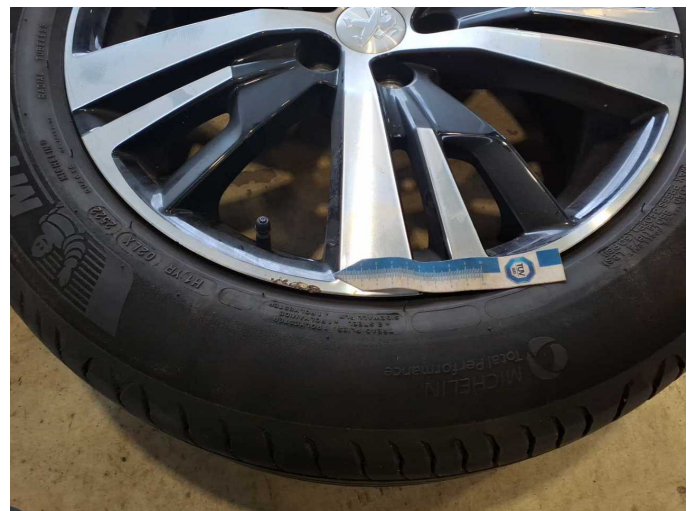
**Damage 3:** 2nd wheel set: 1 alloy rim - Scratch(es) - Loss in value

| No. | Component group | Description |
|---|---|--|
| 3 | 2nd wheel set | 1 alloy rim - Scratch(es) - Loss in value |

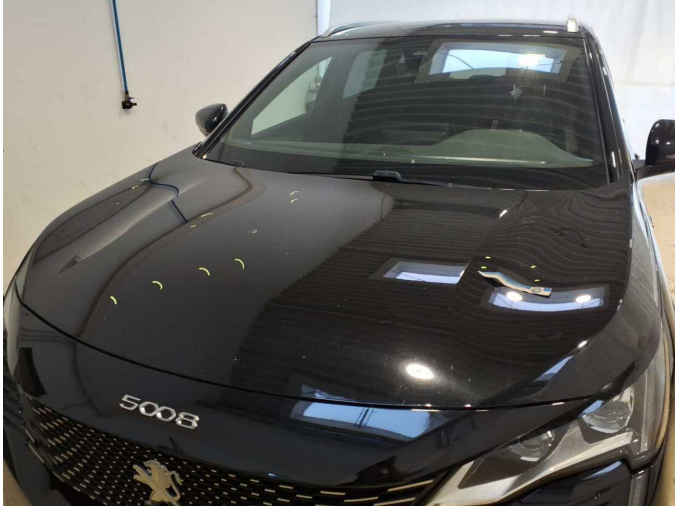
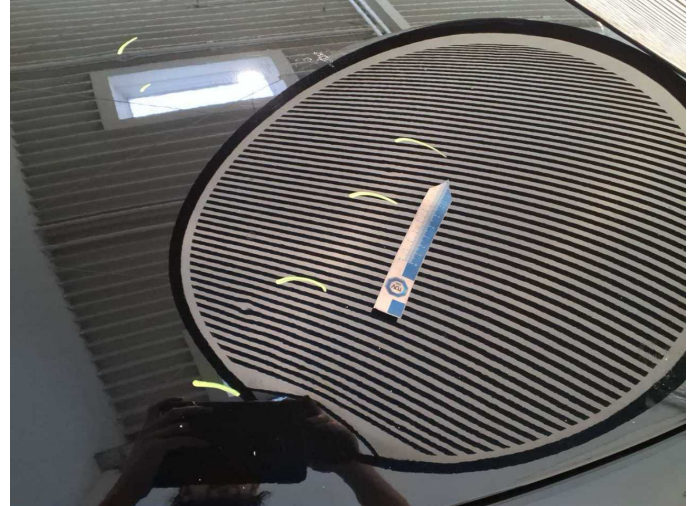
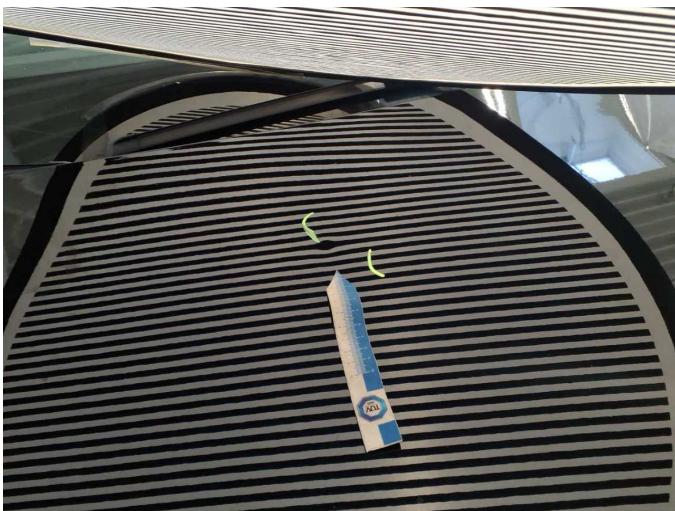
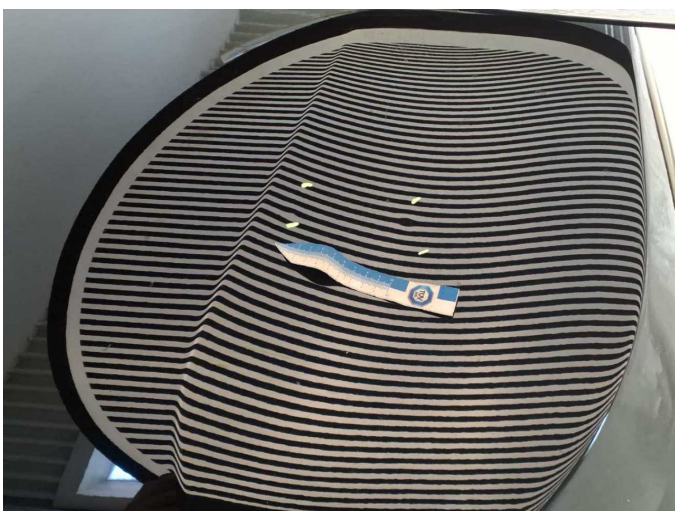
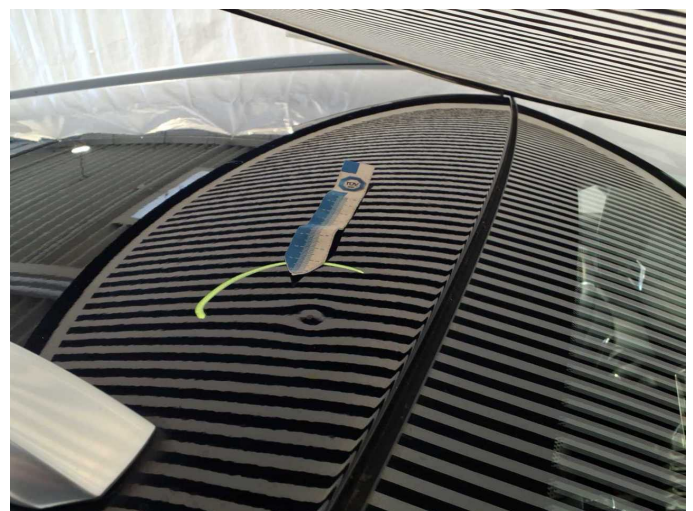
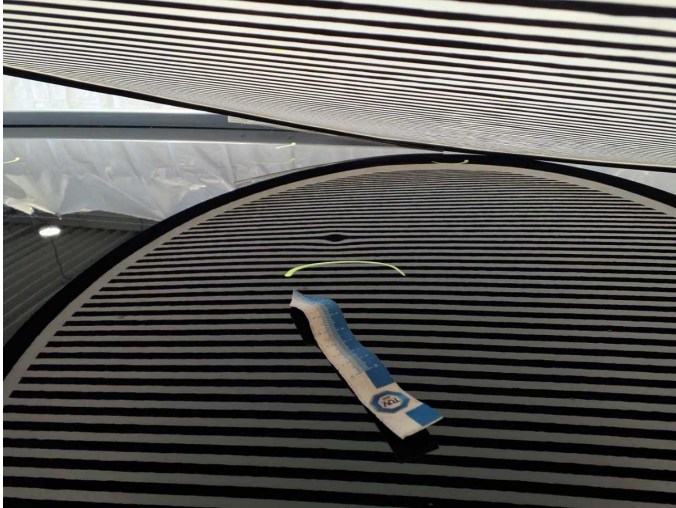
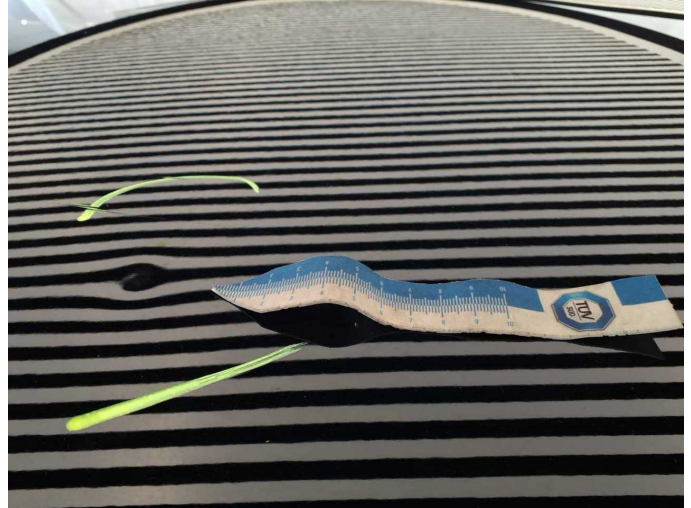
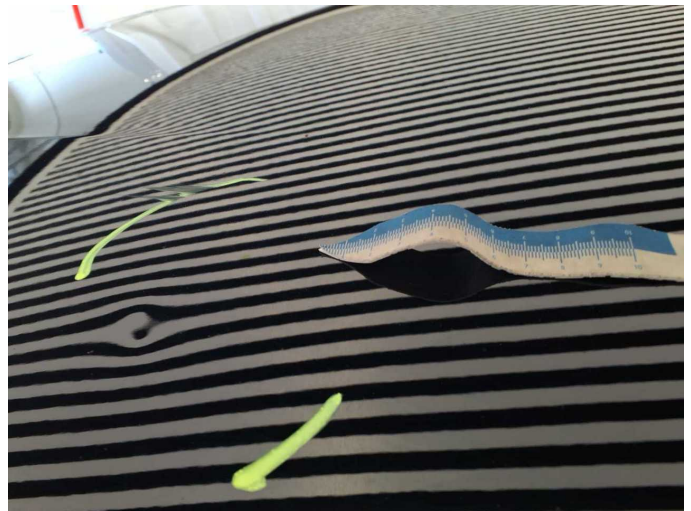
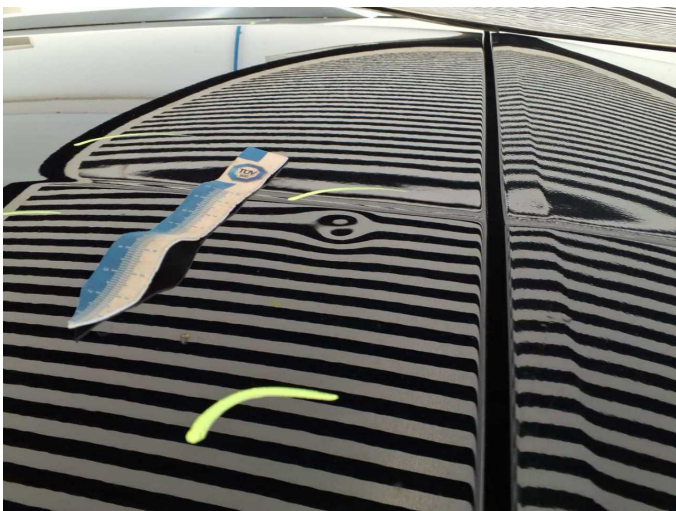
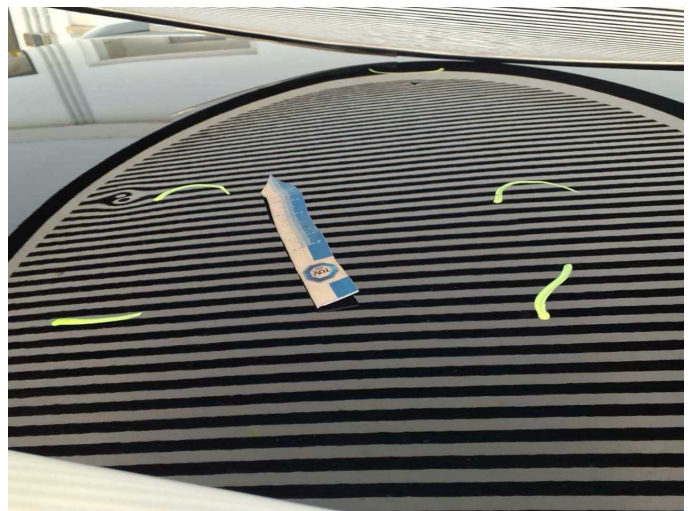
**Damage 4:** Body: Body - Damage by hail - Smooth repair work

Damage 4: Body: Body - Damage by hail - Smooth repair work

| No. | Component group | Description |
|---|---|--|
| 4 | Body | Body - Damage by hail - Smooth repair work |
