Expertise

Protocol number: 46014102  
Order No. / Reference: 26478683  
Inspection date: 16 Jun 2026

| Manufacturer: Volvo | Model: XC90 B5 B AWD Plus Bright |
| VIN: YV1LFM1V7S1391278 | |

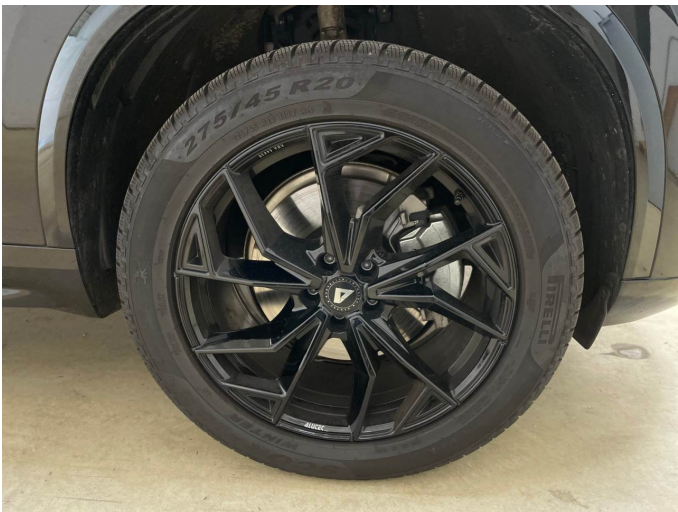
| # | Tyre size | Type of tyre | Manufacturer | Tread depth |
|---|---|---|---|---|
| 1) | 275/45 R20 110V | Winter tyres on Light alloy | Pirelli | 7mm / 7mm |
| 2) | 275/45 R20 110V | Winter tyres on Light alloy | Pirelli | 7mm / 7mm |

Figure 12: Mounted tyres

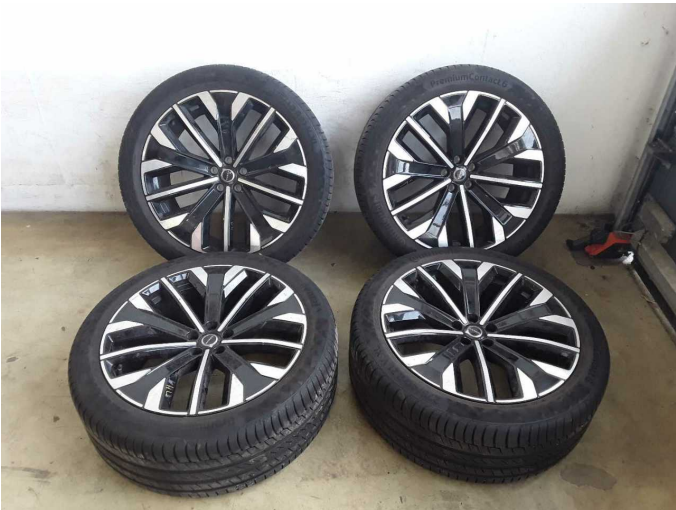
| # | Tyre size | Type of tyre | Manufacturer | Tread depth |
|---|---|---|---|---|
| 1) | 275/40 R21 107V | Summer tyres on Light alloy | Continental | 6mm / 6mm |
| 2) | 275/40 R21 107V | Summer tyres on Light alloy | Continental | 7mm / 7mm |

Figure 17: Additional tyres

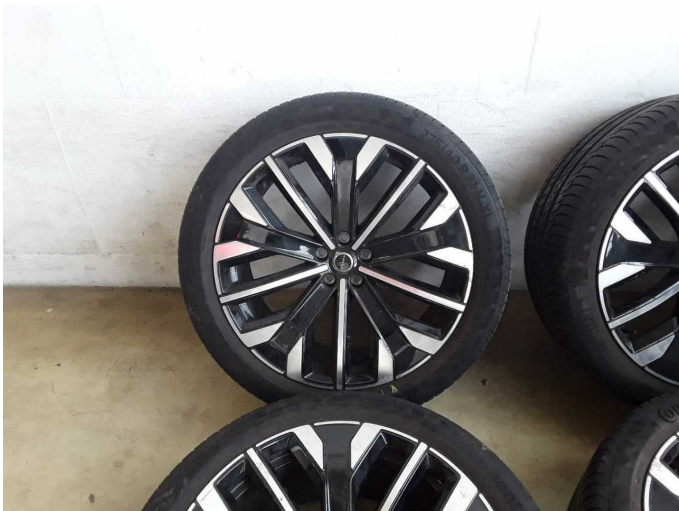
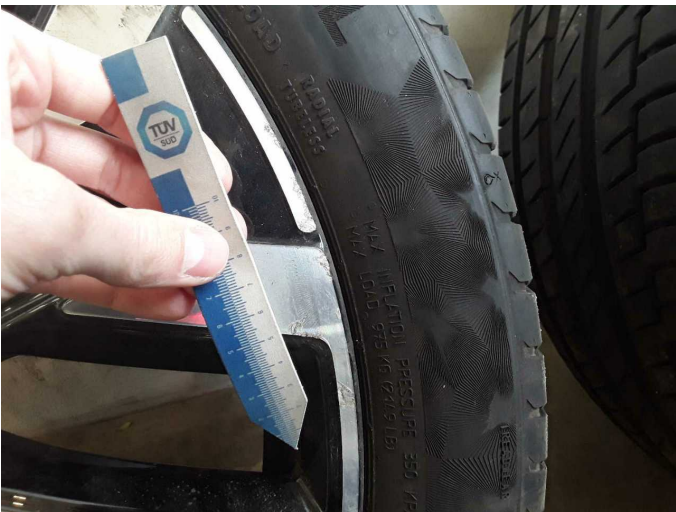
Damage 1: 2nd wheel set: 1 alloy rim - Scratch(es) - Loss in value

| No. | Component group | Description |
|---|---|---|
| 1 | 2nd wheel set | 1 alloy rim - Scratch(es) - Loss in value |

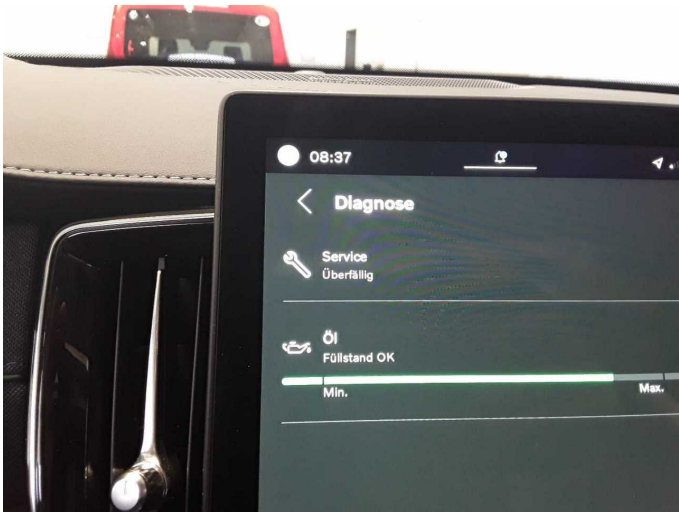
Damage 2: Misc.: Inspection / maintenance - Due - Perform

| No. | Component group | Description |
|---|---|---|
| 2 | Misc. | Inspection / maintenance - Due - Perform |

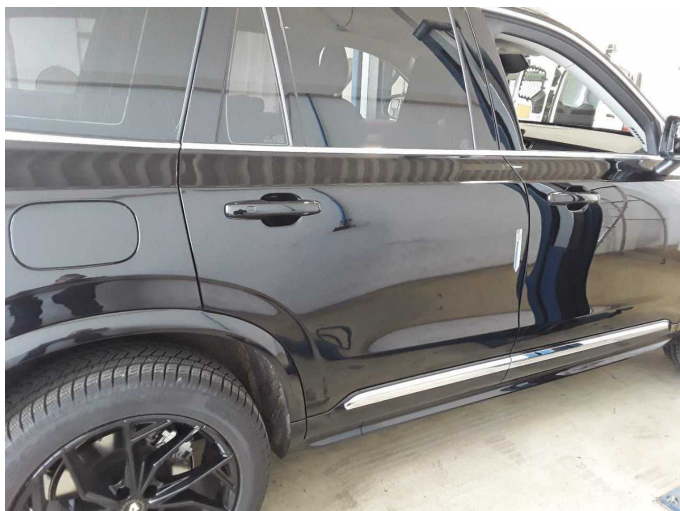
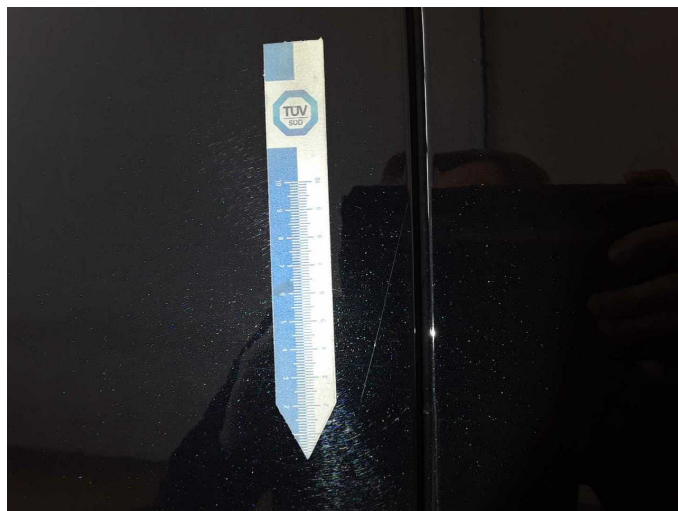
**Damage 3:** Door - rear right side: Door - Scratch(es) - Paint

| No. | Component group | Description |
|---|---|---|
| 3 | Door - rear right side | Door - Scratch(es) - Paint |

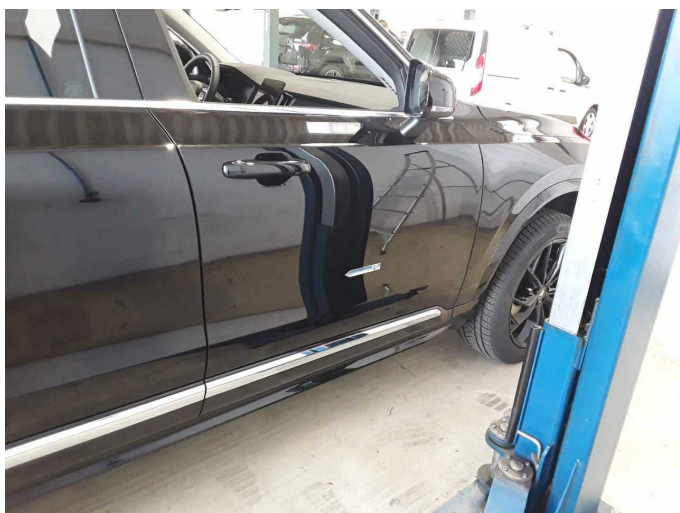
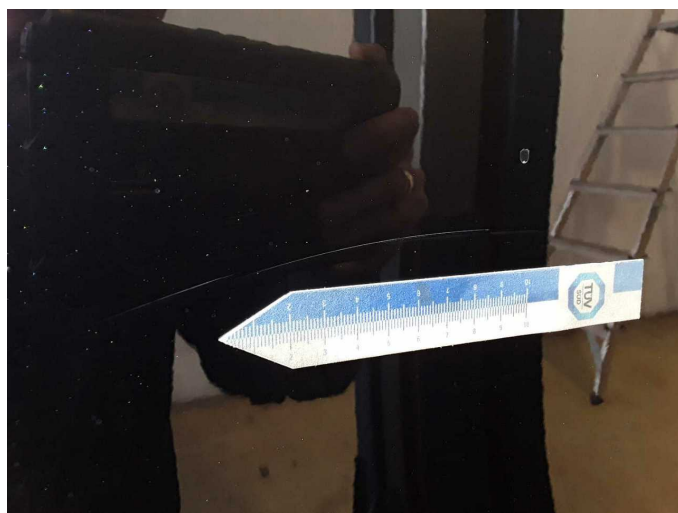
**Damage 4:** Door - front right side: Door - Scratch(es) - Paint

| No. | Component group | Description |
|---|---|---|
| 4 | Door - front right side | Door - Scratch(es) - Paint |

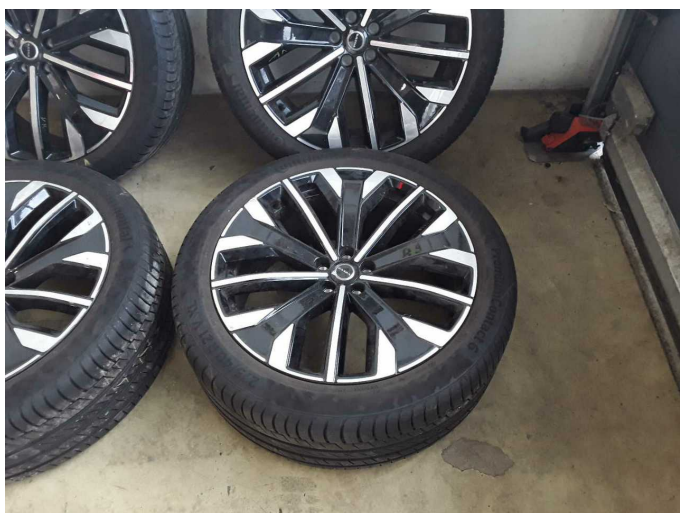
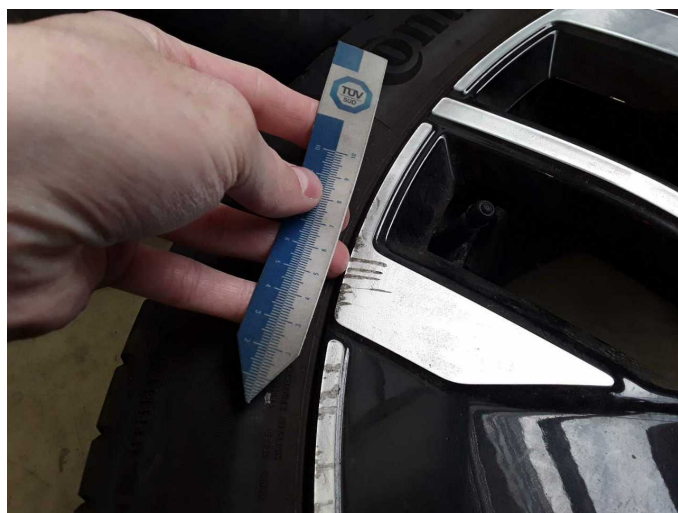
**Damage 5:** 2nd wheel set: 1 alloy rim (Materialabtrag) - Scratched - repair according to calculation

| No. | Component group | Description |
|---|---|---|
| 5 | 2nd wheel set | 1 alloy rim (Materialabtrag) - Scratched - repair according to calculation |

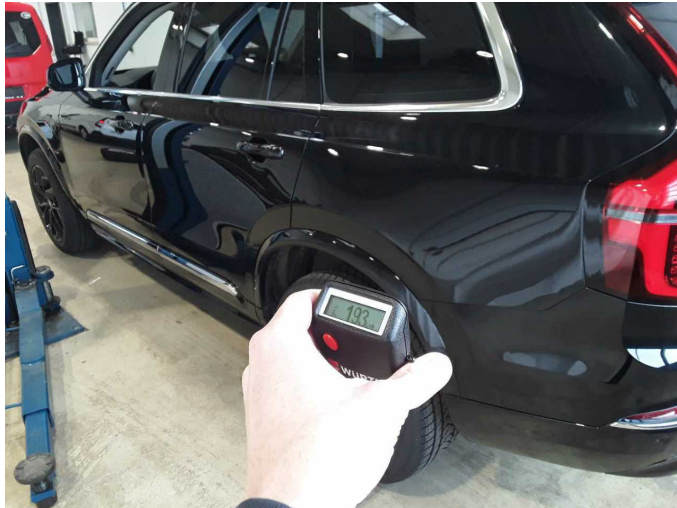
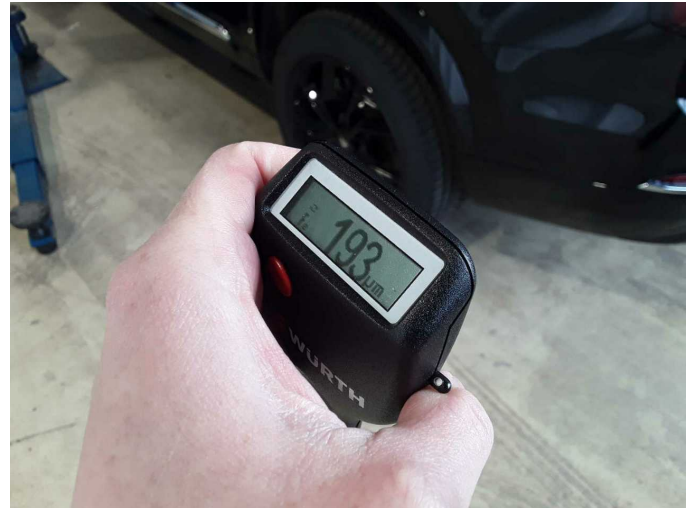
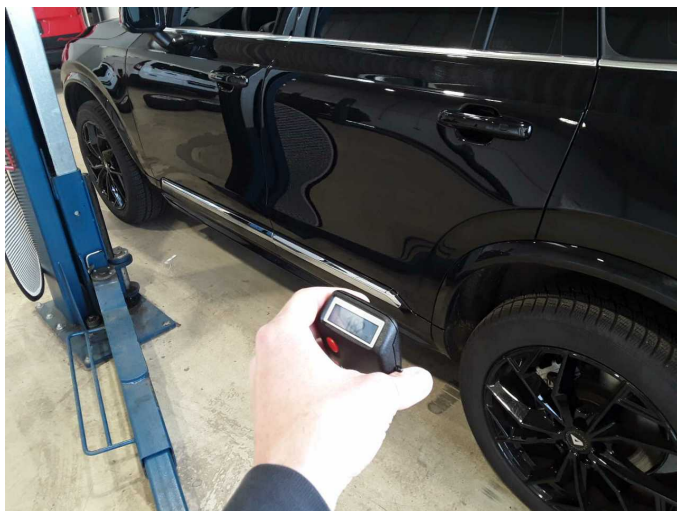
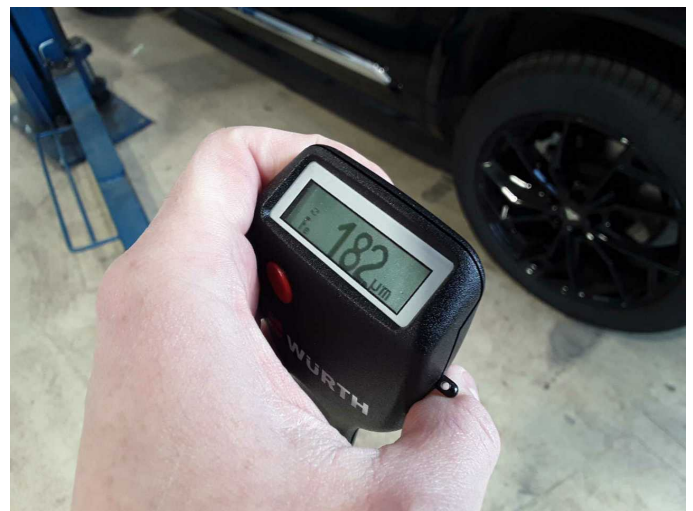
| No. | Repainting |
|---|---|
| 1 | Side panel - rear left side, Door - rear left side, Professionally carried out, Invoice of repair done Non-existent |

| Side panel - rear left side | 193 µm | Door - rear left side | 182 µm |

**Repainting 1:** Side panel - rear left side, Door - rear left side
