Expertise

Protocol number: 46403417  
Order No. / Reference: 26576954  
Inspection date: 8 Jul 2026

Manufacturer: Ford

Model: Focus Turnier 1.5 EcoBlue Start-Stopp-System Aut. TITANIUM

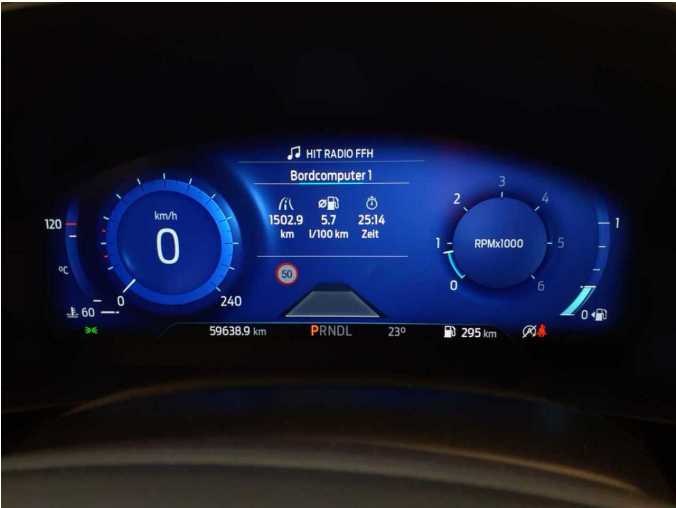
| Vehicle details | |
|---|---|
| Mileage (Read) | 59,638 km |

Figure 7: Instrument cluster

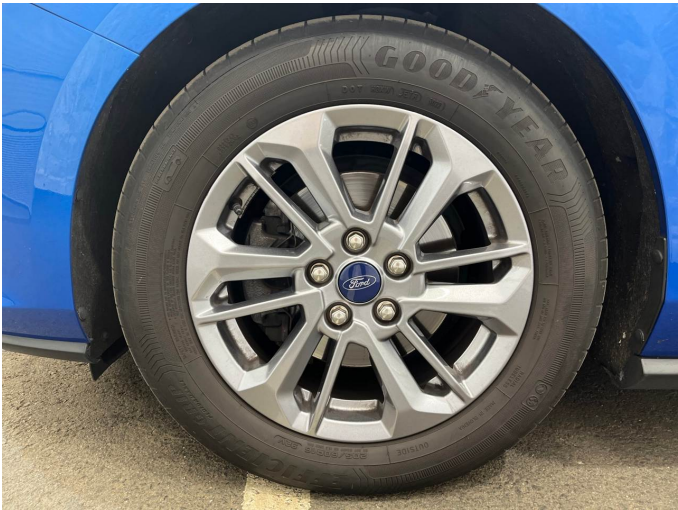
Figure 12: Mounted tyres

| Tyres | | | | |
|---|---|---|---|---|
| 1) | 205/60 R16 92V | Summer tyres on Light alloy | Goodyear | 5mm / 5mm |
| 2) | 205/60 R16 92V | Summer tyres on Light alloy | Goodyear | 6mm / 6mm |

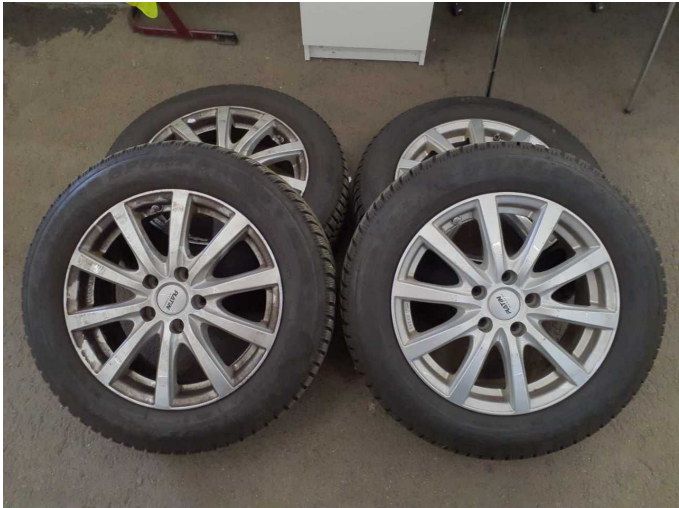
Figure 16: Additional tyres

| Tyres | | | | |
|---|---|---|---|---|
| 1) | 205/60 R16 92H | Winter tyres on Light alloy | Dunlop | 6mm / 6mm |
| 2) | 205/60 R16 92H | Winter tyres on Light alloy | Dunlop | 6mm / 6mm |

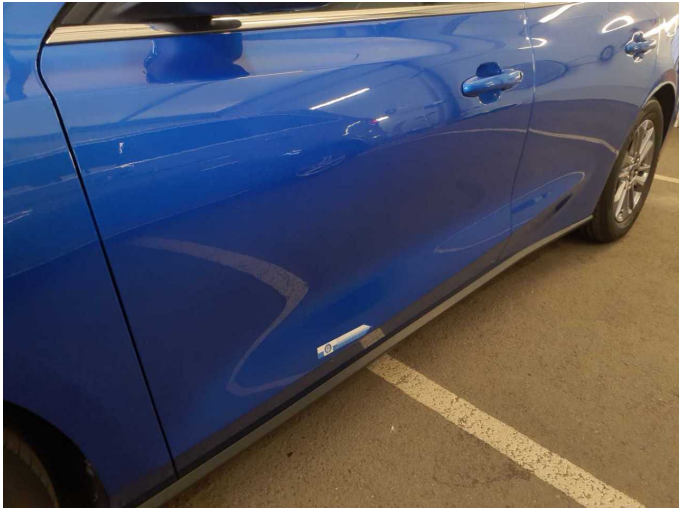
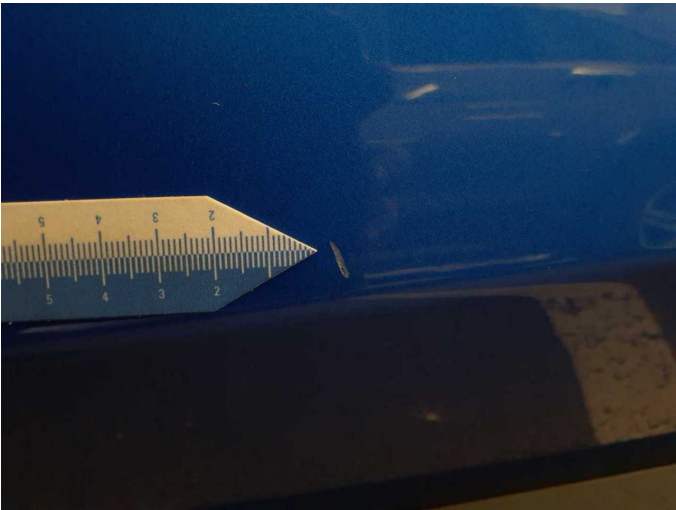
| No. | Component group | Description |
|---|---|---|
| 1 | Door - front left side | Door - Scratch(es) - Smart repair |

Damage 1: Door - front left side: Door - Scratch(es) - Smart repair

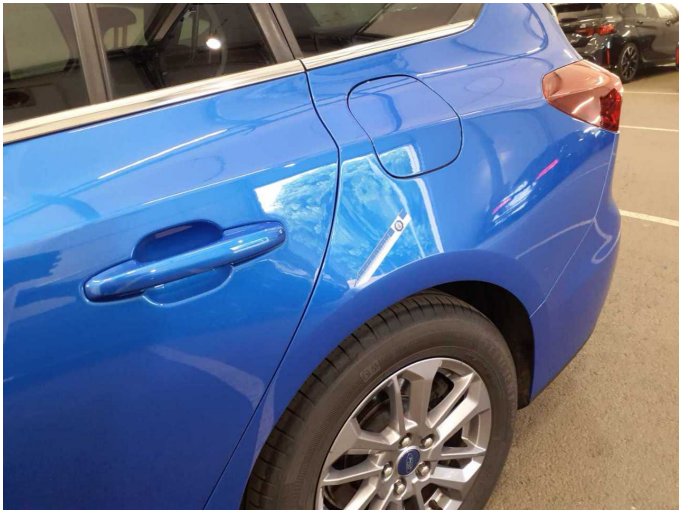
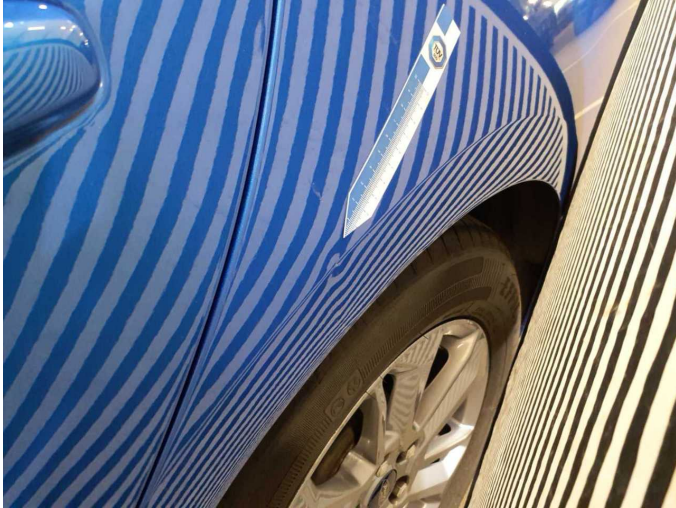
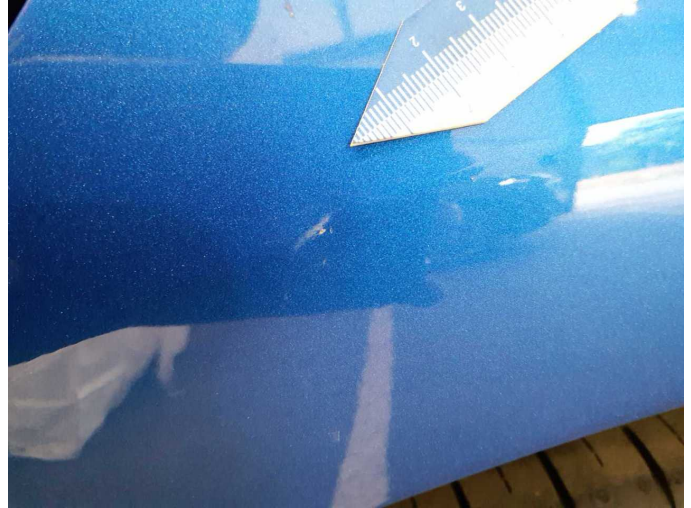
| No. | Component group | Description |
|---|---|---|
| 2 | Side panel - rear left side | Side panel - Dent / paintcoat damage - Smart repair |

Damage 2: Side panel - rear left side: Side panel - Dent / paintcoat damage - Smart repair

**Damage 2:** Side panel - rear left side: Side panel - Dent / paintcoat damage - Smart repair

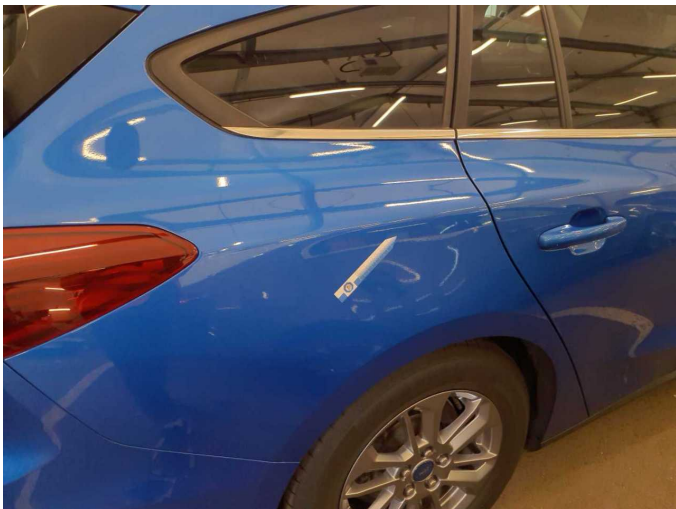
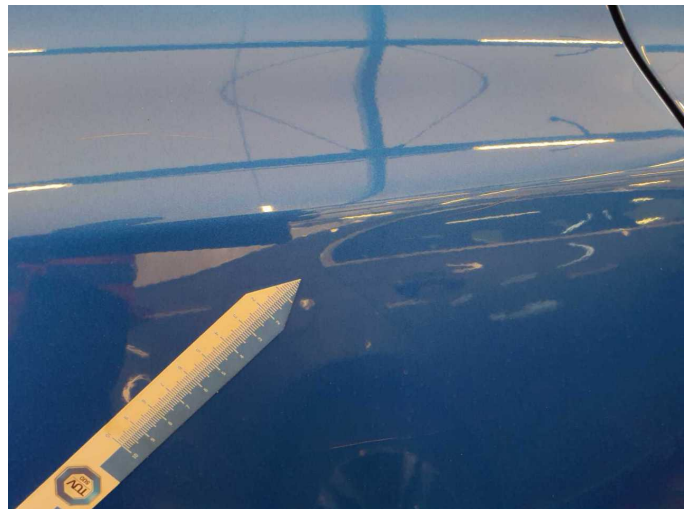
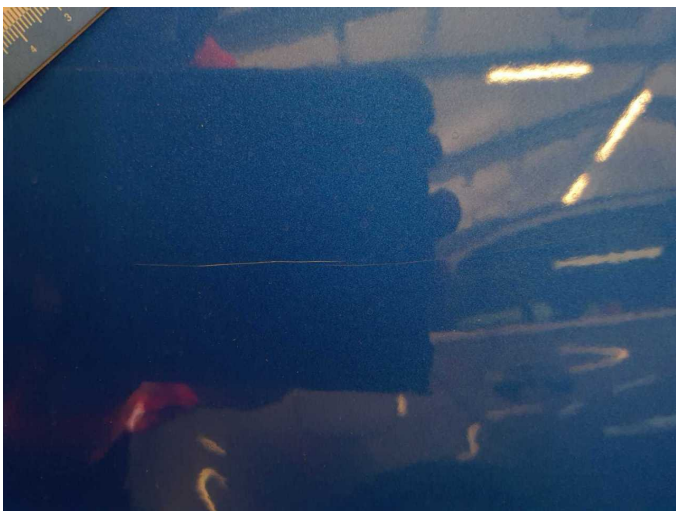
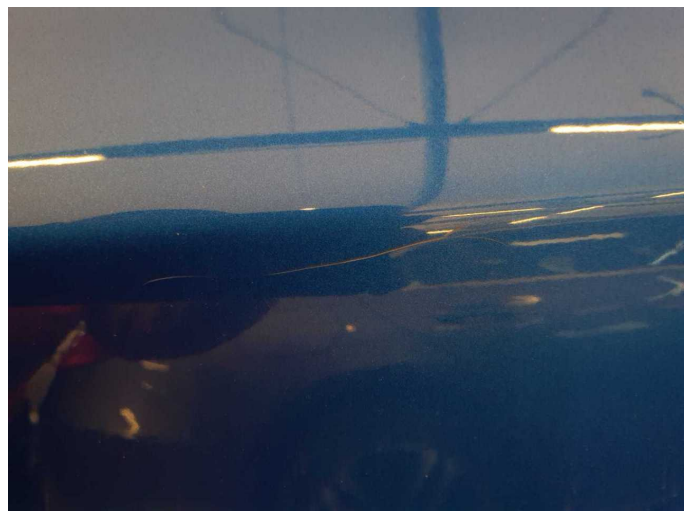
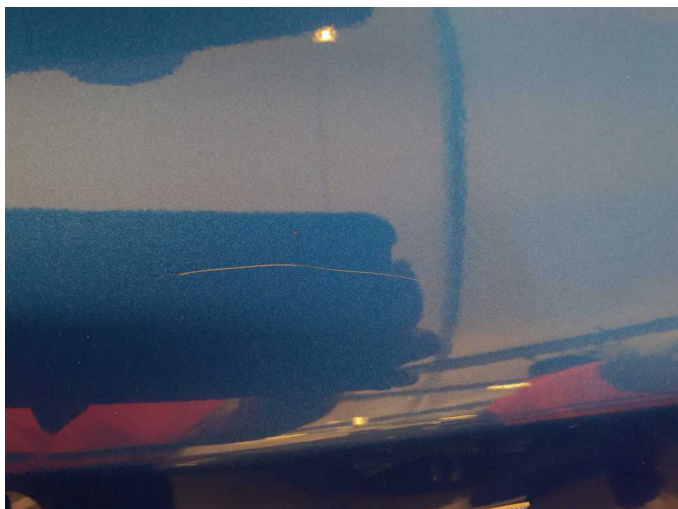
| No. | Component group | Description |
|---|---|---|
| 3 | Side panel - rear right side | Side panel - Scratch(es) - Paint |

**Damage 3:** Side panel - rear right side: Side panel - Scratch(es) - Paint

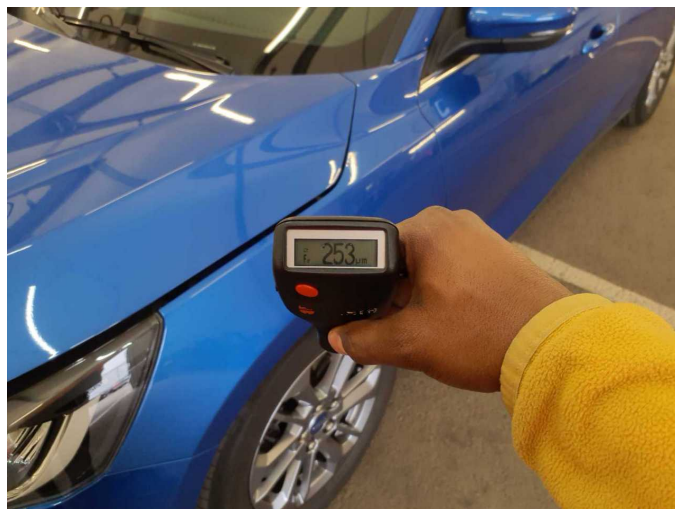
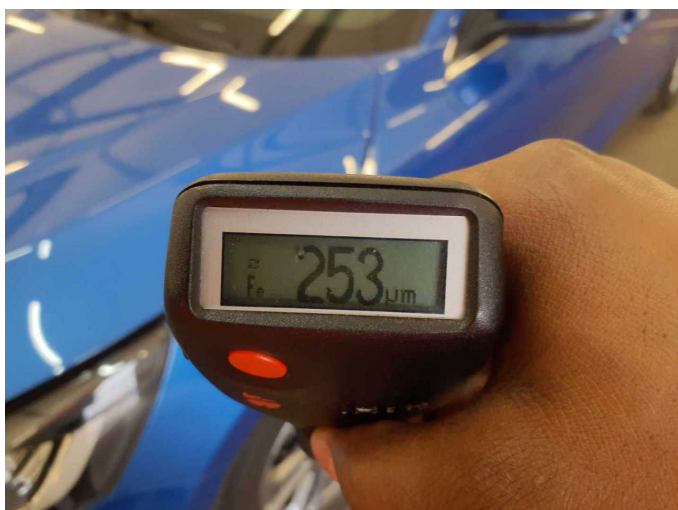
| Mudguard - left side | 253 µm | Bonnet | 220 µm |

**Repainting 1:** Mudguard - left side

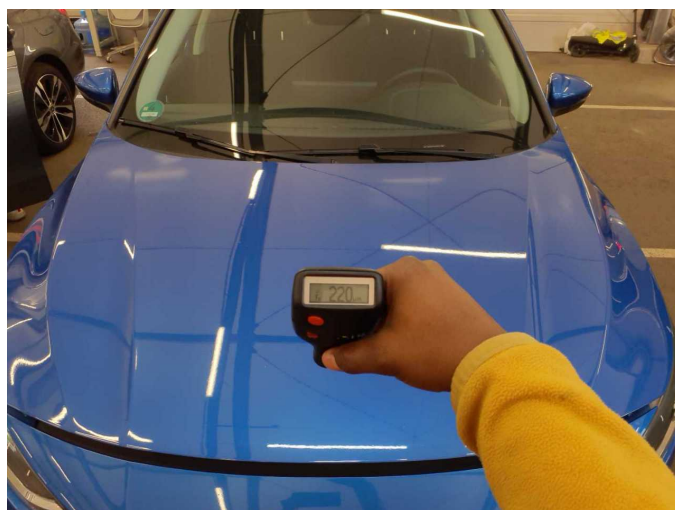
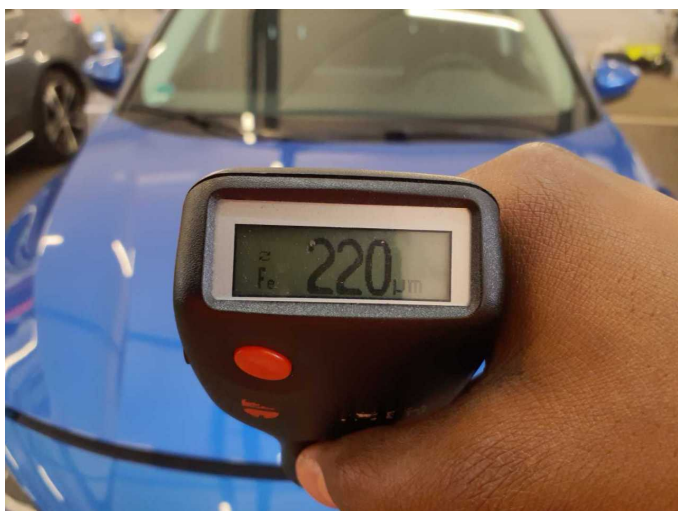
**Repainting 2:** Bonnet

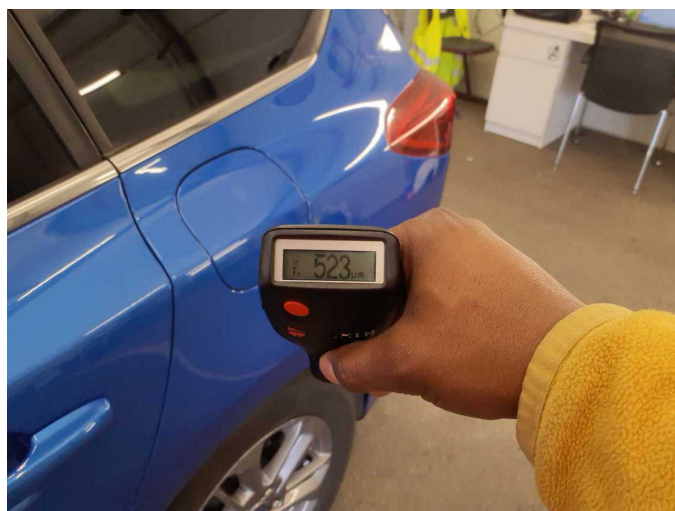
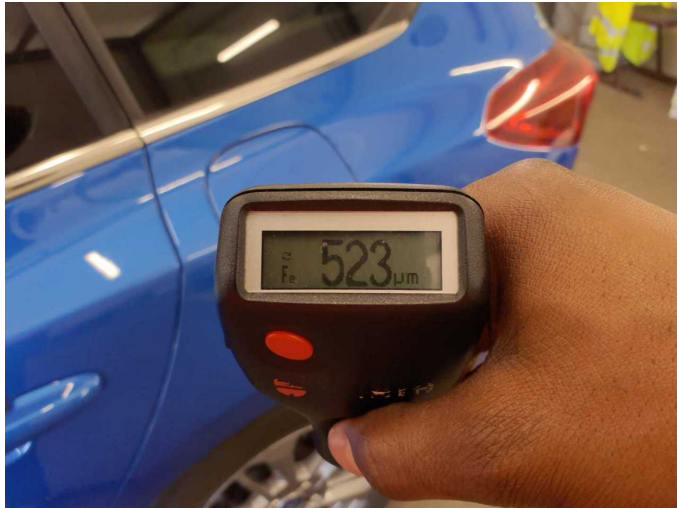
| Side panel - rear left side | 523 µm | Door - rear left side | 300 µm |

**Repainting 3:** Side panel - rear left side

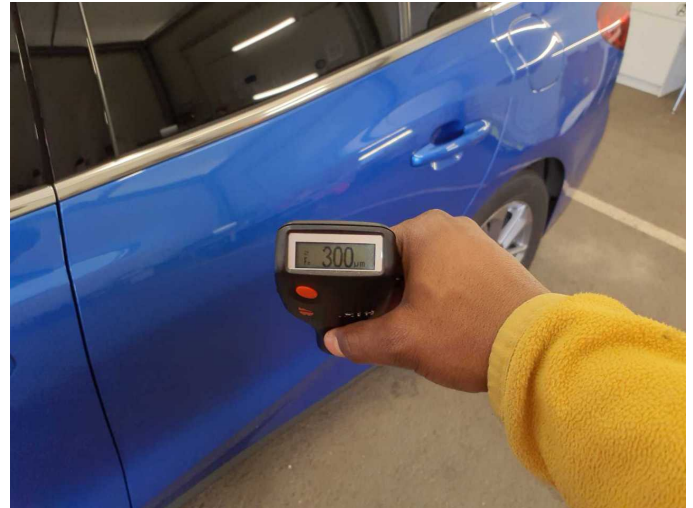
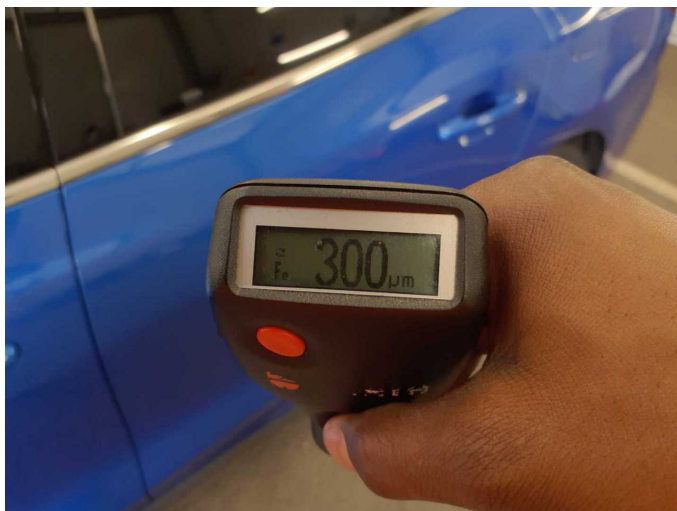
**Repainting 4:** Door - rear left side

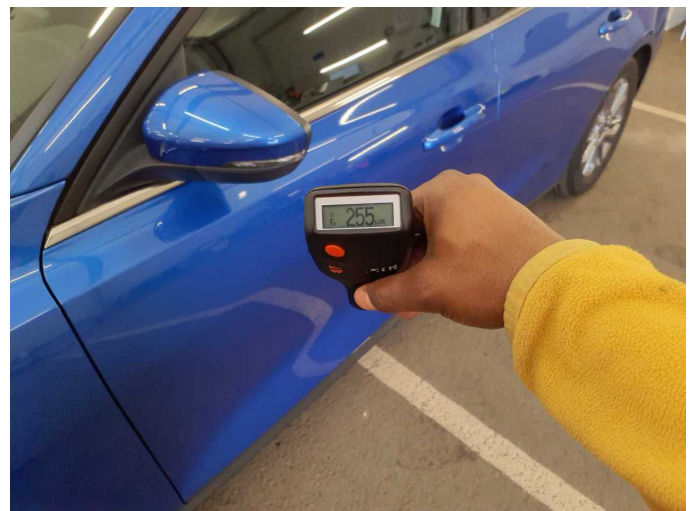
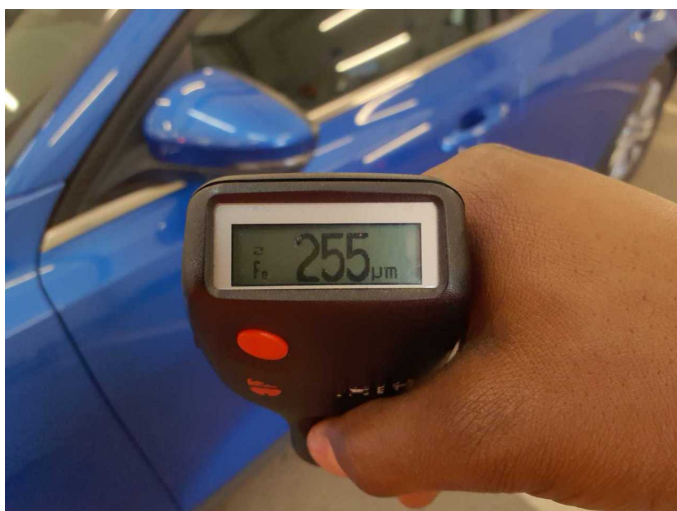
| Door - front left side | 255 µm | | |

**Repainting 5:** Door - front left side
