Expertise

Protocol number: 45805947
Order No. / Reference: 26300101
Inspection date: 22 May 2026

Manufacturer: Volkswagen

Model: Tiguan Allspace 2.0 TDI SCR 4Motion DSG Elegance

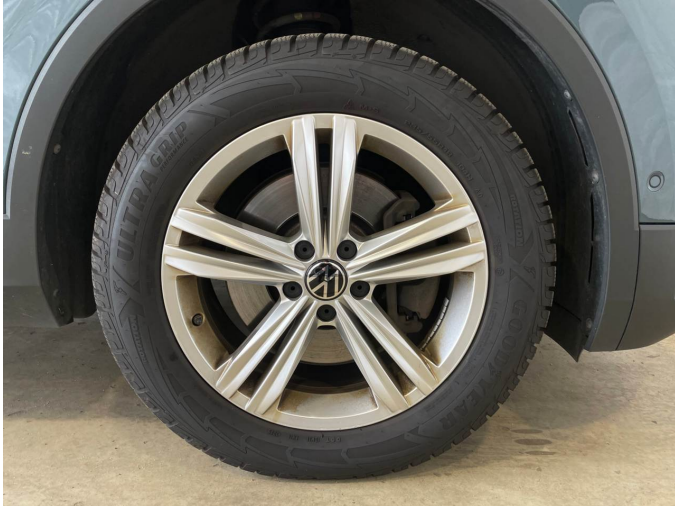
Figure 13: Mounted tyres

#	Tyre size	Type of tyre	Manufacturer	Tread depth
1)	235/55 R18 104H	Winter tyres on Light alloy	Goodyear	7mm / 7mm
2)	235/55 R18 104H	Winter tyres on Light alloy	Goodyear	8mm / 8mm

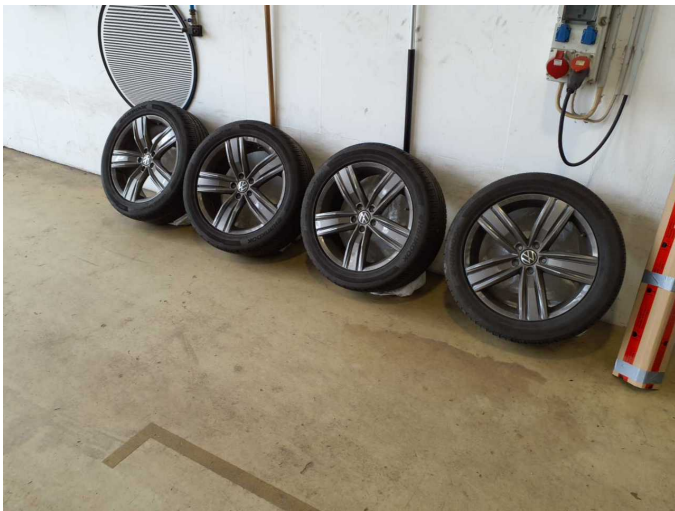
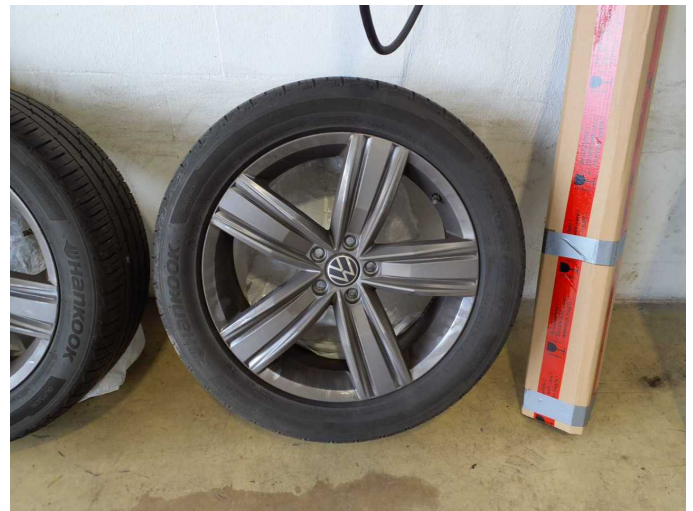
Figure 15: Additional tyres

#	Tyre size	Type of tyre	Manufacturer	Tread depth
1)	235/50 R19 99V	Summer tires (with run-flat tires) on Light alloy	Hankook	4mm / 4mm
2)	235/50 R19 99V	Summer tires (with run-flat tires) on Light alloy	Hankook	5mm / 5mm

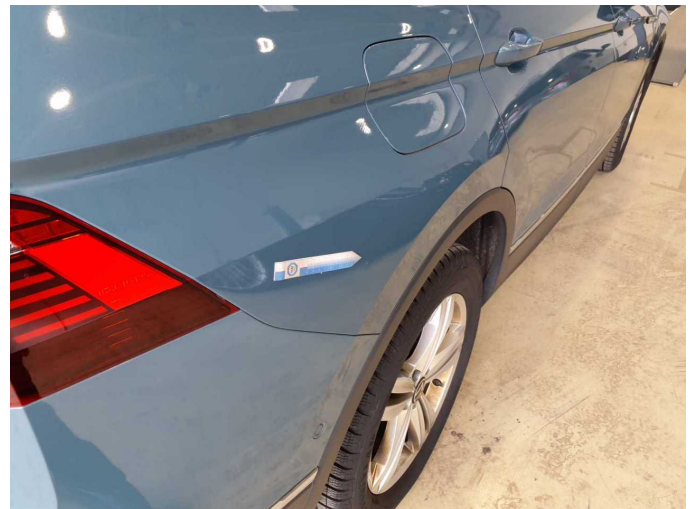
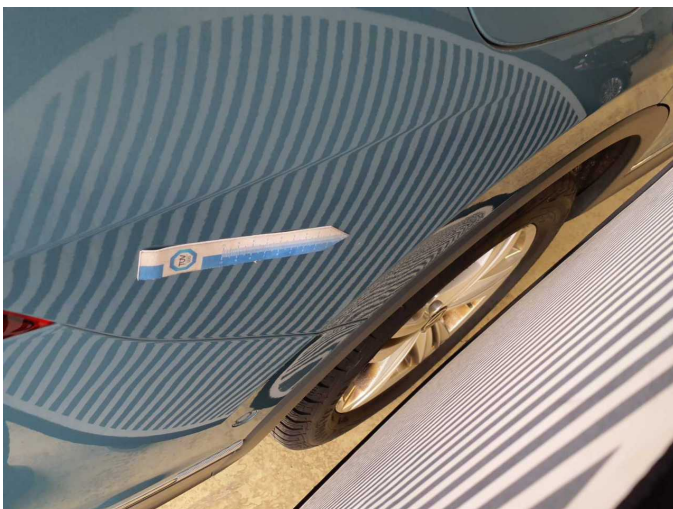
Damage 1: Side panel - rear right side: Side panel - Dent / paintcoat damage - Smart repair

No.	Component group	Description
1	Side panel - rear right side	Side panel - Dent / paintcoat damage - Smart repair
2	Side panel - rear right side	Wheel arch - Scratch(es) - Replace
3	Bonnet	Bonnet - Dent / paintcoat damage - Loss in value
4	Vehicle glazing	Windscreen - Broken / torn - Replace

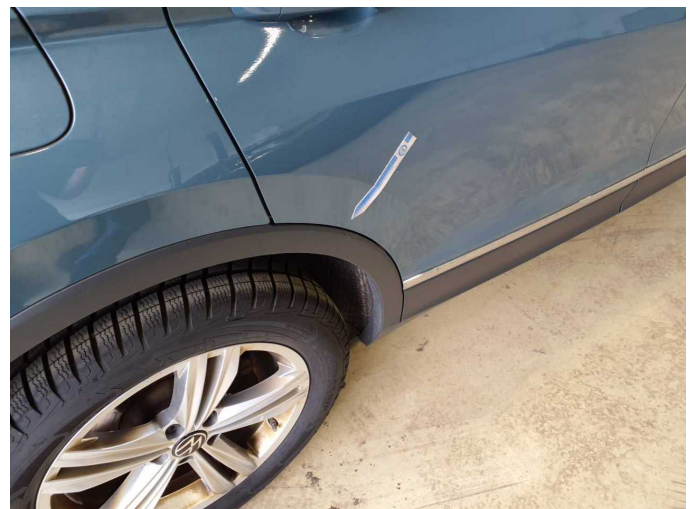
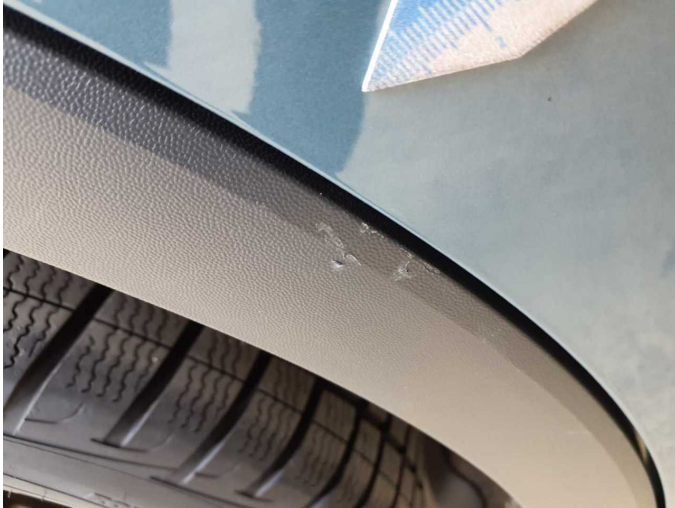
Damage 2: Side panel - rear right side: Wheel arch - Scratch(es) - Replace

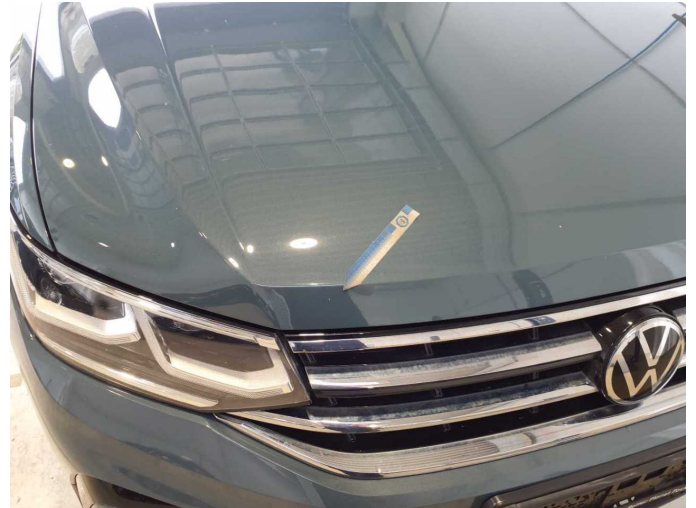
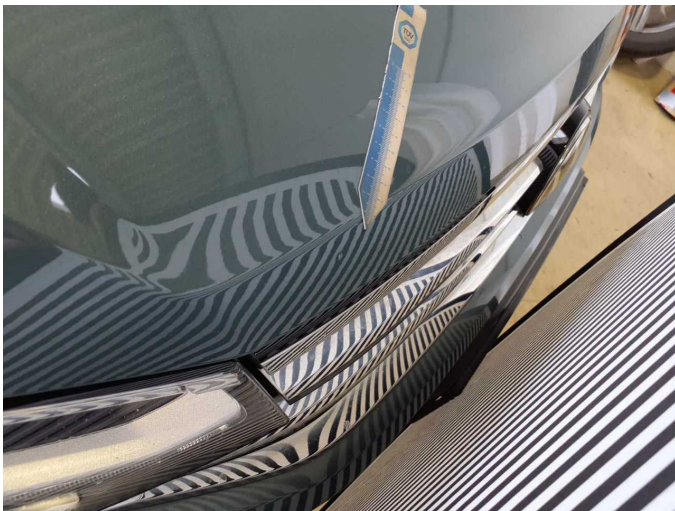
Damage 3: Bonnet: Bonnet - Dent / paintcoat damage - Loss in value

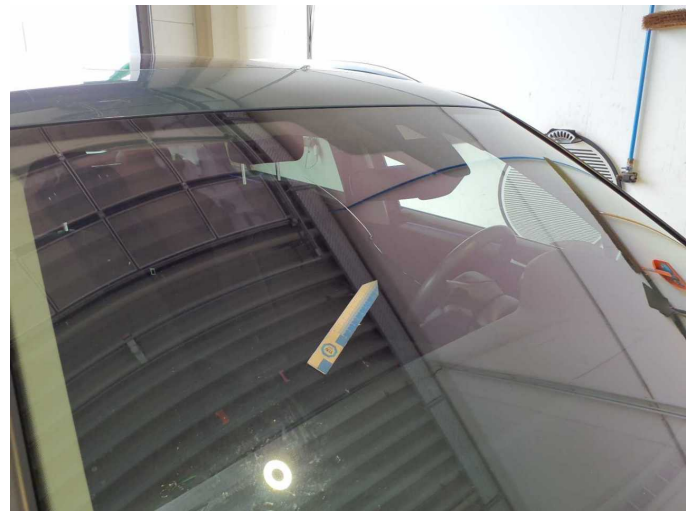
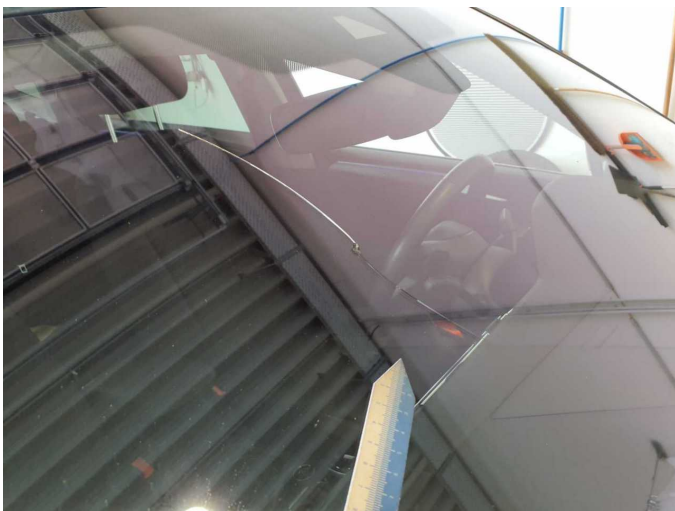
Damage 4: Vehicle glazing: Windscreen - Broken / torn - Replace
