Expertise

Protocol number: 45114534
Order No. / Reference: 26265665
Inspection date: 22 Apr 2026

Manufacturer: Land Rover

Model: Discovery Sport P250 R-Dynamic SE

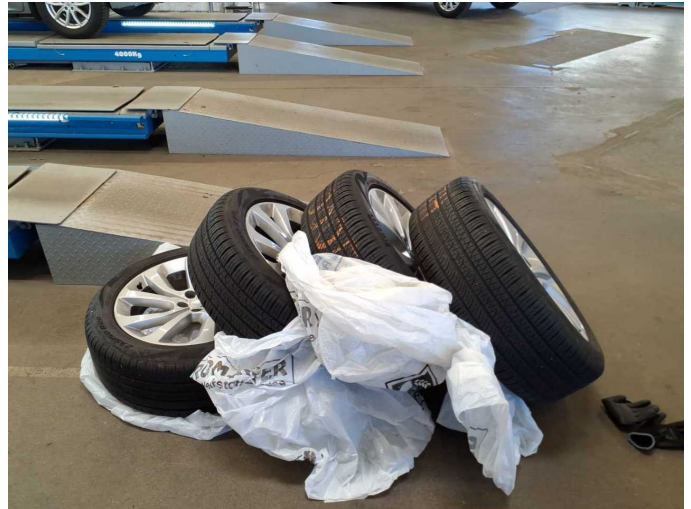
Figure 14: Additional tyres

| # | Tyre size | Type of tyre | Manufacturer | Tread depth |
|---|---|---|---|---|
| 1) | 235/50 R20 104W | Summer tyres on Light alloy | Pirelli | 6mm / 6mm |
| 2) | 235/50 R20 104W | Summer tyres on Light alloy | Pirelli | 6mm / 6mm |

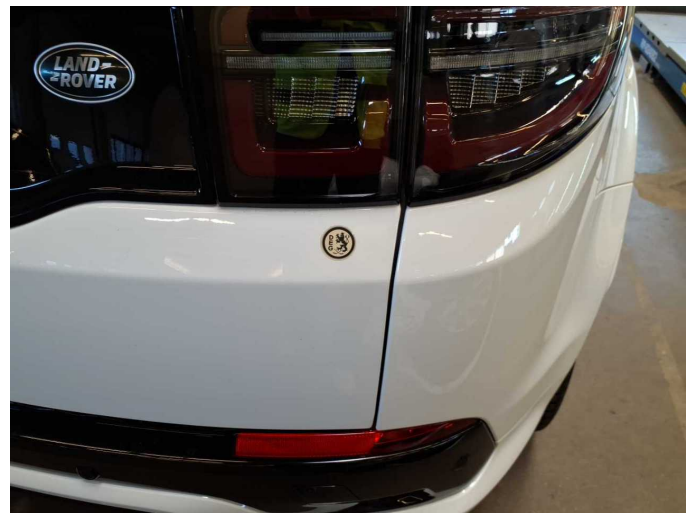
| No. | Component group | Description |
|---|---|--|
| 2 | Boot lid / rear door | Boot lid - Glued / labelled - De-glue / neutralise |

Damage 2: Boot lid / rear door: Boot lid - Glued / labelled - De-glue / neutralise

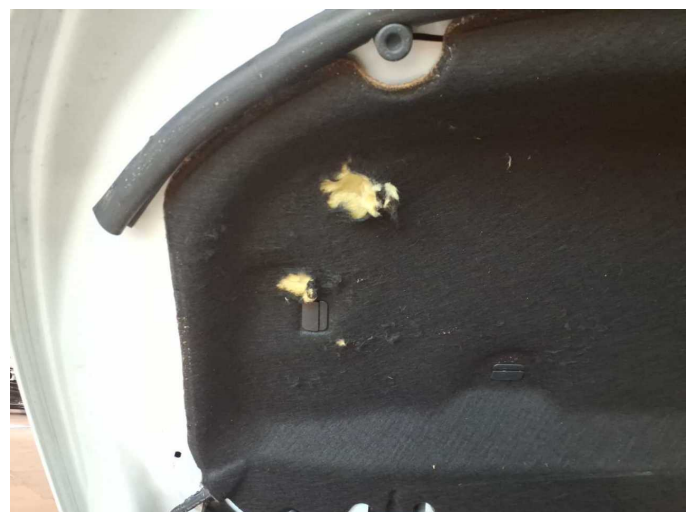
| No. | Component group | Description |
|---|---|--|
| 3 | Bonnet | Insulation lining - Damage caused by marten / rodent - Replace |

Damage 3: Bonnet: Insulation lining - Damage caused by marten / rodent - Replace

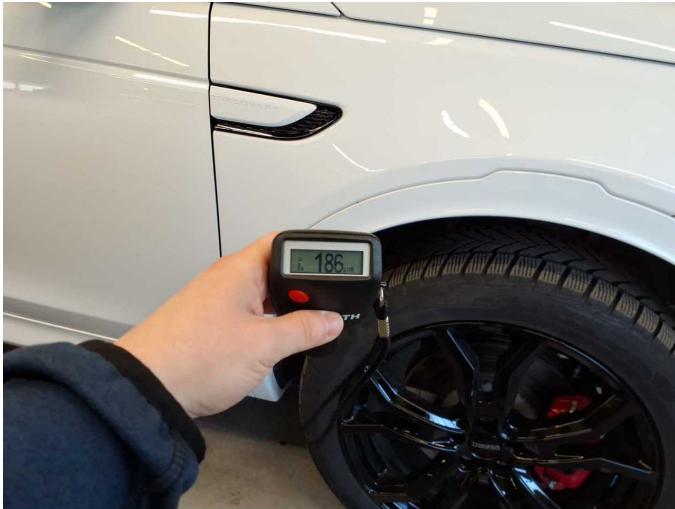
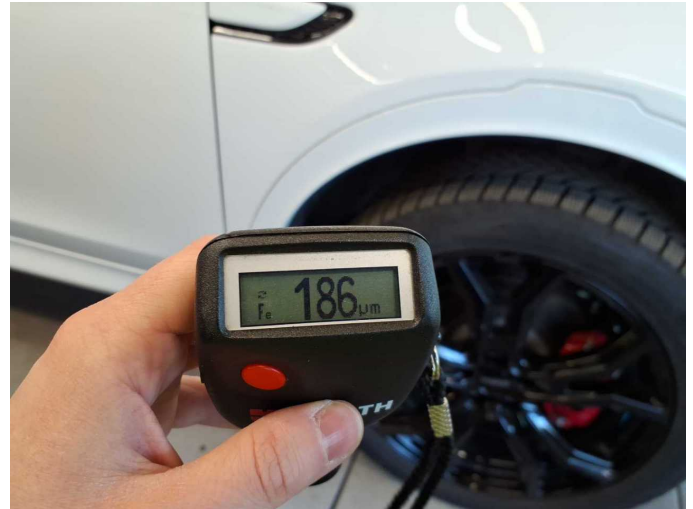
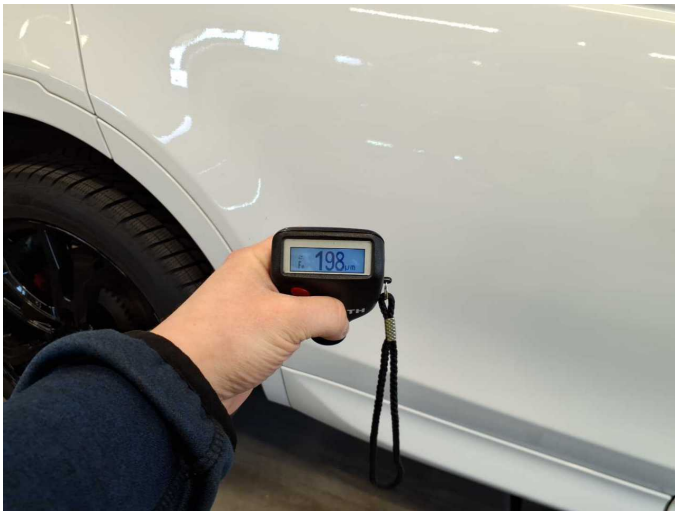
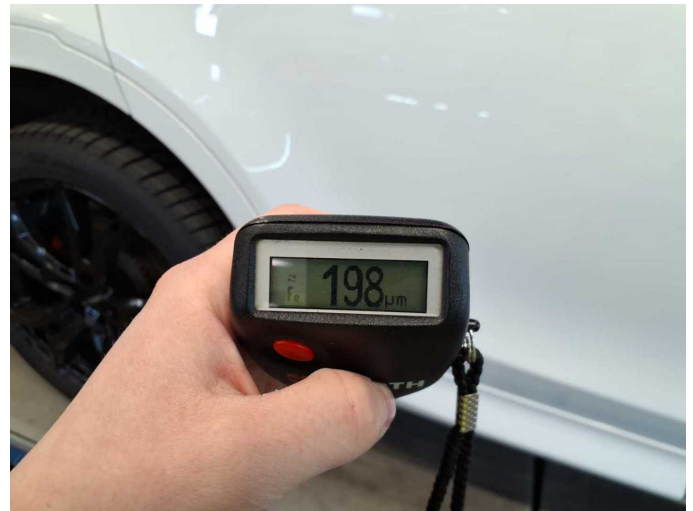
- 1 Mudguard - right side, Door - rear right side, Professionally carried out, Invoice of repair done Non-existent

| Mudguard - right side | 186 µm | Door - rear right side | 198 µm |

Repainting 1: Mudguard - right side, Door - rear right side
