Expertise

Protocol number: 46571851  
Order No. / Reference: 26622270  
Inspection date: 17 Jul 2026

Manufacturer: Seat

Model: Alhambra 1.4 TSI S&S DSG OPF FR-LINE

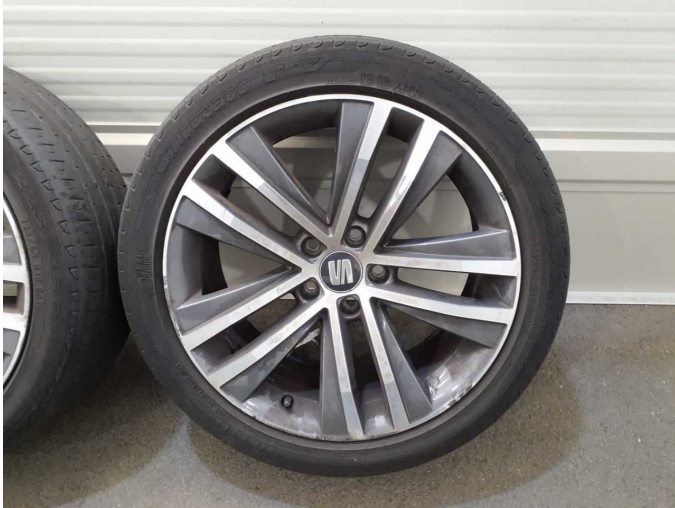
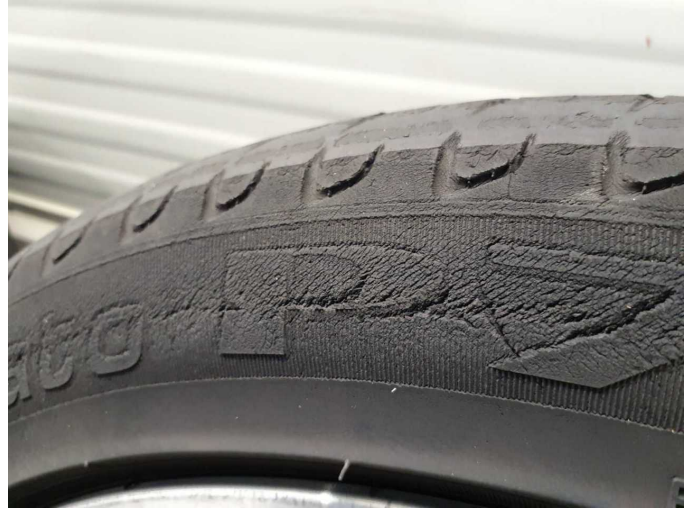
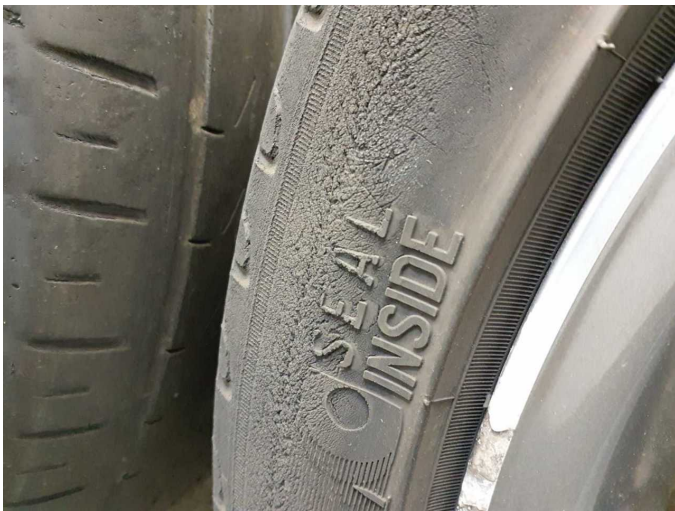
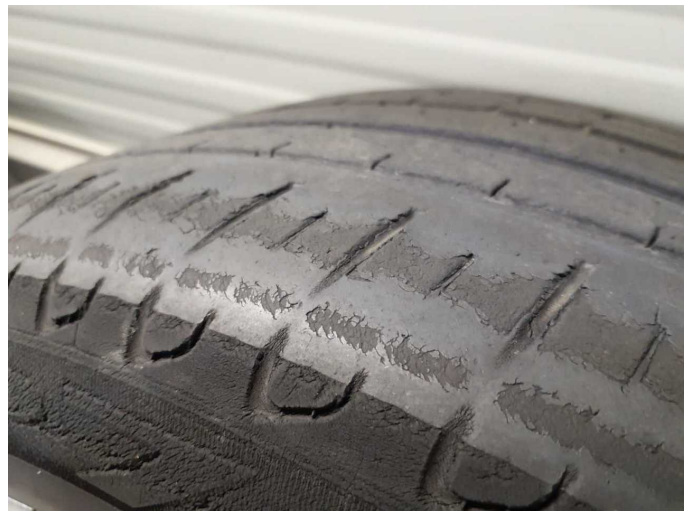
| No. | Component group | Description |
|---|---|---|
| 2 | 2nd wheel set | 1 tyre - Porous / cracked - Replace |

**Damage 2:** 2nd wheel set: 1 tyre - Porous / cracked - Replace

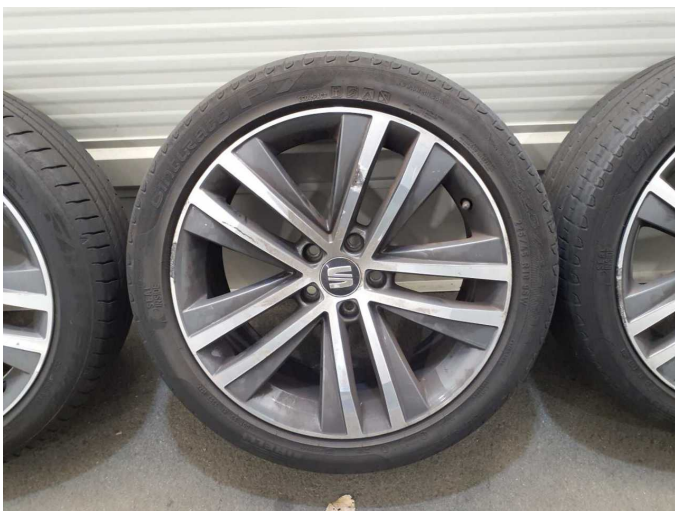
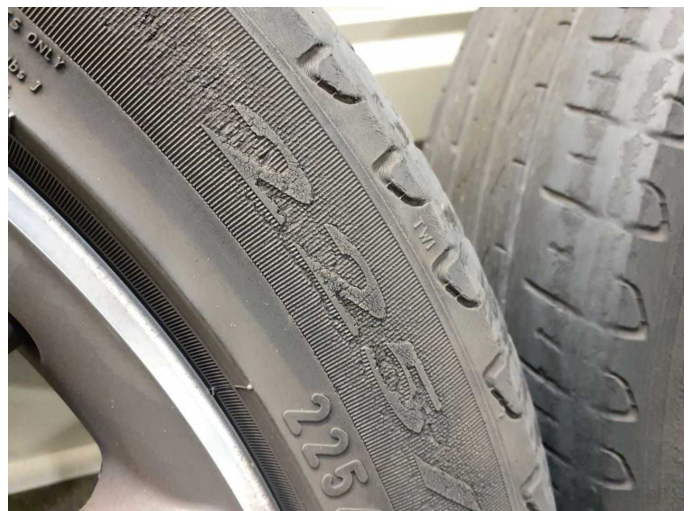
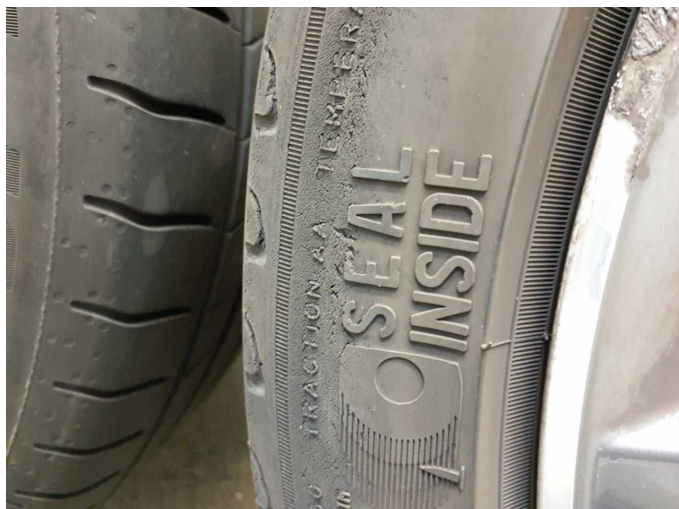
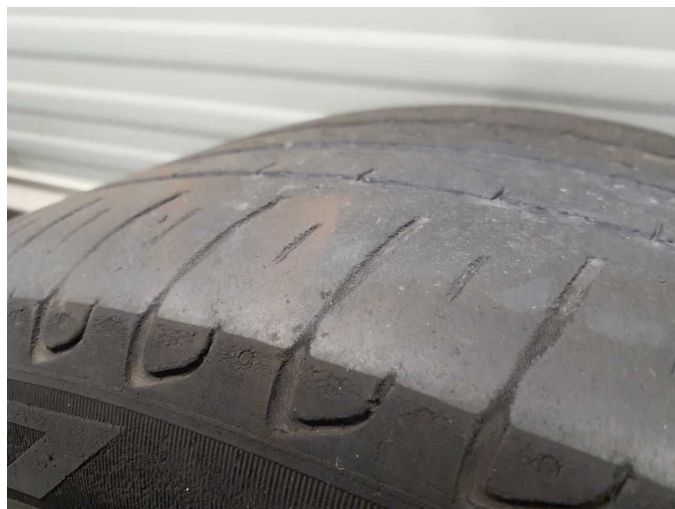
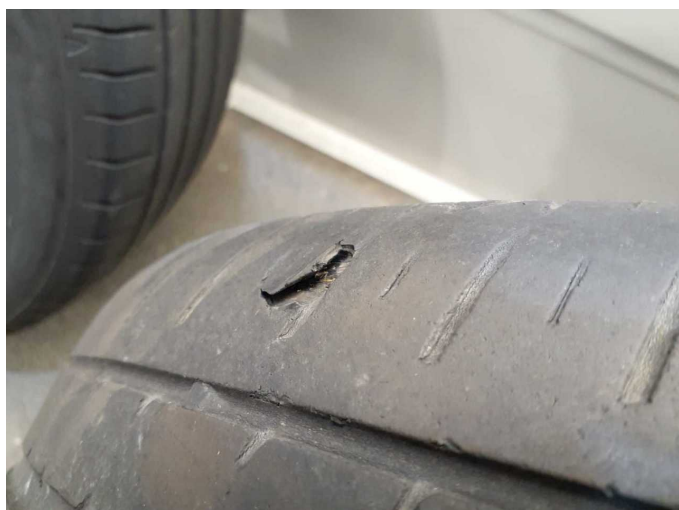
| No. | Component group | Description |
|---|---|---|
| 3 | 2nd wheel set | 1 tyre - Porous / cracked - Replace |

**Damage 3:** 2nd wheel set: 1 tyre - Porous / cracked - Replace

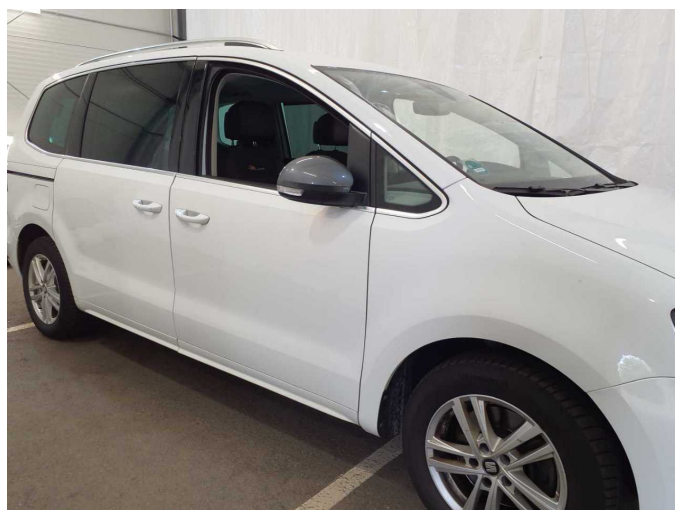
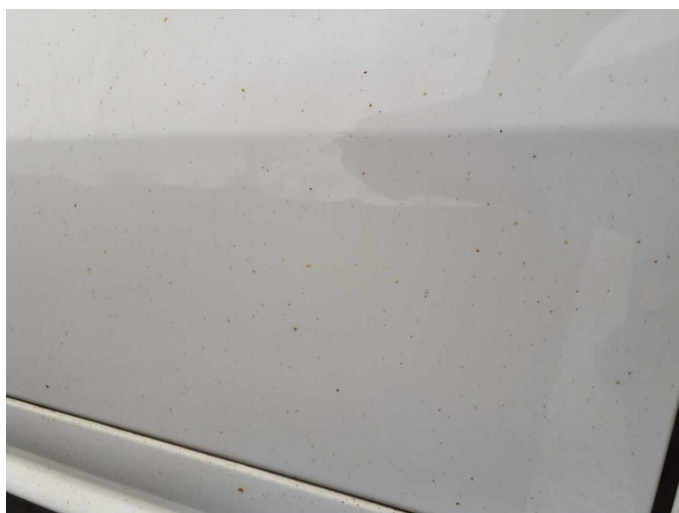
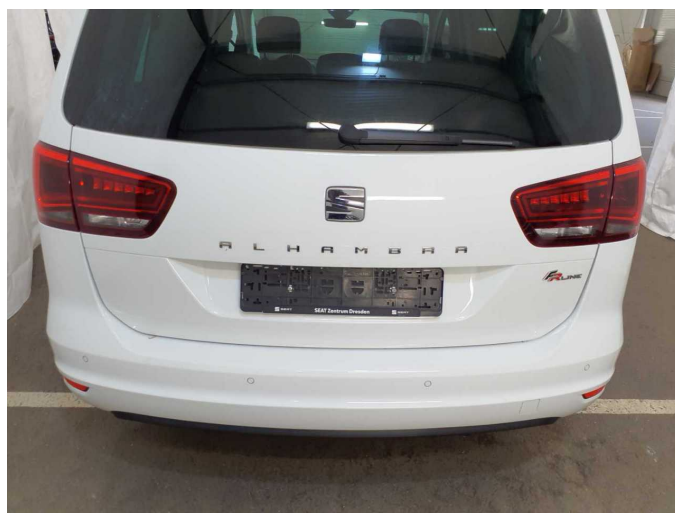
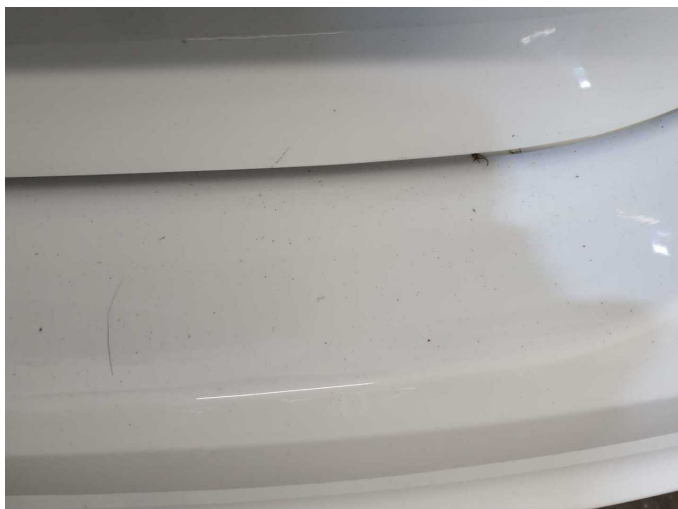
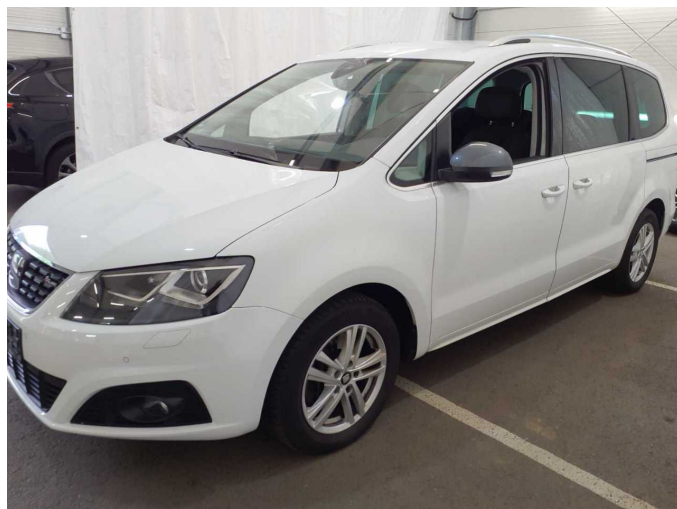
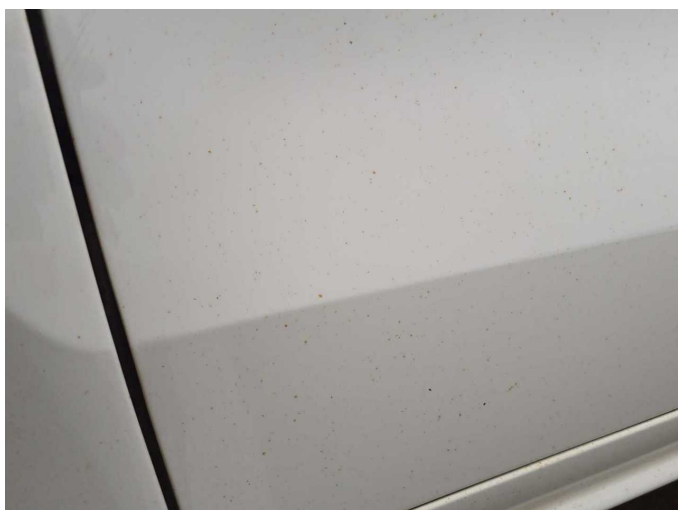
| No. | Component group | Description |
|---|---|---|
| 4 | Body | Body (Flugrost) - Soiled - Clean |

**Damage 4:** Body: Body (Flugrost) - Soiled - Clean

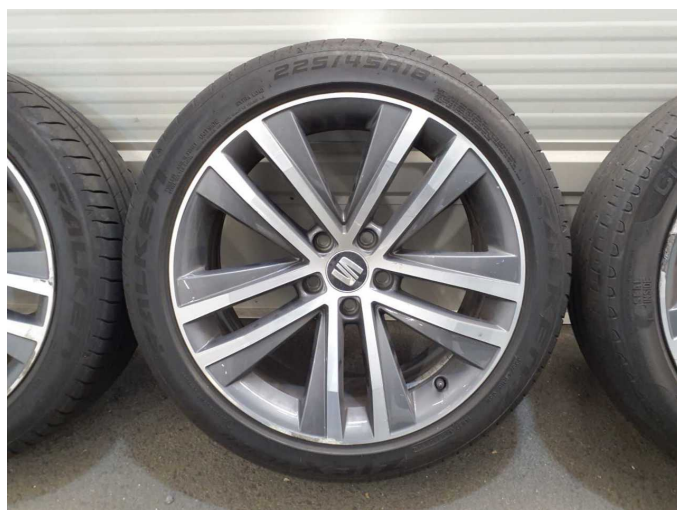
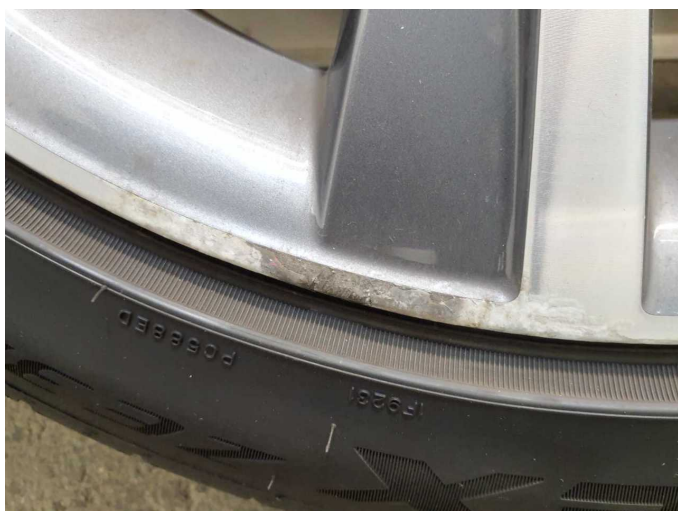
| No. | Component group | Description |
|---|---|---|
| 5 | 2nd wheel set | 1 alloy rim - Scratched - Loss in value |

**Damage 5:** 2nd wheel set: 1 alloy rim - Scratched - Loss in value

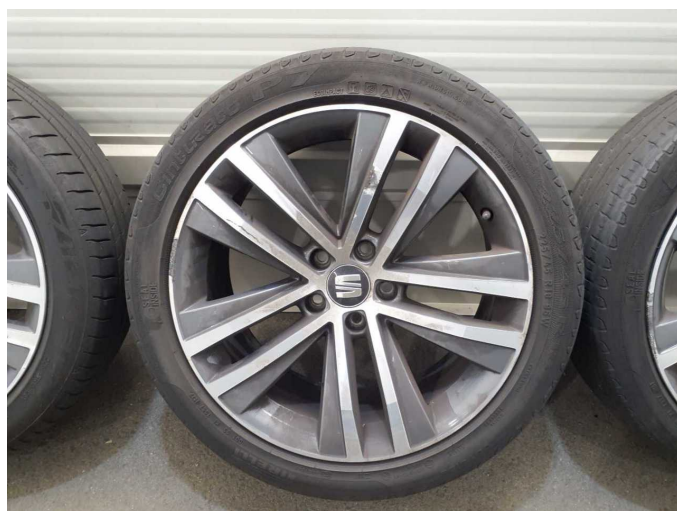
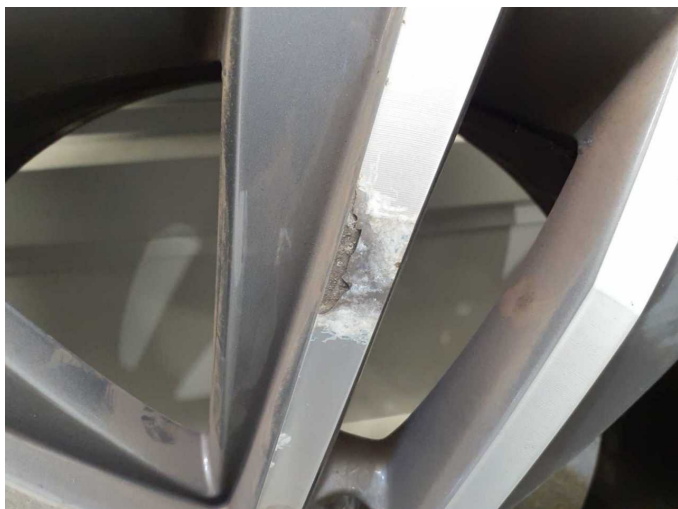
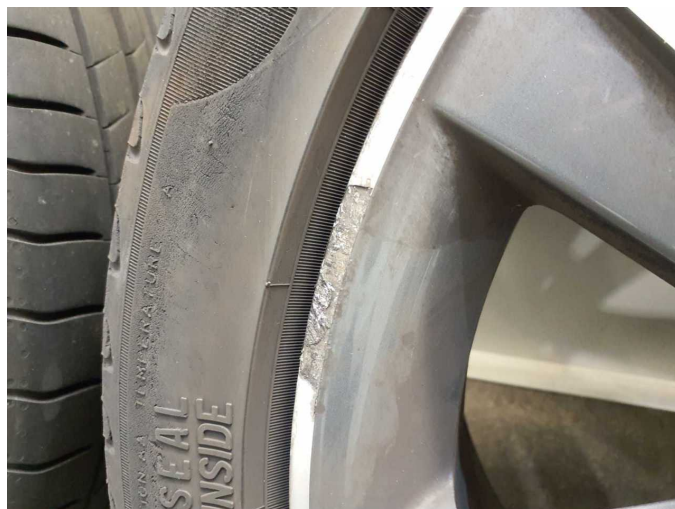
| No. | Component group | Description |
|---|---|---|
| 6 | 2nd wheel set | 1 alloy rim - Scratched - Loss in value |

**Damage 6:** 2nd wheel set: 1 alloy rim - Scratched - Loss in value

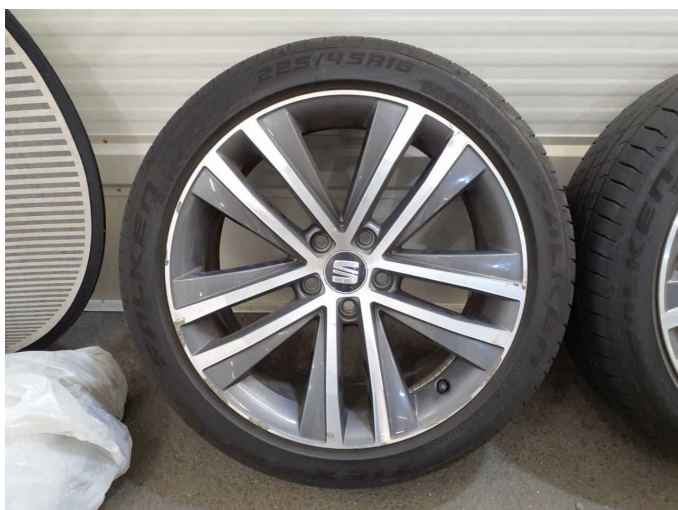
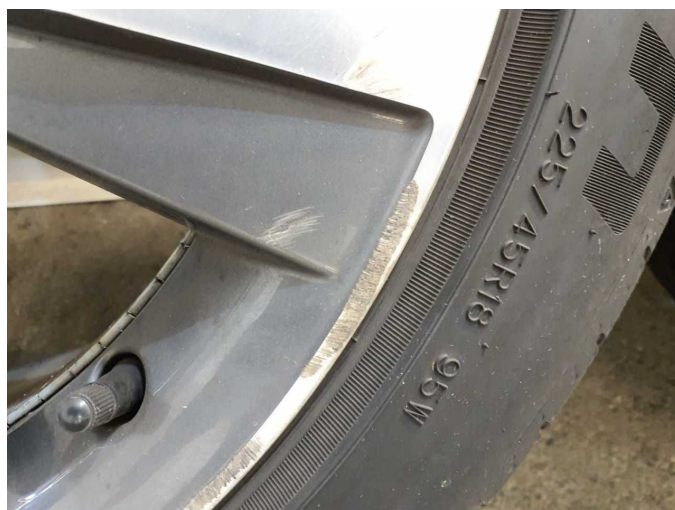
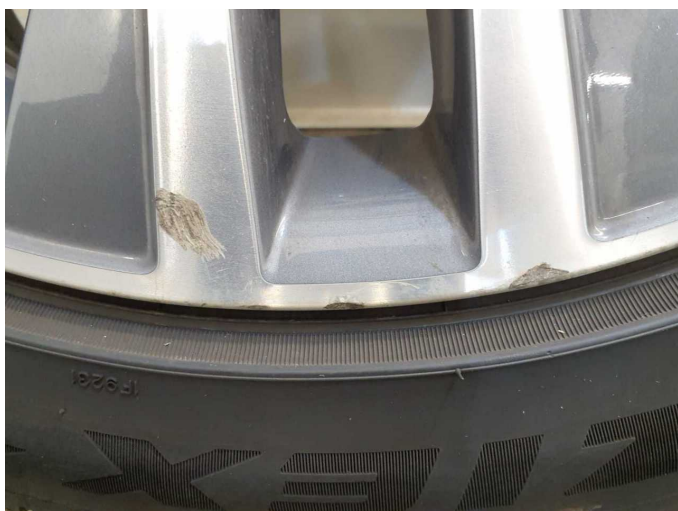
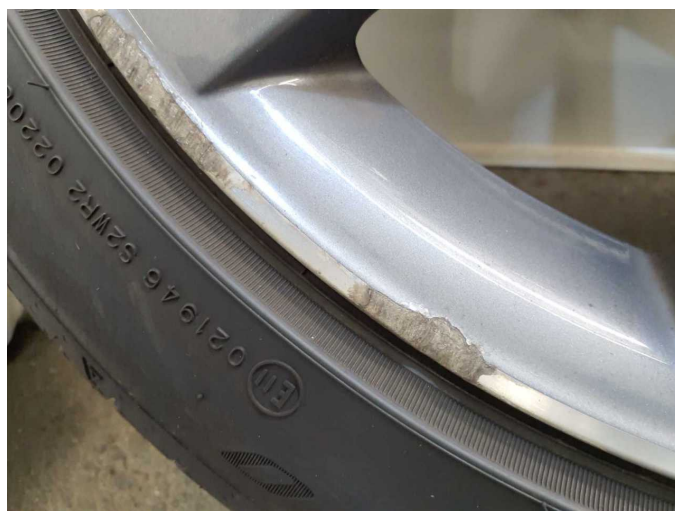
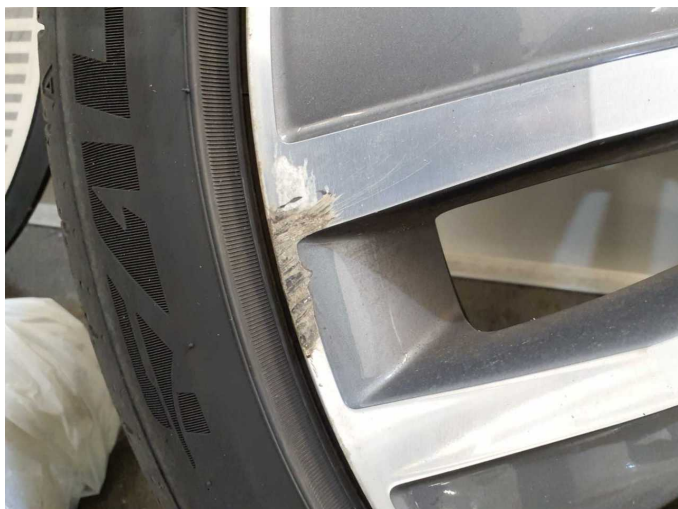
| No. | Component group | Description |
|---|---|---|
| 7 | 2nd wheel set | 1 alloy rim - Scratched - Replace |

**Damage 7:** 2nd wheel set: 1 alloy rim - Scratched - Replace

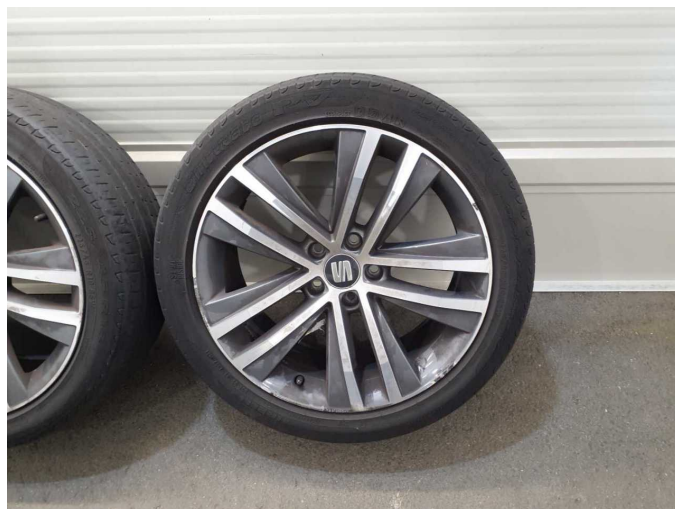
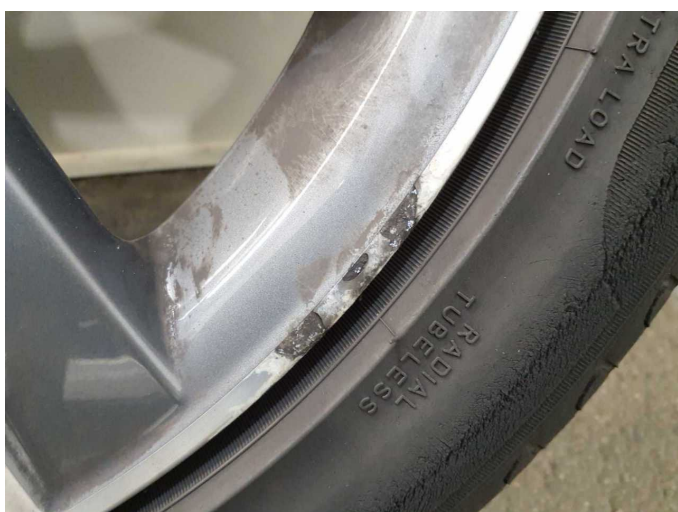
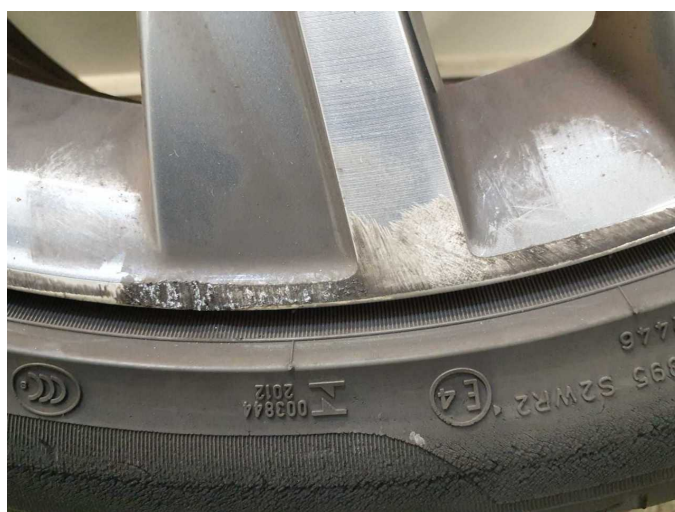
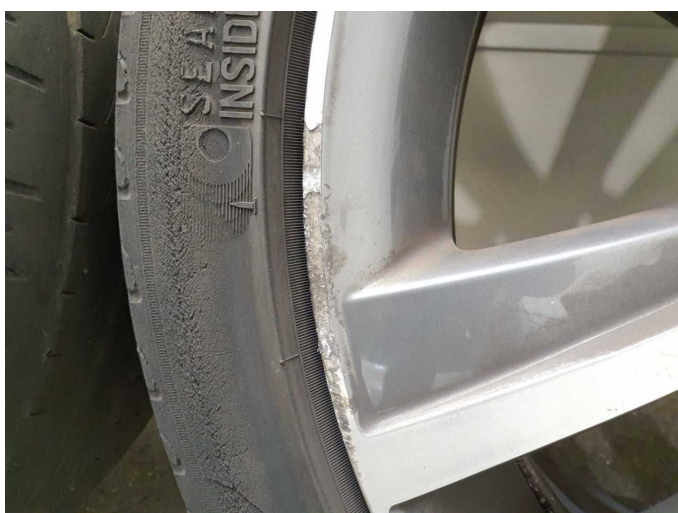
| No. | Component group | Description |
|---|---|---|
| 8 | 2nd wheel set | 1 alloy rim - Scratched - Replace |

**Damage 8:** 2nd wheel set: 1 alloy rim - Scratched - Replace

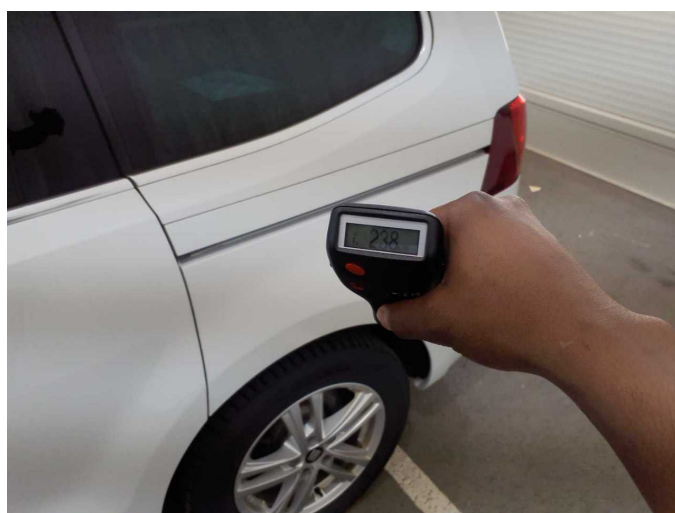
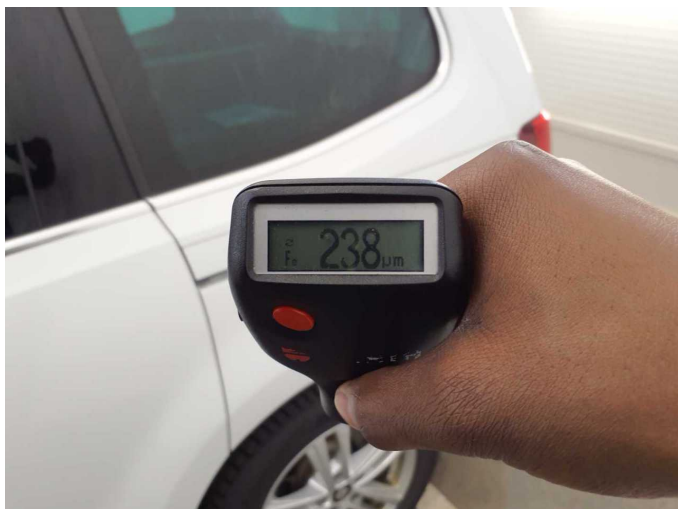
| No. | Repainting |
|---|---|
| 1 | Side panel - rear left side, Professionally carried out, Invoice of repair done Non-existent |

| Side panel - rear left side | 238 µm | Door - rear left side | 225 µm |

**Repainting 1:** Side panel - rear left side

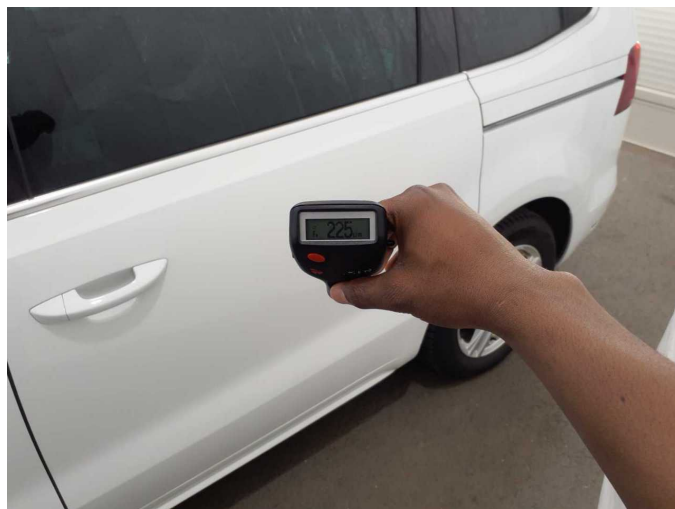
| No. | Repainting |
|---|---|
| 2 | Door - rear left side, Professionally carried out, Invoice of repair done Non-existent |

**Repainting 2:** Door - rear left side

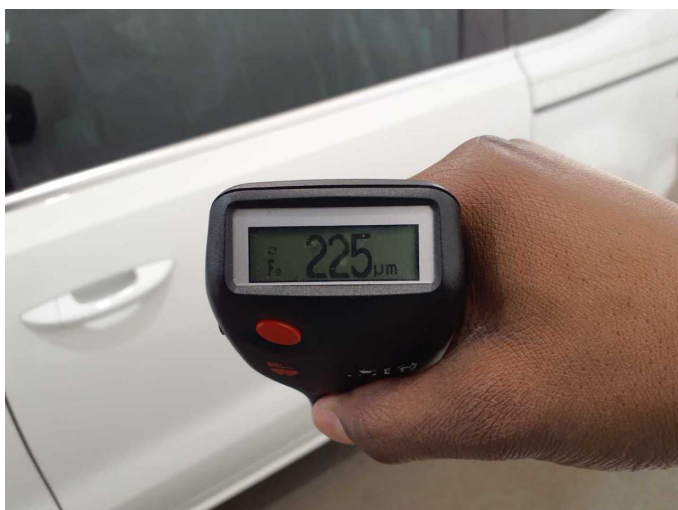
**Repainting 2:** Door - rear left side

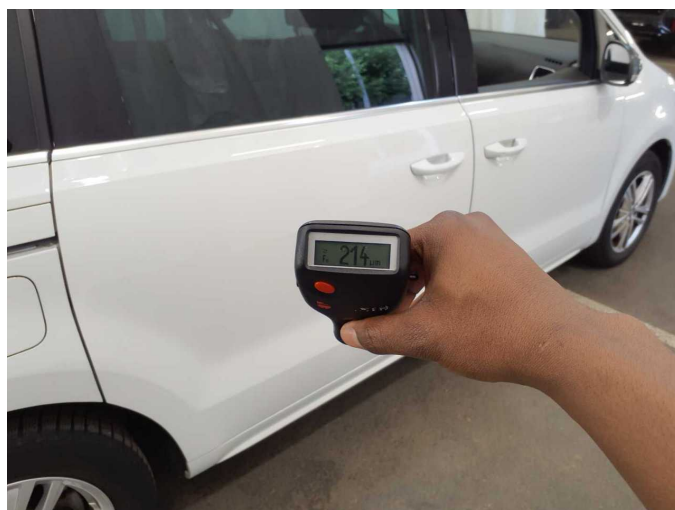
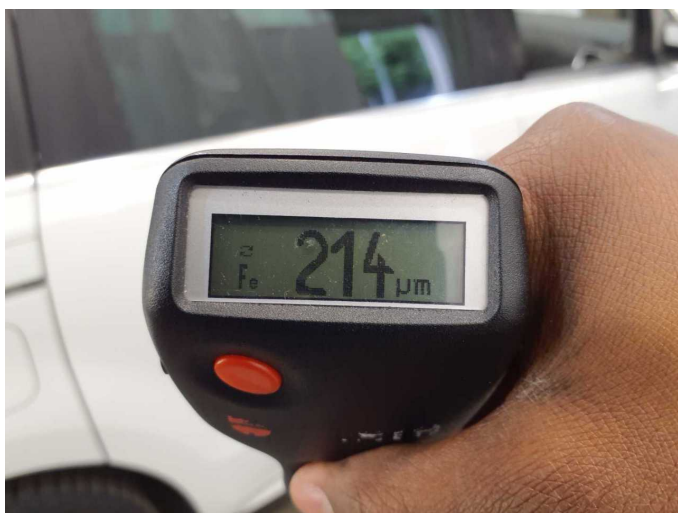
| No. | Repainting |
|---|---|
| 3 | Door - rear right side, Professionally carried out, Invoice of repair done Non-existent |

| Door - rear right side | 214 µm | | |

**Repainting 3:** Door - rear right side
