Expertise

Protocol number: 46312123  
Order No. / Reference: 26656821  
Inspection date: 2 Jul 2026

Manufacturer: Audi

Model: Q3 35 TDI Sportback S tronic S line

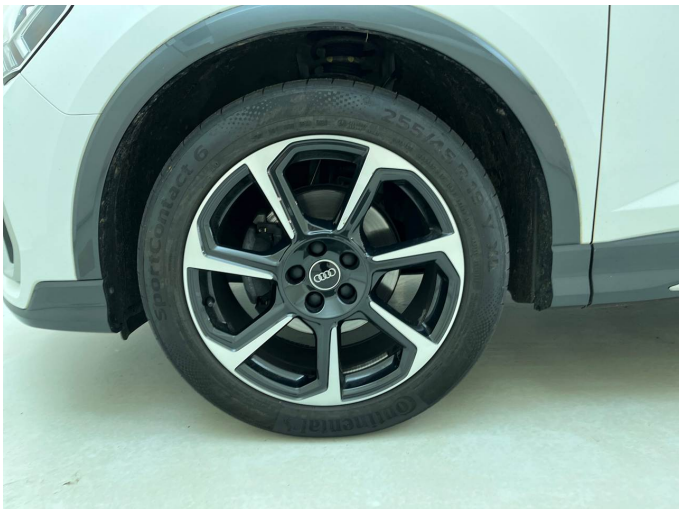
| # | Tyre size | Type of tyre | Manufacturer | Tread depth |
|---|---|---|---|---|
| 1) | 255/45 R19 104Y | Summer tyres on Light alloy | Continental | 2mm / 2mm |
| 2) | 255/45 R19 104Y | Summer tyres on Light alloy | Continental | 5mm / 5mm |

Figure 12: Mounted tyres

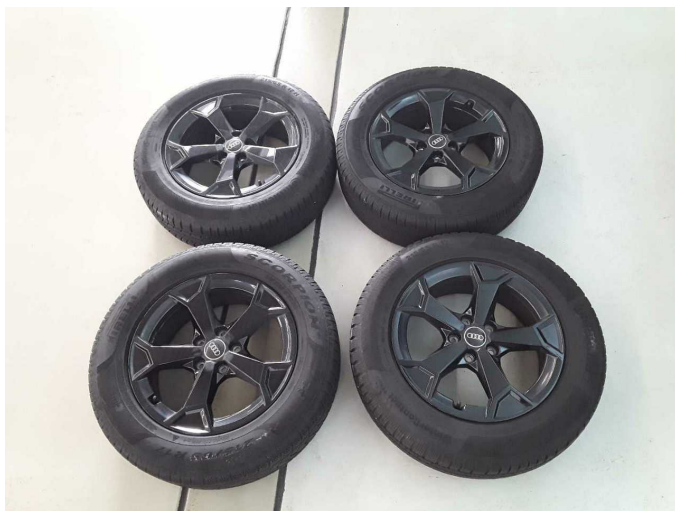
| # | Tyre size | Type of tyre | Manufacturer | Tread depth |
|---|---|---|---|---|
| 1) | 215/65 R17 99H | Winter tyres on Light alloy | Continental | 3mm / 2mm |
| 2) | 215/65 R17 99H | Winter tyres on Light alloy | Continental | 5mm / 5mm |

Figure 15: Additional tyres

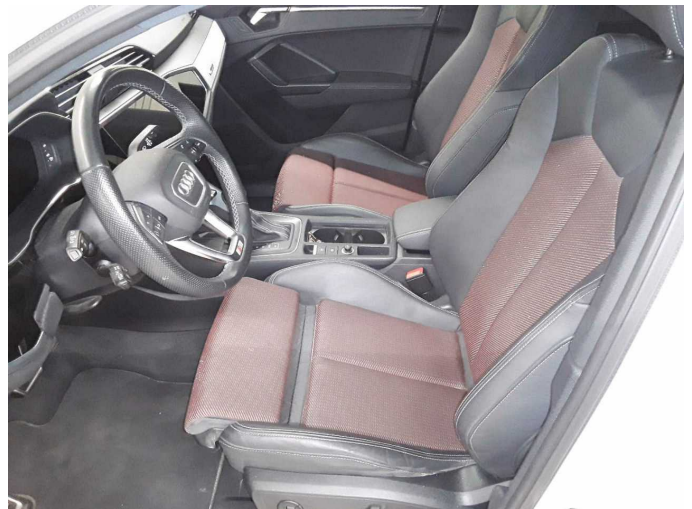
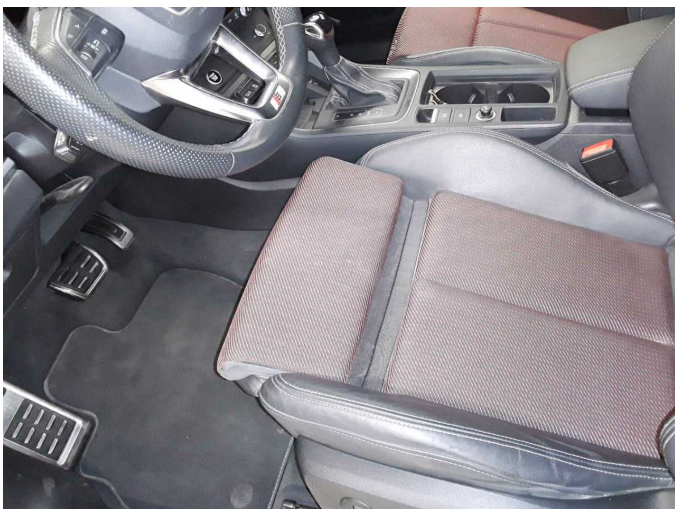
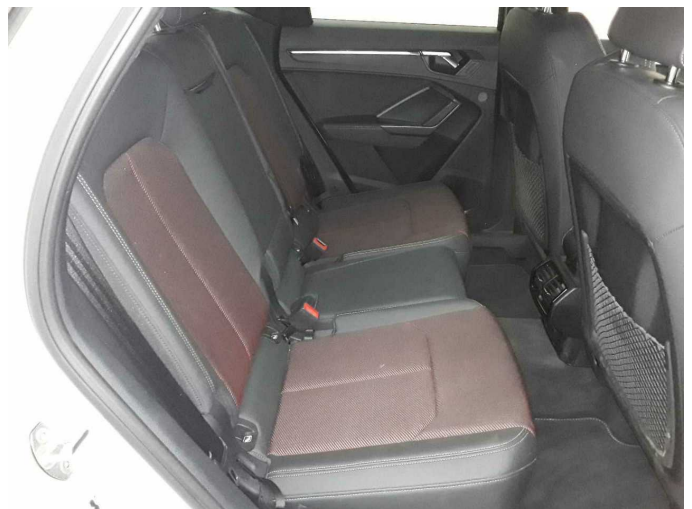
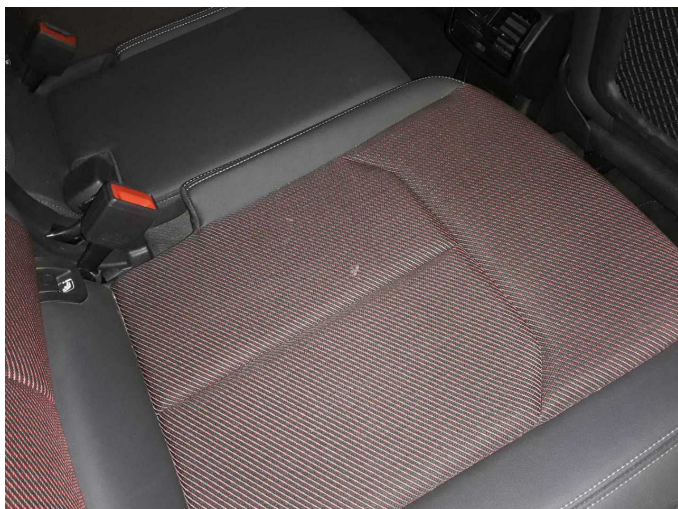
| No. | Component group | Description |
|---|---|---|
| 2 | Seat - front | Seat cover - left side (Sitze) - Soiled - Clean |

Damage 2: Seat - front: Seat cover - left side (Sitze) - Soiled - Clean

**Damage 2:** Seat - front: Seat cover - left side (Sitze) - Soiled - Clean

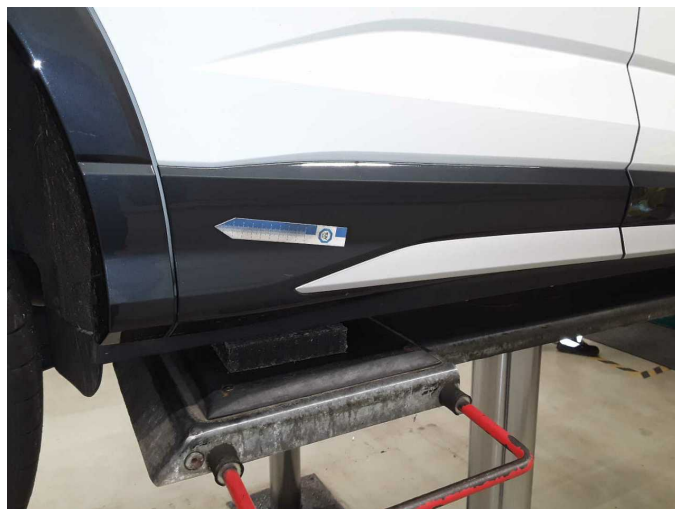
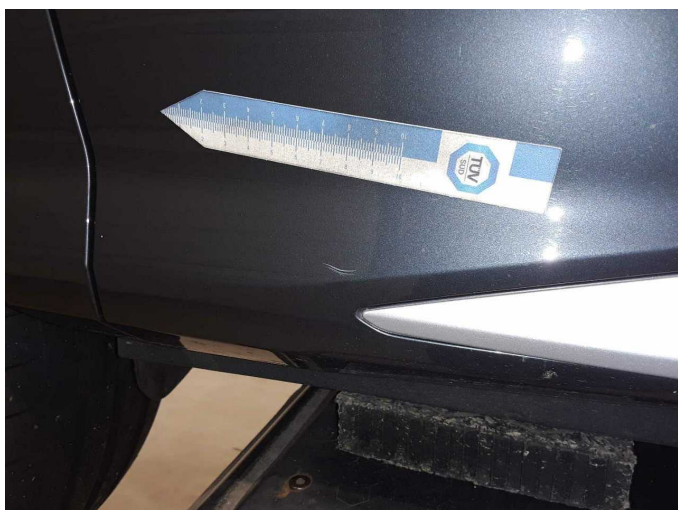
| No. | Component group | Description |
|---|---|---|
| 3 | Door - rear right side | Brightware - lower - Scratch(es) - Smart repair |

**Damage 3:** Door - rear right side: Brightware - lower - Scratch(es) - Smart repair

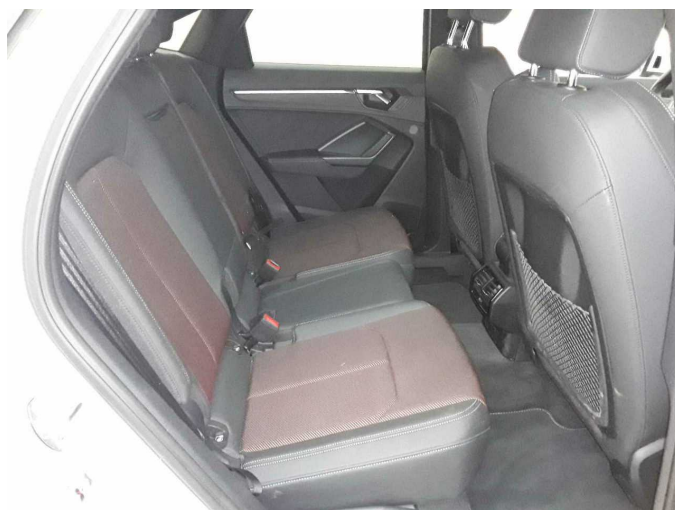
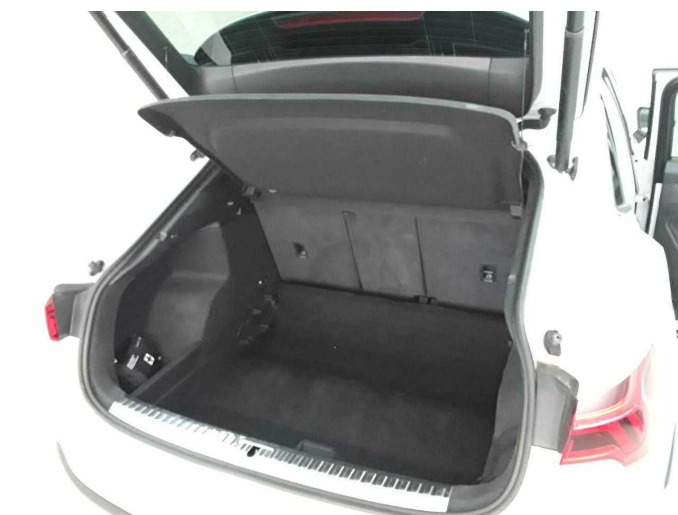
| No. | Component group | Description |
|---|---|---|
| 4 | Interior | Interior - Odour - Ozone treatment |

**Damage 4:** Interior: Interior - Odour - Ozone treatment

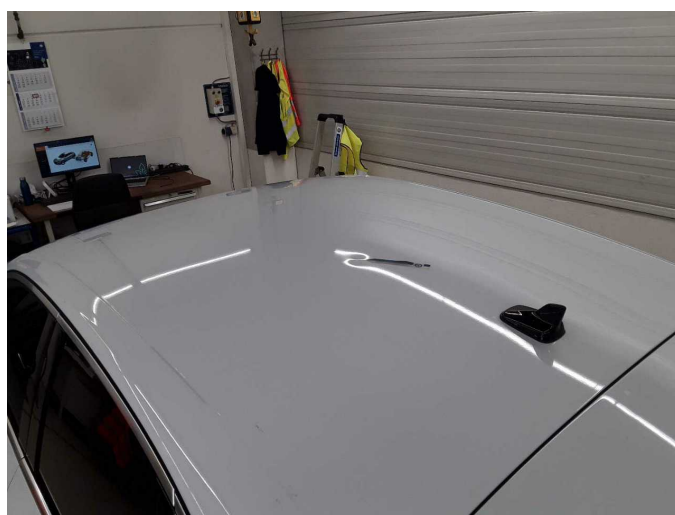
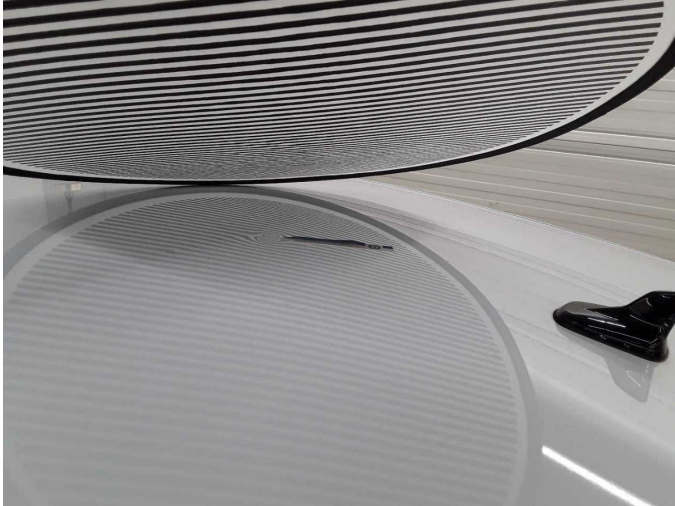
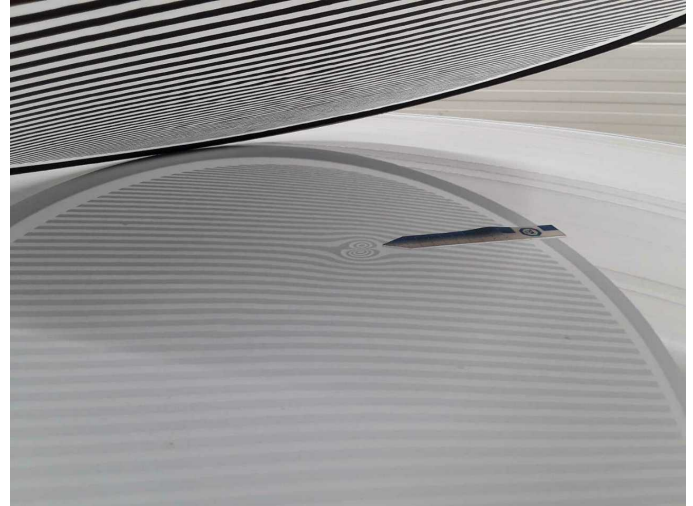
| No. | Component group | Description |
|---|---|---|
| 5 | Roof | Roof - dent(s) - Smart repair |

**Damage 5:** Roof: Roof - dent(s) - Smart repair

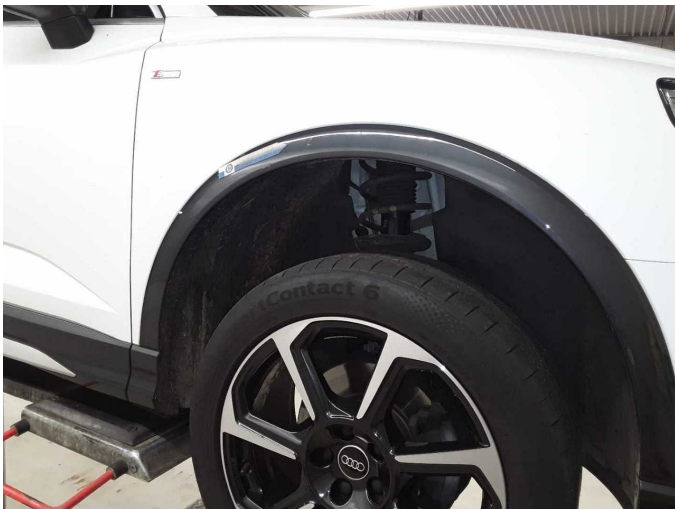
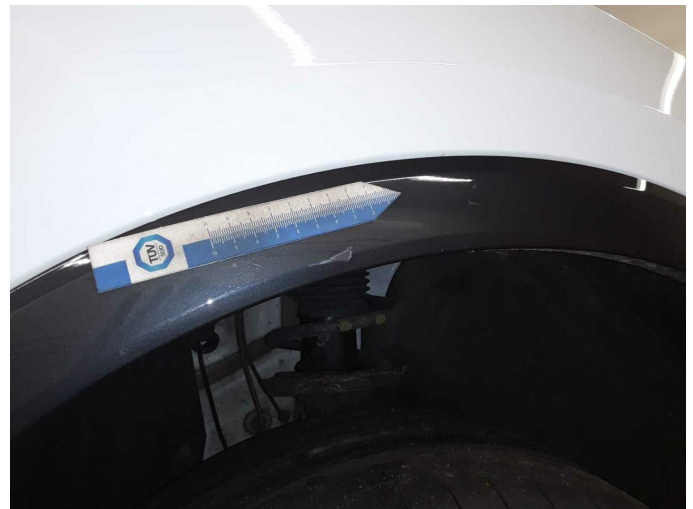
| No. | Component group | Description |
|---|---|---|
| 6 | Mudguard - right side | Wheel well extension - Scratch(es) - Smart repair |

**Damage 6:** Mudguard - right side: Wheel well extension - Scratch(es) - Smart repair

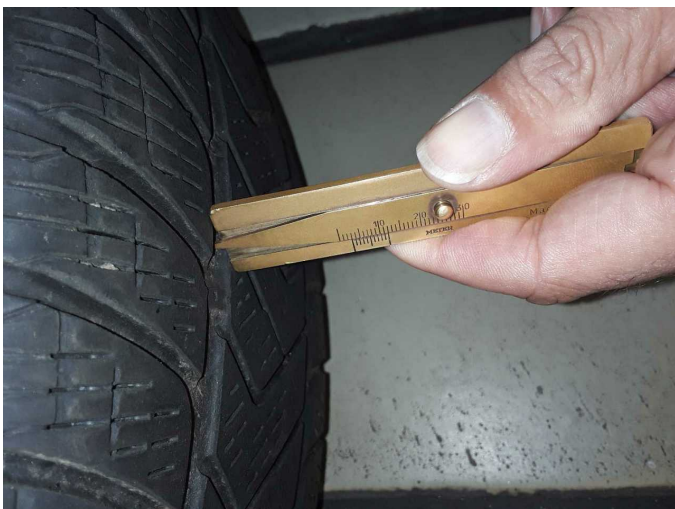
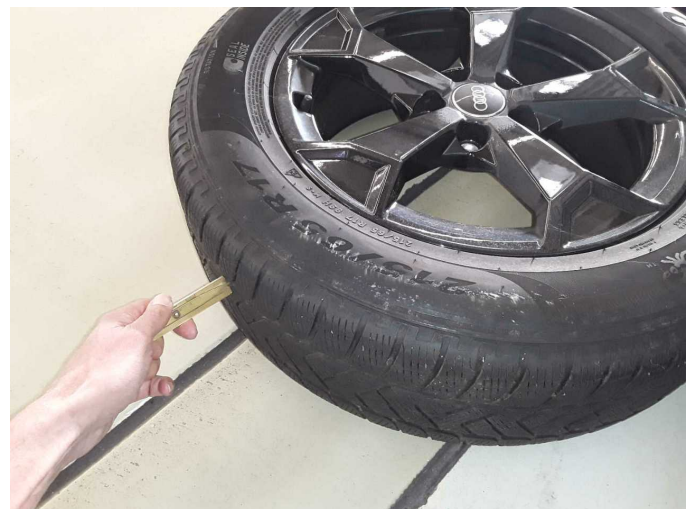
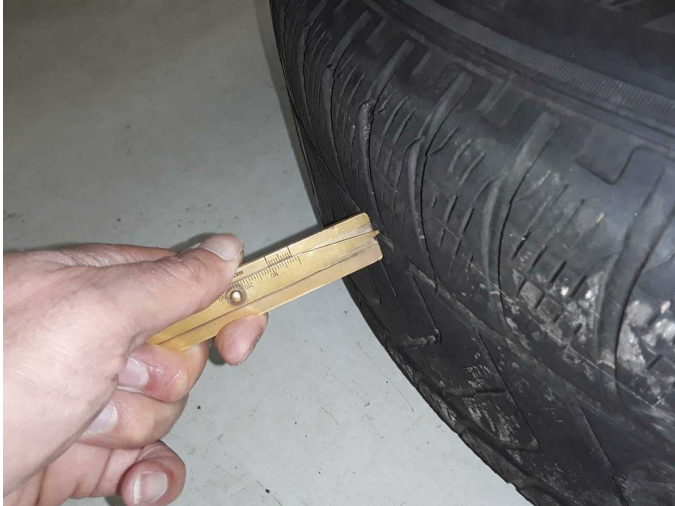
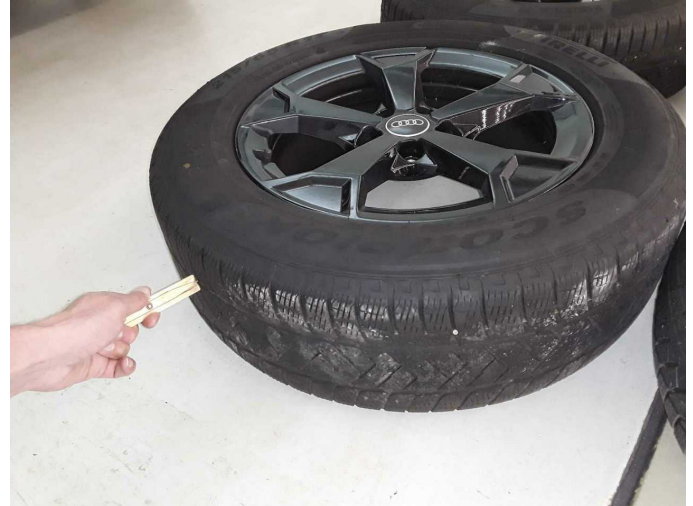
| No. | Component group | Description |
|---|---|---|
| 7 | 2nd wheel set | 2 tyres - does not meet manufacturer specifications - Replace |

**Damage 7:** 2nd wheel set: 2 tyres - does not meet manufacturer specifications - Replace

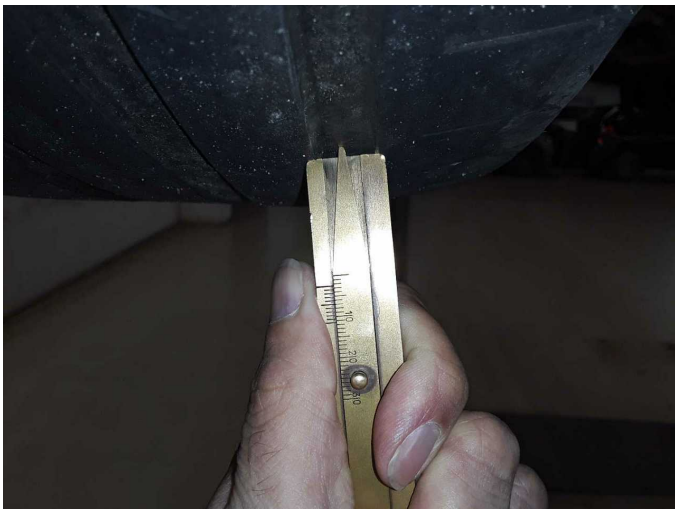
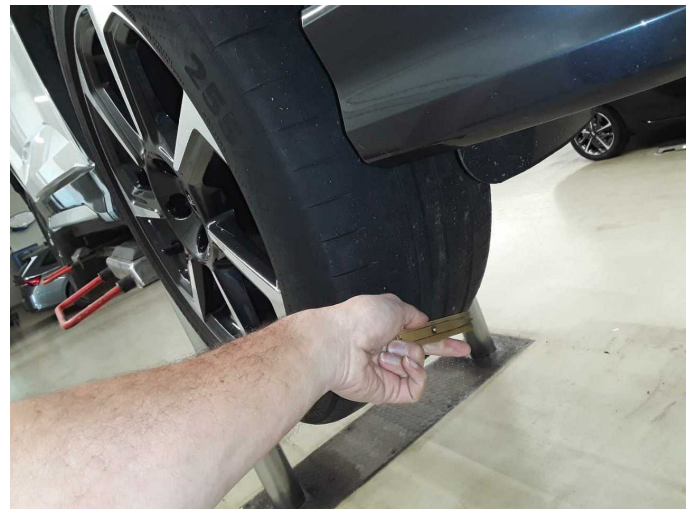
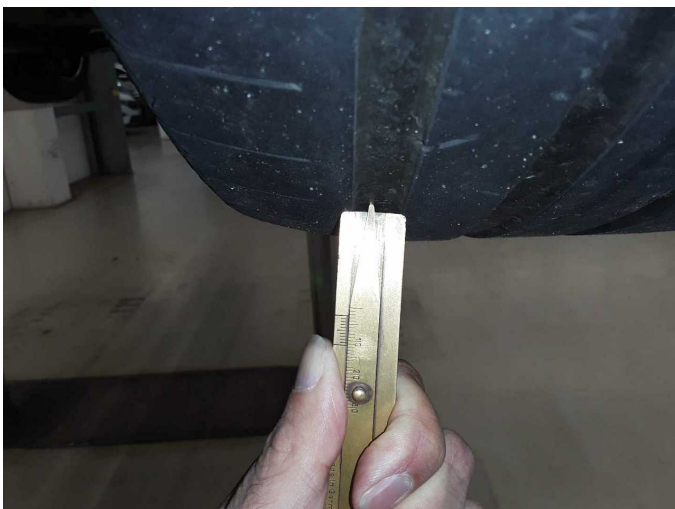
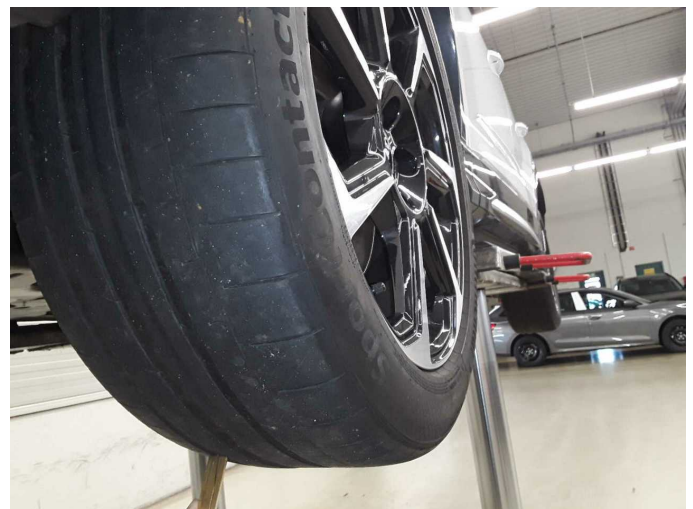
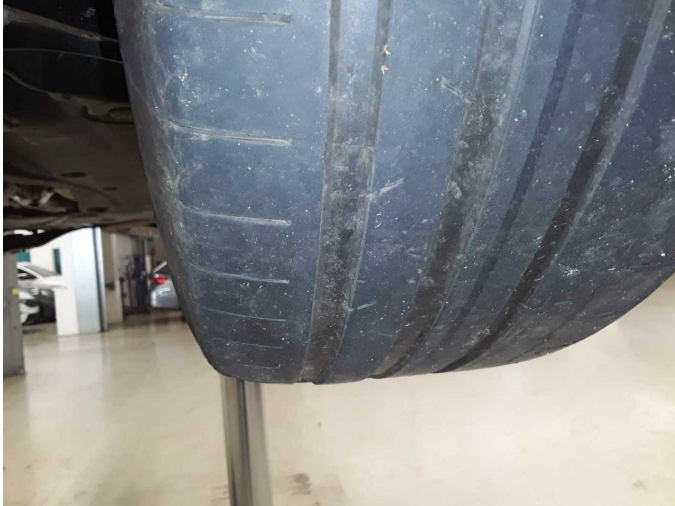
| No. | Component group | Description |
|---|---|---|
| 8 | Wheel / tyres | Tyre - front - does not meet manufacturer specifications - Replace |

**Damage 8:** Wheel / tyres: Tyre - front - does not meet manufacturer specifications - Replace

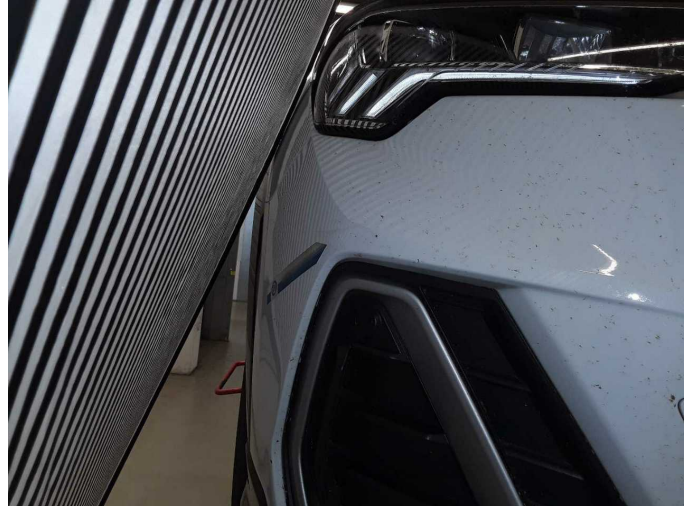
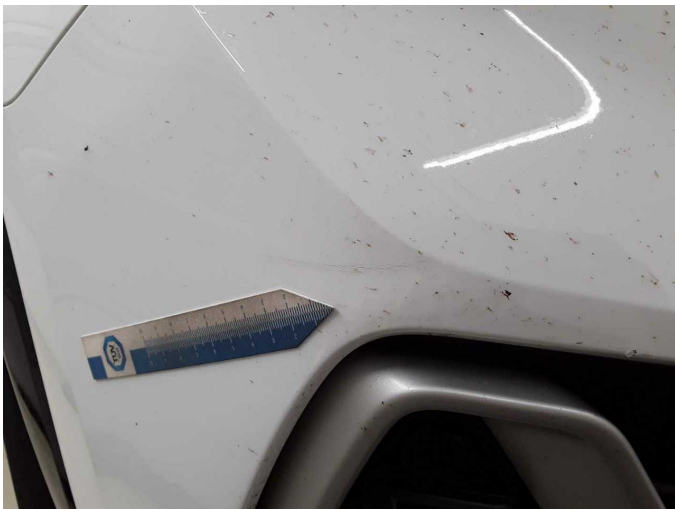
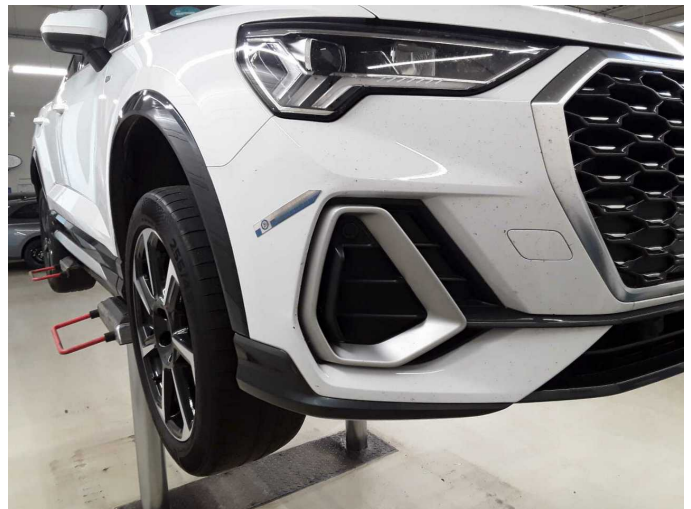
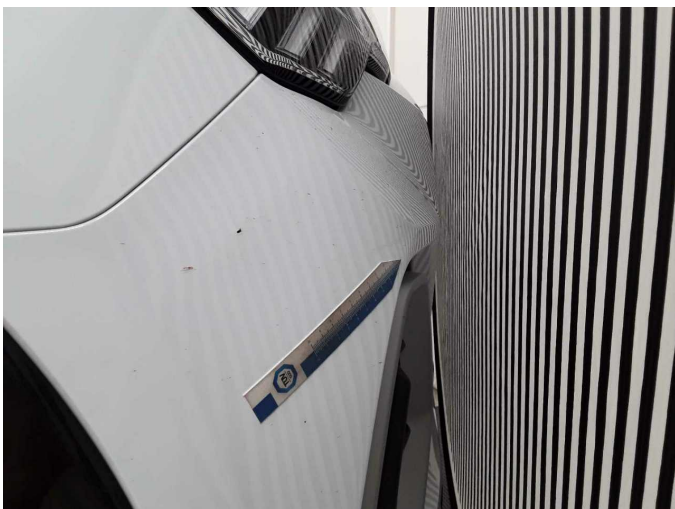
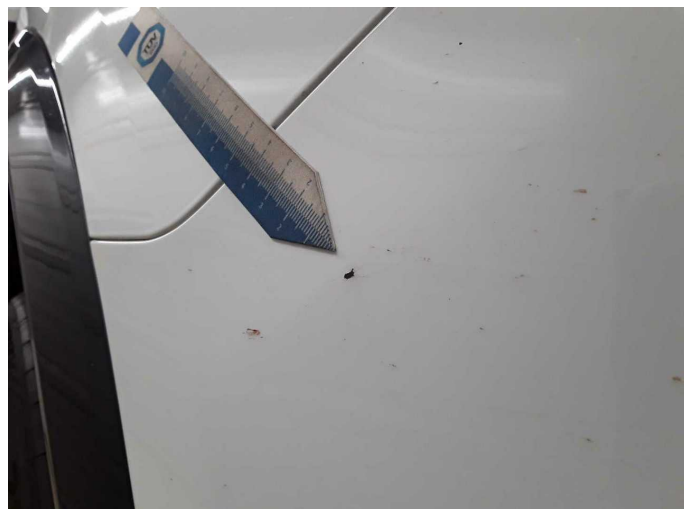
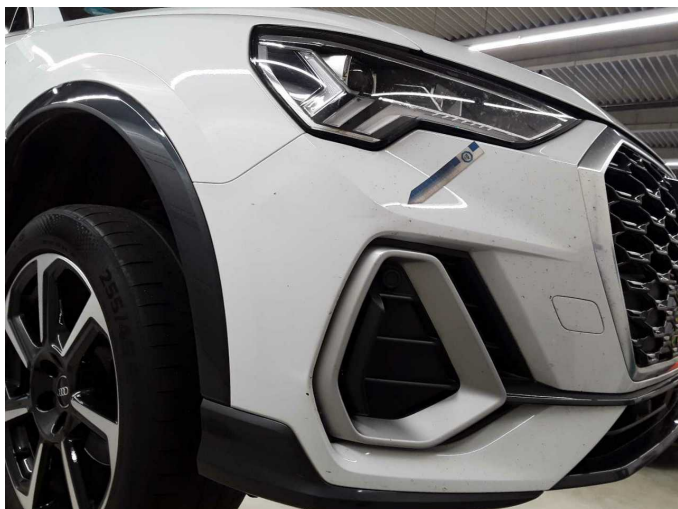
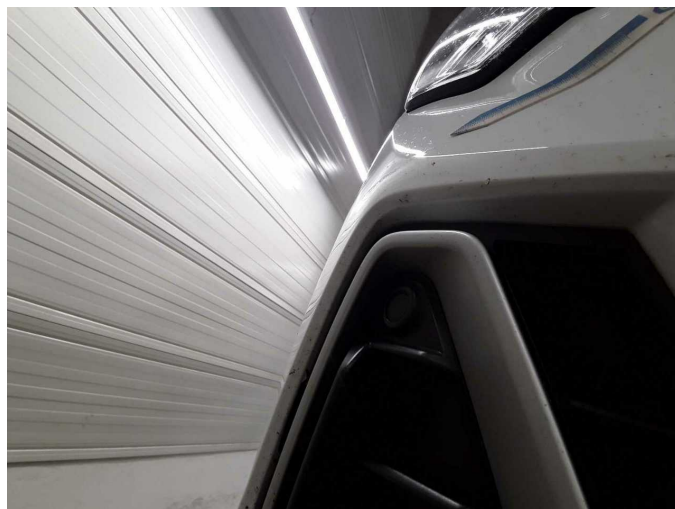
| No. | Component group | Description |
|---|---|---|
| 9 | Front bumper | Front bumper (Rechts) - Scratched - Repair and paint |

**Damage 9:** Front bumper: Front bumper (Rechts) - Scratched - Repair and paint

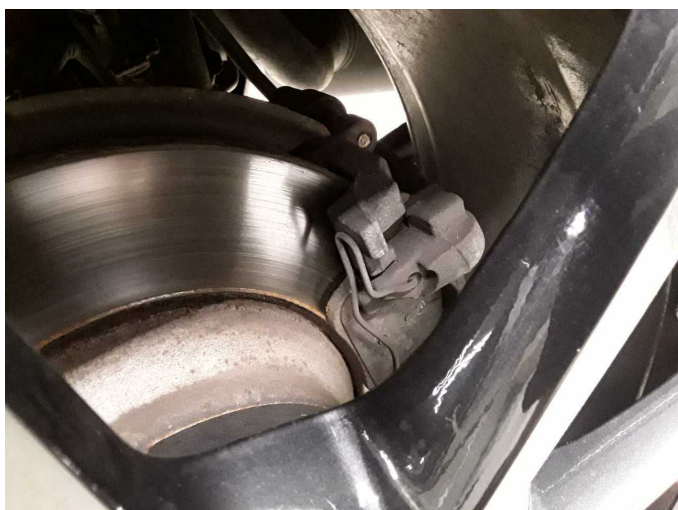
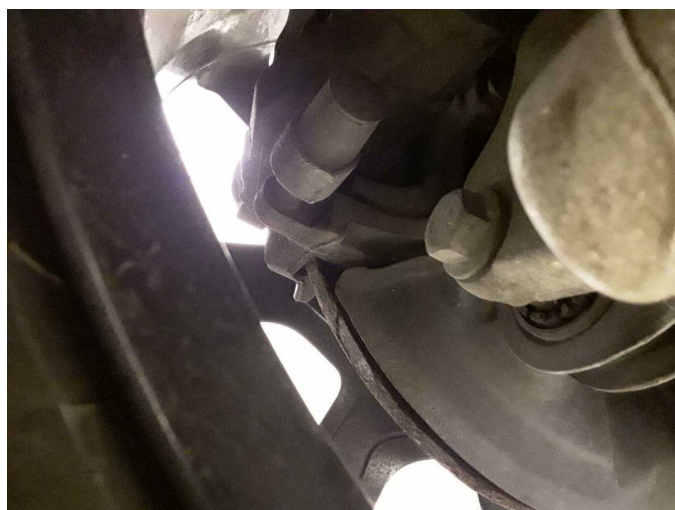
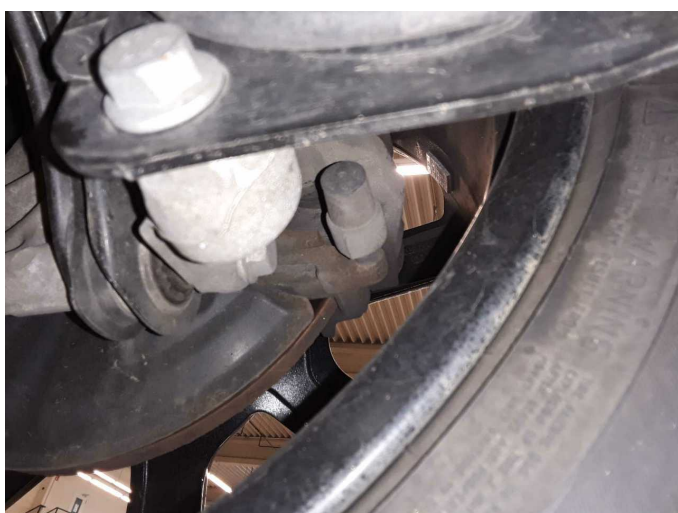
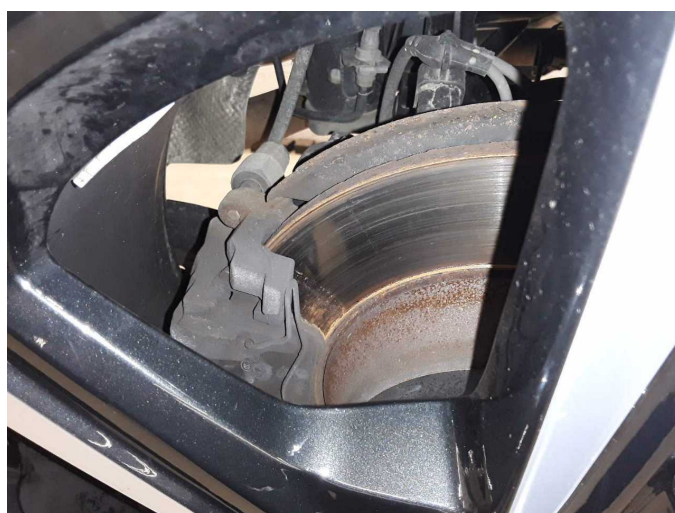
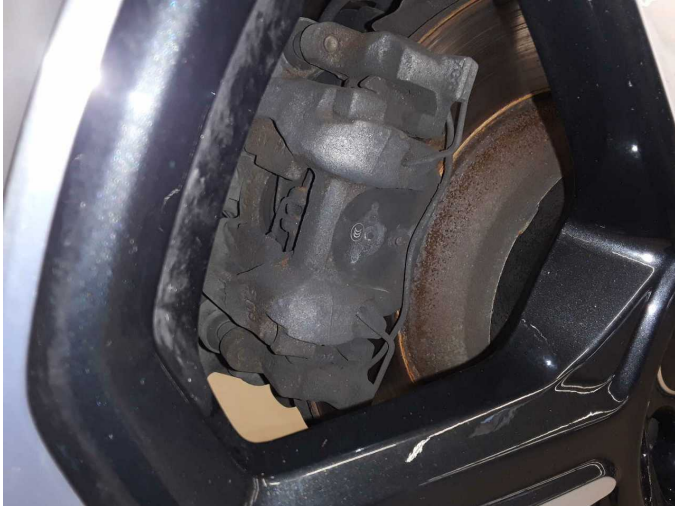
| No. | Component group | Description |
|---|---|---|
| 10 | Braking system | Brake discs and pads - rear - Worn - Replace |

**Damage 10:** Braking system: Brake discs and pads - rear - Worn - Replace

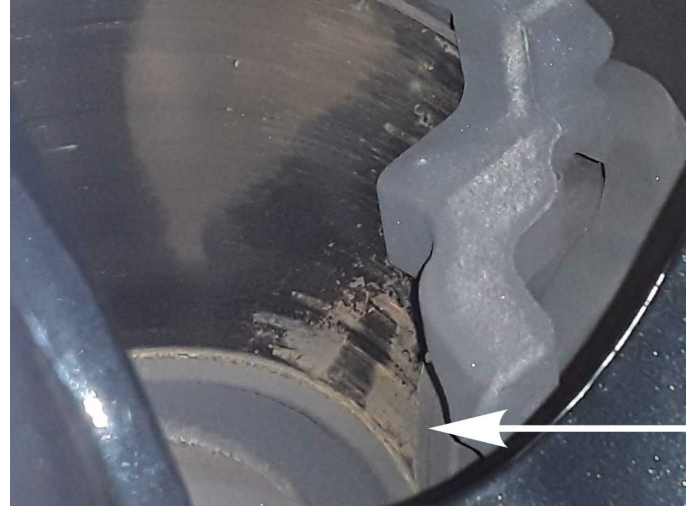
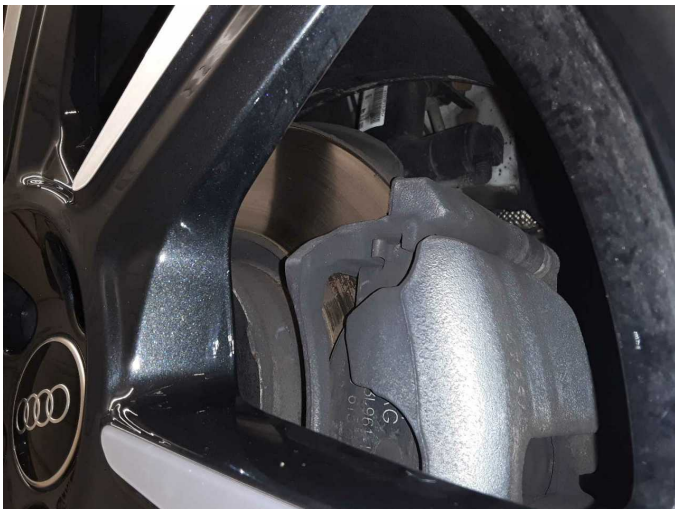
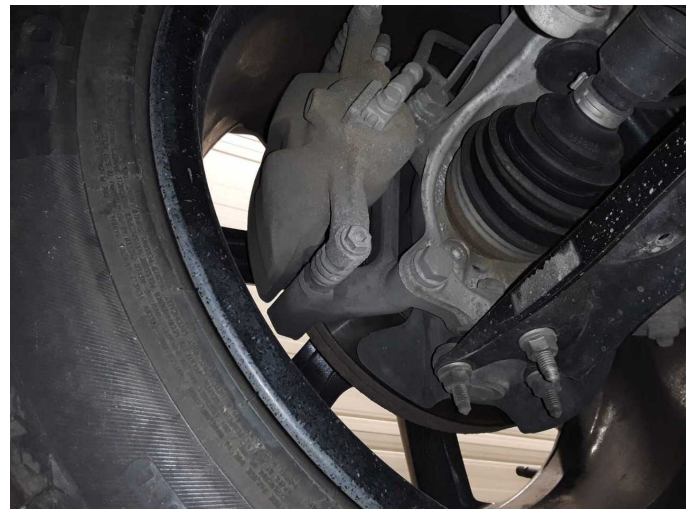
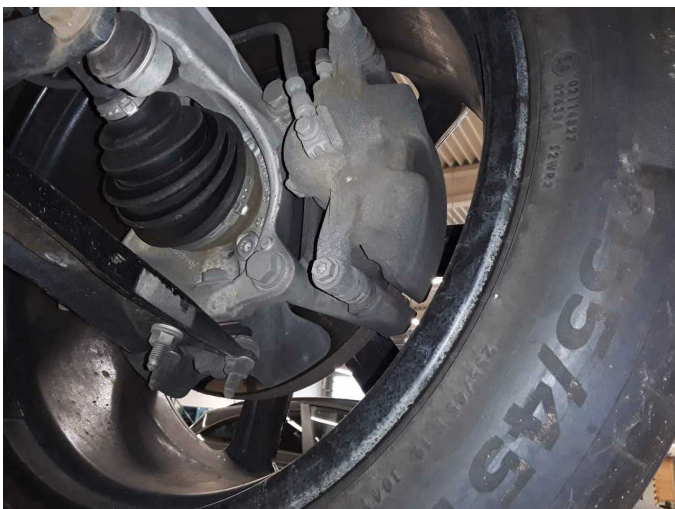
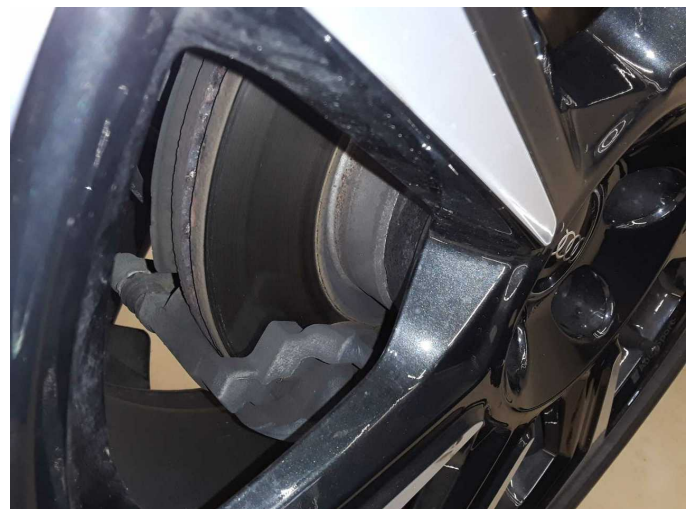
| No. | Component group | Description |
|---|---|---|
| 11 | Braking system | Brake discs and brake pads - front (Scheiben sind stark eingelaufen) - Worn - Replace |

**Damage 11:** Braking system: Brake discs and brake pads - front (Scheiben sind stark eingelaufen) - Worn - Replace

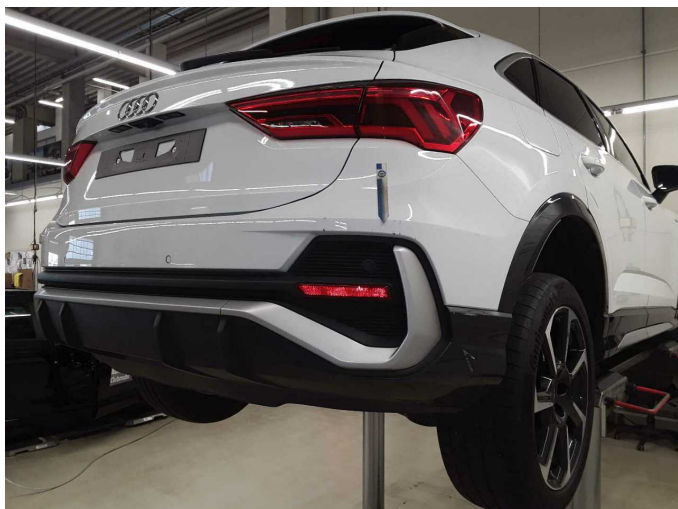
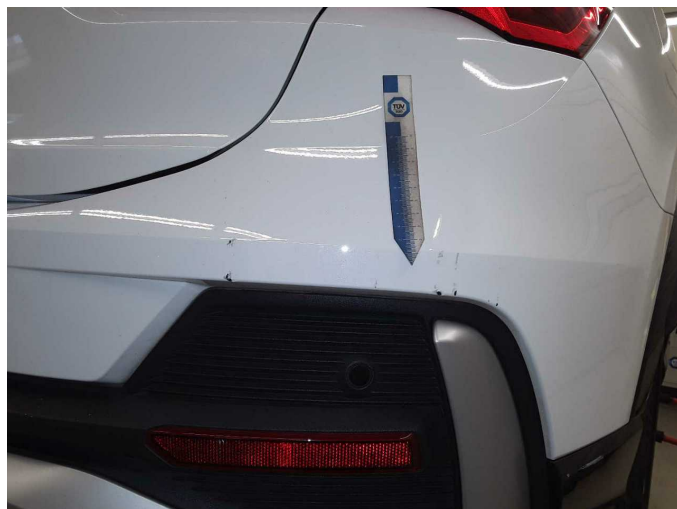
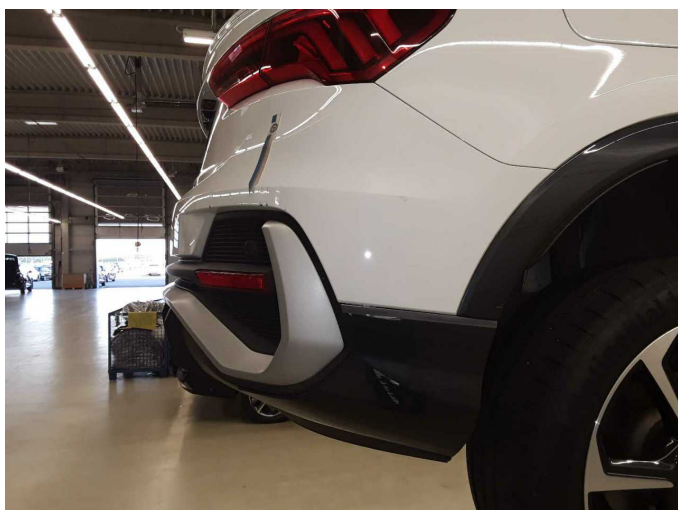
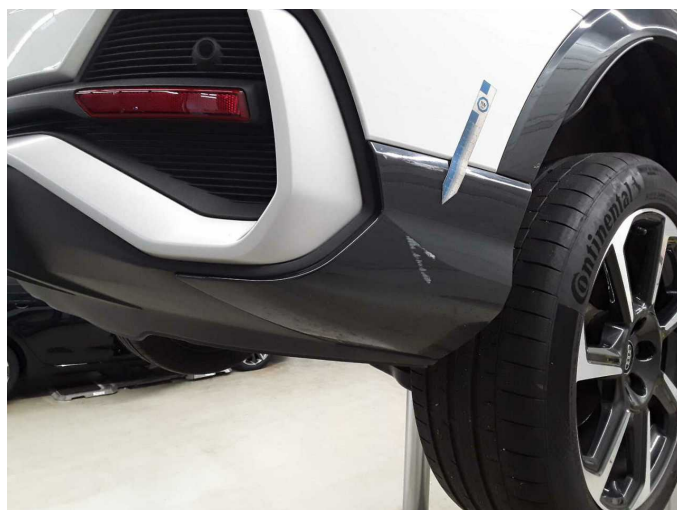
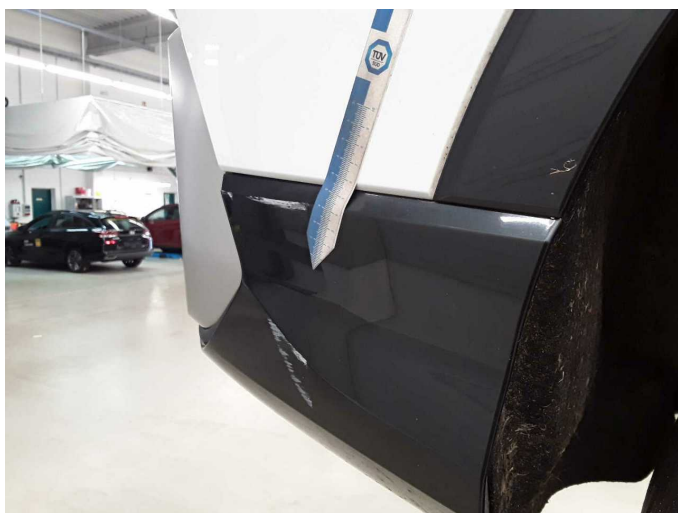
| No. | Component group | Description |
|---|---|---|
| 12 | Rear bumper | Rear bumper (Incl. Anbauteile erneuern) - Scratched - Repair and paint |

**Damage 12:** Rear bumper: Rear bumper (Incl. Anbauteile erneuern) - Scratched - Repair and paint
