Expertise

Protocol number: 46322657  
Order No. / Reference: 26543163  
Inspection date: 6 Jul 2026

Manufacturer: Volkswagen

Model: Tiguan 2.0 TDI SCR Life

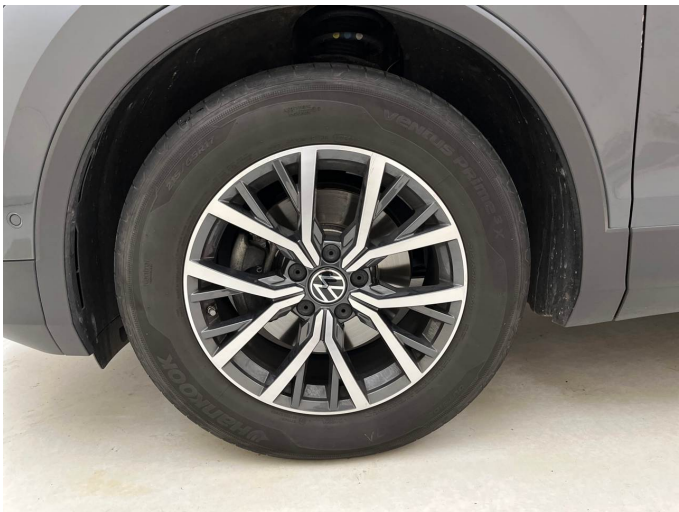
Figure 12: Mounted tyres

| Tyres | | | | |
|---|---|---|---|---|
| 1) | 215/65 R17 99V | Summer tyres on Light alloy | Hankook | 2mm / 2mm |
| 2) | 215/65 R17 99V | Summer tyres on Light alloy | Hankook | 5mm / 5mm |

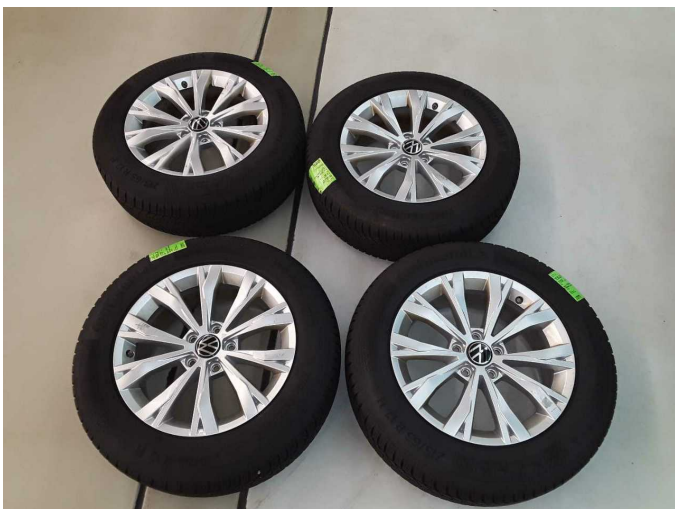
Figure 17: Additional tyres

| Tyres | | | | |
|---|---|---|---|---|
| 1) | 215/65 R17 99H | Winter tyres on Light alloy | Continental | 6mm / 6mm |
| 2) | 215/65 R17 99H | Winter tyres on Light alloy | Continental | 8mm / 8mm |

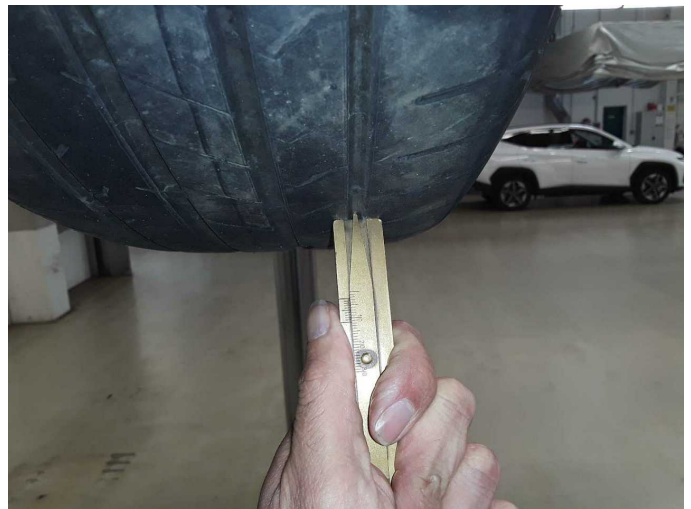
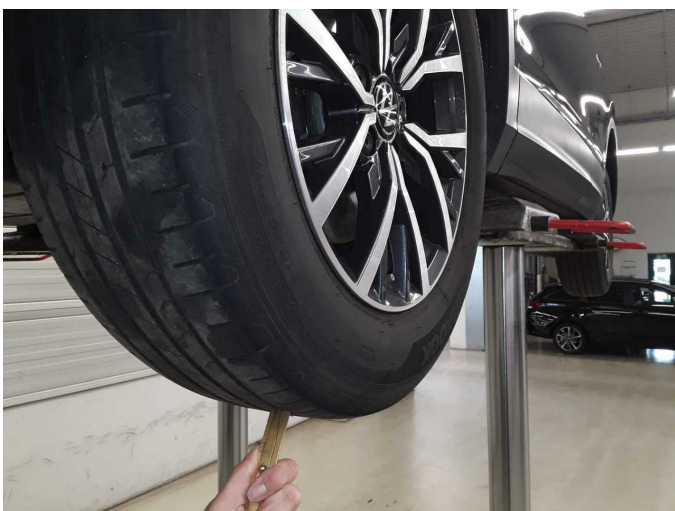
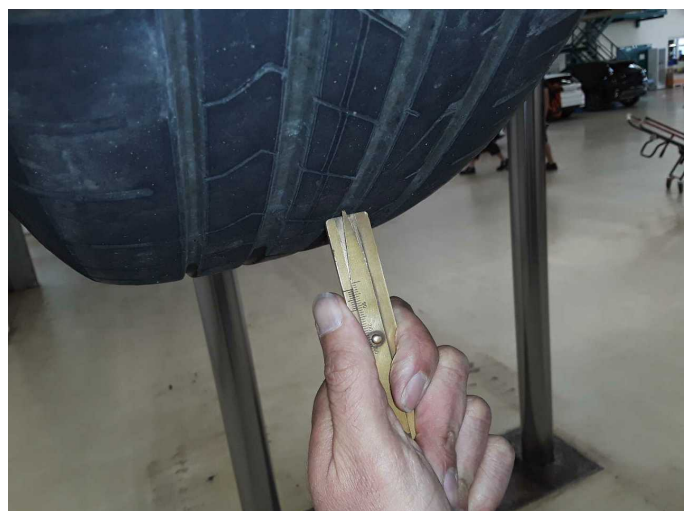
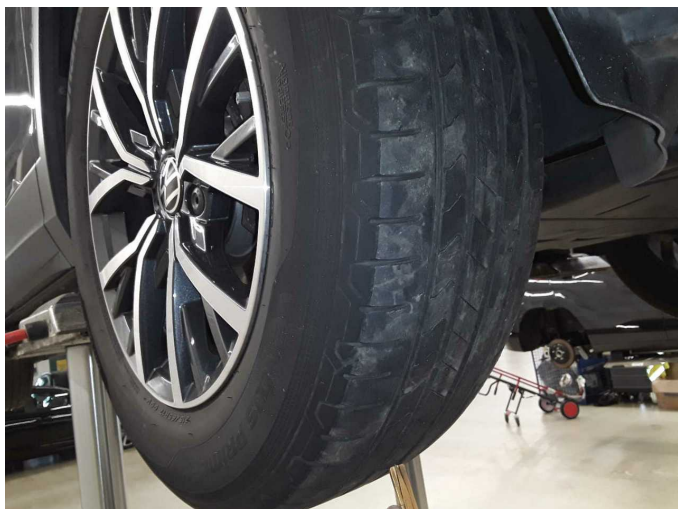
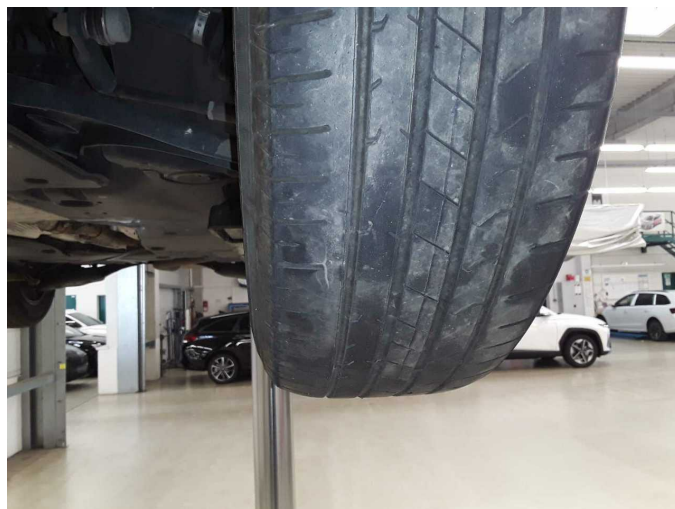
| No. | Component group | Description |
|---|---|---|
| 1 | Wheel / tyres | Tyre - front - does not meet manufacturer specifications - Replace |

**Damage 1:** Wheel / tyres: Tyre - front - does not meet manufacturer specifications - Replace

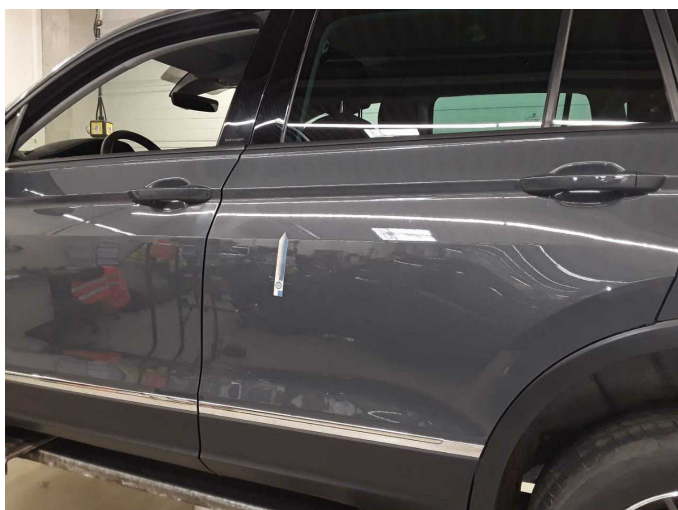
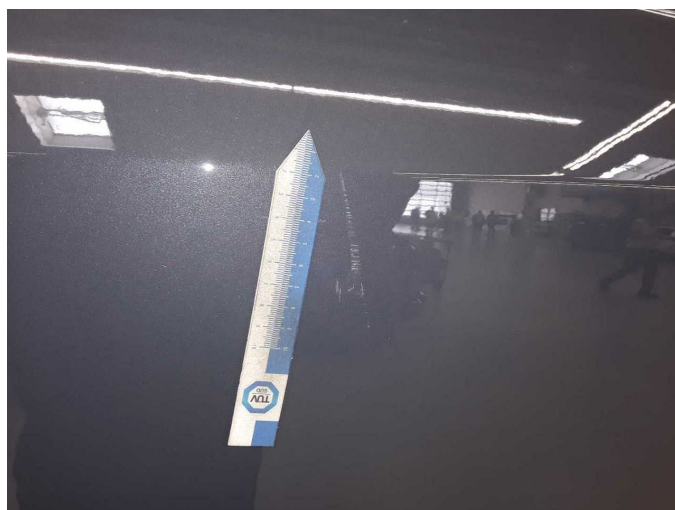
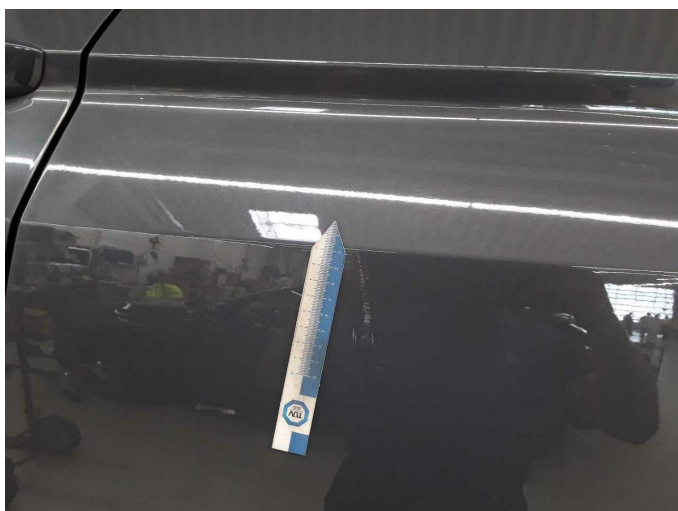
| No. | Component group | Description |
|---|---|---|
| 2 | Door - rear left side | Door - Scratched - Repair and paint |

**Damage 2:** Door - rear left side: Door - Scratched - Repair and paint

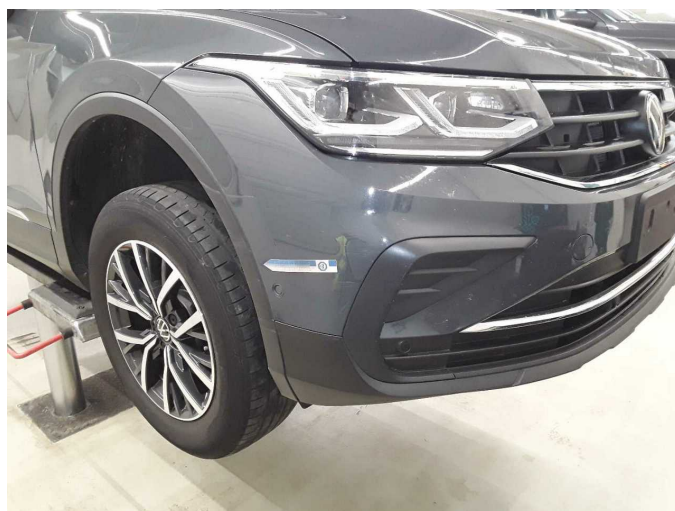
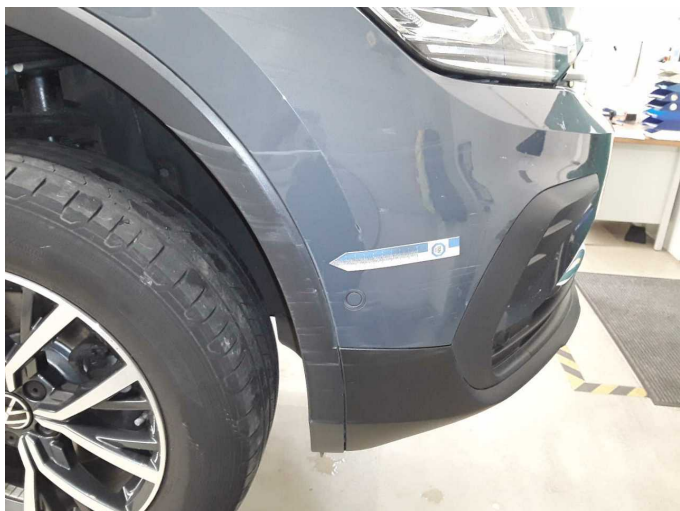
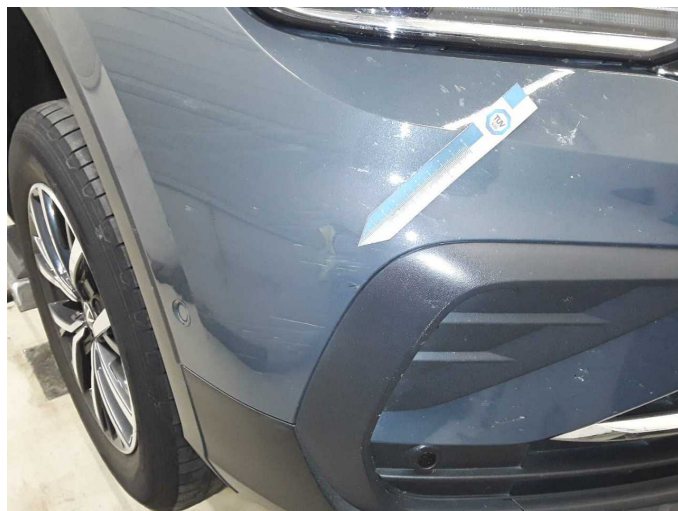
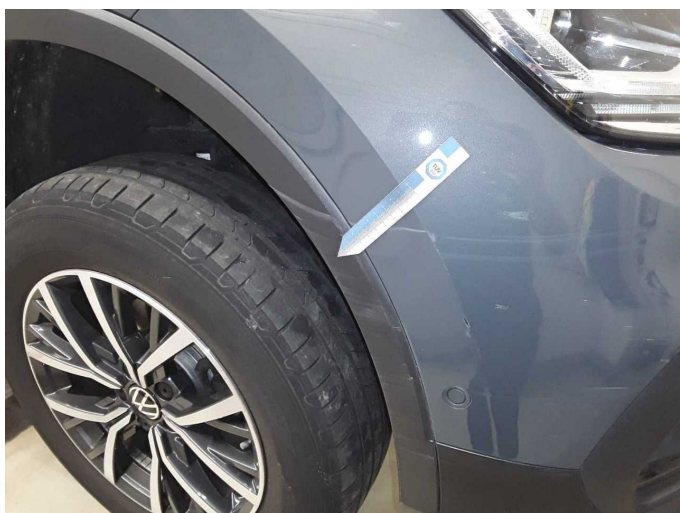
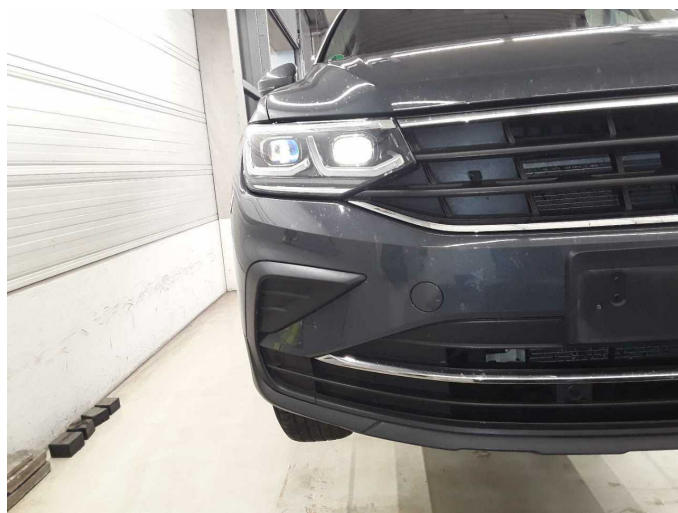
| No. | Component group | Description |
|---|---|---|
| 3 | Front bumper | Front bumper (Incl. Anbauteile erneuern) - Scratched - Repair and paint |

**Damage 3:** Front bumper: Front bumper (Incl. Anbauteile erneuern) - Scratched - Repair and paint
