Expertise

Protocol number: 46841196  
Order No. / Reference: 26751405  
Inspection date: 3 Aug 2026

Manufacturer: Ford

Model: Focus Turnier 1.5 EcoBlue Start-Stopp-System TITANIUM

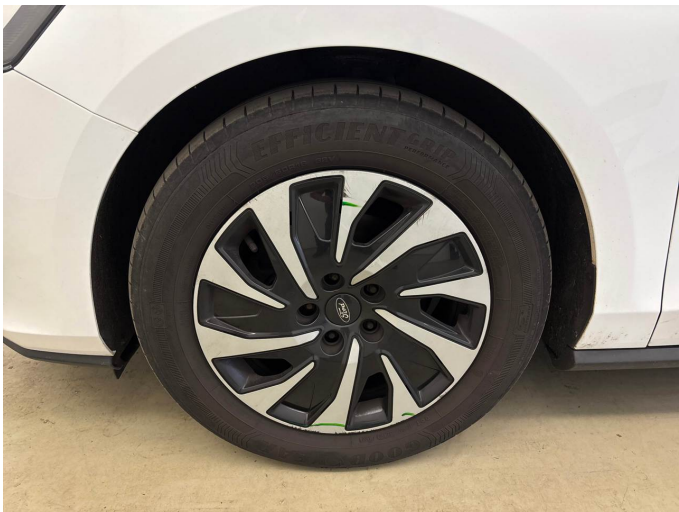
| # | Tyre size | Type of tyre | Manufacturer | Tread depth |
|---|---|---|---|---|
| 1) | 205/60 R16 92V | Summer tyres on Steel rim with wheel cover | Goodyear | 4mm / 4mm |
| 2) | 205/60 R16 92V | Summer tyres on Steel rim with wheel cover | Goodyear | 4mm / 4mm |

Figure 12: Mounted tyres

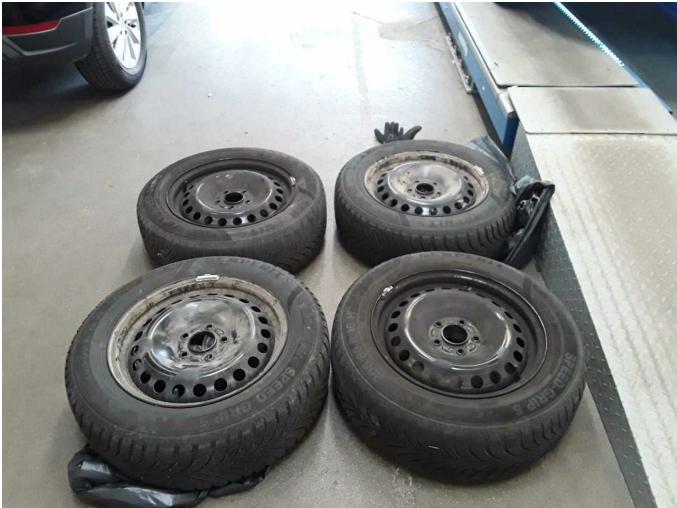
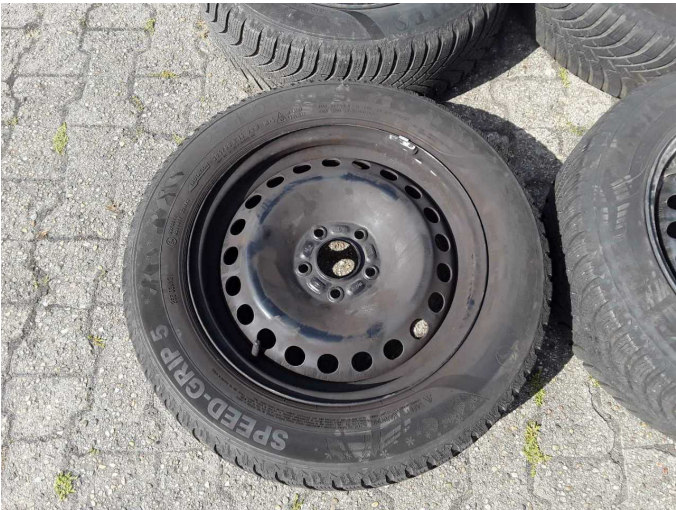
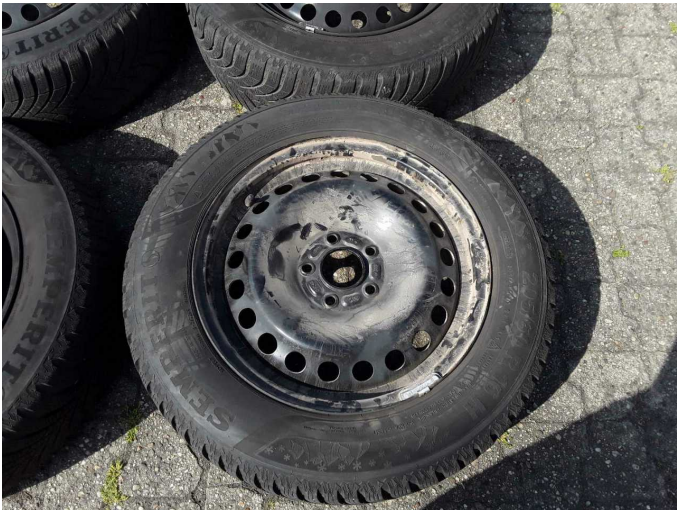
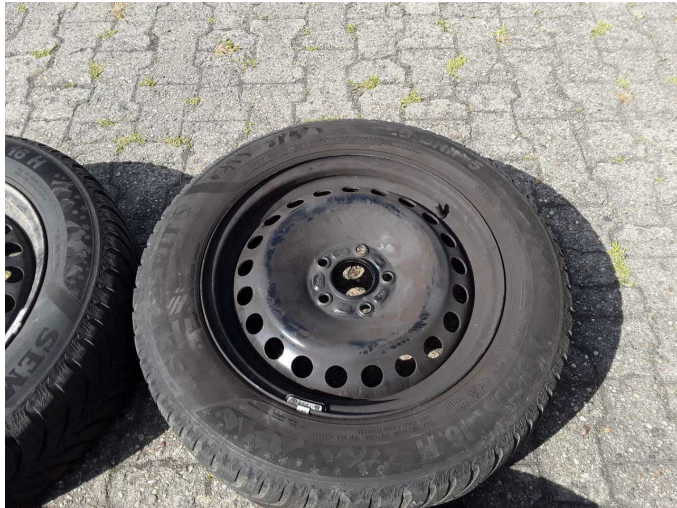
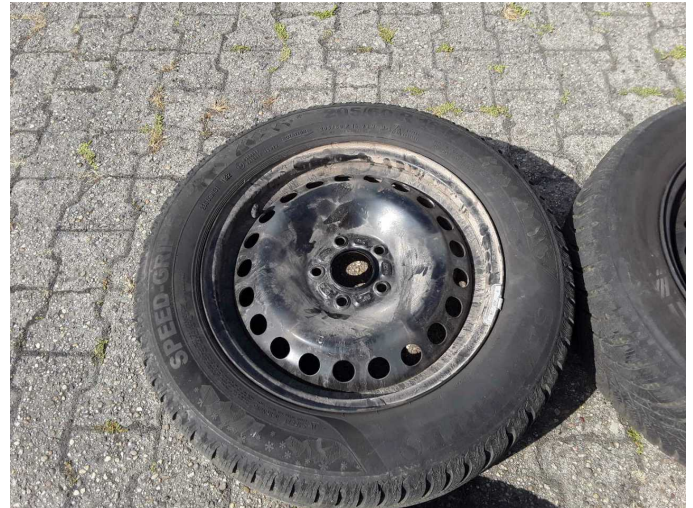
| # | Tyre size | Type of tyre | Manufacturer | Tread depth |
|---|---|---|---|---|
| 1) | 205/60 R16 92H | Winter tyres on Steel | Semperit | 4mm / 4mm |
| 2) | 205/60 R16 92H | Winter tyres on Steel | Semperit | 6mm / 6mm |

Figure 16: Additional tyres

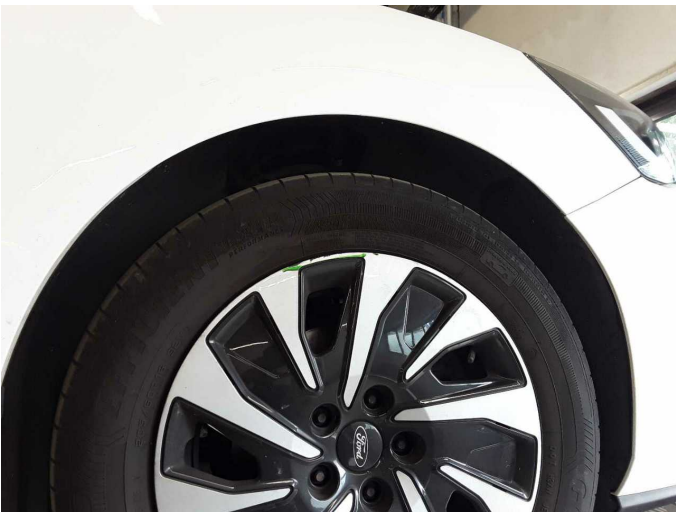
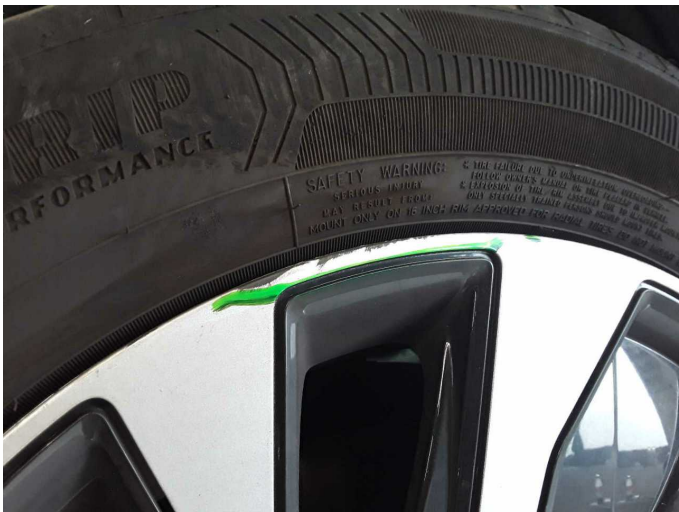
| No. | Component group | Description |
|---|---|---|
| 1 | Wheel / tyres | Wheel cover - front right side - Scratched - Loss in value |

Damage 1: Wheel / tyres: Wheel cover - front right side - Scratched - Loss in value

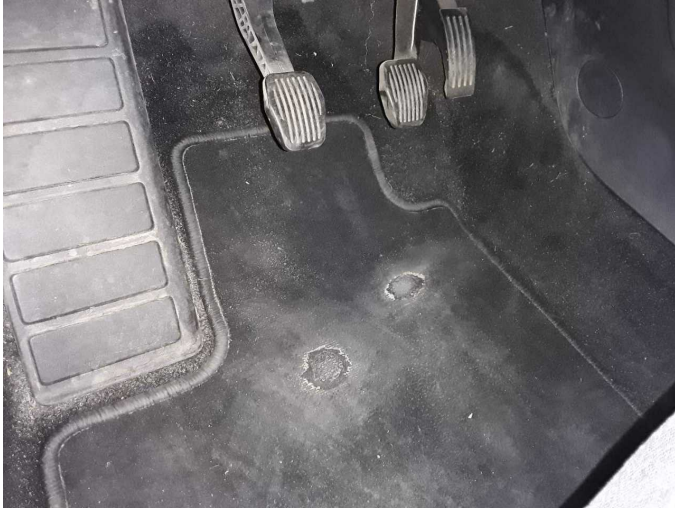
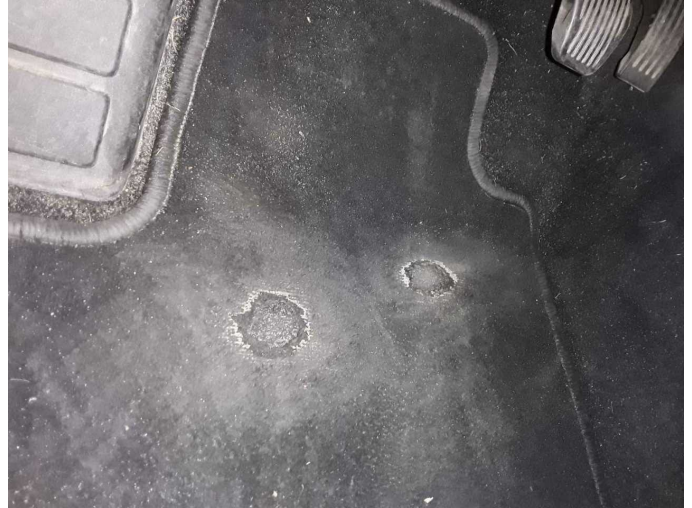
| No. | Component group | Description |
|---|---|---|
| 2 | Trim / covers | Carpet - front left side - Broken / torn - Replace |

**Damage 2:** Trim / covers: Carpet - front left side - Broken / torn - Replace

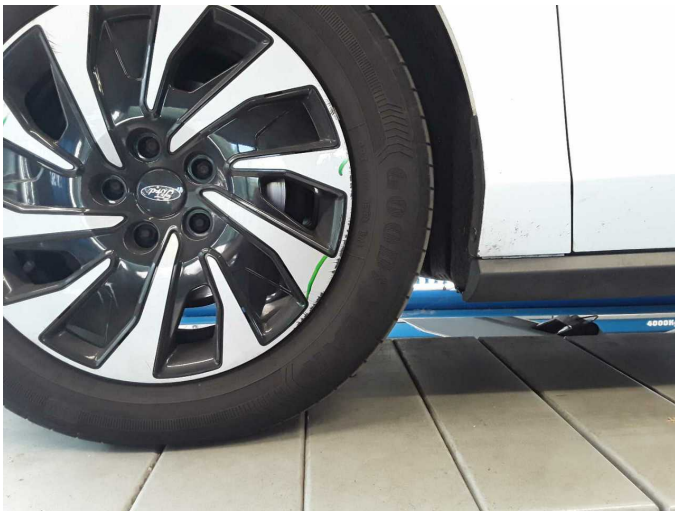
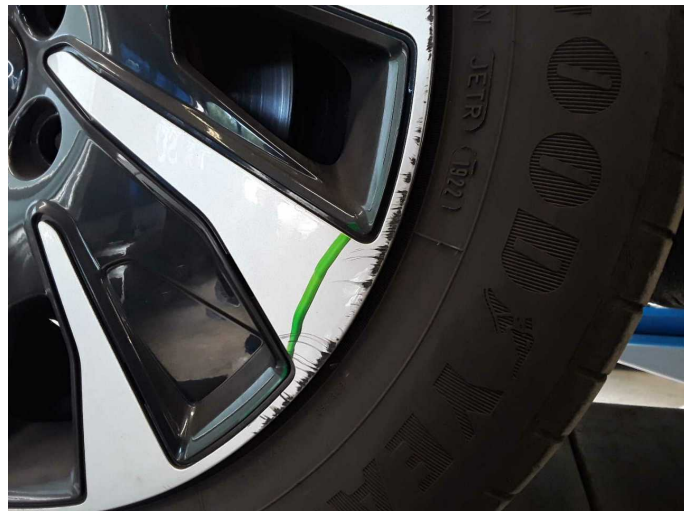
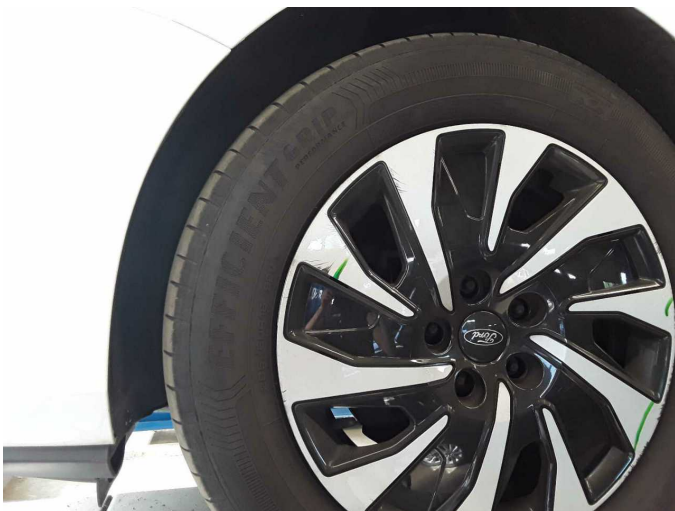
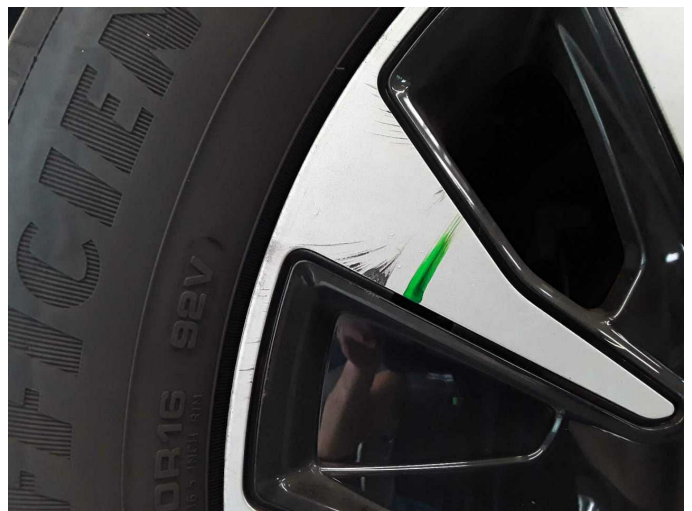
| No. | Component group | Description |
|---|---|---|
| 3 | Wheel / tyres | Wheel cover - front left side - Scratched - Replace |

**Damage 3:** Wheel / tyres: Wheel cover - front left side - Scratched - Replace

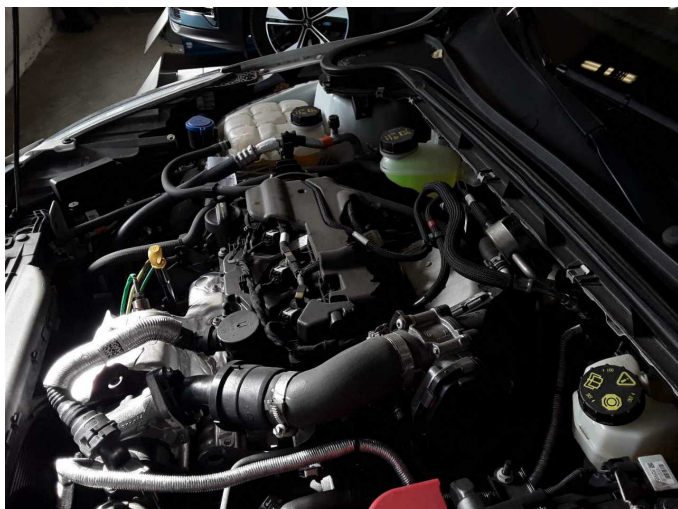
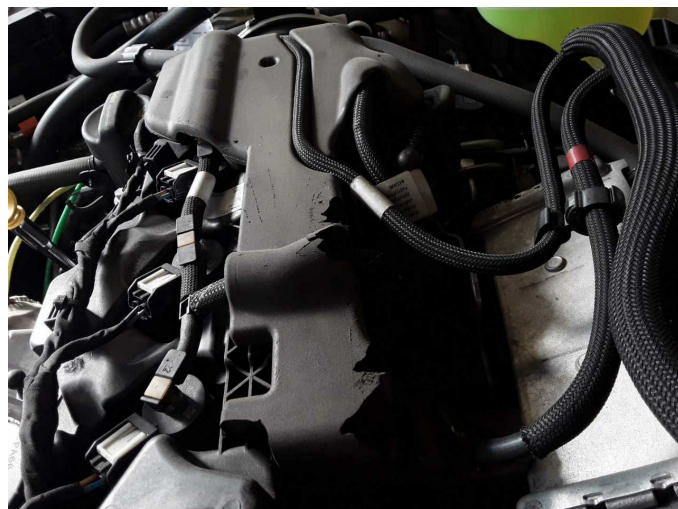
| No. | Component group | Description |
|---|---|---|
| 4 | Bonnet | Insulation lining - Broken / torn - Replace |

**Damage 4:** Bonnet: Insulation lining - Broken / torn - Replace

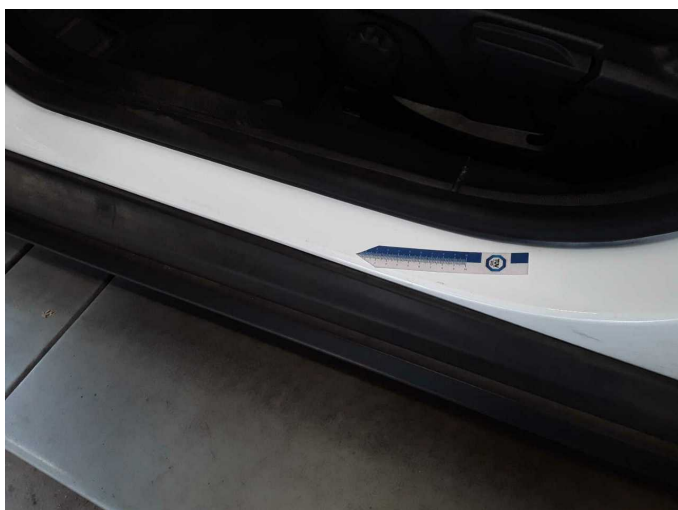
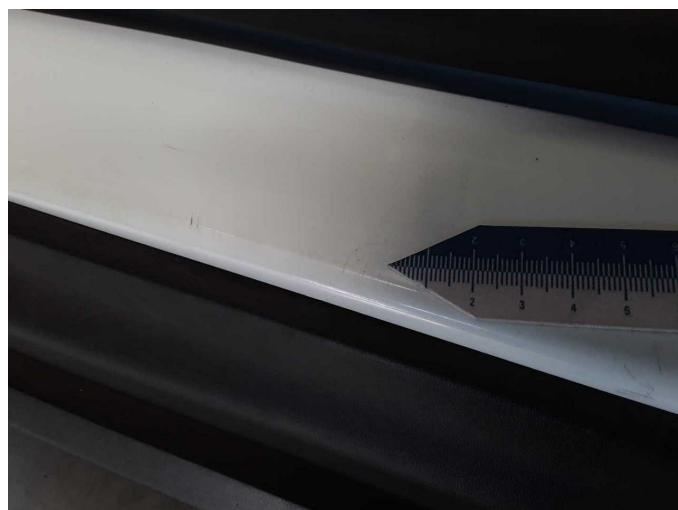
| No. | Component group | Description |
|---|---|---|
| 5 | Sill - left side | Sill - Scratched - Smart repair |

**Damage 5:** Sill - left side: Sill - Scratched - Smart repair

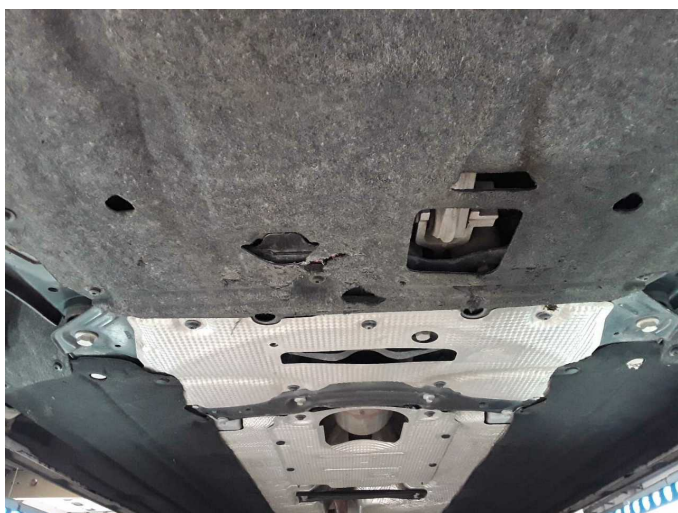
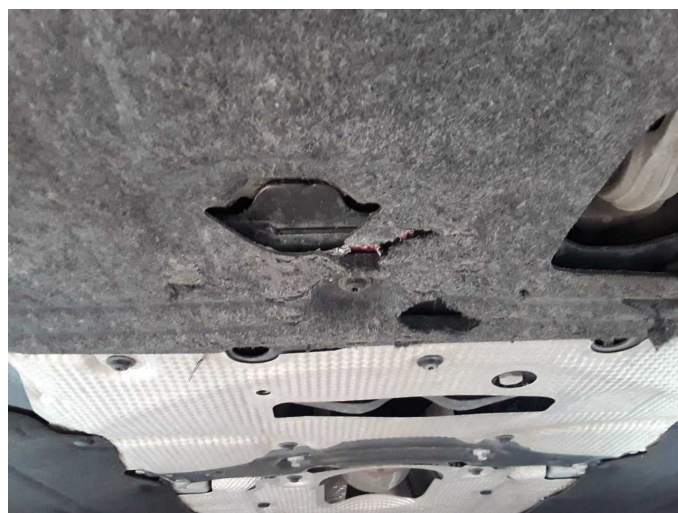
| No. | Component group | Description |
|---|---|---|
| 6 | Engine | Engine cowling - lower - Broken / torn - Replace |

**Damage 6:** Engine: Engine cowling - lower - Broken / torn - Replace

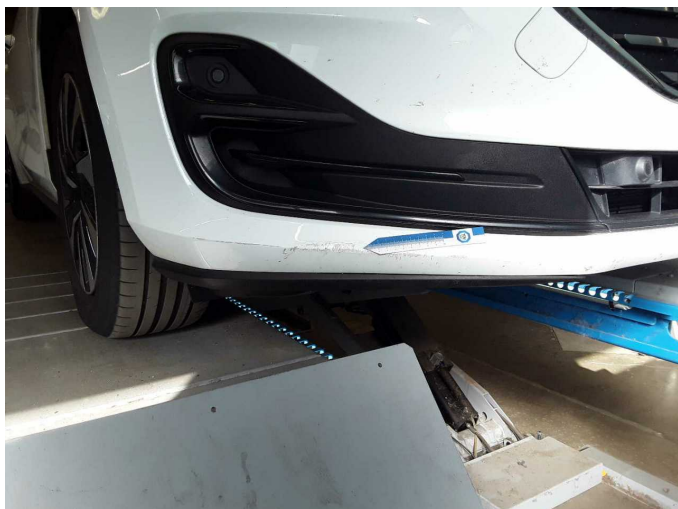
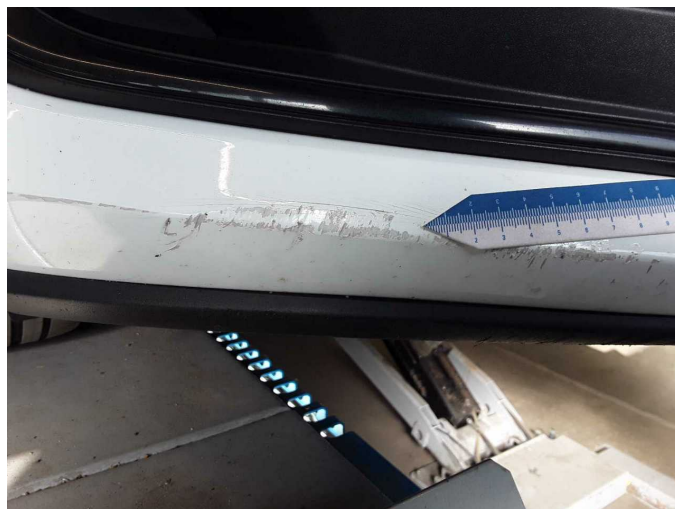
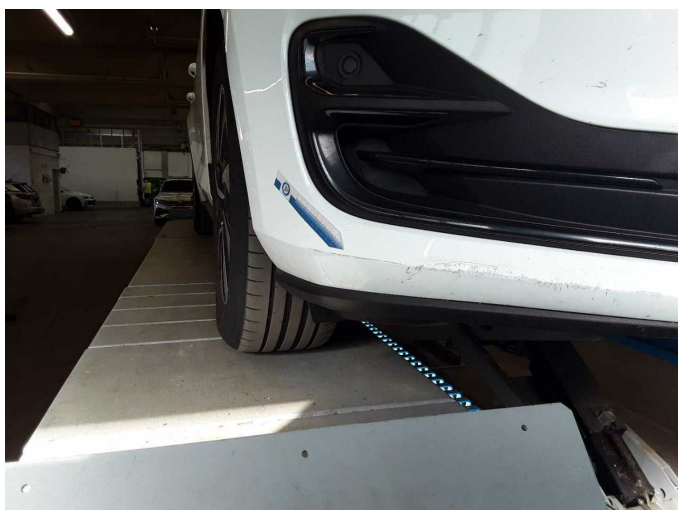
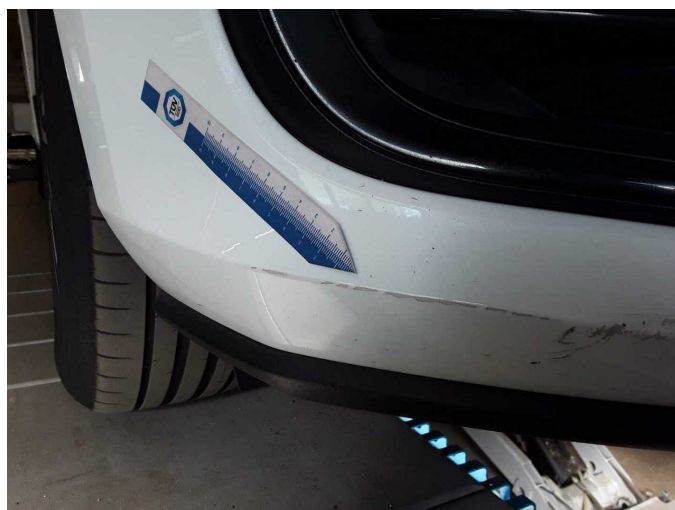
| No. | Component group | Description |
|---|---|---|
| 7 | Front bumper | Front bumper - Scratched - Paint |

**Damage 7:** Front bumper: Front bumper - Scratched - Paint

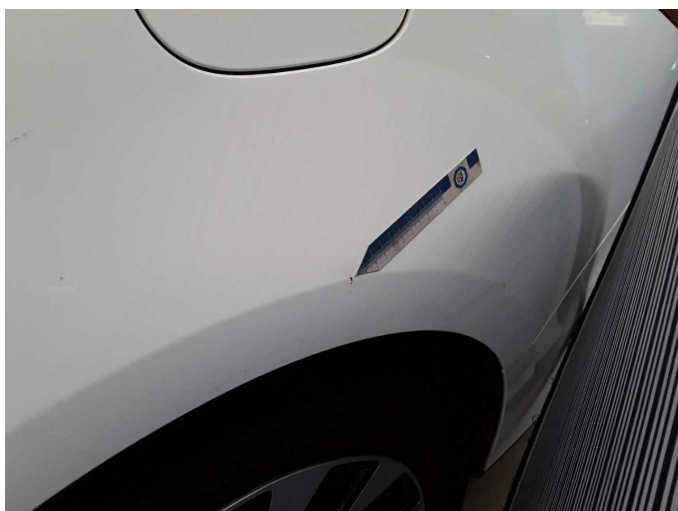
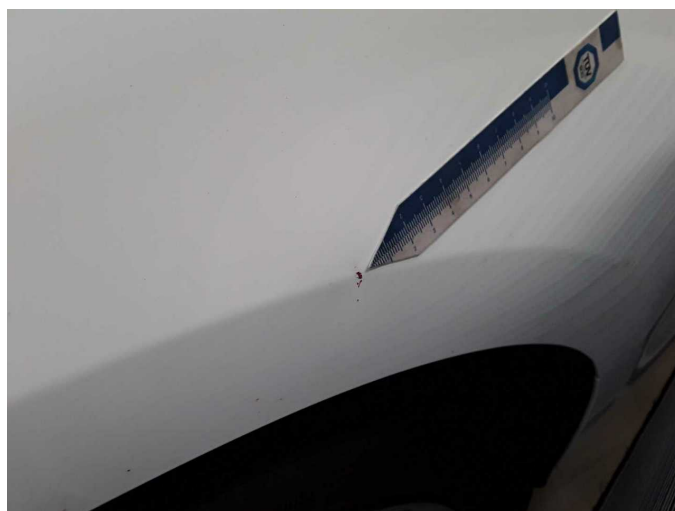
| No. | Component group | Description |
|---|---|---|
| 8 | Side panel - rear left side | Side panel - Dent / paintcoat damage - Repair and paint |

**Damage 8:** Side panel - rear left side: Side panel - Dent / paintcoat damage - Repair and paint

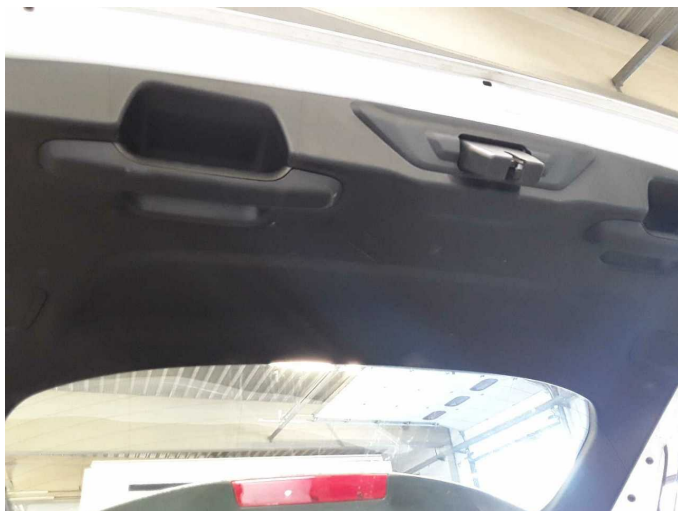
| No. | Component group | Description |
|---|---|---|
| 1 | Boot lid / rear door | Trim - standard - lower - Scratched - No deduction |

**Wear and tear 1:** Boot lid / rear door: Trim - standard - lower - Scratched  
- No deduction
