Expertise

Protocol number: 46352953  
Order No. / Reference: 26495188  
Inspection date: 30 Jun 2026

Manufacturer: Volkswagen  
VIN: WVGZZZCD6PW519223

Model: Golf Variant 2.0 TDI SCR DSG Life

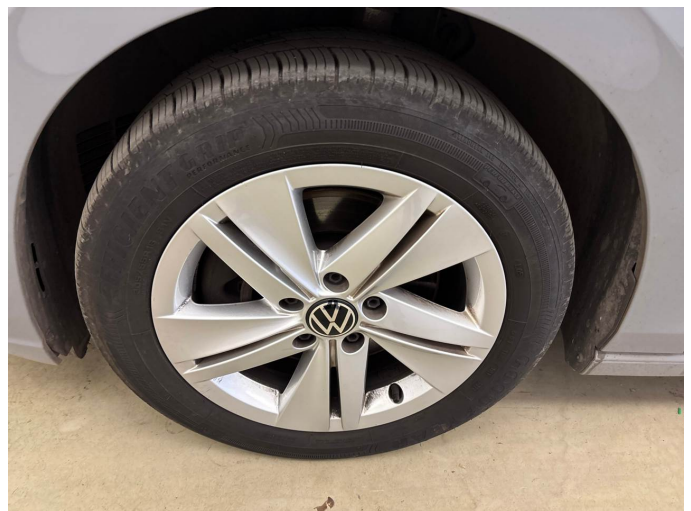
Figure 12: Mounted tyres

| # | Tyre size | Type of tyre | Manufacturer | Tread depth |
|---|---|---|---|---|
| 1) | 205/55 R16 91H | Summer tyres on Light alloy | Goodyear | 4mm / 4mm |
| 2) | 205/55 R16 91H | Summer tyres on Light alloy | Bridgestone | 4mm / 4mm |

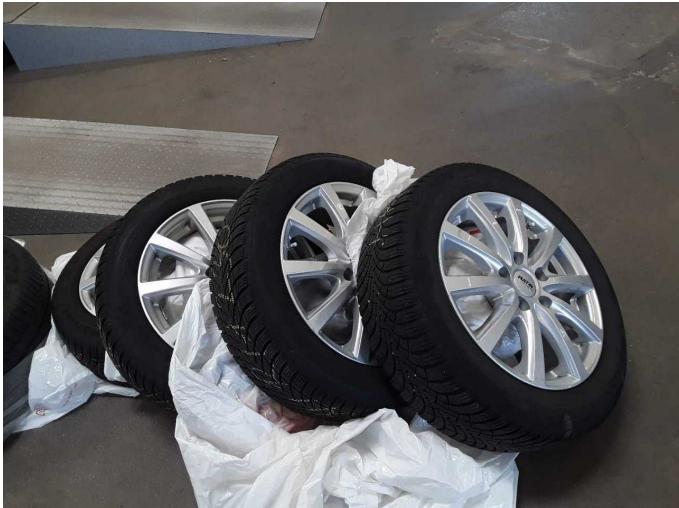
Figure 14: Additional tyres

| # | Tyre size | Type of tyre | Manufacturer | Tread depth |
|---|---|---|---|---|
| 1) | 205/55 R16 91H | Winter tyres on Light alloy | Goodyear | 5mm / 5mm |
| 2) | 205/55 R16 91H | Winter tyres on Light alloy | Goodyear | 5mm / 5mm |

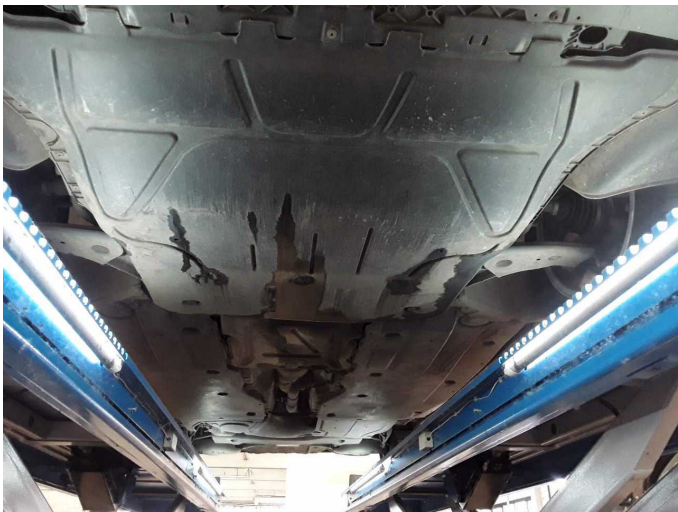
Damage 2: Engine: Engine - Leaking - Diagnosed and repair if necessary

| No. | Component group | Description |
|---|---|---|
| 2 | Engine | Engine - Leaking - Diagnosed and repair if necessary |

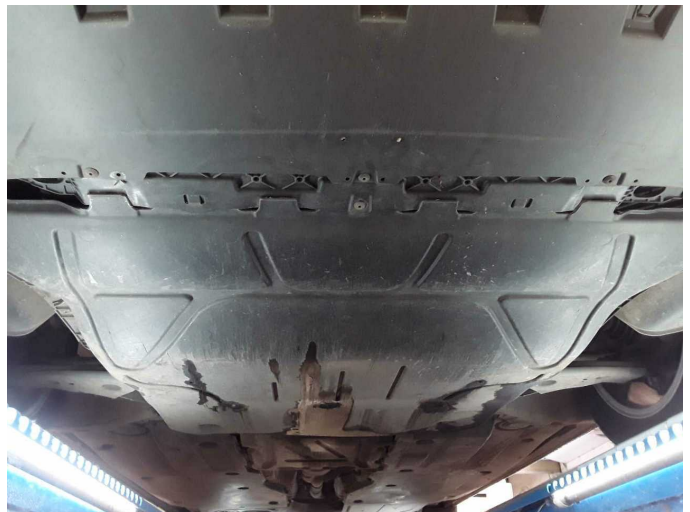
Wear and tear 1: Body: Underbody panelling - Scratched - No deduction

| No. | Component group | Description |
|---|---|---|
| 1 | Body | Underbody panelling - Scratched - No deduction |

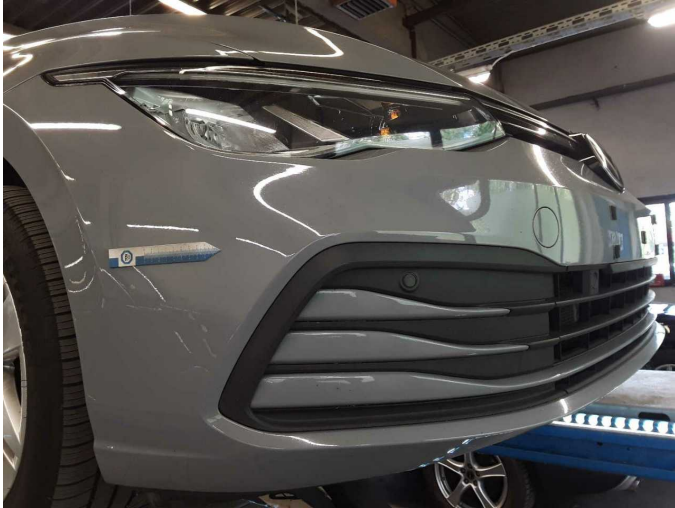
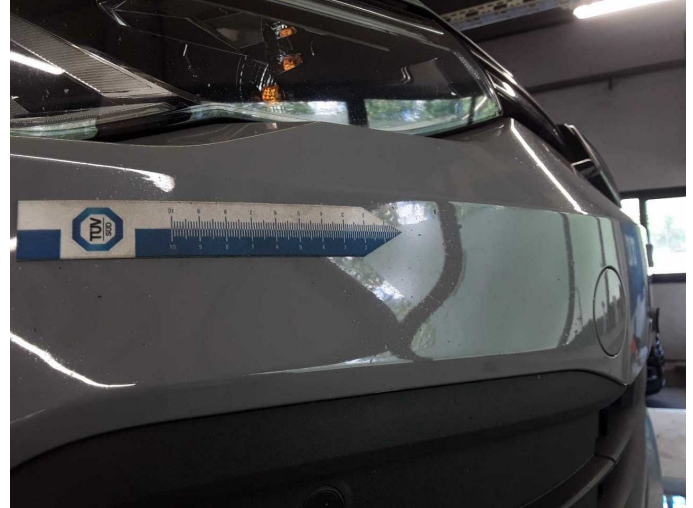
**Wear and tear 2:** Front bumper: Front bumper - Stone chips - No deduction

| No. | Component group | Description |
|---|---|---|
| 2 | Front bumper | Front bumper - Stone chips - No deduction |

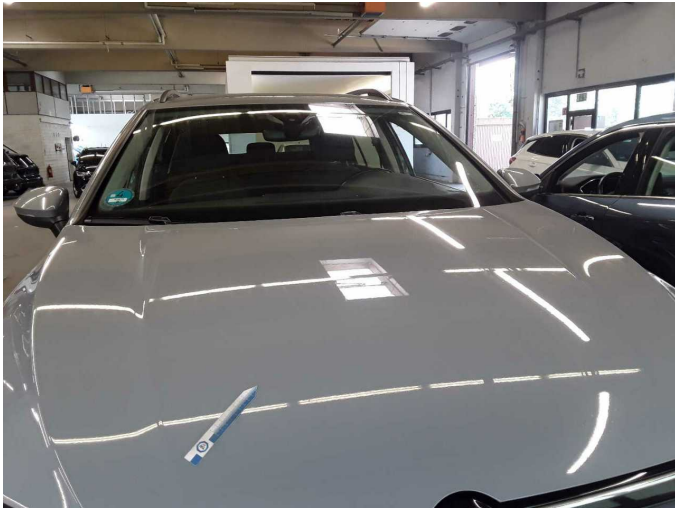
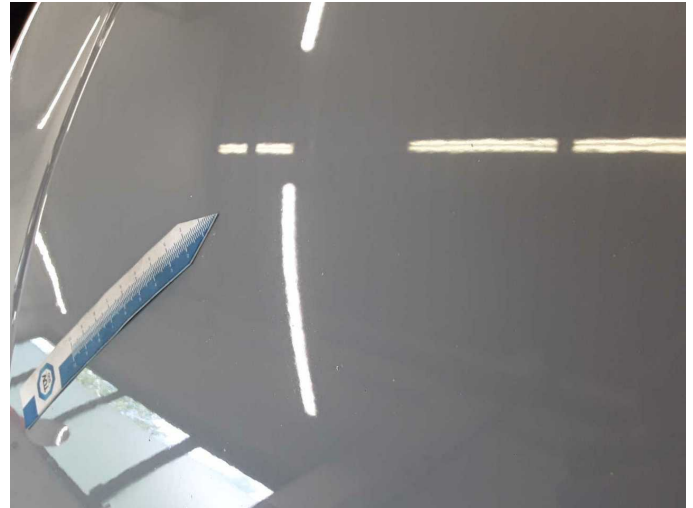
**Wear and tear 4:** Bonnet: Bonnet - Stone chips - No deduction

| No. | Component group | Description |
|---|---|---|
| 4 | Bonnet | Bonnet - Stone chips - No deduction |

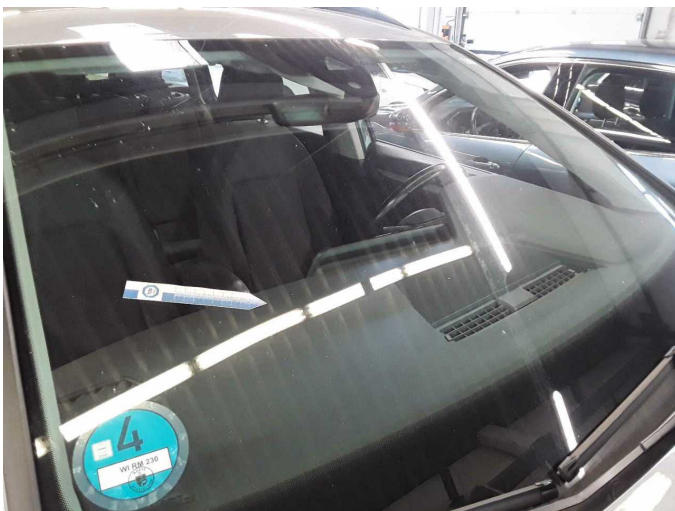
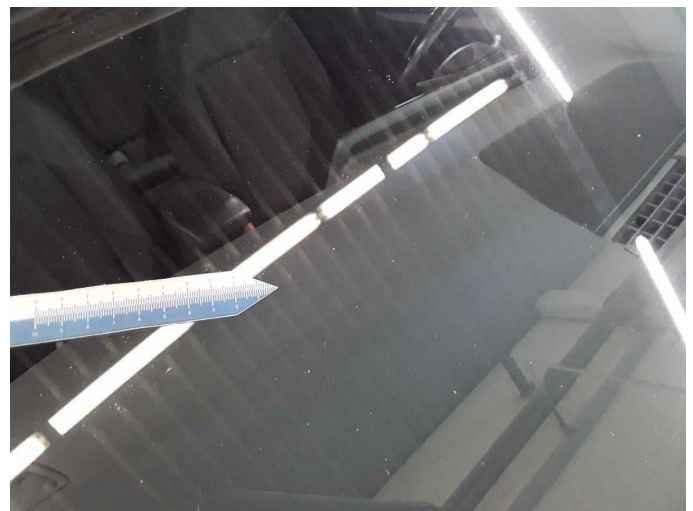
**Wear and tear 5:** Vehicle glazing: Windscreen - Stone chips - No deduction

| No. | Component group | Description |
|---|---|---|
| 5 | Vehicle glazing | Windscreen - Stone chips - No deduction |
