Expertise

Protocol number: 46852213  
Order No. / Reference: 26811425  
Inspection date: 3 Aug 2026

Manufacturer: Skoda  
VIN: TMBJH8NZ0RC013250

Model: Superb Combi 2.0 TDI DSG L&K

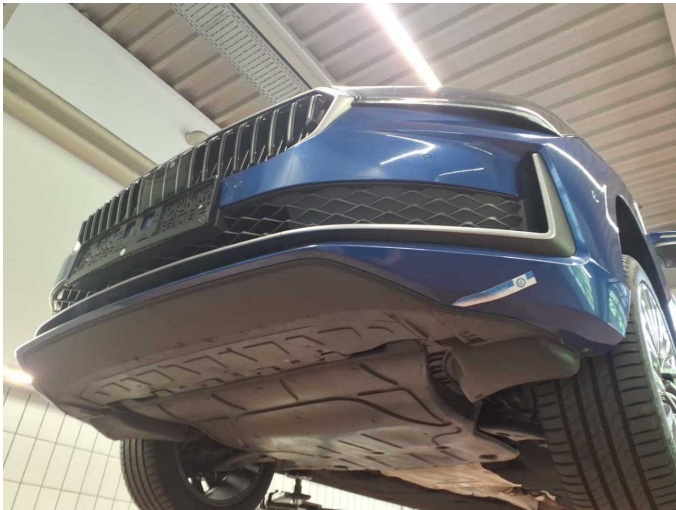
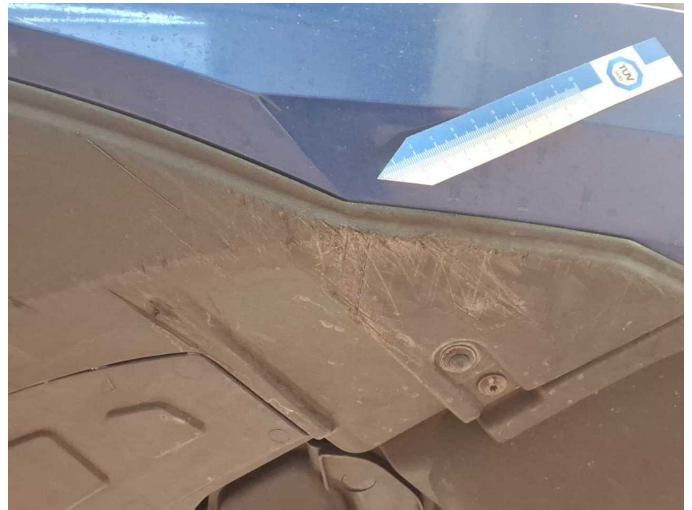
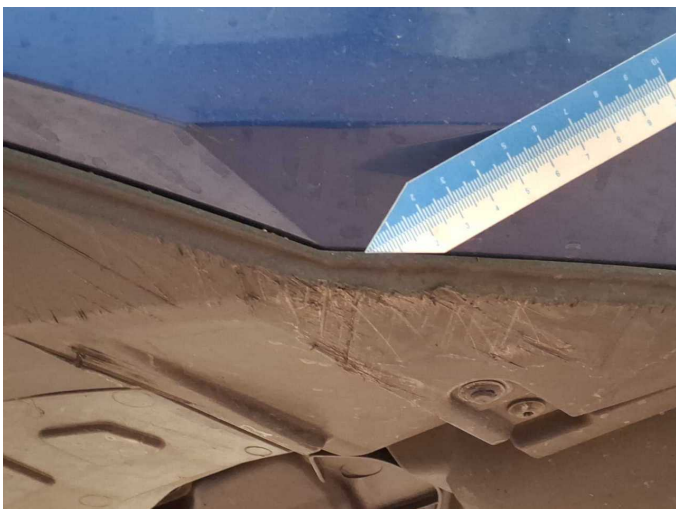
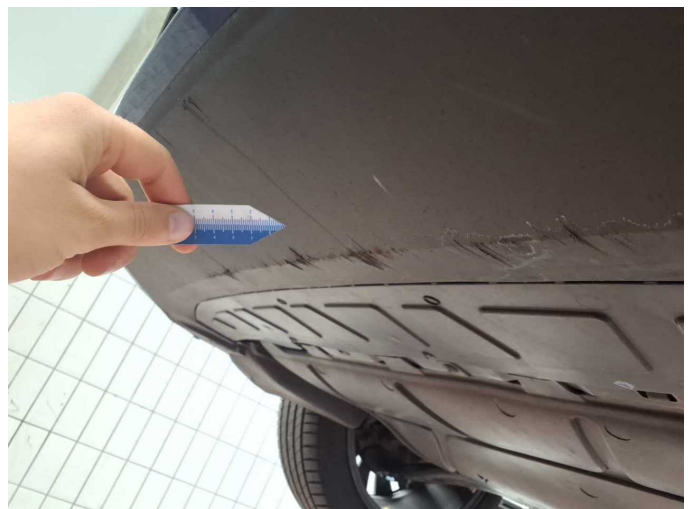
| No. | Component group | Description |
|---|---|---|
| 1 | Body | Underbody panelling - Scratched - Replace |

Damage 1: Body: Underbody panelling - Scratched - Replace

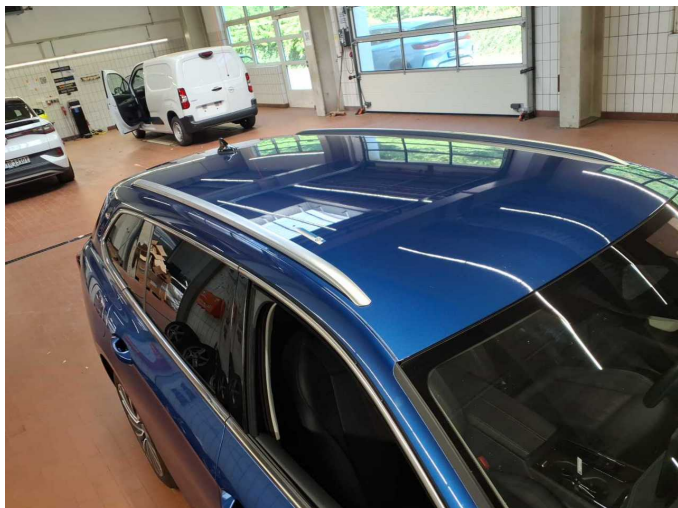
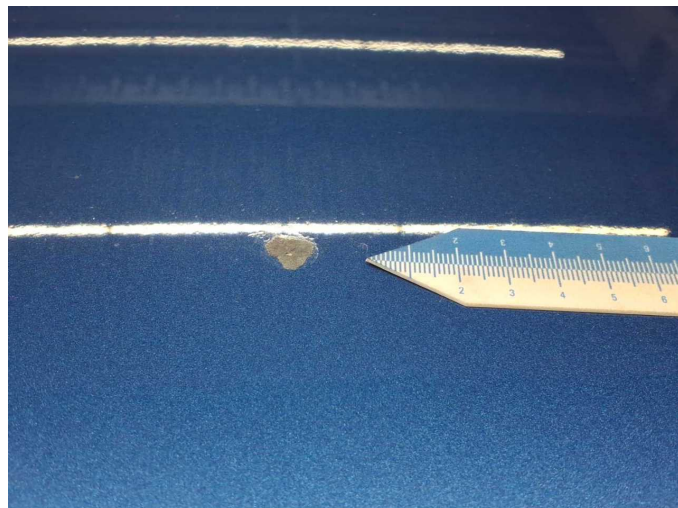
| No. | Component group | Description |
|---|---|---|
| 2 | Roof | Roof (Harz,Mehrkosten möglich) - Soiled - Conditioning |

**Damage 2:** Roof: Roof (Harz,Mehrkosten möglich) - Soiled - Conditioning

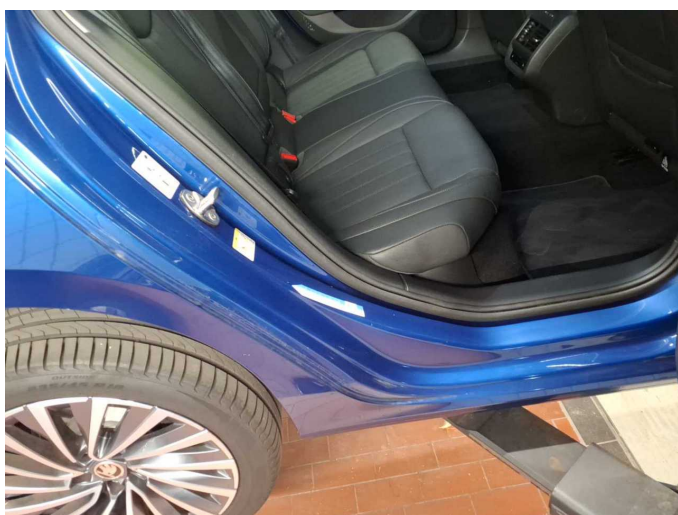
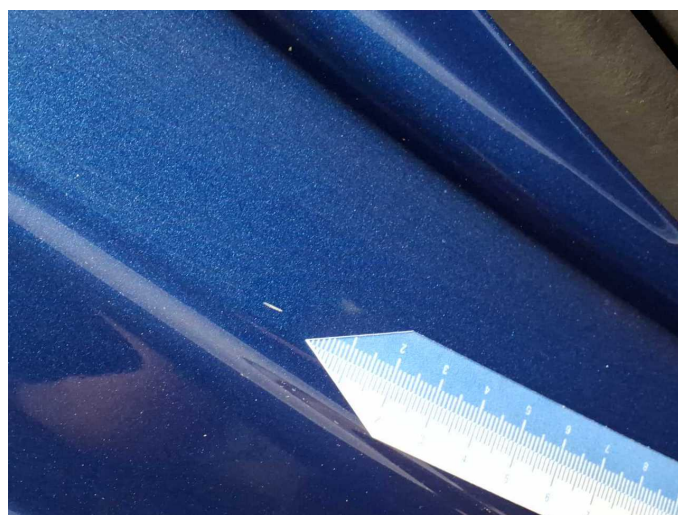
| No. | Component group | Description |
|---|---|---|
| 3 | Side panel - rear right side | Sill - Scratch(es) - Smart repair |

**Damage 3:** Side panel - rear right side: Sill - Scratch(es) - Smart repair

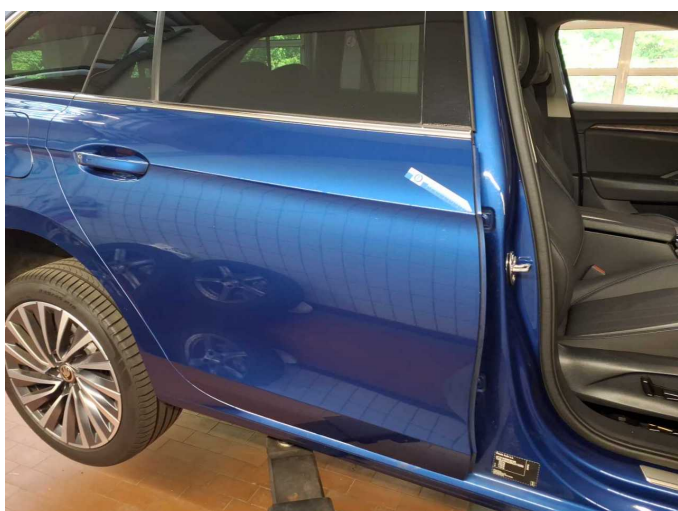
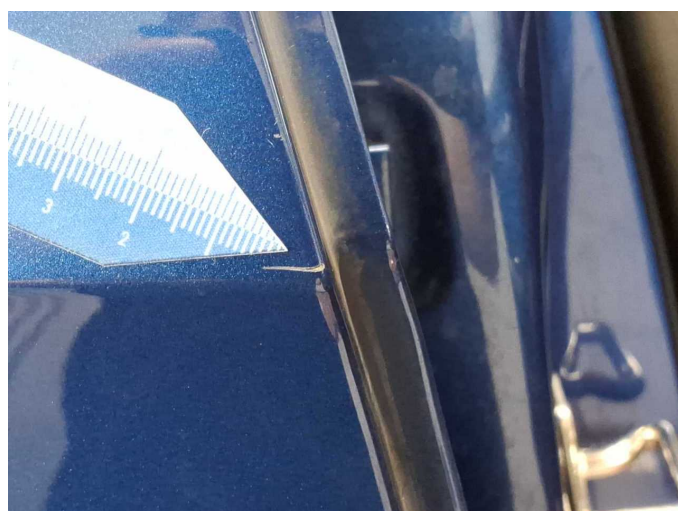
| No. | Component group | Description |
|---|---|---|
| 4 | Door - rear right side | Door - Scratch(es) - Smart repair |

**Damage 4:** Door - rear right side: Door - Scratch(es) - Smart repair

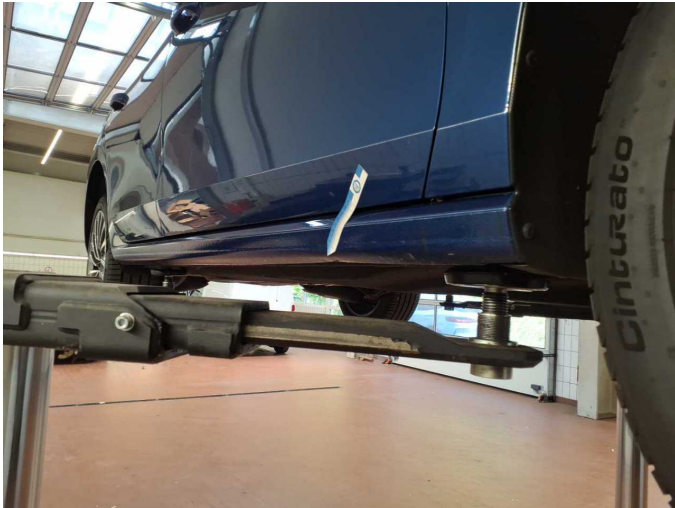
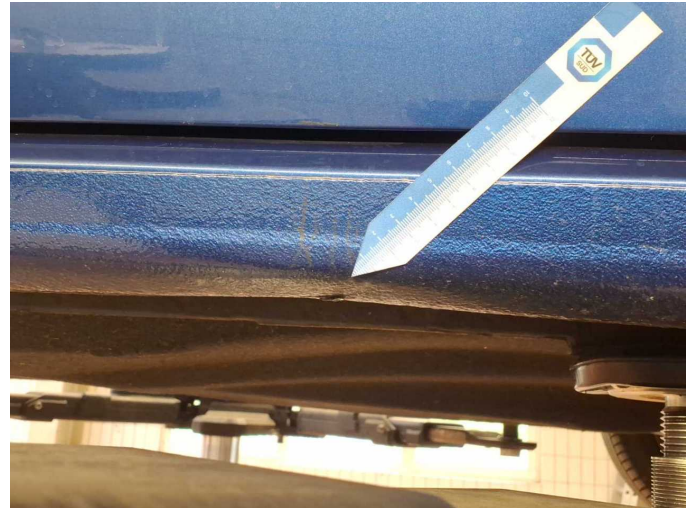
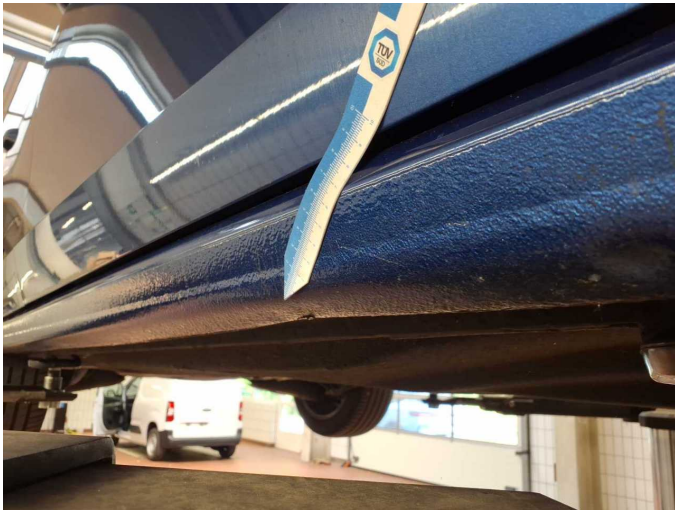
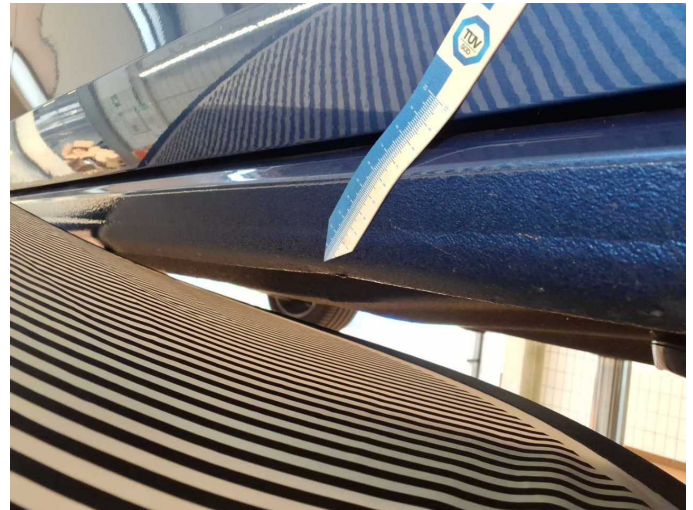
| No. | Component group | Description |
|---|---|---|
| 5 | Sill - right side | Sill - dent(s) - Smart repair |

**Damage 5:** Sill - right side: Sill - dent(s) - Smart repair

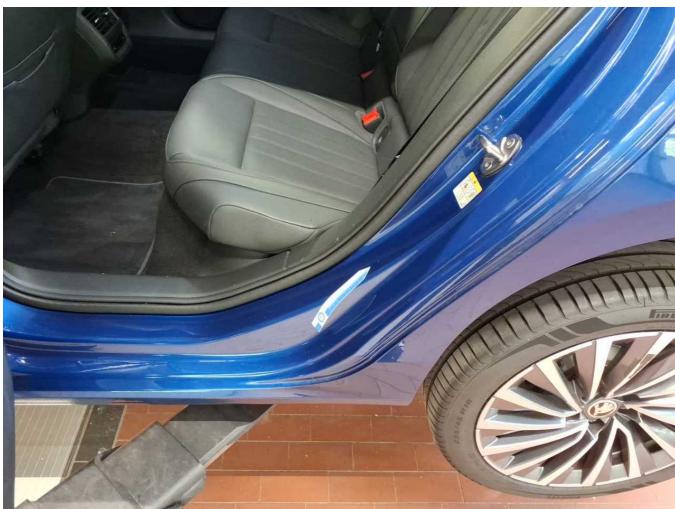
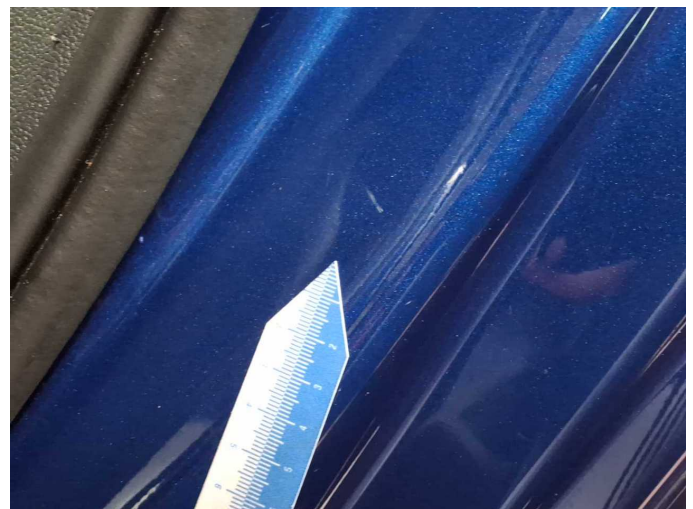
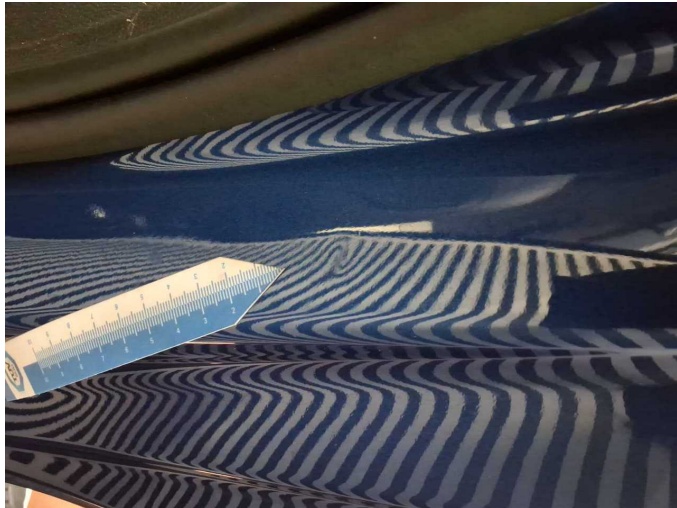
| No. | Component group | Description |
|---|---|---|
| 6 | Side panel - rear left side | Sill - Dent / paintcoat damage - Smart repair |

**Damage 6:** Side panel - rear left side: Sill - Dent / paintcoat damage - Smart repair

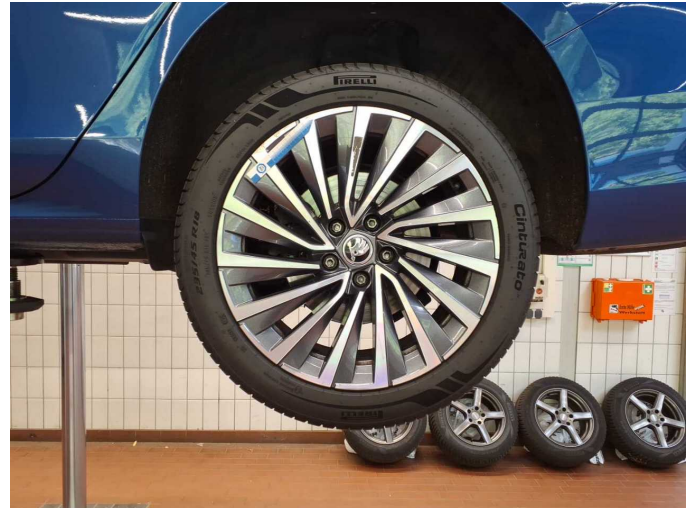
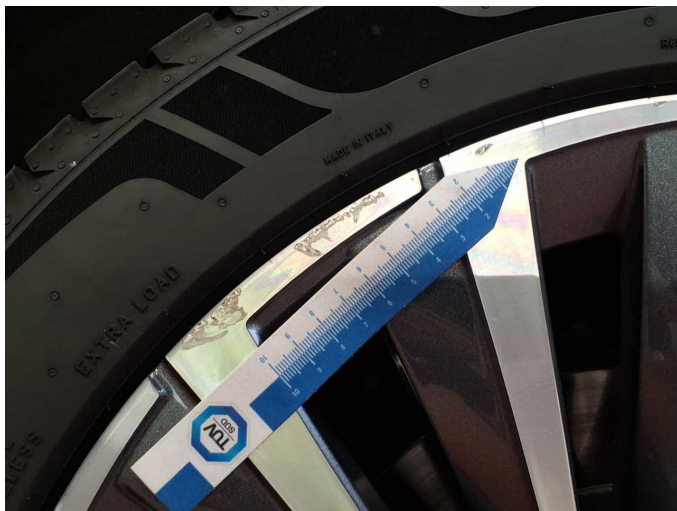
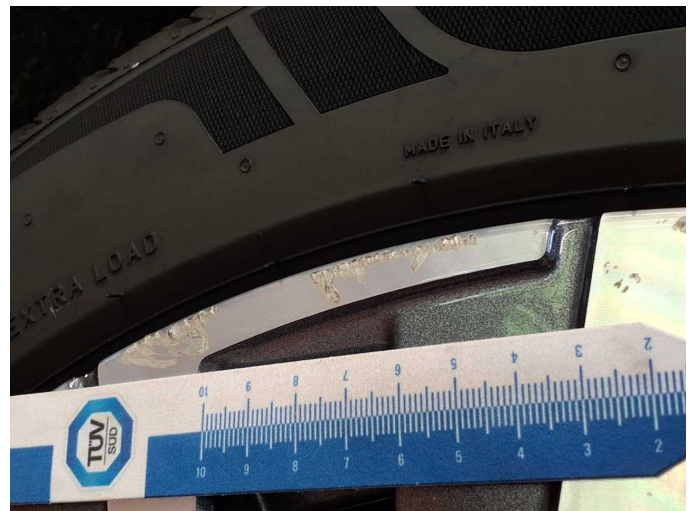
| No. | Component group | Description |
|---|---|---|
| 8 | Wheel / tyres | Alloy rim - rear left side - Scratched - Loss in value |

**Damage 8:** Wheel / tyres: Alloy rim - rear left side - Scratched - Loss in value

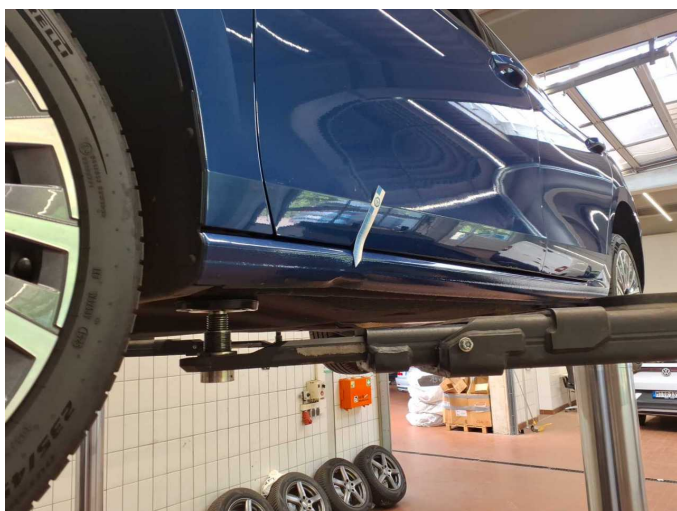
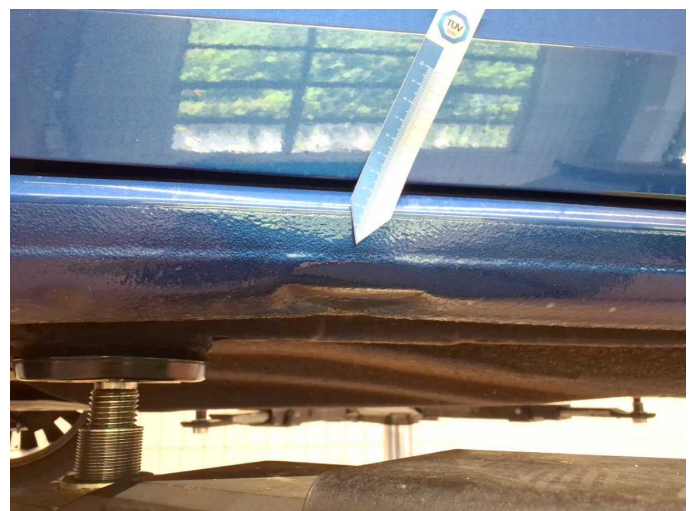
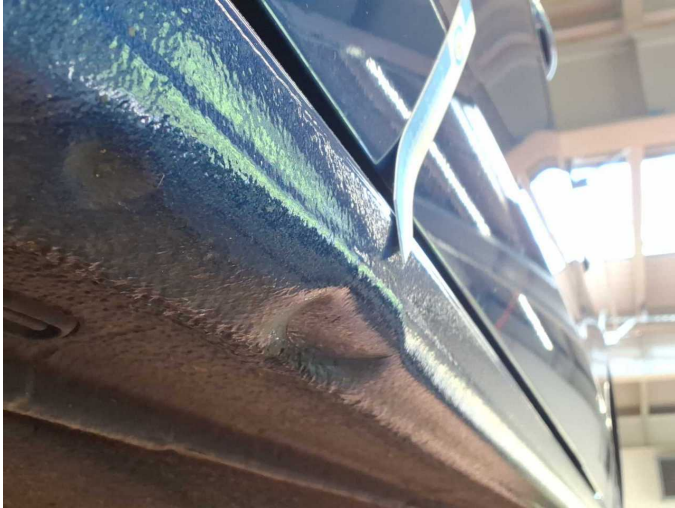
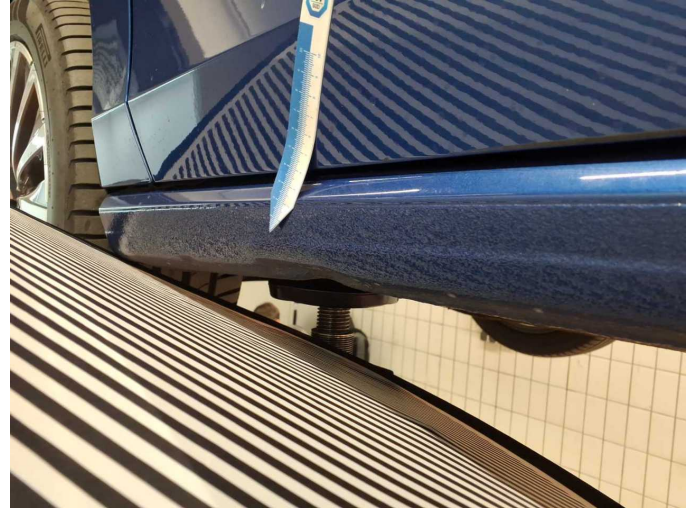
| No. | Component group | Description |
|---|---|---|
| 9 | Sill - left side | Sill - Deformed - Repair and paint |

**Damage 9:** Sill - left side: Sill - Deformed - Repair and paint

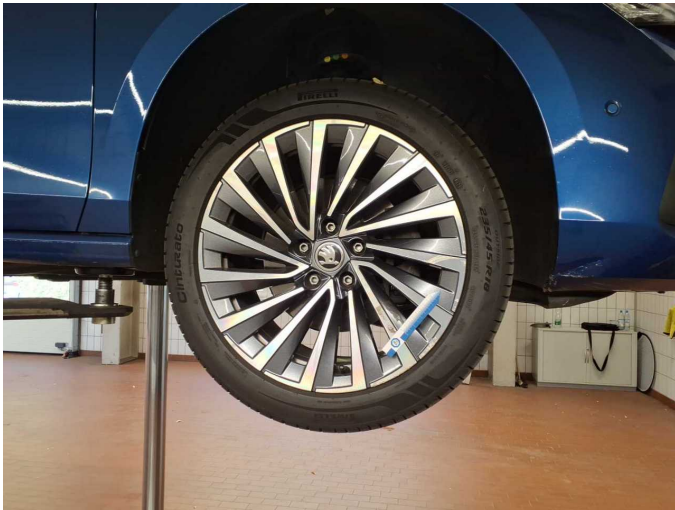
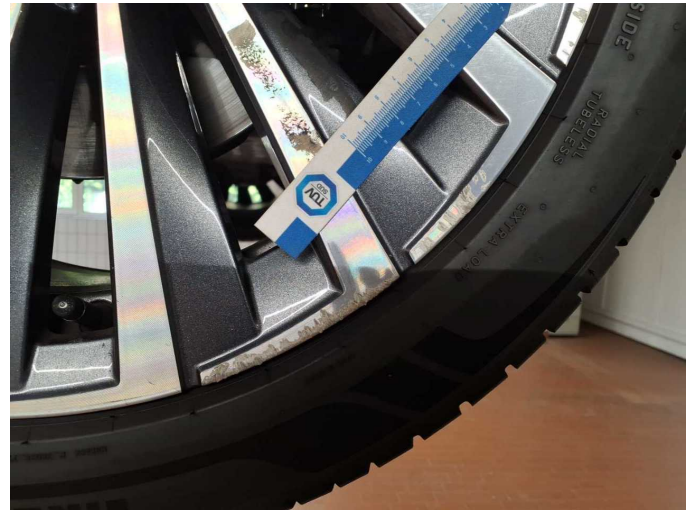
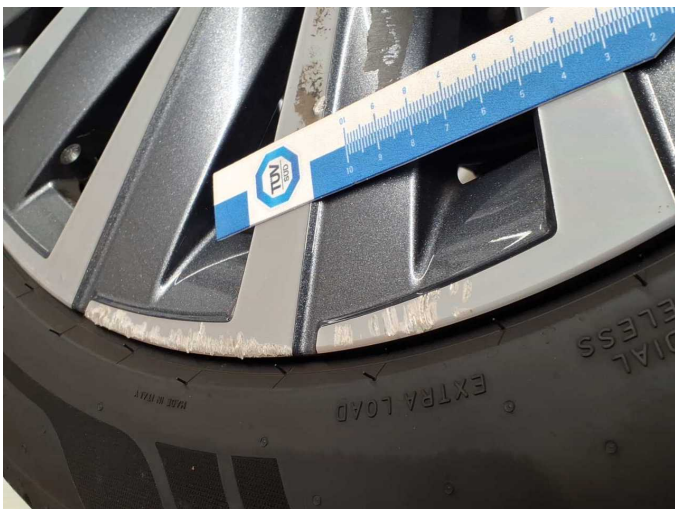
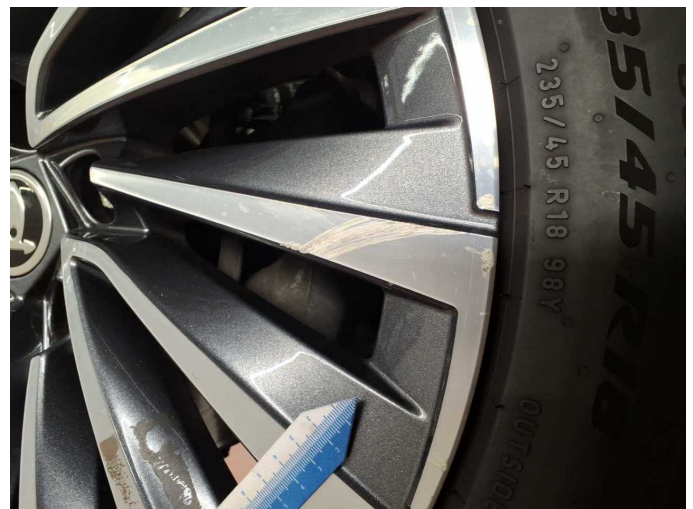
| No. | Component group | Description |
|---|---|---|
| 10 | Wheel / tyres | Alloy rim - front right side - Scratched - Replace |

**Damage 10:** Wheel / tyres: Alloy rim - front right side - Scratched - Replace

| No. | Component group | Description |
|---|---|---|
| 7 | Front axle | Axles / undercarriage (wegen der beschädigten Felgen) - Specify findings - Measure |

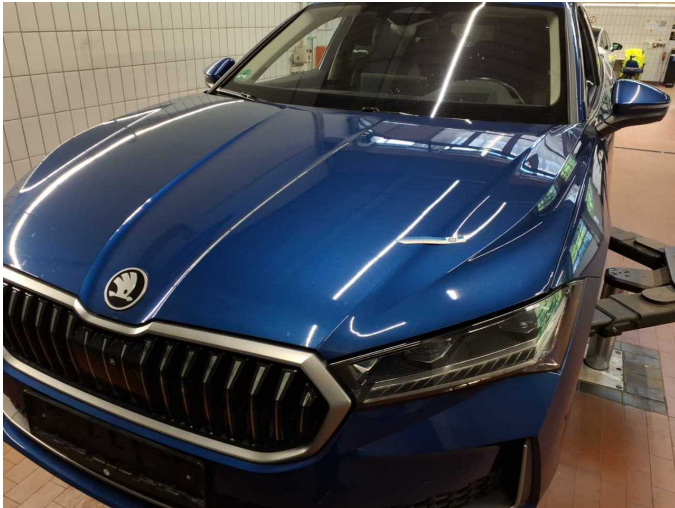
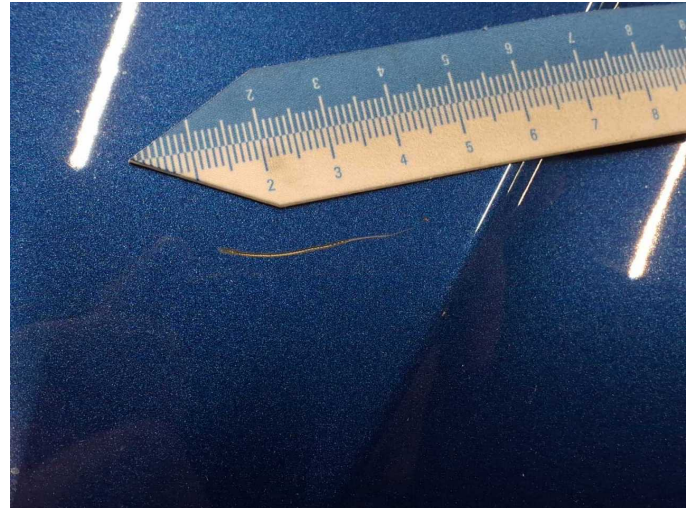
| No. | Component group | Description |
|---|---|---|
| 11 | Bonnet | Bonnet - Scratch(es) - Paint |

**Damage 11:** Bonnet: Bonnet - Scratch(es) - Paint

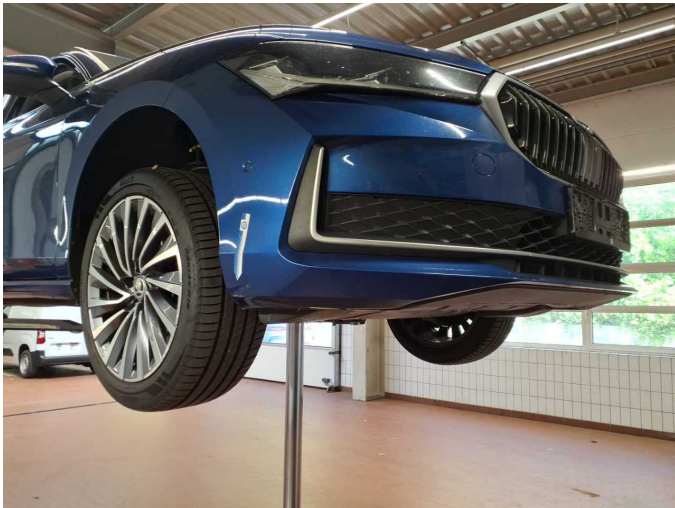
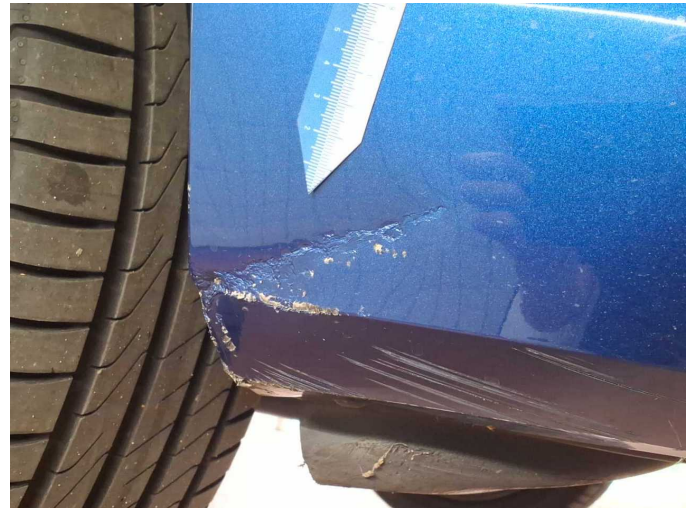
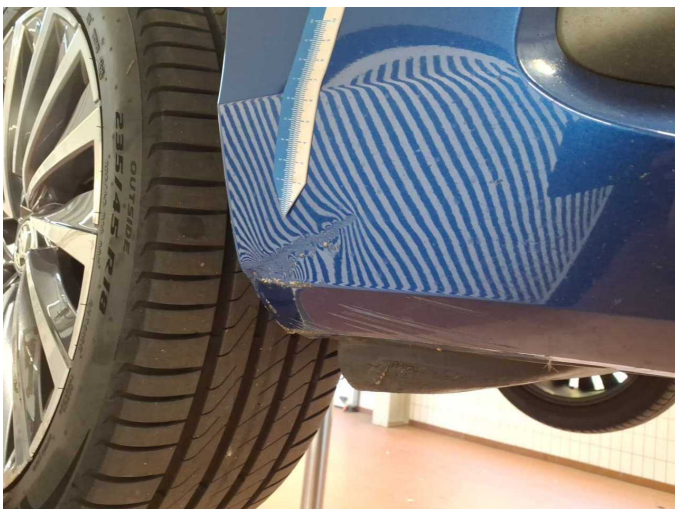
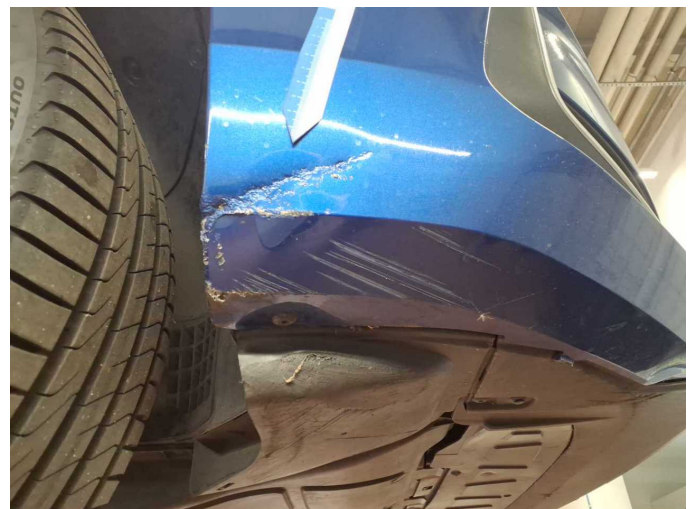
| No. | Component group | Description |
|---|---|---|
| 12 | Front bumper | Front bumper - Deformed - Repair and paint |

**Damage 12:** Front bumper: Front bumper - Deformed - Repair and paint

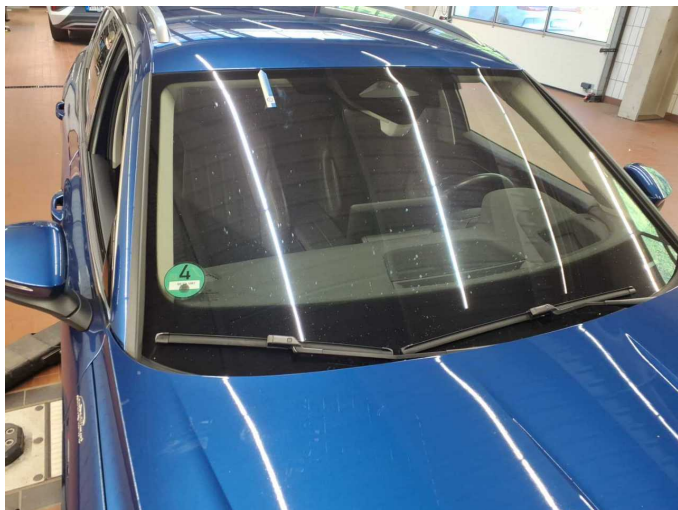
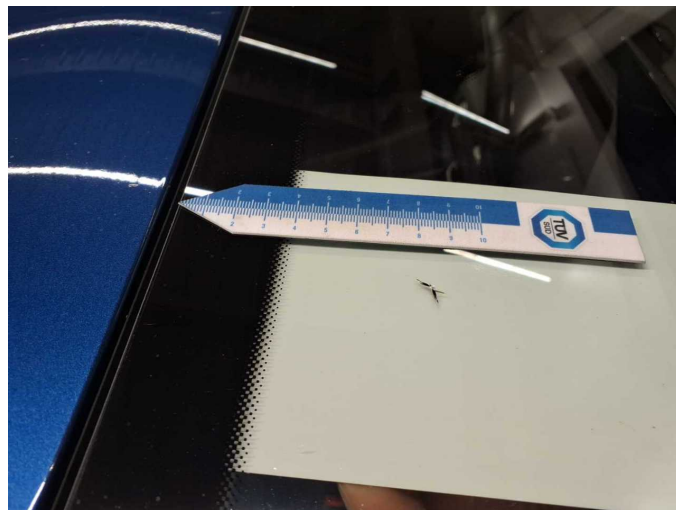
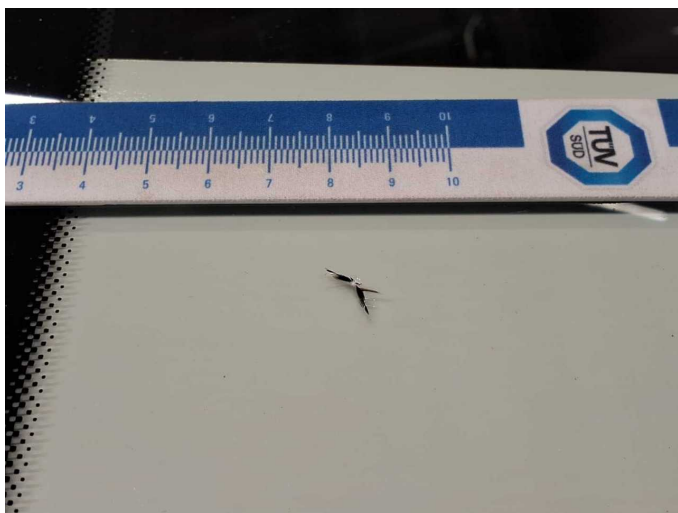
| No. | Component group | Description |
|---|---|---|
| 13 | Vehicle glazing | Windscreen (Randbereich) - Stone chips - repair according to calculation |

**Damage 13:** Vehicle glazing: Windscreen (Randbereich) - Stone chips - repair according to calculation

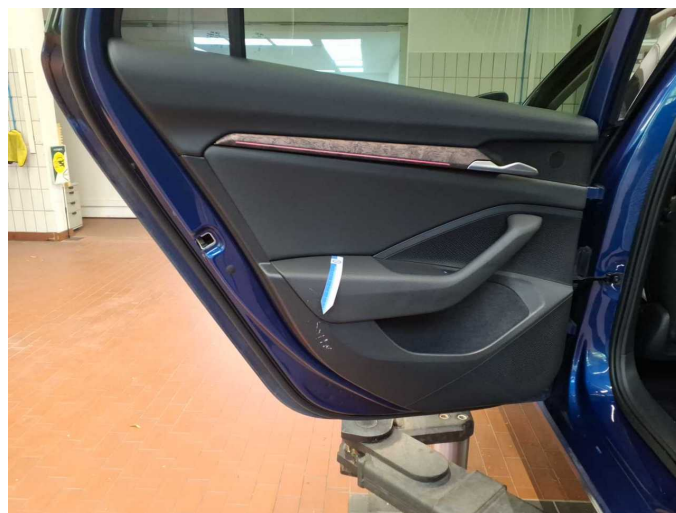
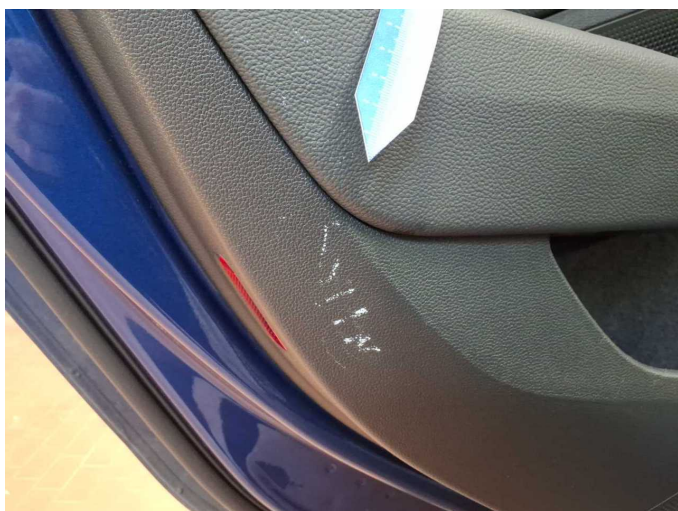
| No. | Component group | Description |
|---|---|---|
| 2 | Trim / covers | Door trim - rear left side - Soiled - No deduction |

**Wear and tear 2:** Trim / covers: Door trim - rear left side - Soiled - No deduction
