Expertise

Protocol number: 46572635  
Order No. / Reference: 26565903  
Inspection date: 17 Jul 2026

Manufacturer: Mercedes-Benz  
VIN: W1N4N1AB9PJ523524

Model: GLA 180 d 8G-DCT Style

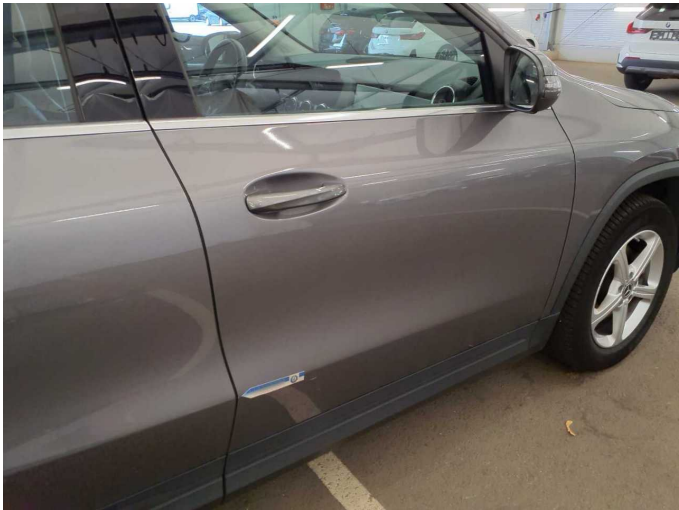
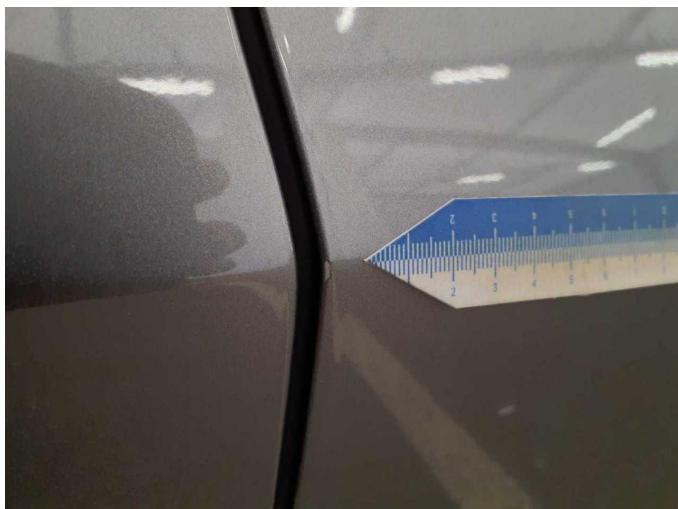
| No. | Component group | Description |
|---|---|---|
| 1 | Door - front right side | Door edge - Scratch(es) - Smart repair |

Damage 1: Door - front right side: Door edge - Scratch(es) - Smart repair

**Damage 1:** Door - front right side: Door edge - Scratch(es) - Smart repair

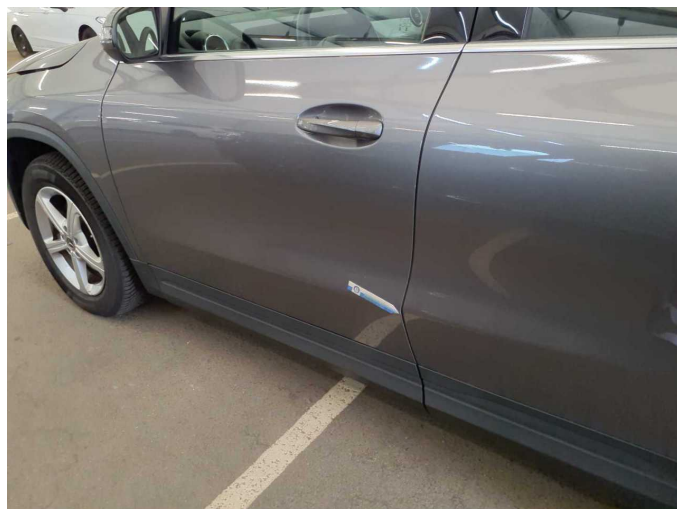
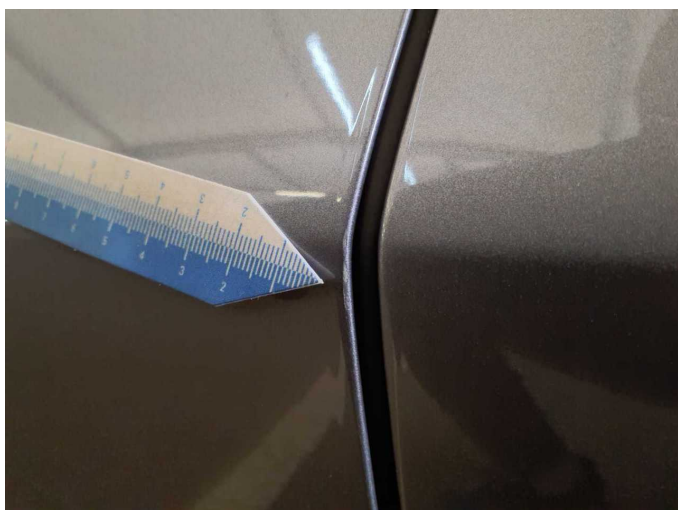
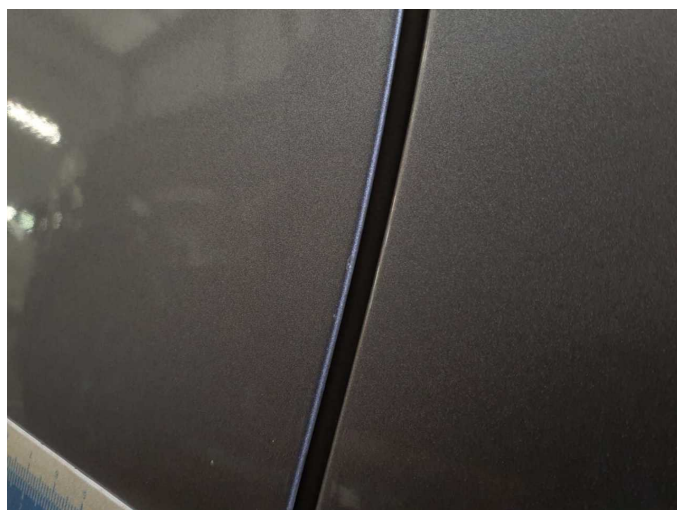
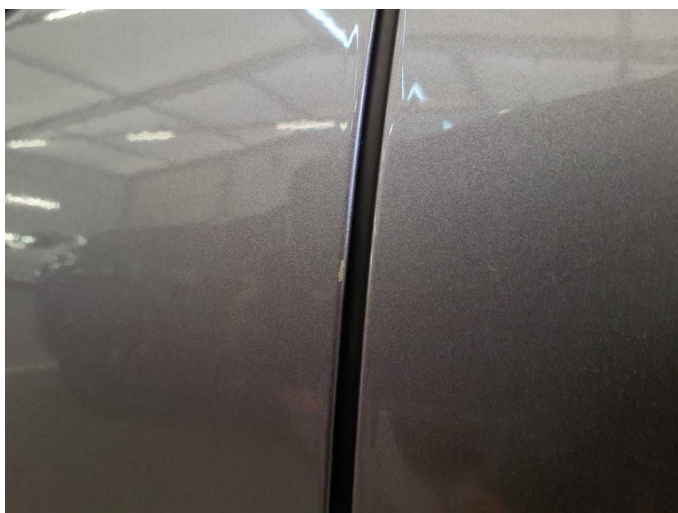
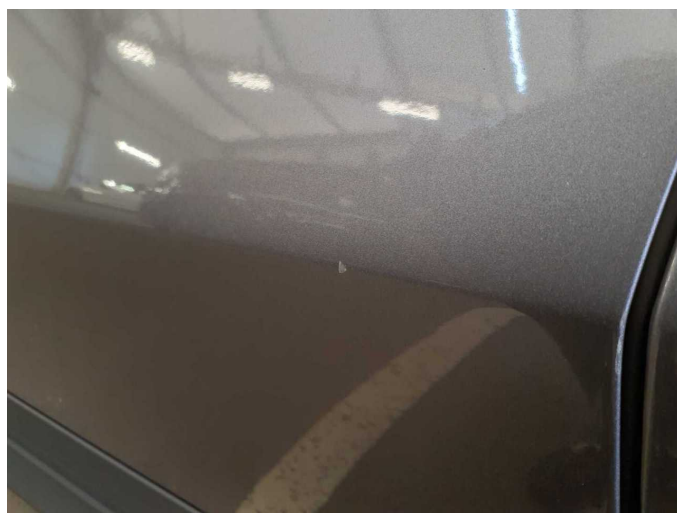
| No. | Component group | Description |
|---|---|---|
| 2 | Door - front left side | Door edge - Scratch(es) - Smart repair |

**Damage 2:** Door - front left side: Door edge - Scratch(es) - Smart repair

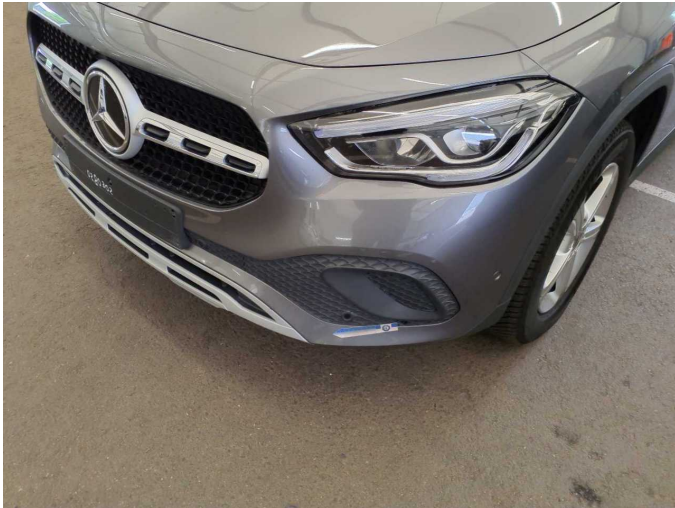
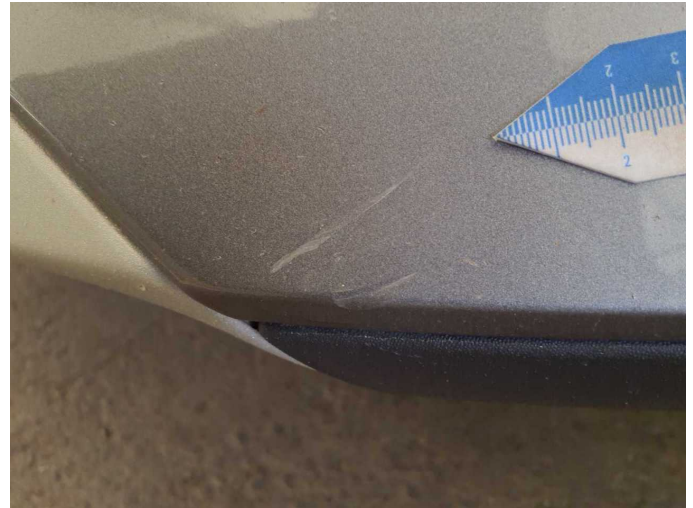
| No. | Component group | Description |
|---|---|---|
| 3 | Front bumper | Front bumper - Scratch(es) - Smart repair |

**Damage 3:** Front bumper: Front bumper - Scratch(es) - Smart repair

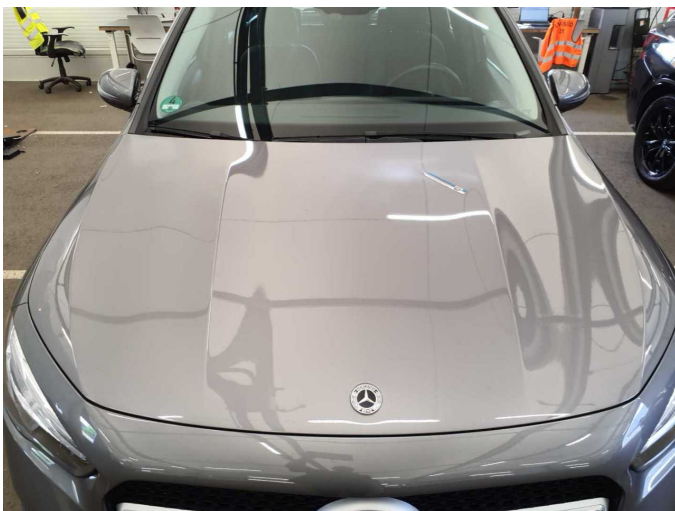
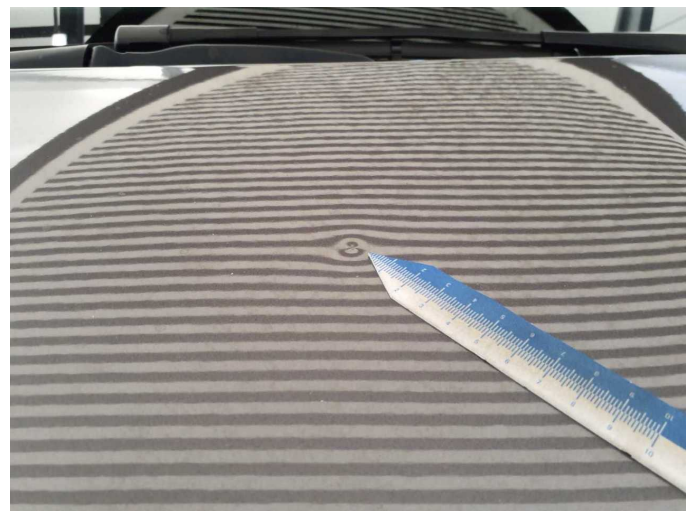
| No. | Component group | Description |
|---|---|---|
| 4 | Bonnet | Bonnet - dent(s) - Smart repair |

**Damage 4:** Bonnet: Bonnet - dent(s) - Smart repair
