Expertise

Protocol number: 46080236  
Order No. / Reference: 26328391  
Inspection date: 22 Jun 2026

Manufacturer: Opel  
VIN: VXKUHZKXZP4042903

Model: Corsa-e Elegance

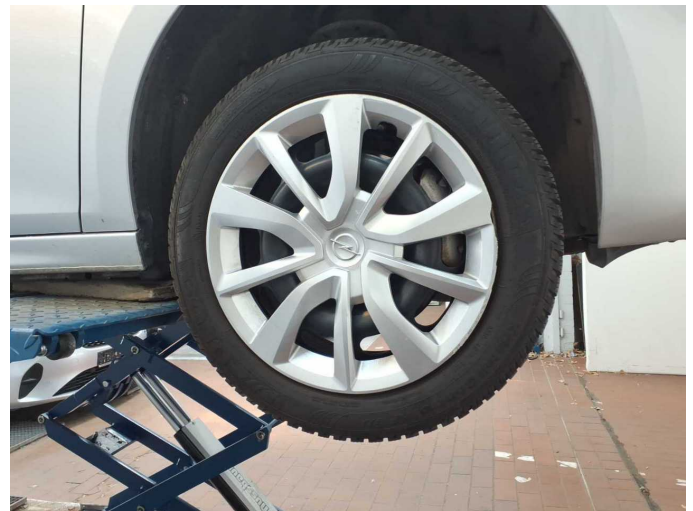
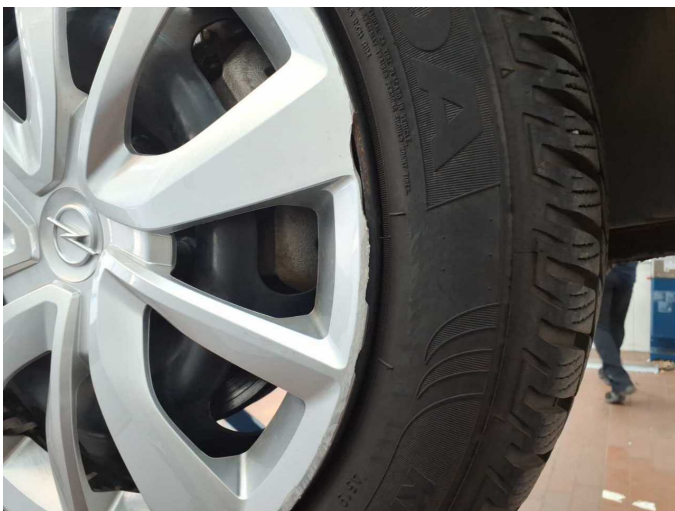
**Damage 2:** Wheel / tyres: Wheel cover - front right side - Broken / torn - Replace

| No. | Component group | Description |
|---|---|---|
| 2 | Wheel / tyres | Wheel cover - front right side - Broken / torn - Replace |

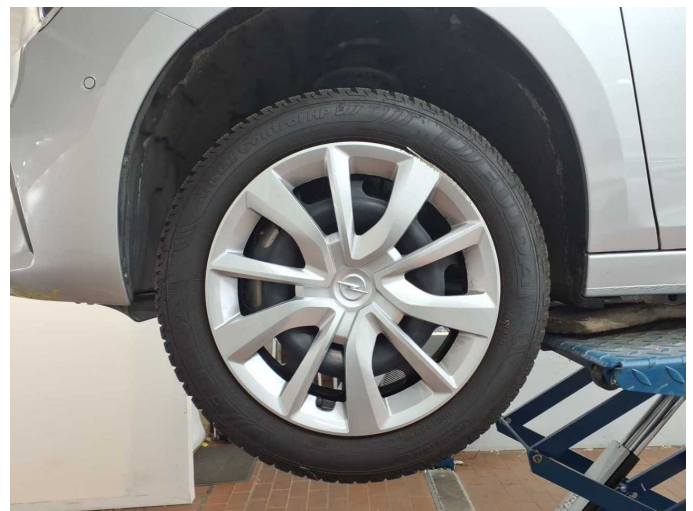
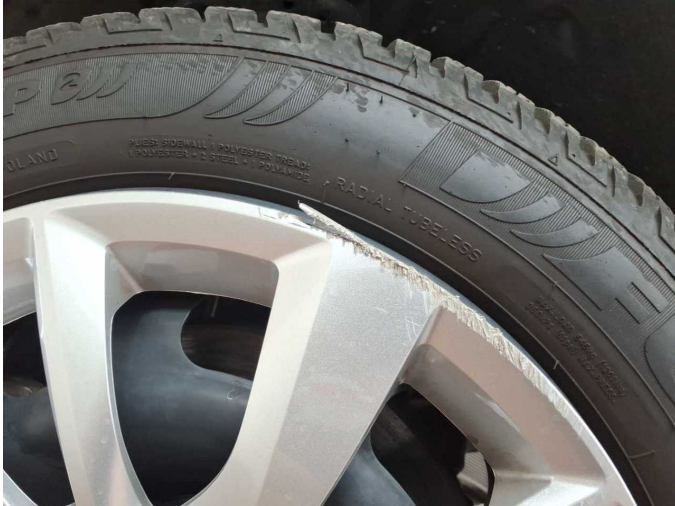
**Damage 3:** Wheel / tyres: Wheel cover - front left side - Broken / torn - Replace

| No. | Component group | Description |
|---|---|---|
| 3 | Wheel / tyres | Wheel cover - front left side - Broken / torn - Replace |

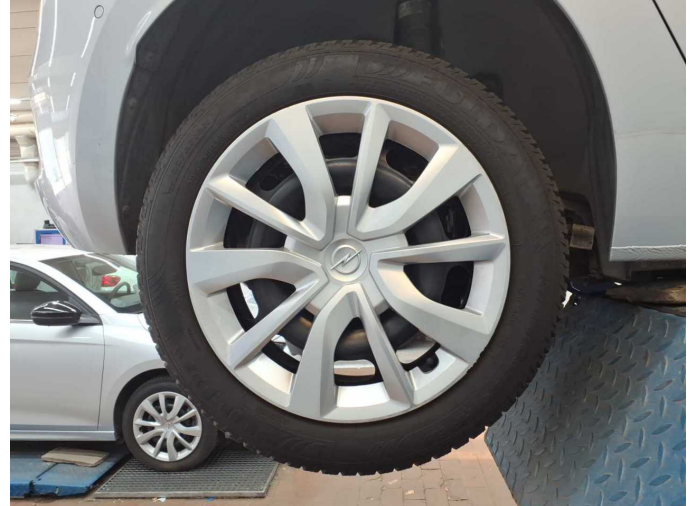
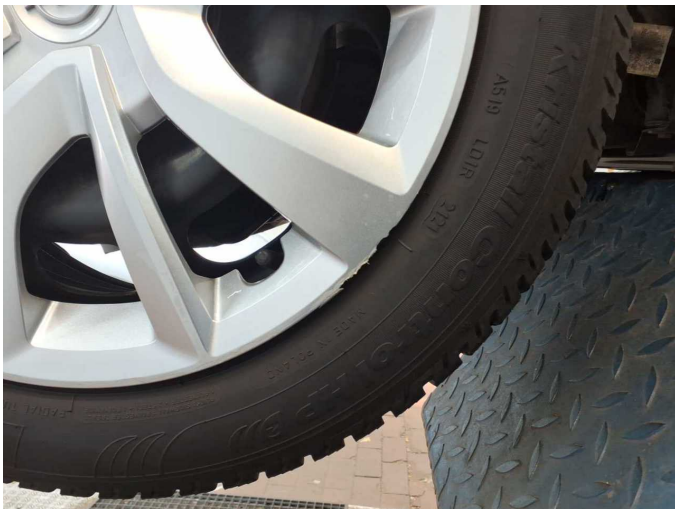
**Damage 4:** Wheel / tyres: Wheel cover - rear right side - Broken / torn - Replace

| No. | Component group | Description |
|---|---|---|
| 4 | Wheel / tyres | Wheel cover - rear right side - Broken / torn - Replace |

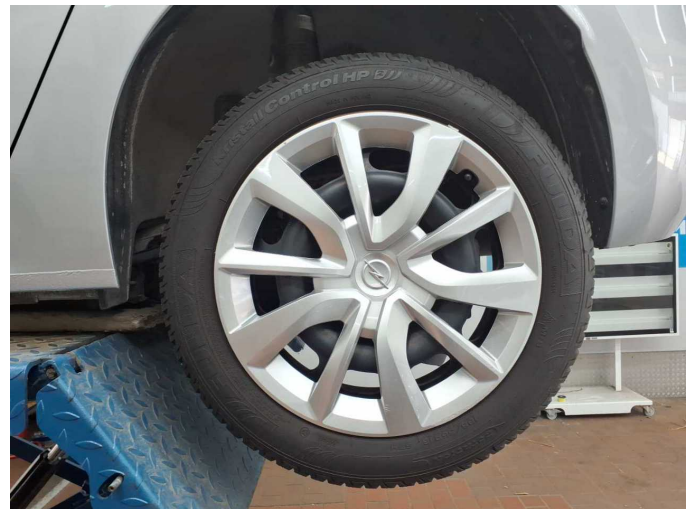
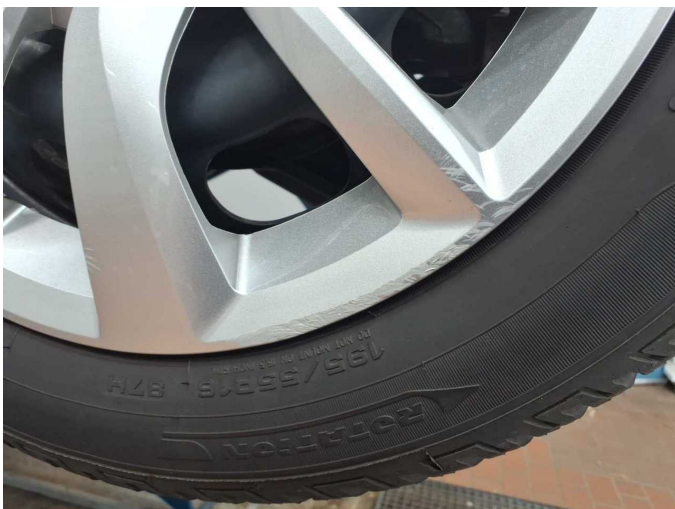
**Damage 5:** Wheel / tyres: Wheel cover - rear left side - Scratch(es) - Replace

| No. | Component group | Description |
|---|---|---|
| 5 | Wheel / tyres | Wheel cover - rear left side - Scratch(es) - Replace |

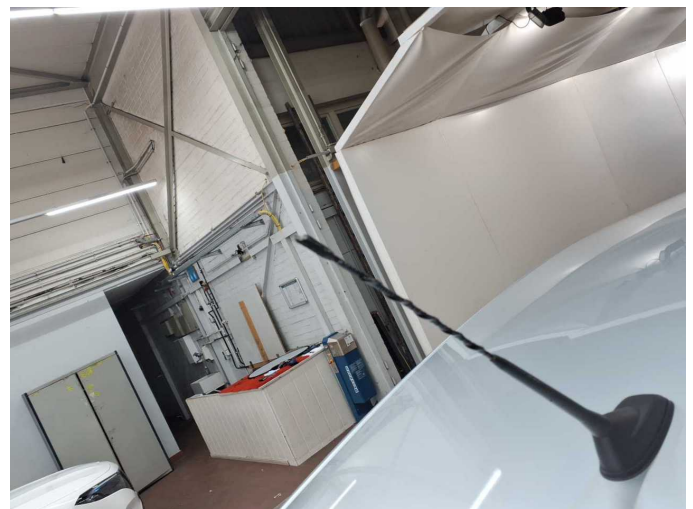
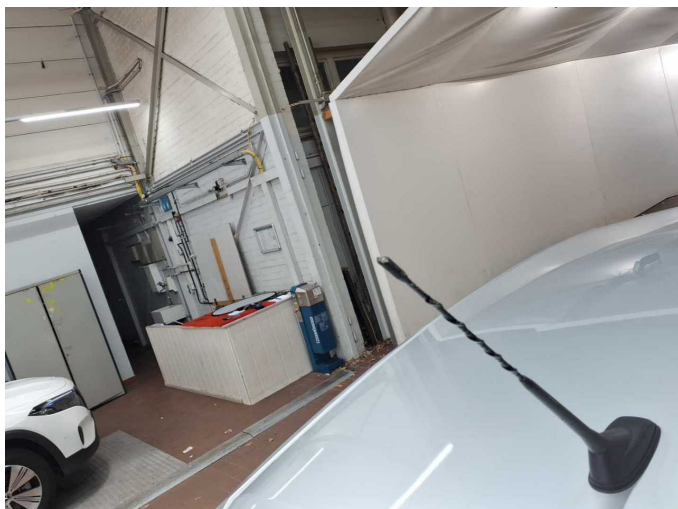
**Damage 6:** Roof: Stub aerial - Damage caused by marten / rodent - Replace

| No. | Component group | Description |
|---|---|---|
| 6 | Roof | Stub aerial - Damage caused by marten / rodent - Replace |

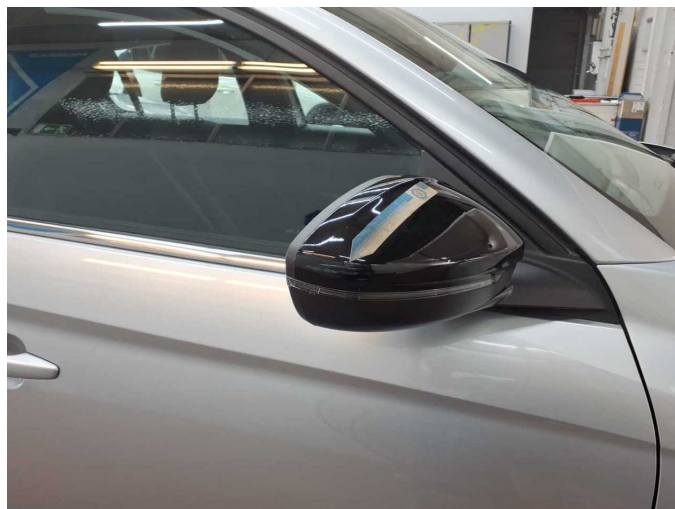
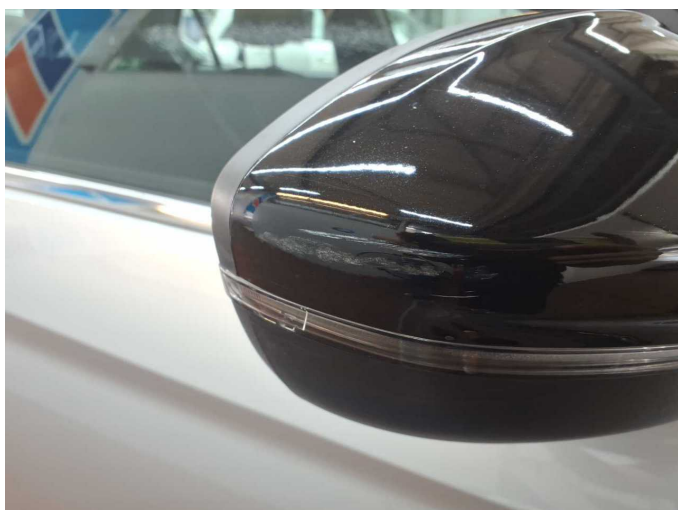
**Damage 7:** Wing mirror - right side: Cap - Scratch(es) - Smart repair

| No. | Component group | Description |
|---|---|---|
| 7 | Wing mirror - right side | Cap - Scratch(es) - Smart repair |

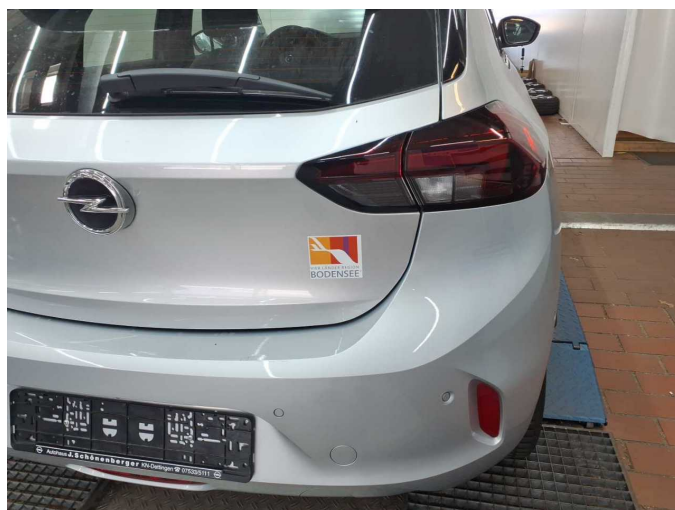
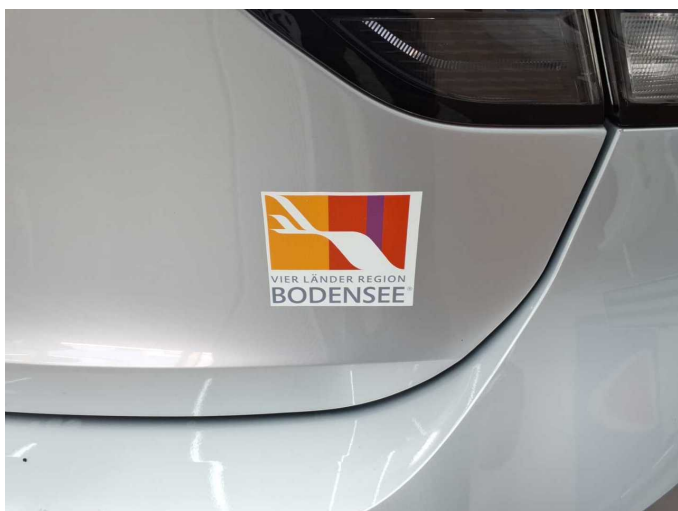
**Damage 8:** Boot lid / rear door: Boot lid - Glued / labelled - De-glue / neutralise

| No. | Component group | Description |
|---|---|---|
| 8 | Boot lid / rear door | Boot lid - Glued / labelled - De-glue / neutralise |

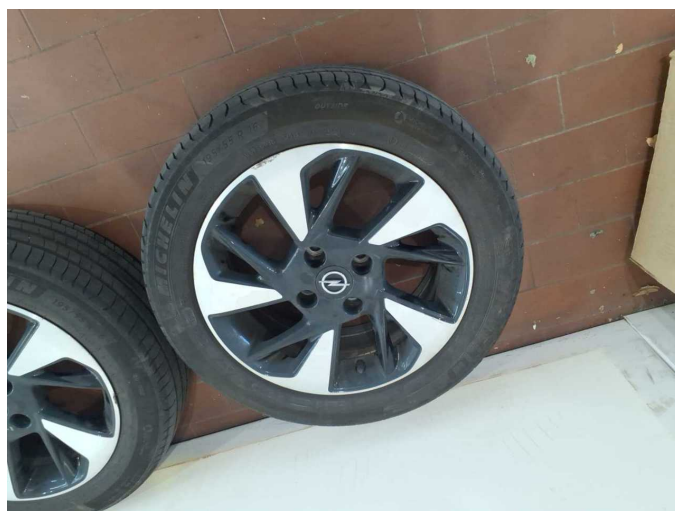
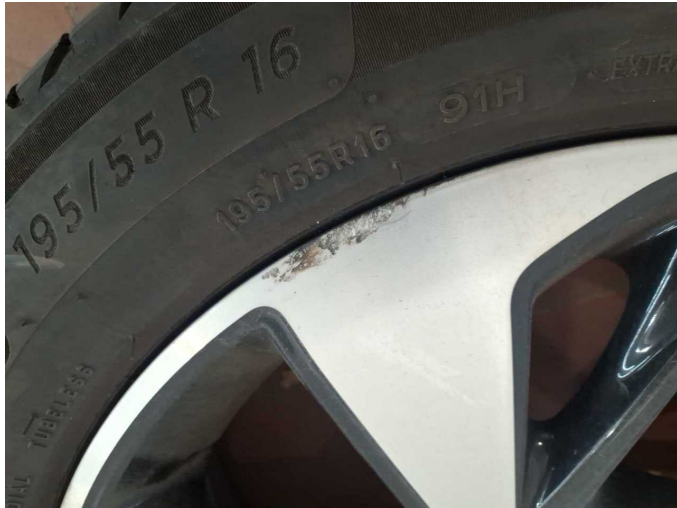
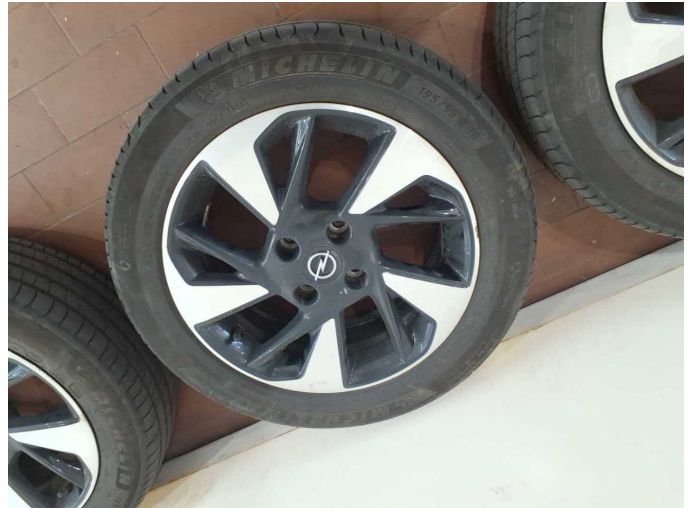
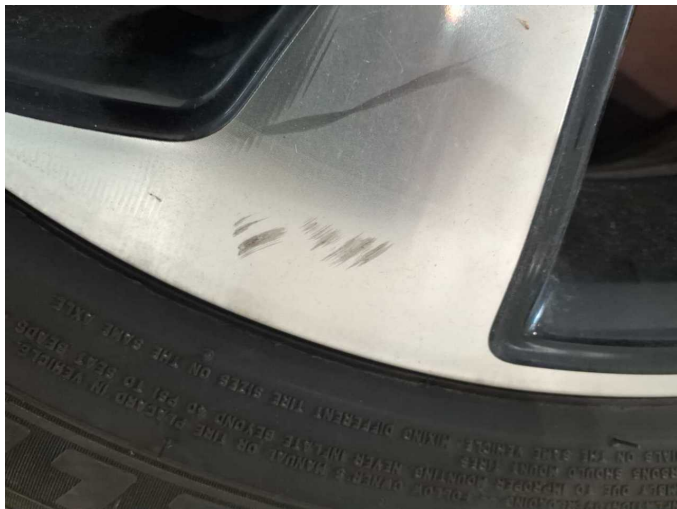
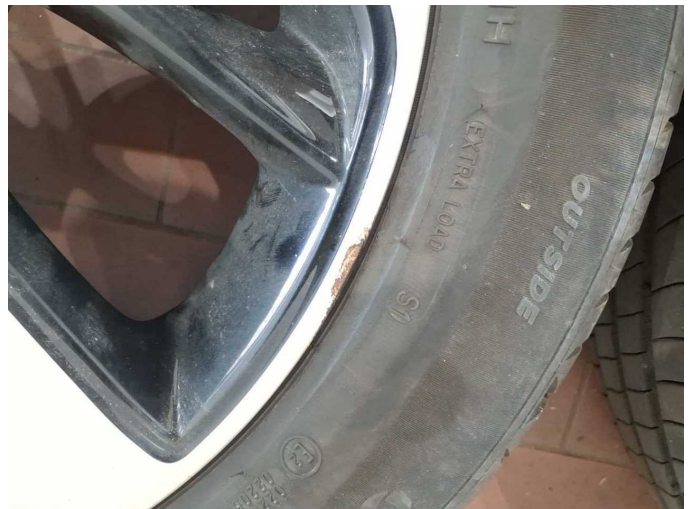
**Damage 9:** 2nd wheel set: 2 alloy rims - Scratch(es) - Loss in value

| No. | Component group | Description |
|---|---|---|
| 9 | 2nd wheel set | 2 alloy rims - Scratch(es) - Loss in value |

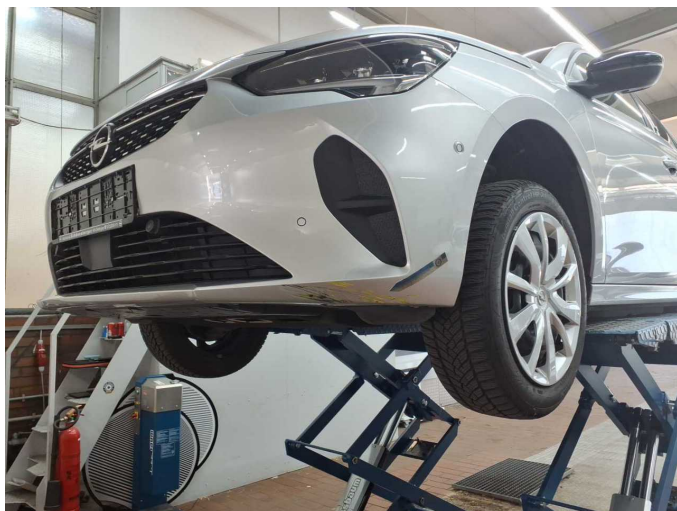
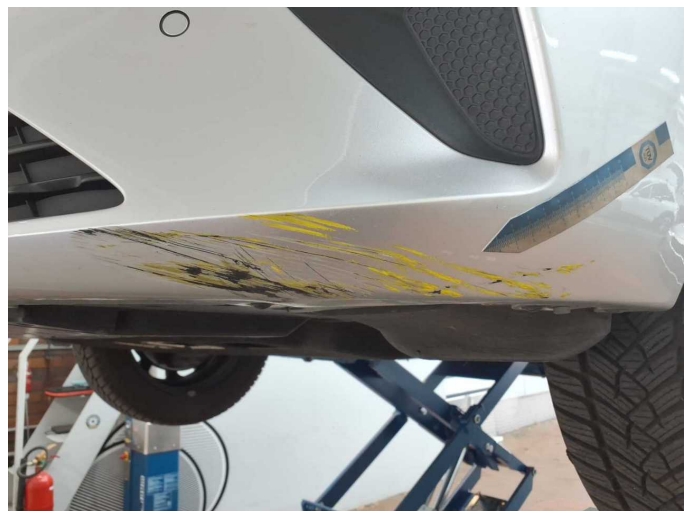
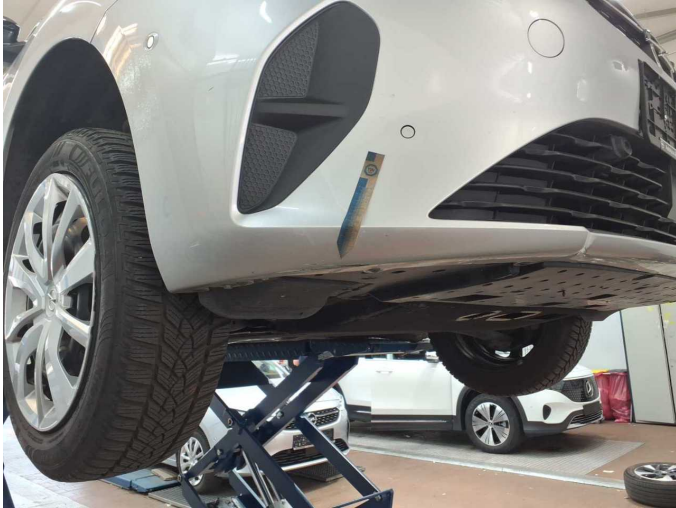
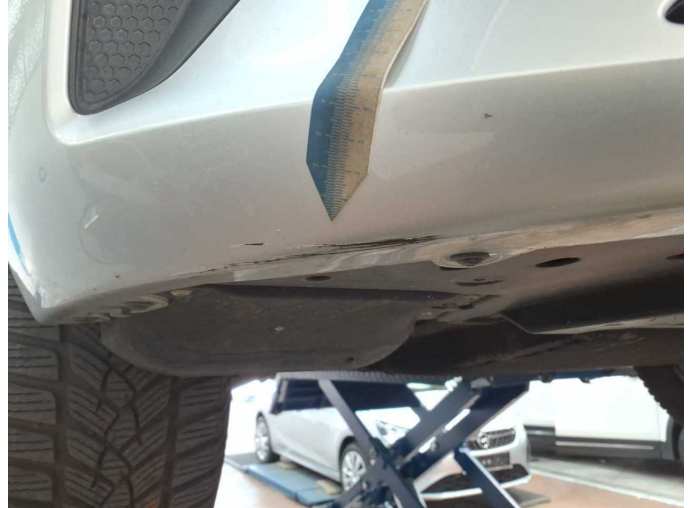
**Damage 10:** Front bumper: Front bumper - Scratch(es) - Paint

| No. | Component group | Description |
|---|---|---|
| 10 | Front bumper | Front bumper - Scratch(es) - Paint |
