Expertise

Protocol number: 46826525  
Order No. / Reference: 26640025  
Inspection date: 29 Jul 2026

Model: GLE 350 de 4Matic 9G-TRONIC AMG Line

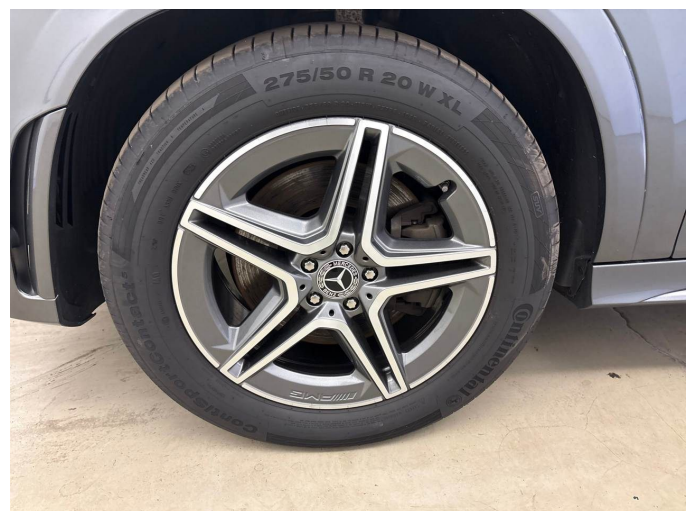
**Figure 12: Mounted tyres**

| # | Tyre size | Type of tyre | Manufacturer | Tread depth |
|---|---|---|---|---|
| 1) | 275/50 R20 113W | Summer tyres on Light alloy | Continental | 5mm / 5mm |
| 2) | 275/50 R20 113W | Summer tyres on Light alloy | Continental | 5mm / 5mm |

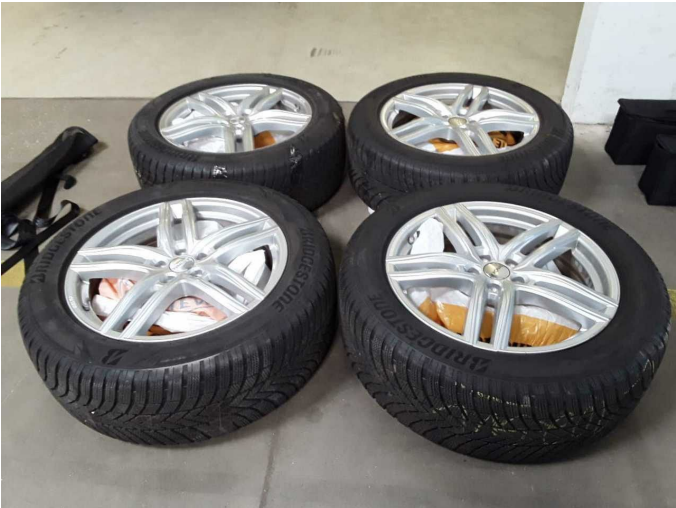
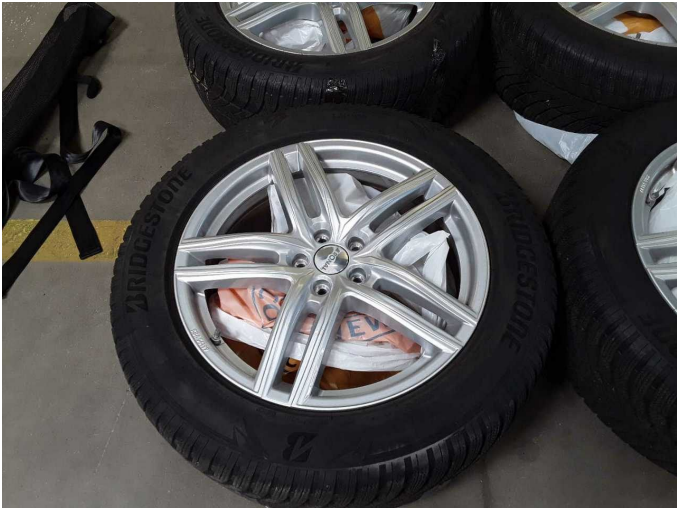
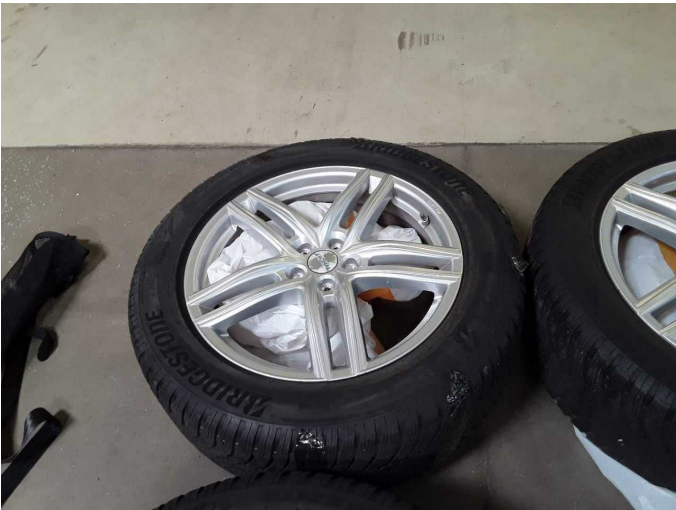
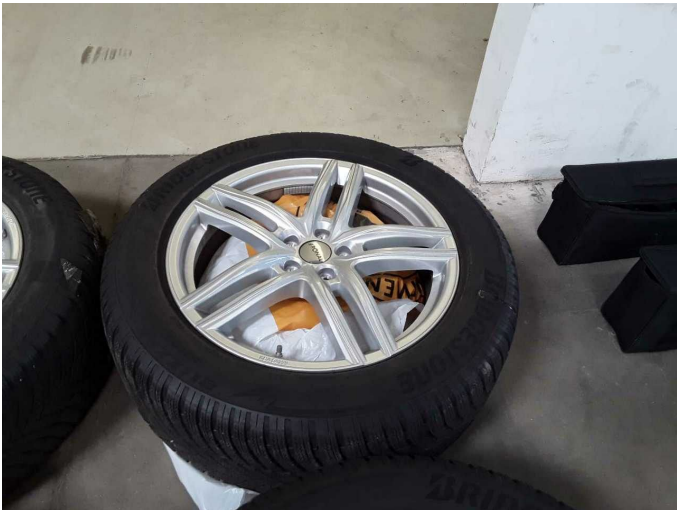
| # | Tyre size | Type of tyre | Manufacturer | Tread depth |
|---|---|---|---|---|
| 1) | 275/50 R20 113V | Winter tyres on Light alloy | Bridgestone | 7mm / 7mm |
| 2) | 275/50 R20 113V | Winter tyres on Light alloy | Bridgestone | 6mm / 6mm |

Figure 15: Additional tyres

Figure 16: Additional tyres

Figure 17: Additional tyres

Figure 18: Additional tyres

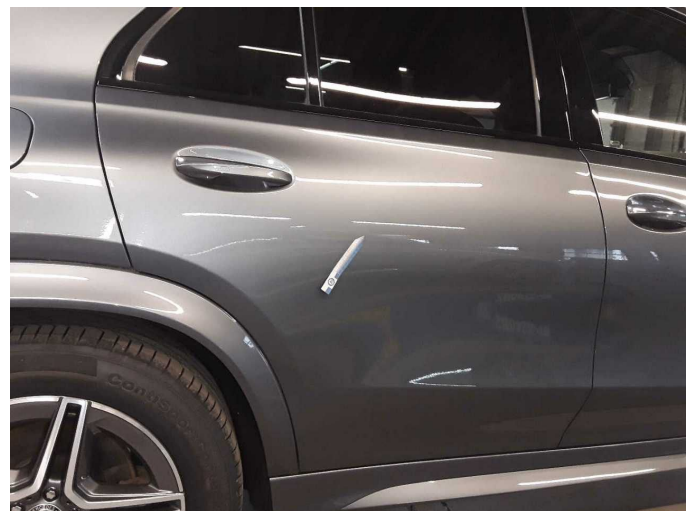
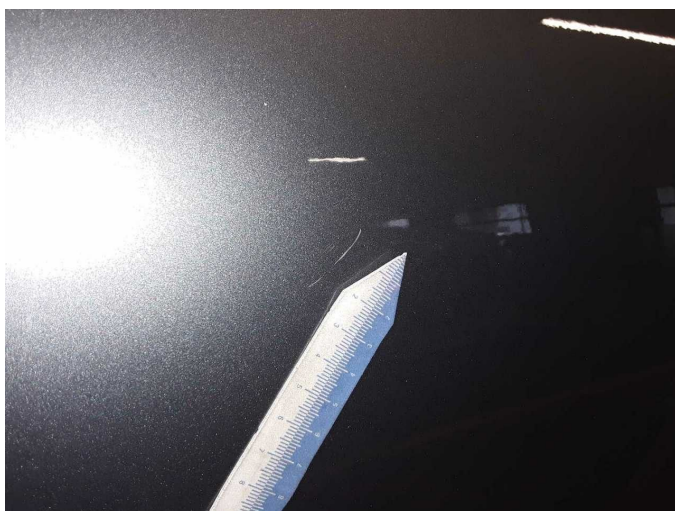
**Damage 1:** Door - rear right side: Door - Abrasion - Smart repair

| No. | Component group | Description |
|---|---|---|
| 1 | Door - rear right side | Door - Abrasion - Smart repair |

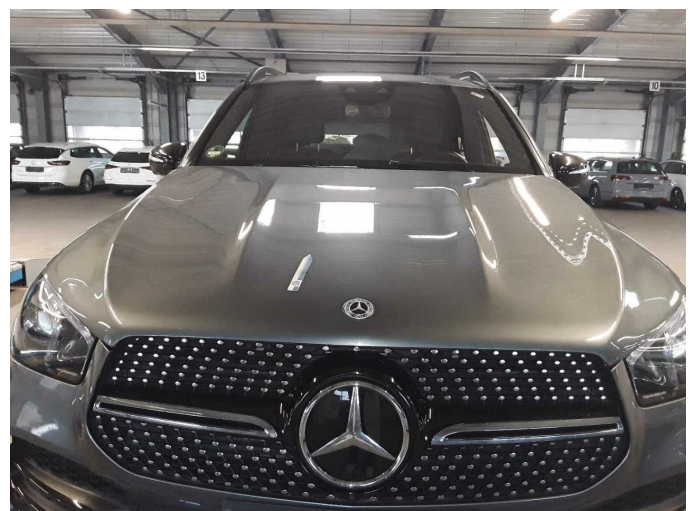
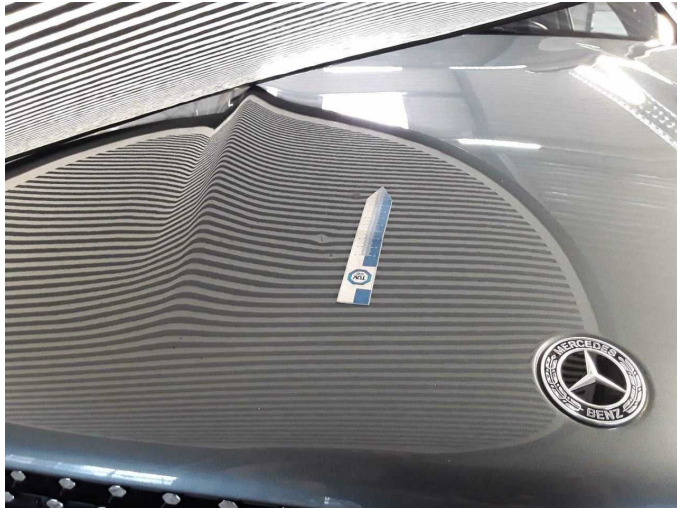
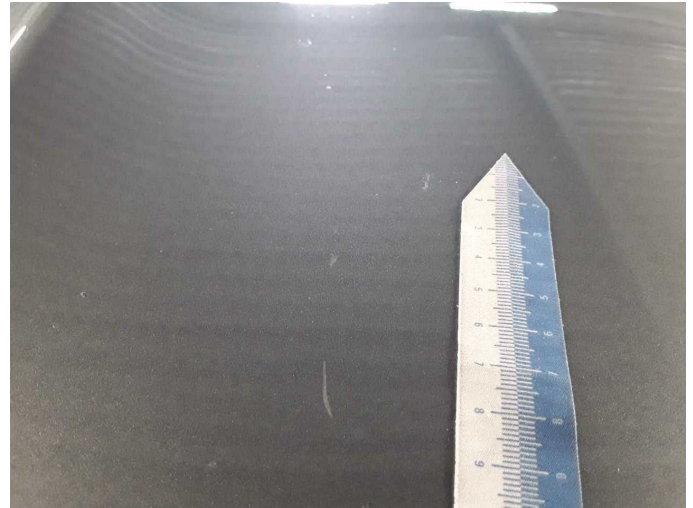
**Damage 2:** Bonnet: Bonnet - Dent / paintcoat damage - Paint

| No. | Component group | Description |
|---|---|---|
| 2 | Bonnet | Bonnet - Dent / paintcoat damage - Paint |

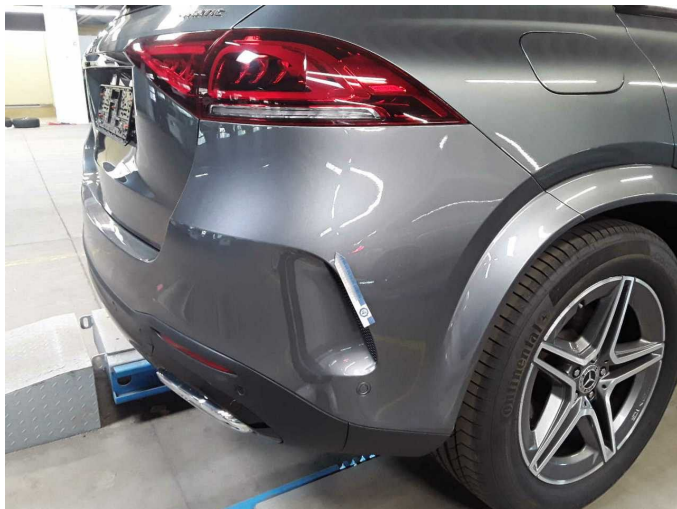
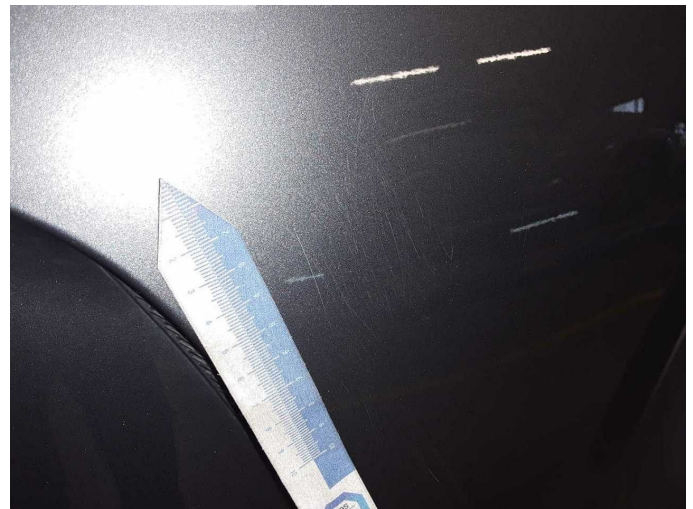
**Wear and tear 1:** Rear bumper: Rear bumper - Abrasion - Cover / polish

| No. | Component group | Description |
|---|---|---|
| 1 | Rear bumper | Rear bumper - Abrasion - Cover / polish |
