Expertise

Protocol number: 46049048  
Order No. / Reference: 26426754  
Inspection date: 15 Jun 2026

Manufacturer: Mercedes-Benz

Model: GLB 220 d 4Matic 8G-DCT AMG Line

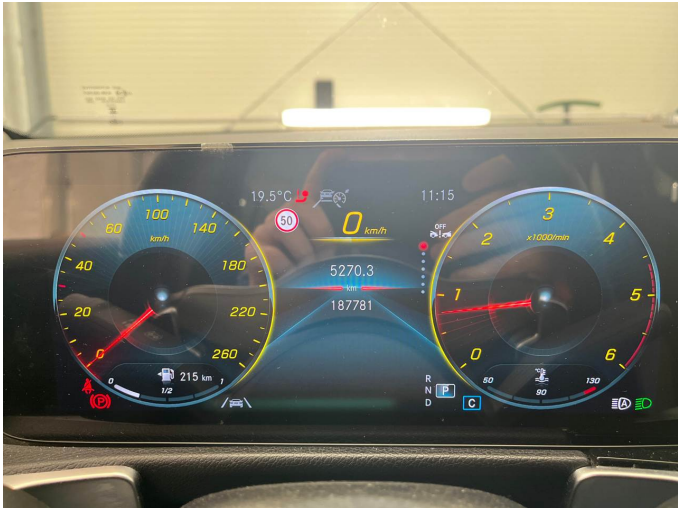
| Vehicle details | |
|---|---|
| Mileage (Read) | 187,781 km |

Figure 7: Instrument cluster

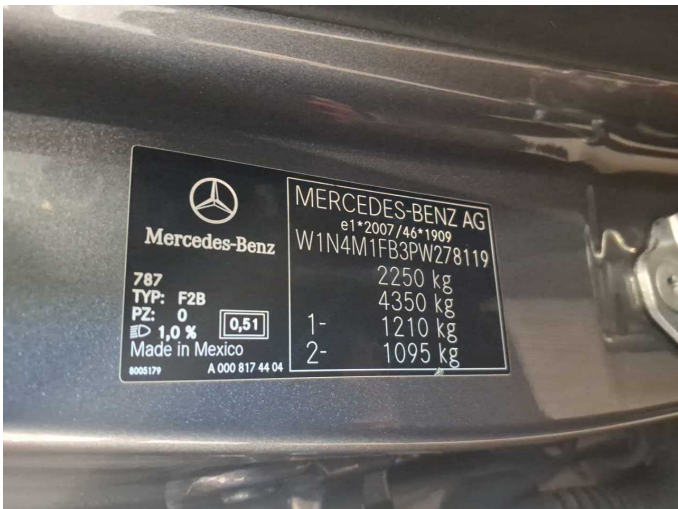
| VIN comparison | The vehicle identification number (VIN) was read from the vehicle and its conformity with the submitted documents was confirmed by the undersigned during the inspection. |

Figure 11: VIN

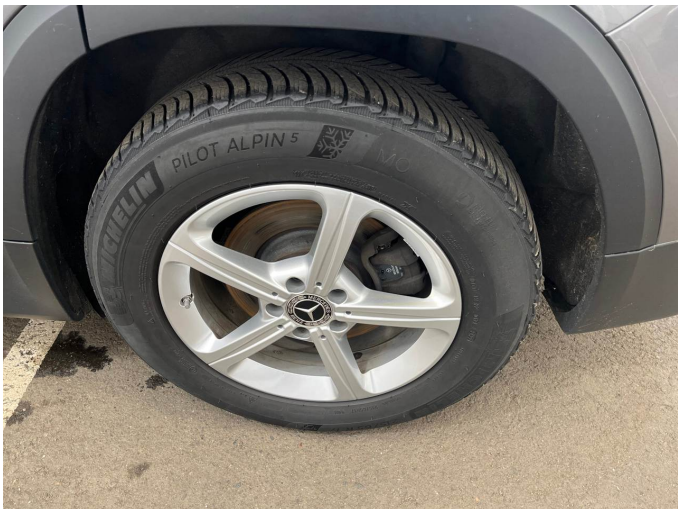
| # | Tyre size | Type of tyre | Manufacturer | Tread depth |
|---|---|---|---|---|
| 1) | 215/65 R17 99H | Winter tyres on Light alloy | Michelin | 5mm / 5mm |
| 2) | 215/65 R17 99H | Winter tyres on Light alloy | Michelin | 6mm / 6mm |

Figure 12: Mounted tyres

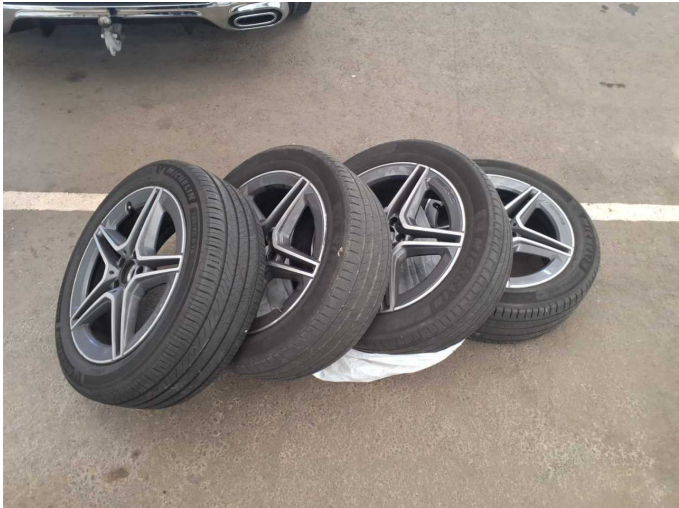
| # | Tyre size | Type of tyre | Manufacturer | Tread depth |
|---|---|---|---|---|
| 1) | 235/50 R19 103W | Summer tyres on Light alloy | Michelin | 5mm / 5mm |
| 2) | 235/50 R19 103W | Summer tyres on Light alloy | Michelin | 6mm / 6mm |

Figure 16: Additional tyres

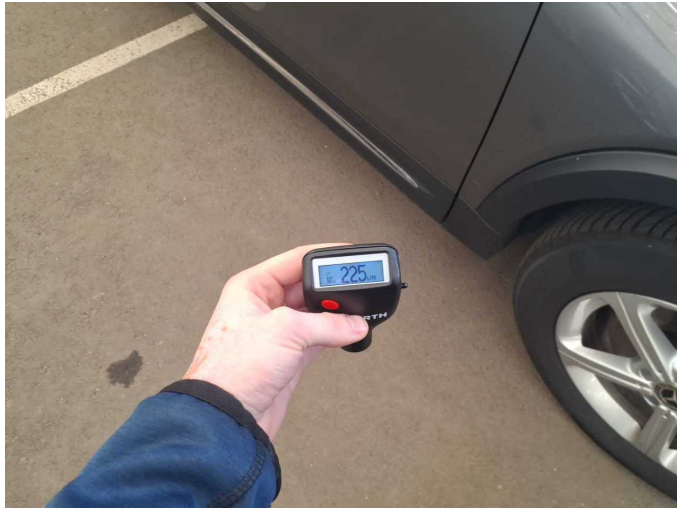
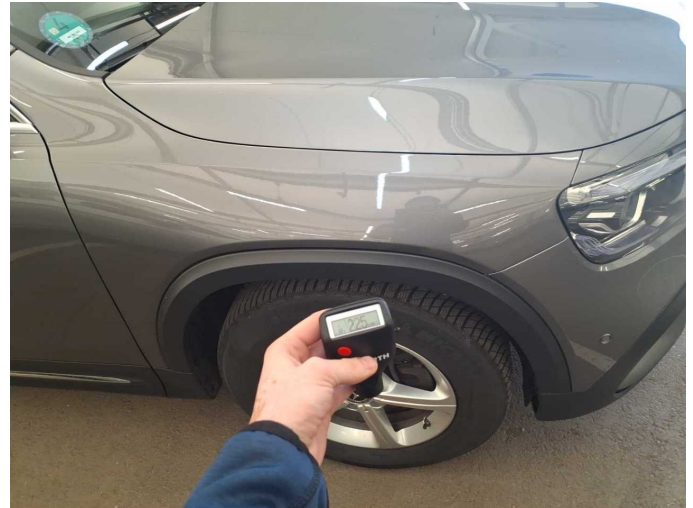
| No. | Repainting |
|---|---|
| 1 | Mudguard - right side |

| Mudguard - right side | 225 µm | Side panel - rear right side | 270 µm |

**Repainting 1:** Mudguard - right side

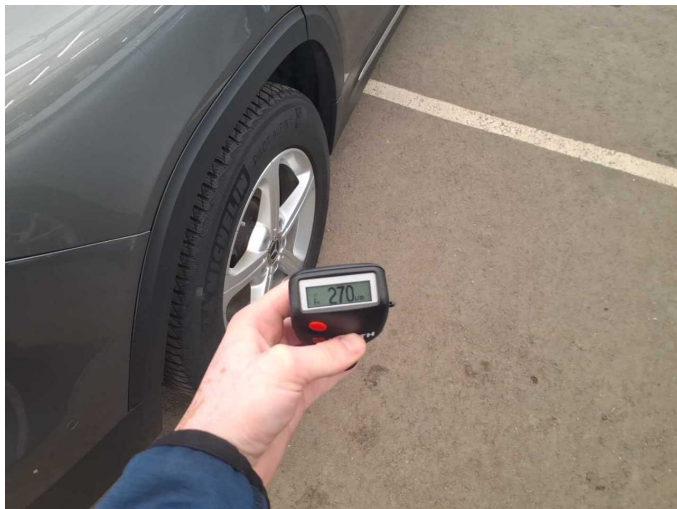
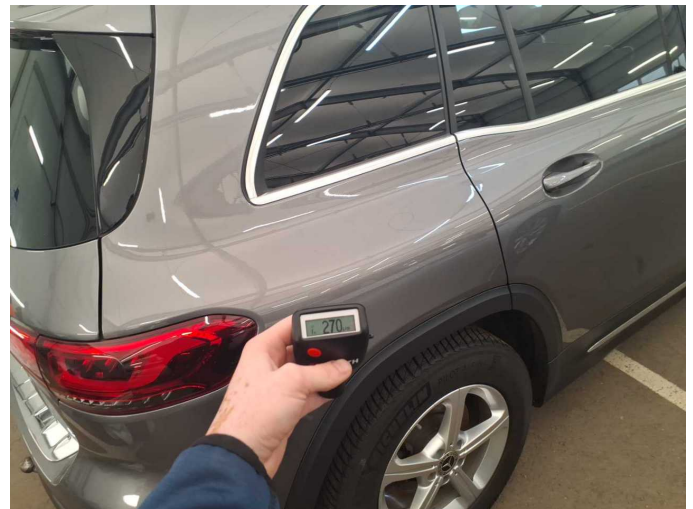
| No. | Repainting |
|---|---|
| 2 | Side panel - rear right side |

**Repainting 2:** Side panel - rear right side
