Expertise

Protocol number: 46703538  
Order No. / Reference: 26689110  
Inspection date: 23 Jul 2026

Manufacturer: Skoda  
VIN: TMBLJ9NS9P8007517

Model: Kodiah 2.0 TDI 4x4 DSG Ambition

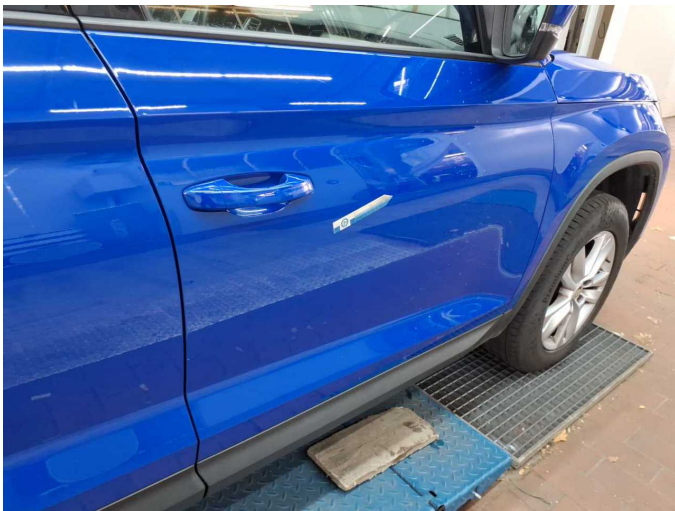
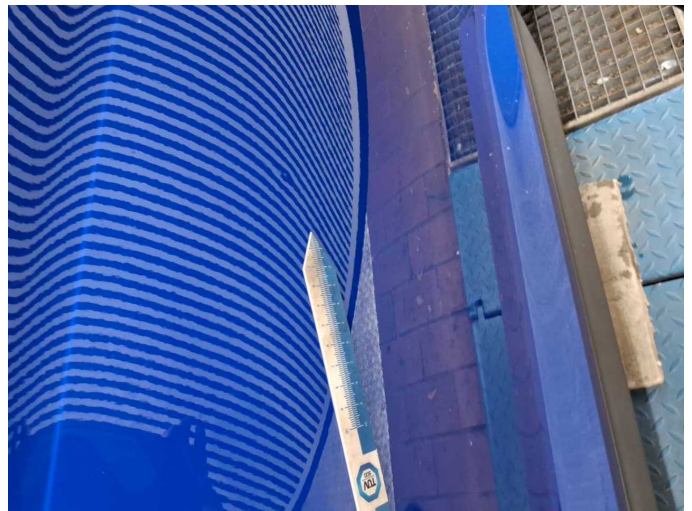
| No. | Component group | Description |
|---|---|---|
| 2 | Door - front right side | Door - dent(s) - Smart repair |

Damage 2: Door - front right side: Door - dent(s) - Smart repair

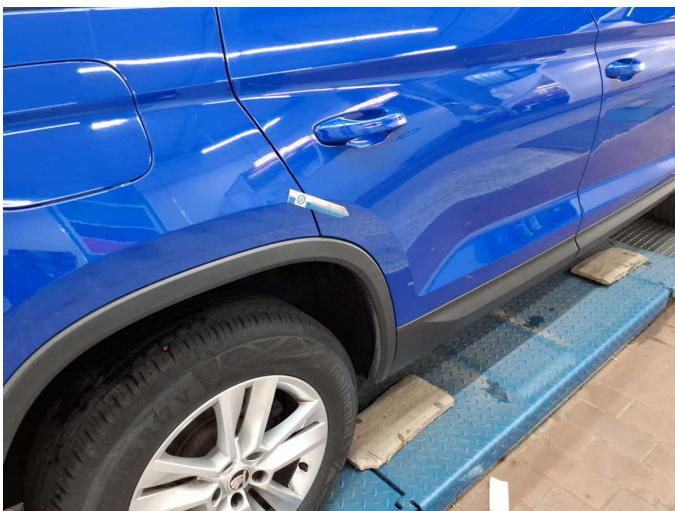
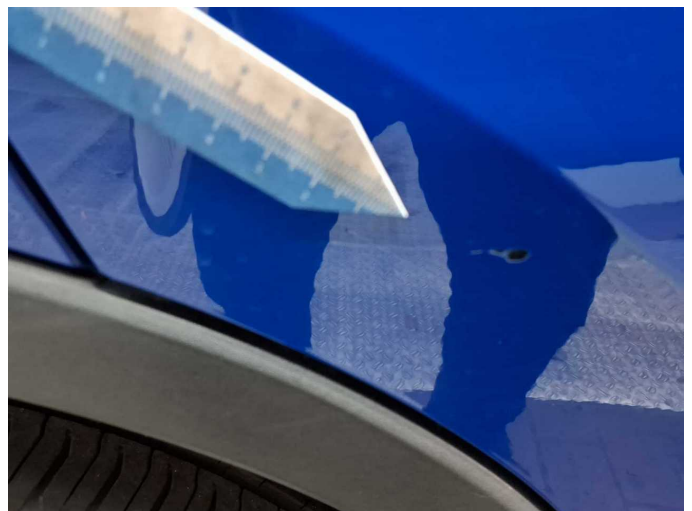
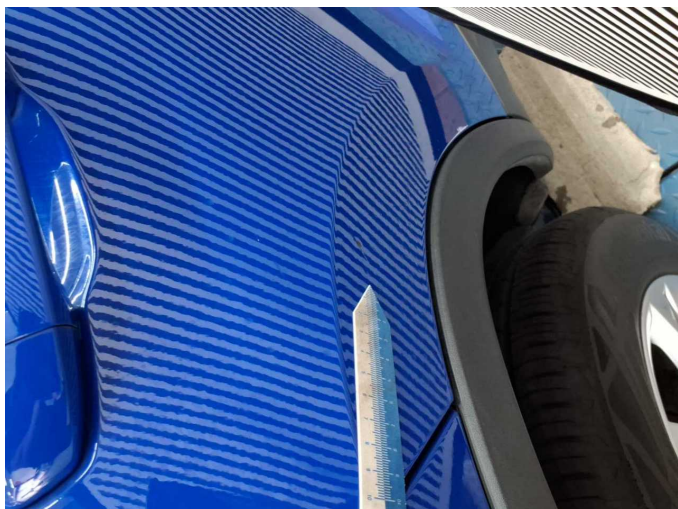
| No. | Component group | Description |
|---|---|---|
| 3 | Door - rear right side | Door - Dent / paintcoat damage - Smart repair |

Damage 3: Door - rear right side: Door - Dent / paintcoat damage - Smart repair

**Damage 3:** Door - rear right side: Door - Dent / paintcoat damage - Smart repair

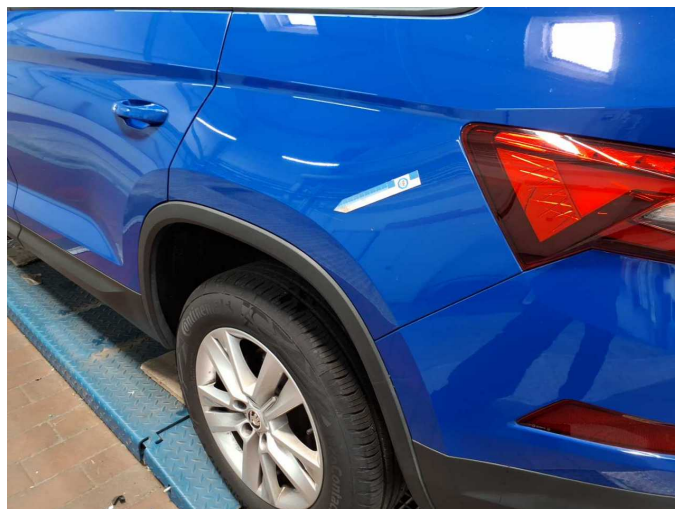
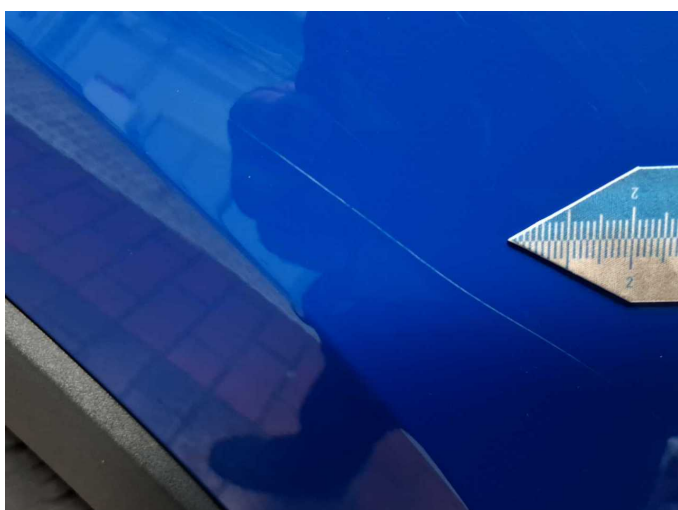
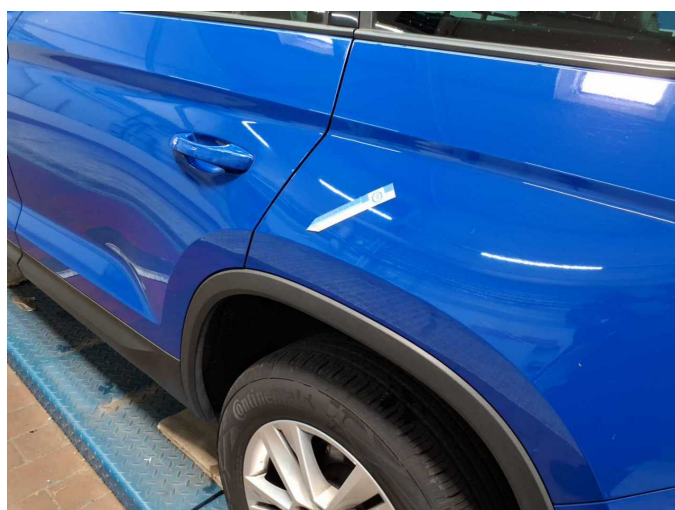
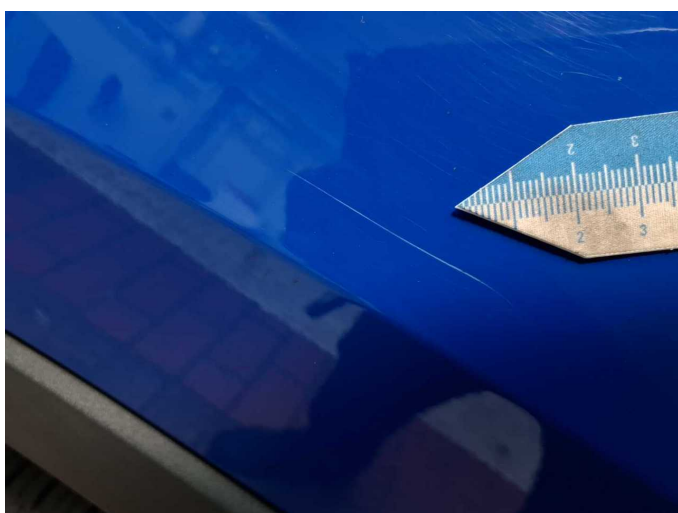
| No. | Component group | Description |
|---|---|---|
| 4 | Side panel - rear left side | Side panel - Scratch(es) - Paint |

**Damage 4:** Side panel - rear left side: Side panel - Scratch(es) - Paint

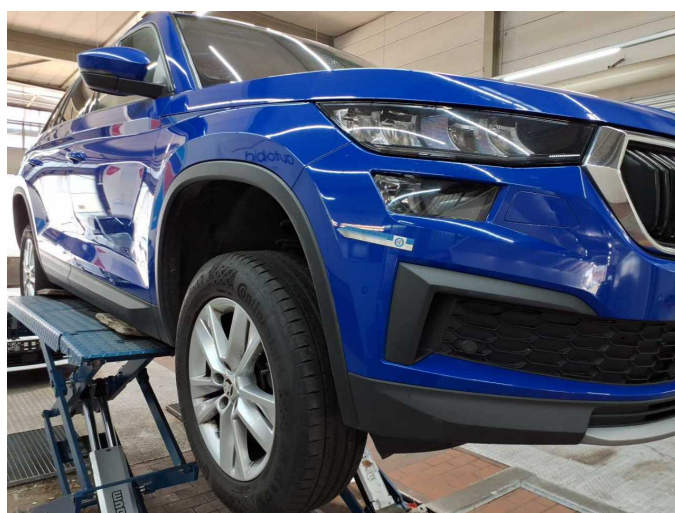
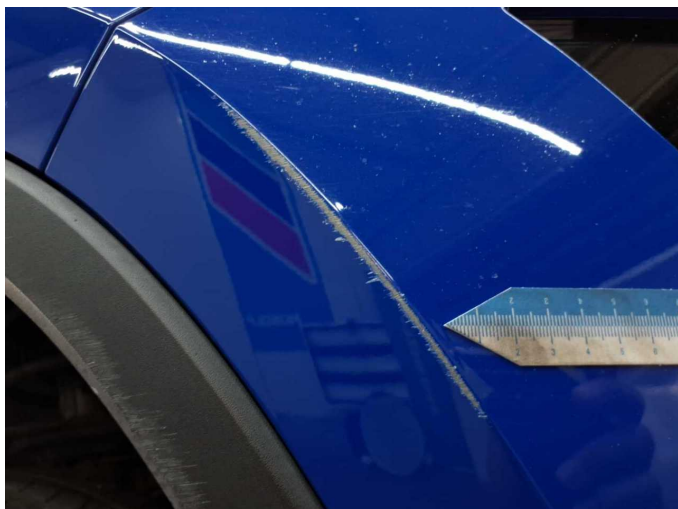
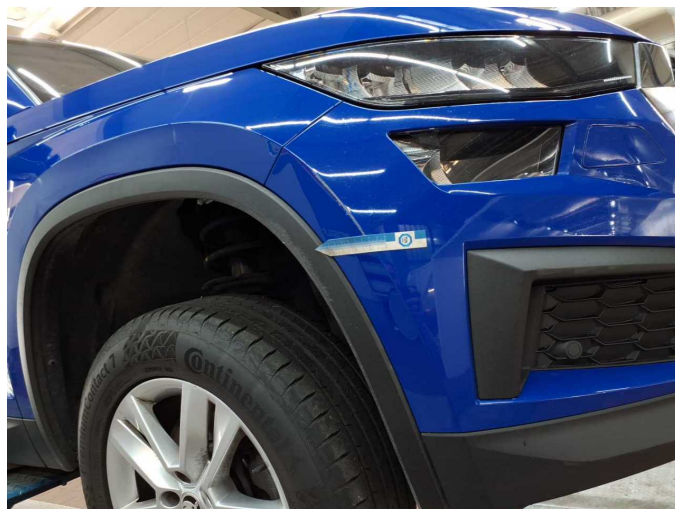
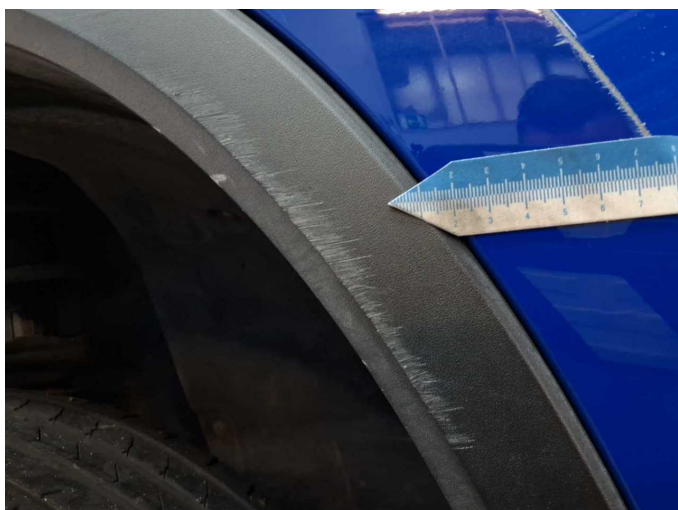
| No. | Accident |
|---|---|
| 1 | Front, Side right |

**Accident 1:** Front, Side right

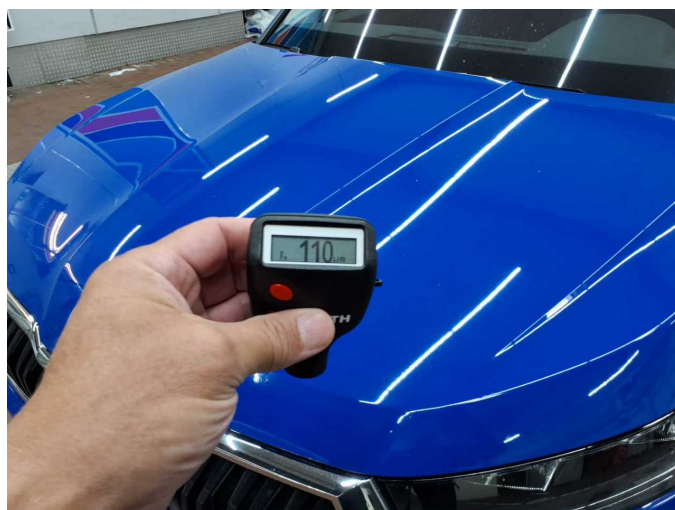
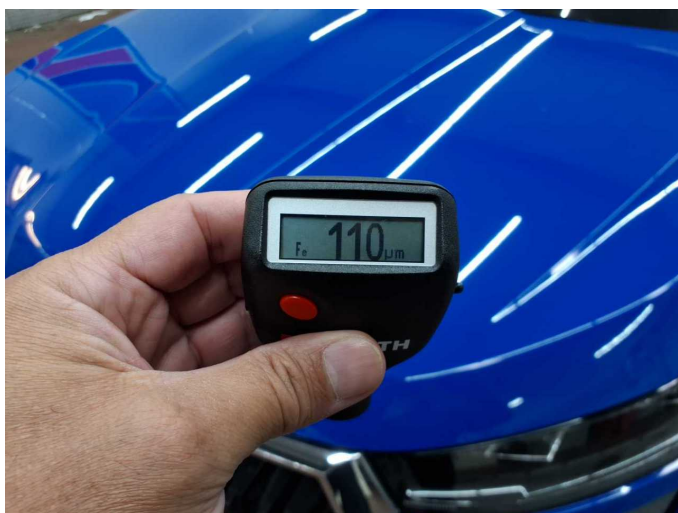
1 Bonnet, Professionally carried out

Bonnet 110 µm |

**Repainting 1:** Bonnet
