Expertise

Protocol number: 46223206  
Order No. / Reference: 26565960  
Inspection date: 29 Jun 2026

Model: GLC 300 de 4Matic 9G-TRONIC

VIN: W1N2539111V344977

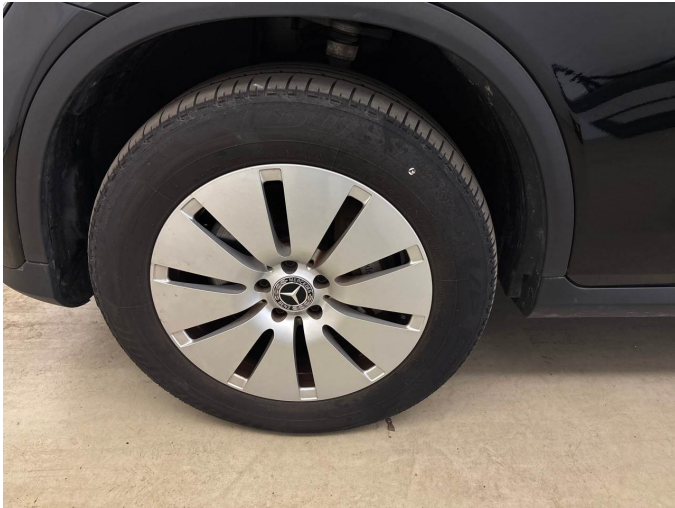
| # | Tyre size | Type of tyre | Manufacturer | Tread depth |
|---|---|---|---|---|
| 1) | 235/60 R18 103V | Summer tyres on Light alloy | Bridgestone | 5mm / 5mm |
| 2) | 235/60 R18 103V | Summer tyres on Light alloy | Bridgestone | 5mm / 5mm |

Figure 13: Mounted tyres

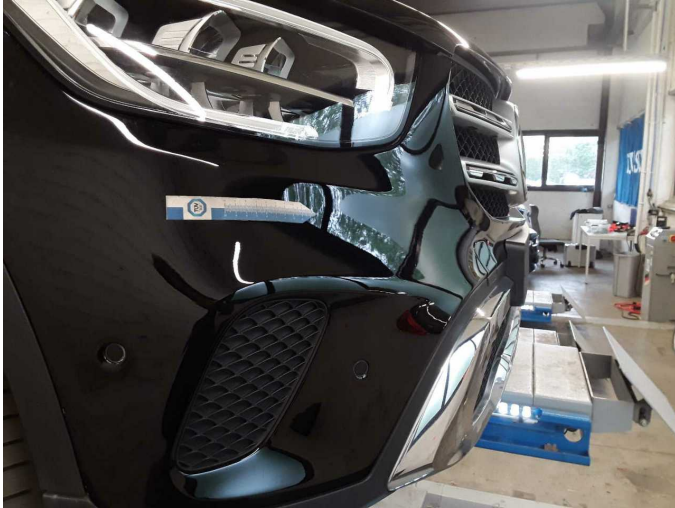
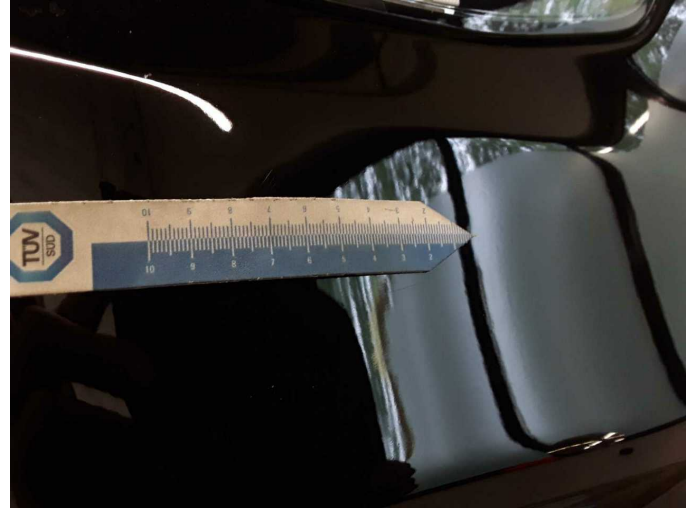
| No. | Component group | Description |
|---|---|---|
| 1 | Front bumper | Front bumper - Stone chips - No deduction |

**Wear and tear 1:** Front bumper: Front bumper - Stone chips - No deduction

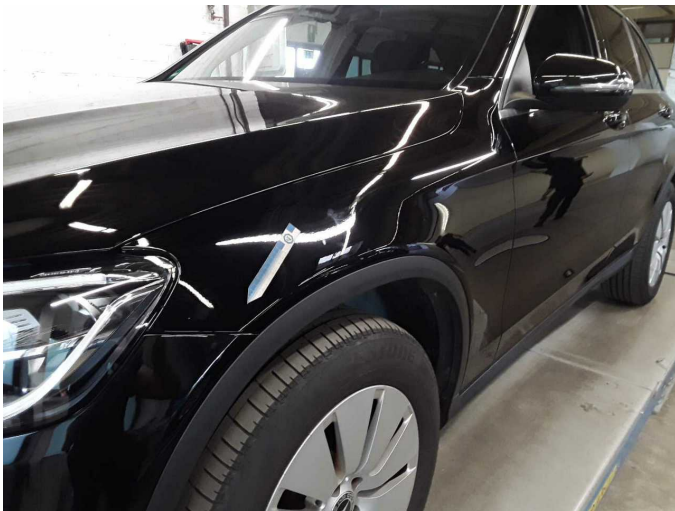
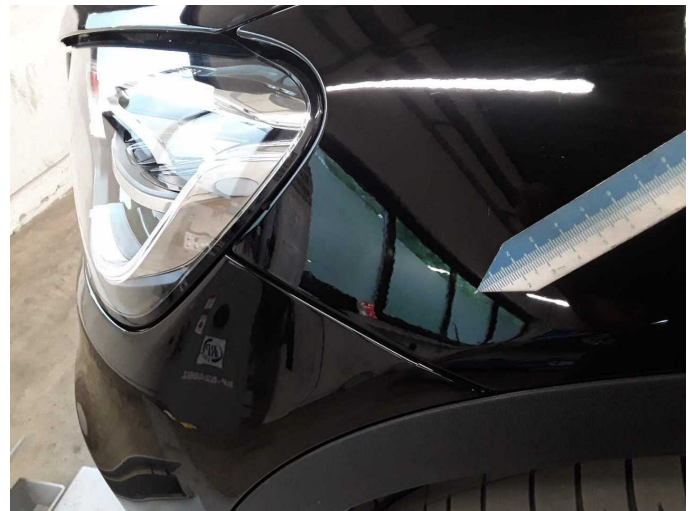
| No. | Component group | Description |
|---|---|---|
| 2 | Mudguard - left side | Mudguard - left side - Stone chips - No deduction |

**Wear and tear 2:** Mudguard - left side: Mudguard - left side - Stone chips - No deduction

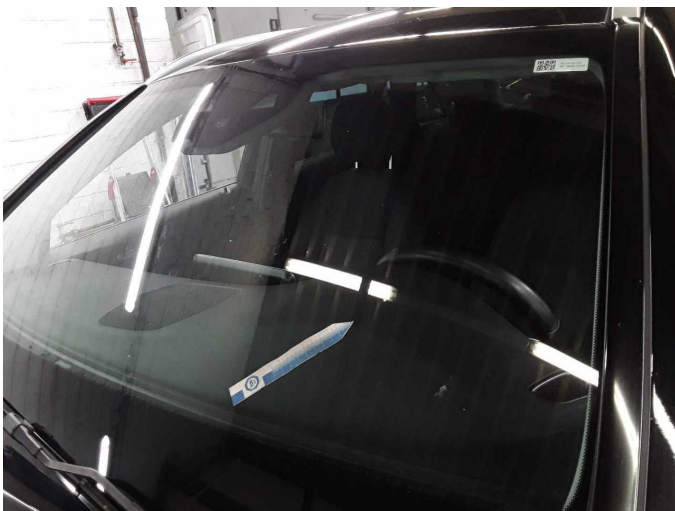
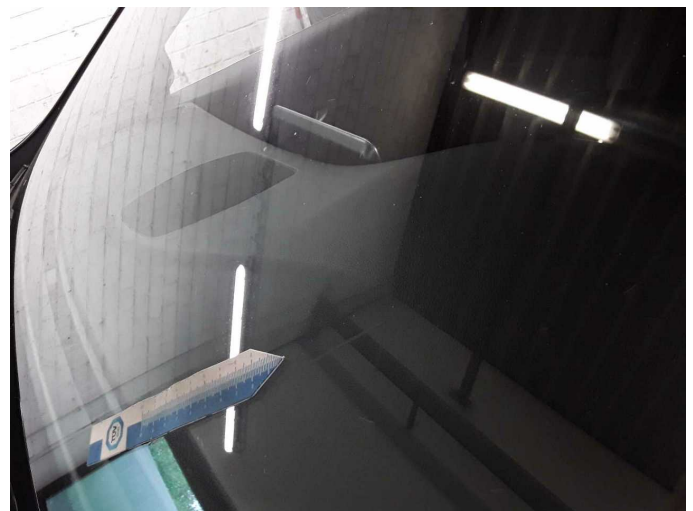
| No. | Component group | Description |
|---|---|---|
| 3 | Vehicle glazing | Windscreen - Stone chips - No deduction |

**Wear and tear 3:** Vehicle glazing: Windscreen - Stone chips - No deduction

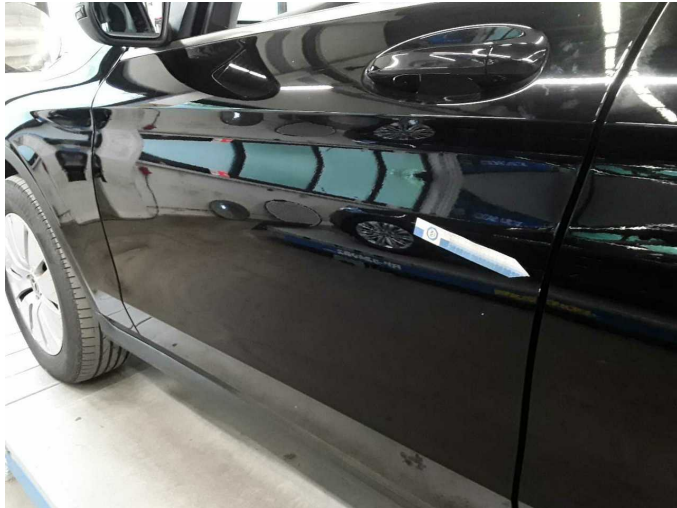
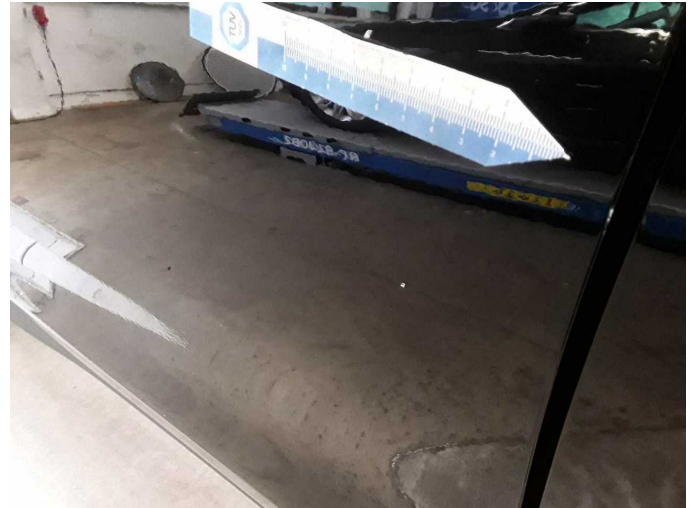
| No. | Component group | Description |
|---|---|---|
| 4 | Door - front left side | Door - Scratch(es) - No deduction |

**Wear and tear 4:** Door - front left side: Door - Scratch(es) - No deduction

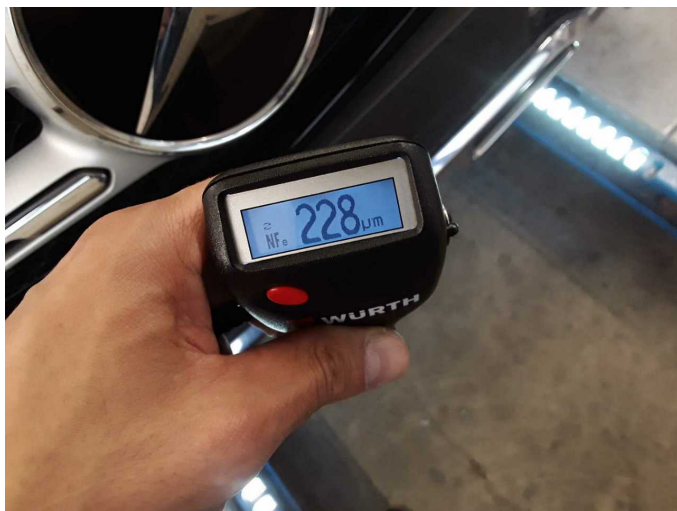
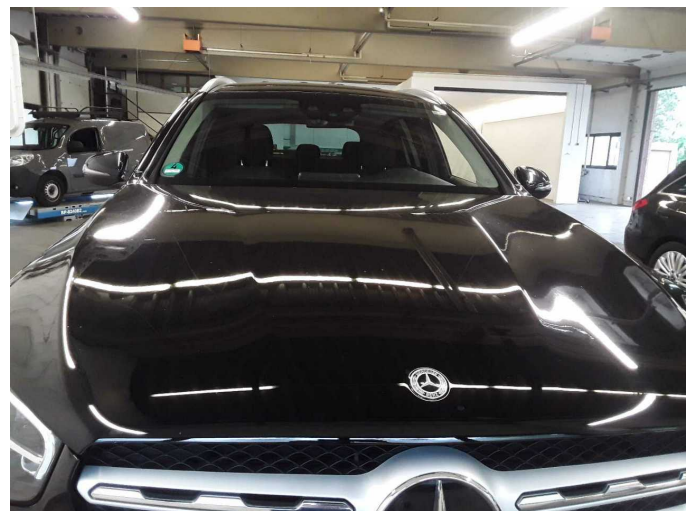
| No. | Repainting |
|---|---|
| 1 | Bonnet, Professionally carried out, Invoice of repair done Non-existent |

| Bonnet | 228 µm |

**Repainting 1:** Bonnet
