Expertise

Protocol number: 46596278  
Order No. / Reference: 26757766  
Inspection date: 15 Jul 2026

Manufacturer: Volkswagen

Model: Caddy Cargo 2.0 TDI BMT Maxi

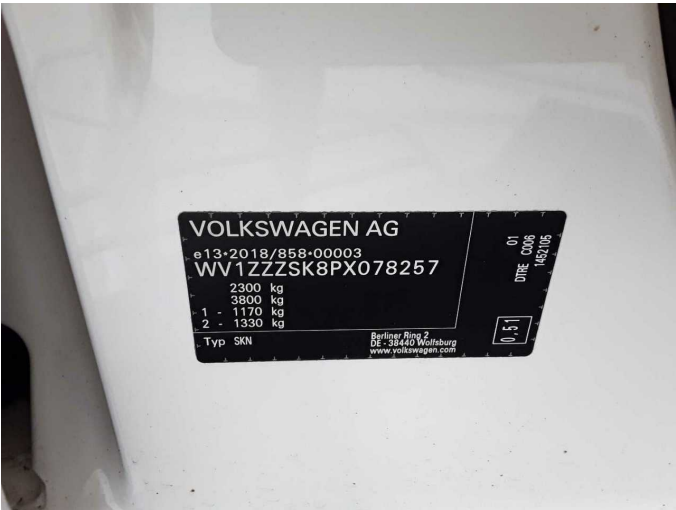
Figure 11: VIN

| VIN comparison | The vehicle identification number (VIN) was read from the vehicle and its conformity with the submitted documents was confirmed by the undersigned during the inspection. |

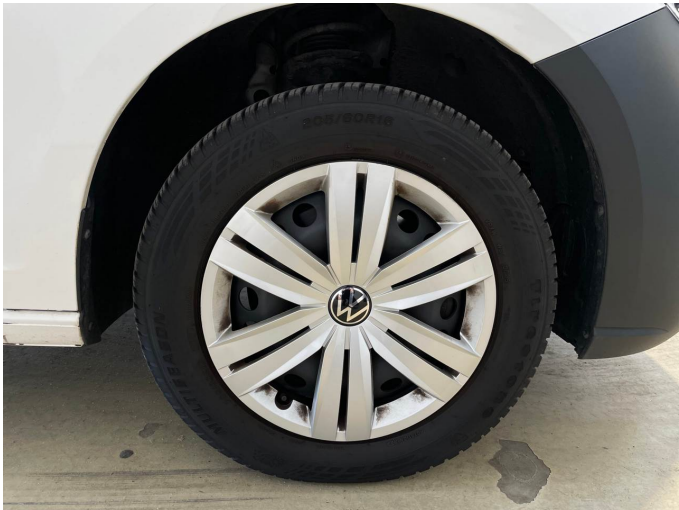
Figure 12: Mounted tyres

| # | Tyre size | Type of tyre | Manufacturer | Tread depth |
|---|---|---|---|---|
| 1) | 205/60 R16 96V | All-season tyres on Steel rim with wheel cover | Firestone | 5mm / 5mm |
| 2) | 205/60 R16 96V | All-season tyres on Steel rim with wheel cover | Firestone | 5mm / 5mm |

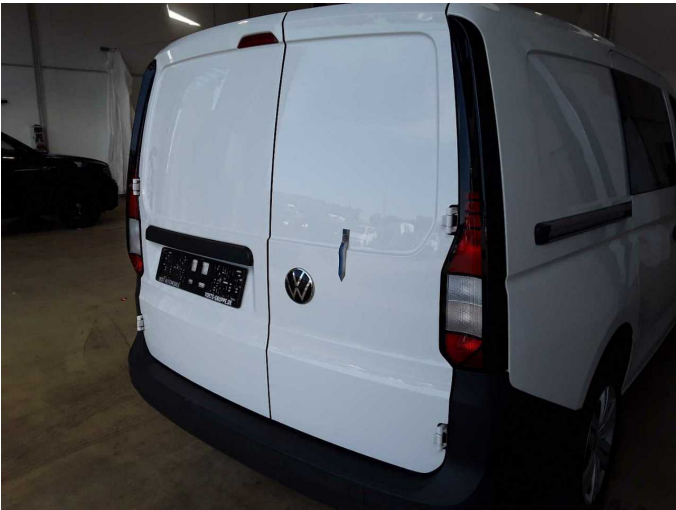
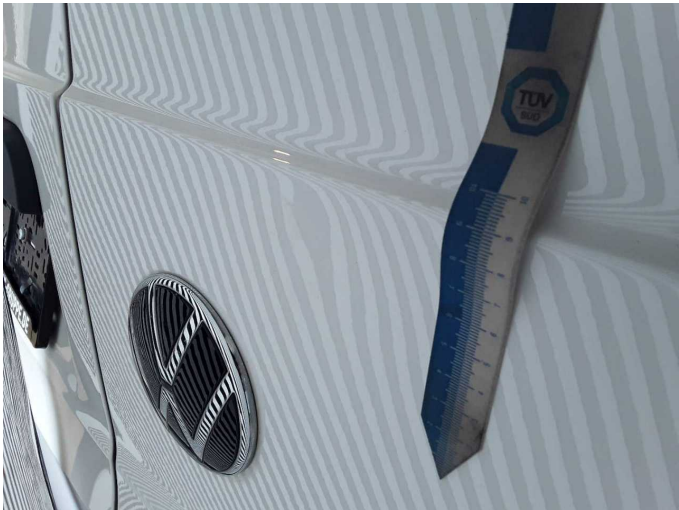
| No. | Component group | Description |
|---|---|---|
| 1 | Boot lid / rear door | Rear door - right side - dent(s) - Smart repair |

Damage 1: Boot lid / rear door: Rear door - right side - dent(s) - Smart repair

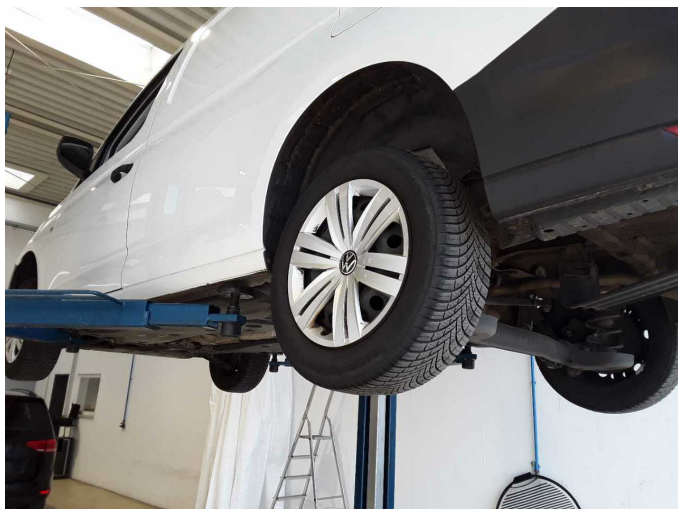
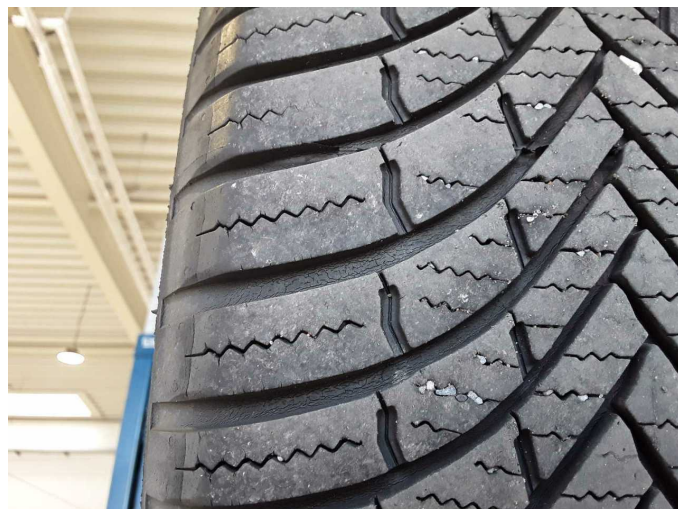
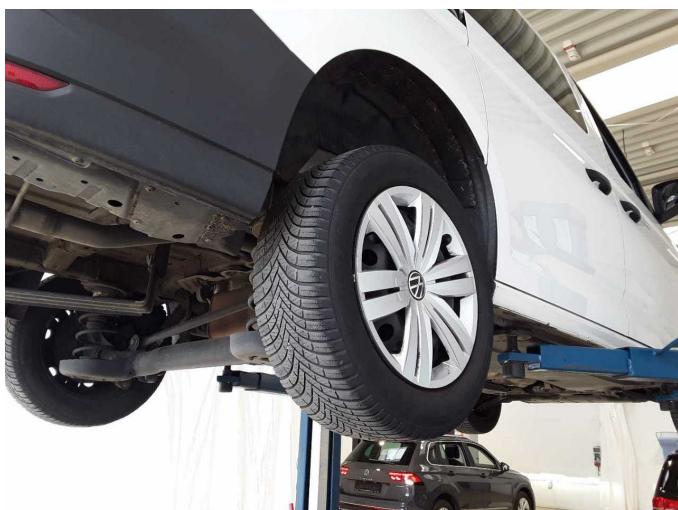
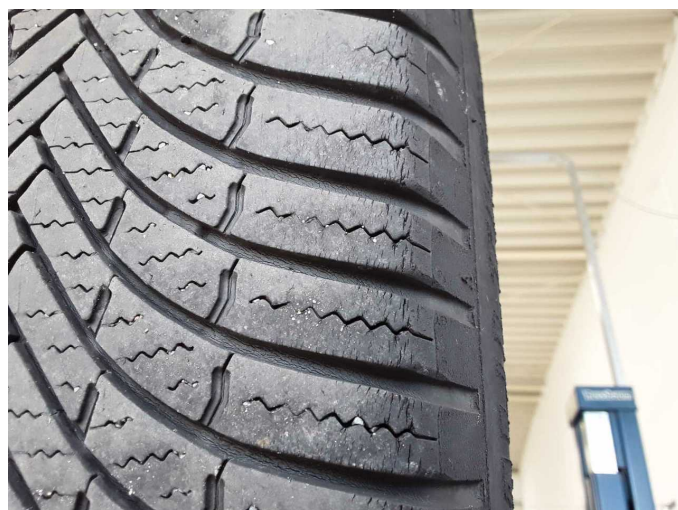
| No. | Component group | Description |
|---|---|---|
| 2 | Wheel / tyres | Tyre - right - Porous / cracked - Replace |

**Damage 2:** Wheel / tyres: Tyre - right - Porous / cracked - Replace

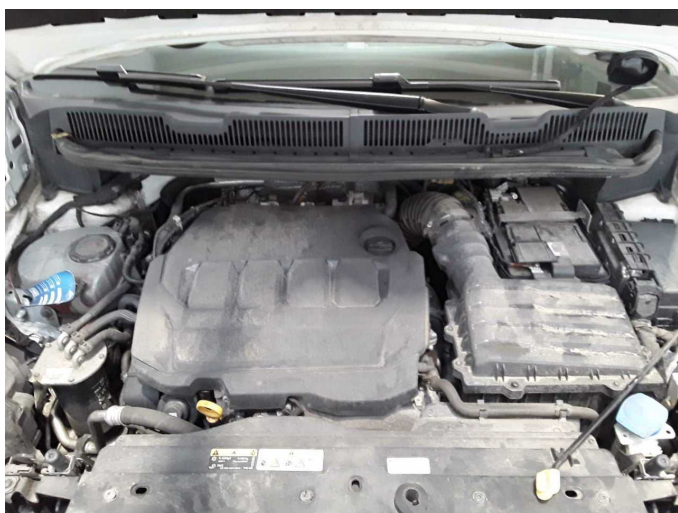
| Engine function test | An engine test run was performed, problem has been detected<br>This is due to the following reason.:<br>Unrund |

| No. | Component group | Description |
|---|---|---|
| 3 | Engine | Engine (Unrund lauf) - Functional / admissibility - Perform diagnosis |

**Damage 3:** Engine: Engine (Unrunder lauf) - Functional / admissibility - Perform diagnosis

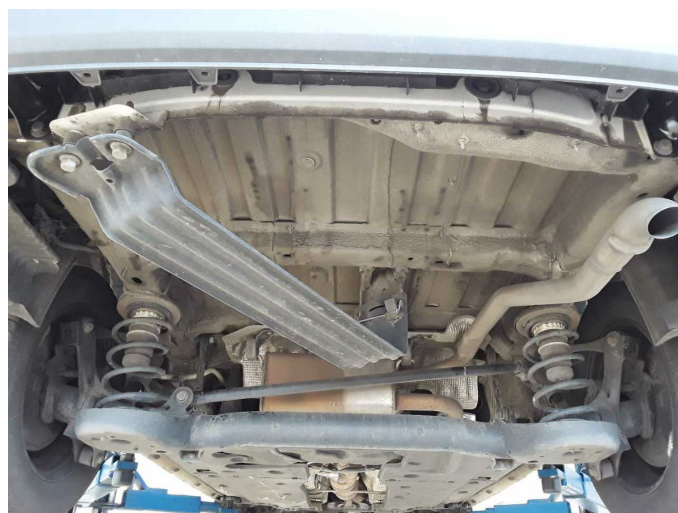
Wheel / tyres - Spare wheel

**Missing part 1:** Wheel / tyres: Spare wheel - Missing - Replace
