Expertise

Protocol number: 46151794  
Order No. / Reference: 26570845  
Inspection date: 23 Jun 2026

Manufacturer: Audi

Model: A6 Avant 40 TDI quattro S tronic design

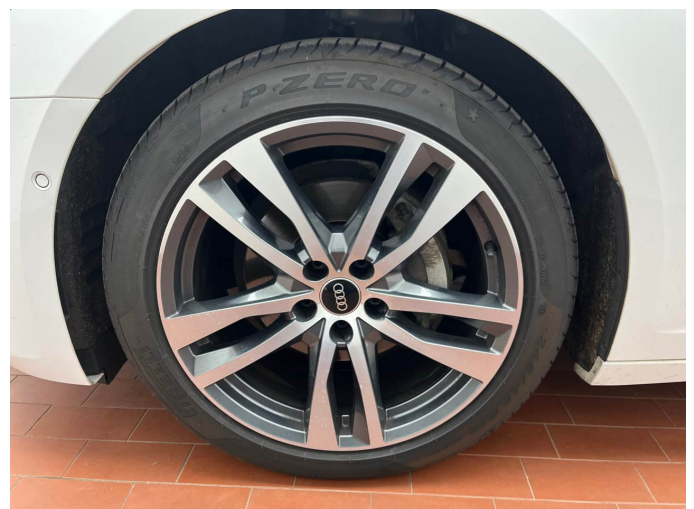
Figure 12: Mounted tyres

| # | Tyre size | Type of tyre | Manufacturer | Tread depth |
|---|---|---|---|---|
| 1) | 245/45 R19 102Y | Summer tyres on Light alloy | Pirelli | 6mm / 6mm |
| 2) | 245/45 R19 102Y | Summer tyres on Light alloy | Pirelli | 6mm / 6mm |

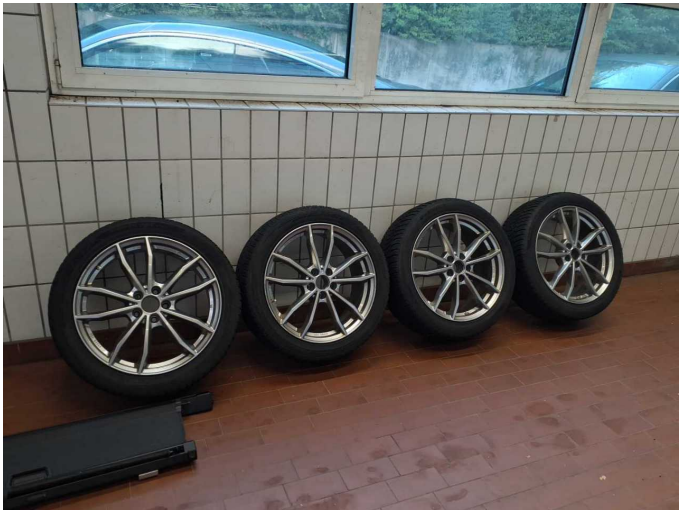
Figure 16: Additional tyres

| # | Tyre size | Type of tyre | Manufacturer | Tread depth |
|---|---|---|---|---|
| 1) | 245/45 R19 102V | Winter tyres on Light alloy | Hankook | 3mm / 2mm |
| 2) | 245/45 R19 102V | Winter tyres on Light alloy | Hankook | 5mm / 5mm |

| No. | Component group | Description |
|---|---|---|
| 4 | 2nd wheel set | 2 tyres (Kein Teil der Ausstattung (unter 4mm Profiltiefe)) - Does not meet the leasing specifications - No deduction |

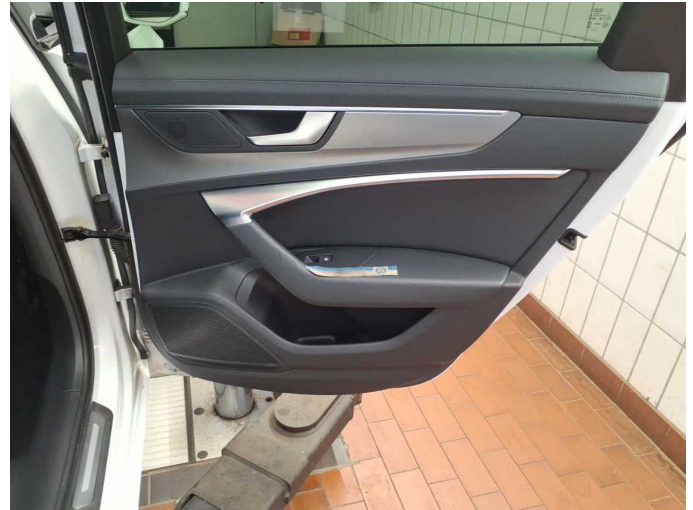
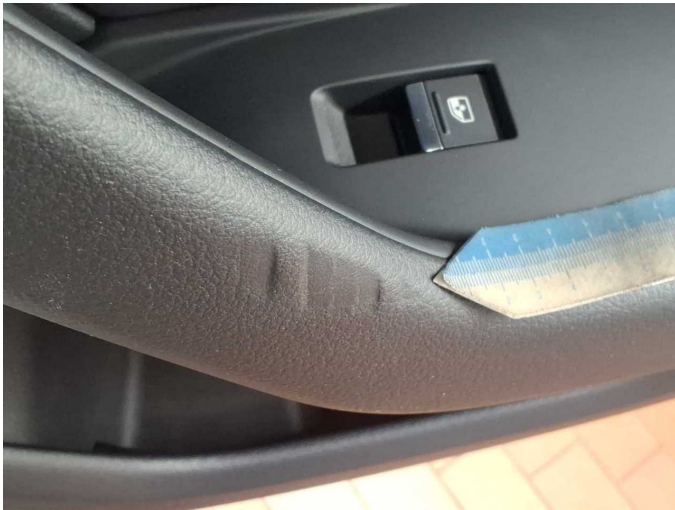
| No. | Component group | Description |
|---|---|---|
| 1 | Trim / covers | Door trim - rear right side (Druckstelle Reifen) - Smart repair |

**Damage 1:** Trim / covers: Door trim - rear right side (Druckstelle Reifen) - Smart repair

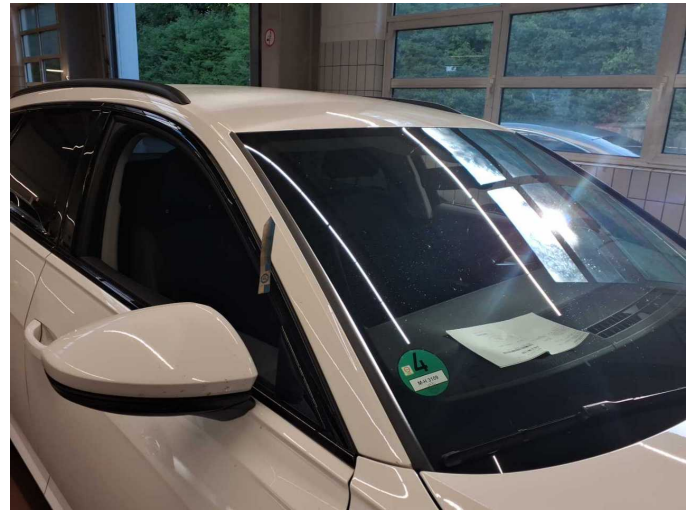
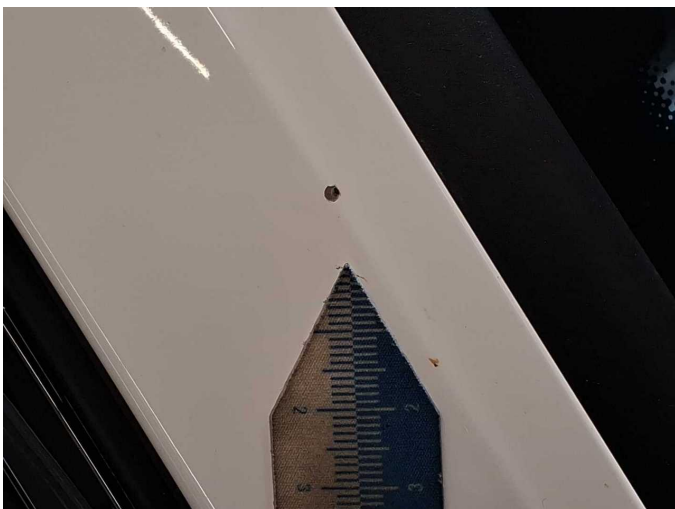
| No. | Component group | Description |
|---|---|---|
| 2 | Body | A-pillar - right side - Stone chips - Smart repair |

**Damage 2:** Body: A-pillar - right side - Stone chips - Smart repair

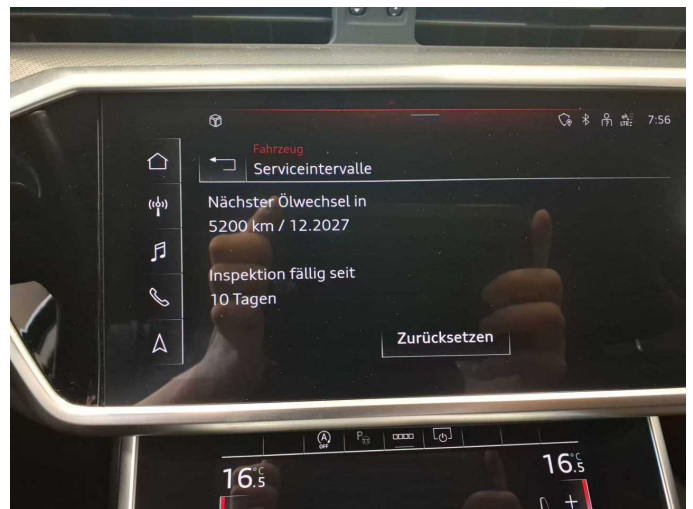
| No. | Component group | Description |
|---|---|---|
| 3 | Misc. | Inspection / maintenance - Due - Perform |

**Damage 3:** Misc.: Inspection / maintenance - Due - Perform

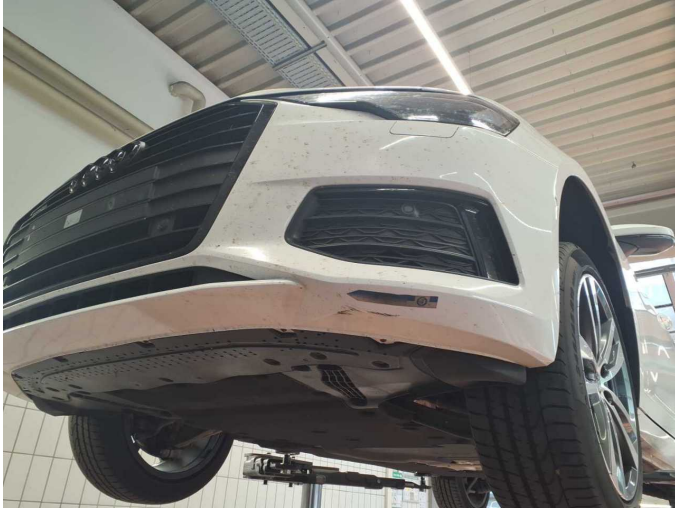
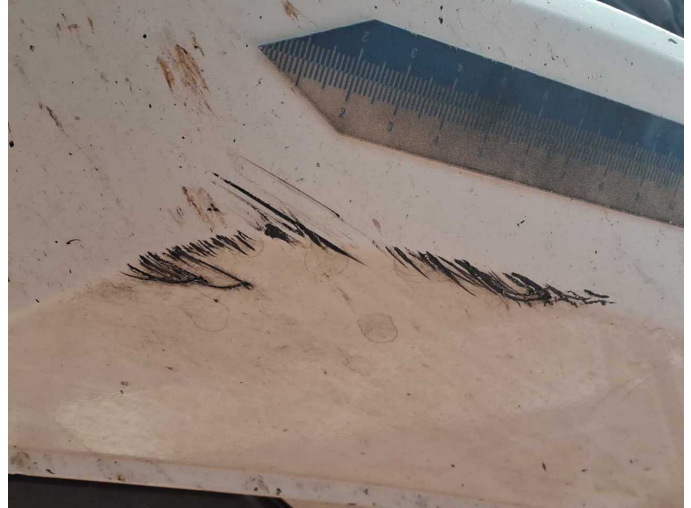
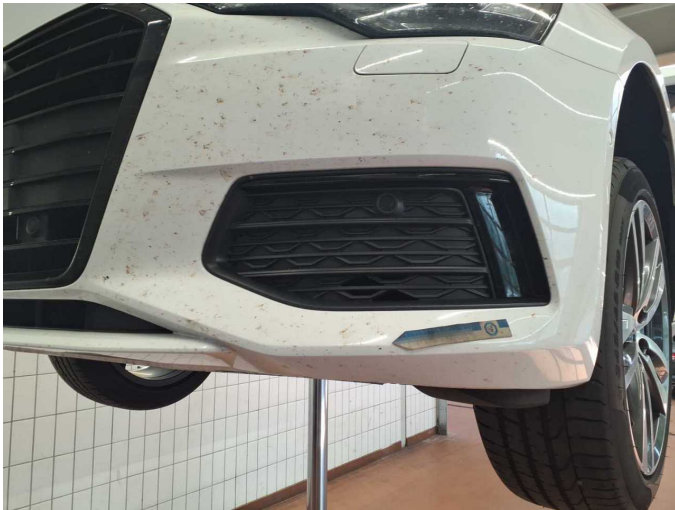
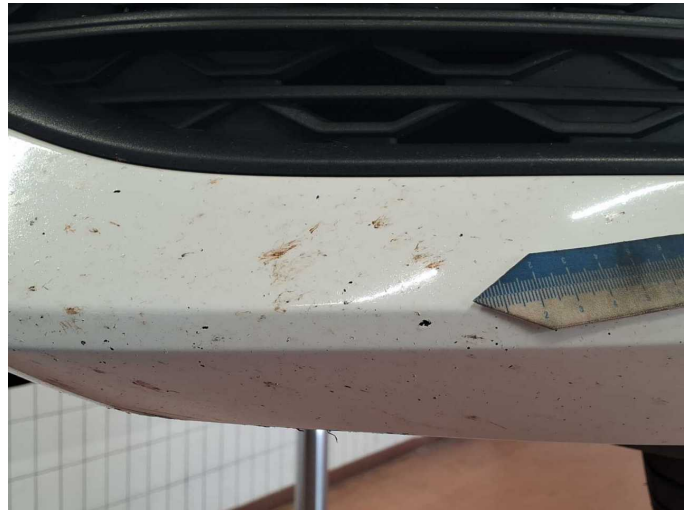
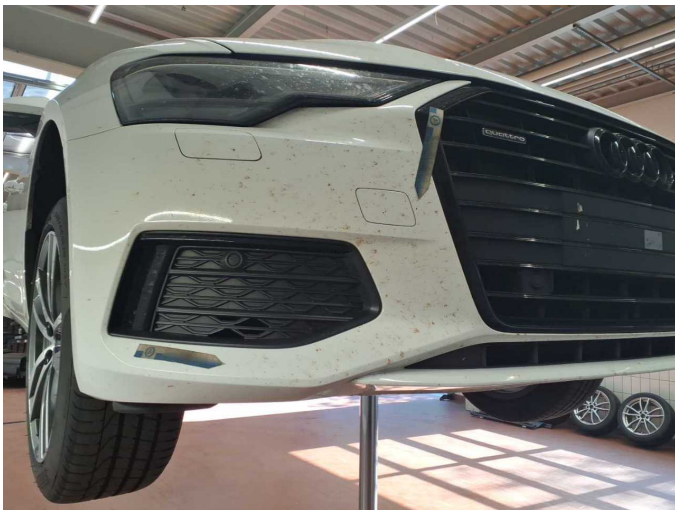
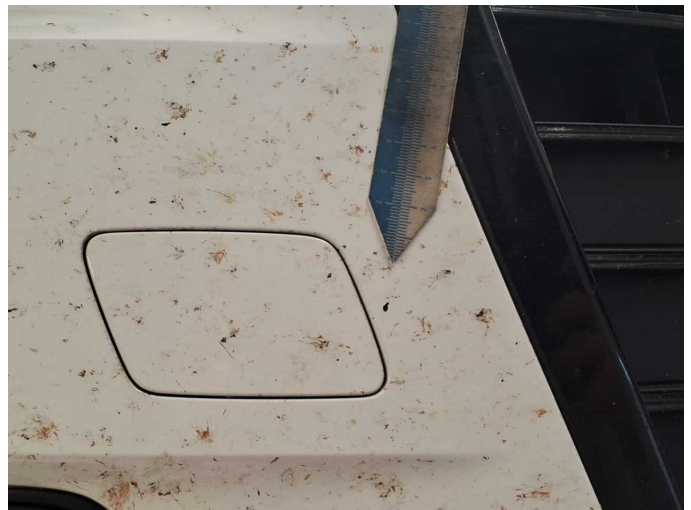
| No. | Component group | Description |
|---|---|---|
| 4 | Front bumper | Front bumper (+ Steinschläge) - Scratched - Paint |

**Damage 4:** Front bumper: Front bumper (+ Steinschläge) - Scratched - Paint

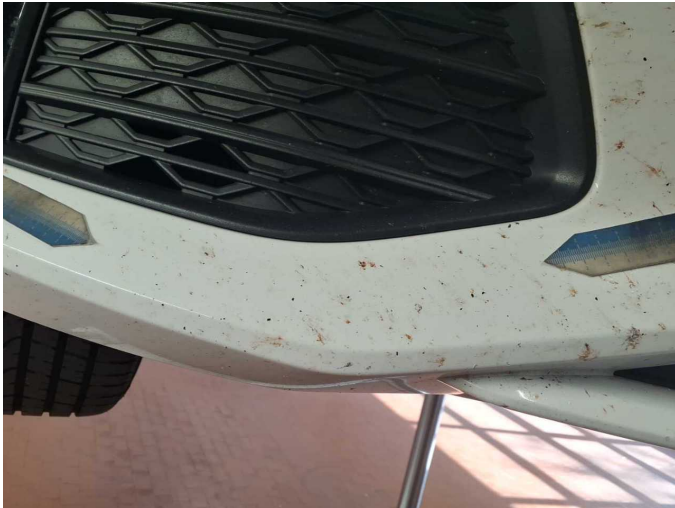
**Damage 4:** Front bumper: Front bumper (+ Steinschläge) - Scratched - Paint

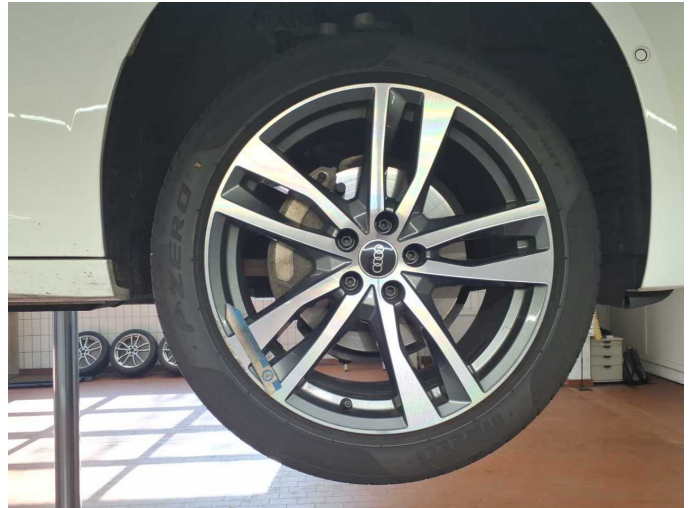
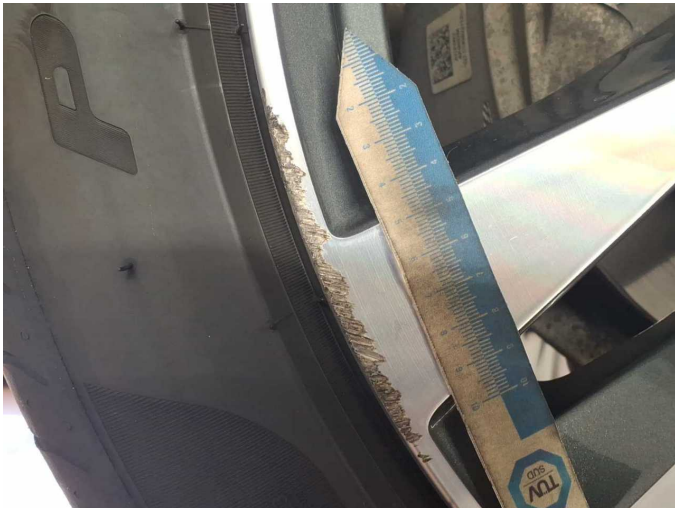
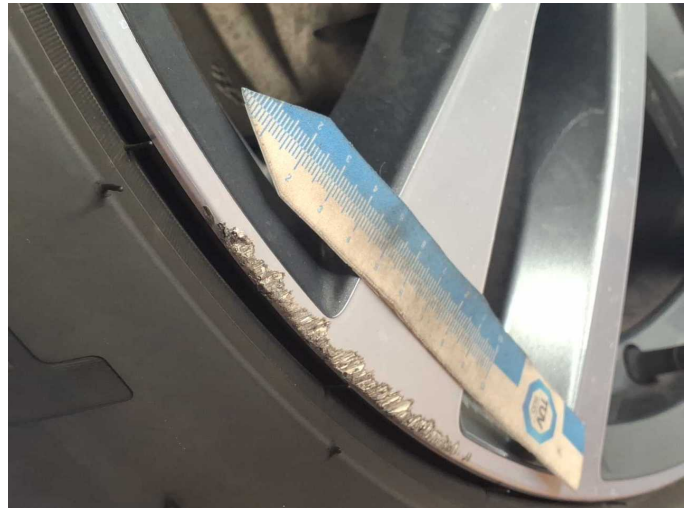
| No. | Component group | Description |
|---|---|---|
| 5 | Wheel / tyres | Alloy rim - front right side - Scratched - Replace |

**Damage 5:** Wheel / tyres: Alloy rim - front right side - Scratched - Replace

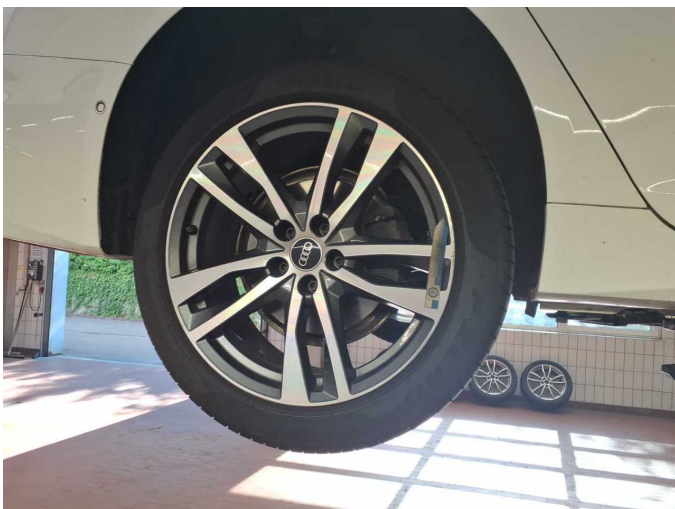
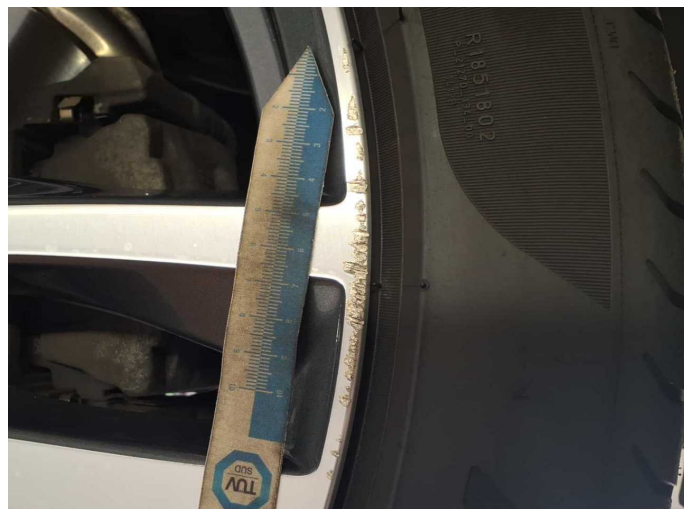
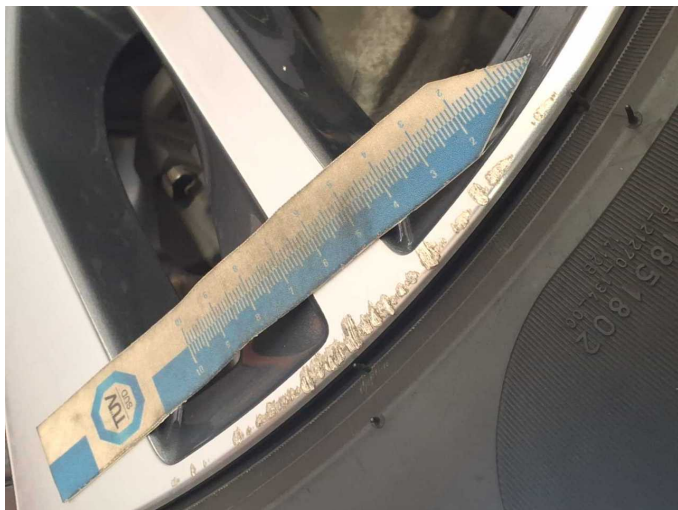
| No. | Component group | Description |
|---|---|---|
| 6 | Wheel / tyres | Alloy rim - rear right side - Scratched - Replace |

**Damage 6:** Wheel / tyres: Alloy rim - rear right side - Scratched - Replace
