Expertise

Protocol number: 46504750  
Order No. / Reference: 26610806  
Inspection date: 30 Jun 2026

Manufacturer: Polestar

Model: 2 Single Motor 69kWh

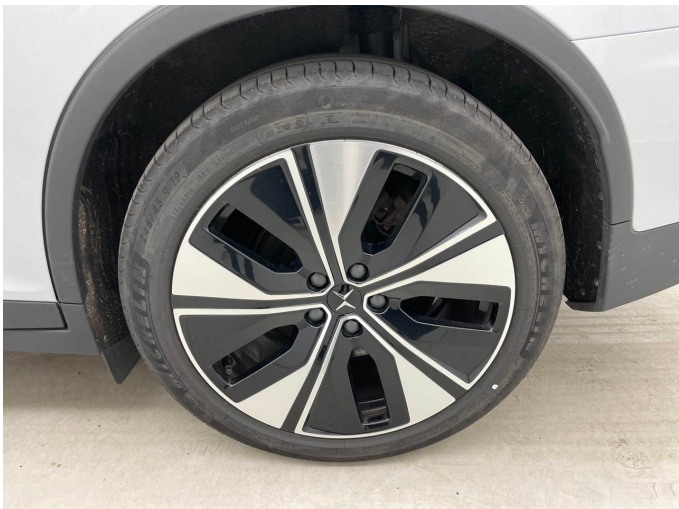
Figure 12: Mounted tyres

| # | Tyre size | Type of tyre | Manufacturer | Tread depth |
|---|---|---|---|---|
| 1) | 245/45 R19 102V | Summer tyres on Light alloy | Michelin | 5mm / 5mm |
| 2) | 245/45 R19 102V | Summer tyres on Light alloy | Michelin | 6mm / 6mm |

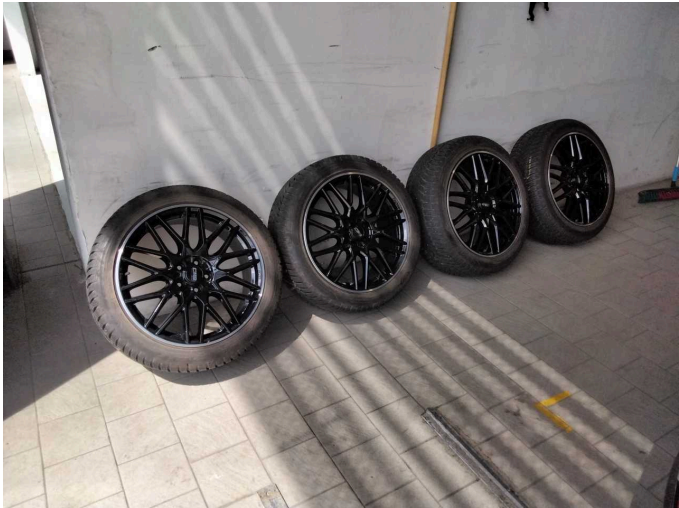
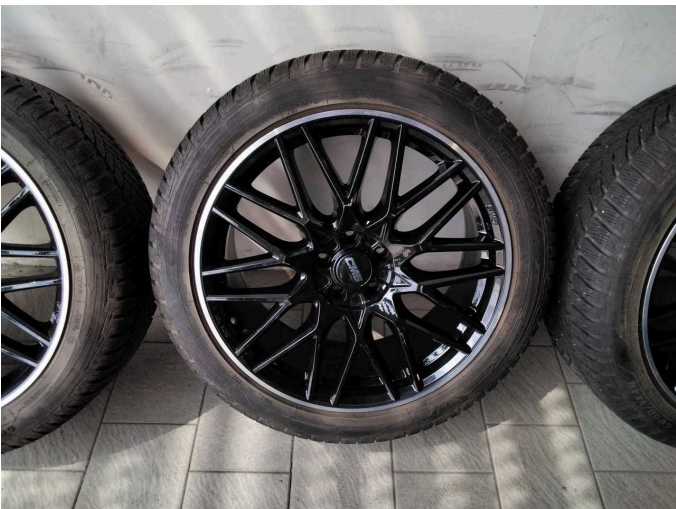
Figure 16: Additional tyres

| # | Tyre size | Type of tyre | Manufacturer | Tread depth |
|---|---|---|---|---|
| 1) | 245/45 R19 102V | Winter tyres on Light alloy | Goodyear | 8mm / 8mm |
| 2) | 245/45 R19 102V | Winter tyres on Light alloy | Goodyear | 8mm / 8mm |

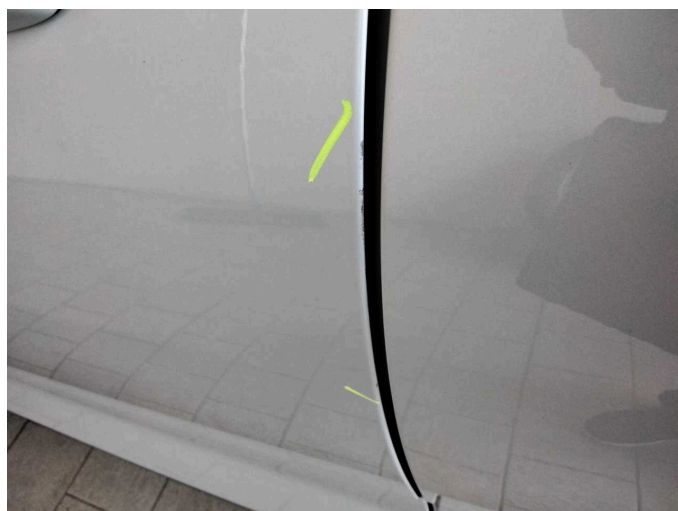
Damage 1: Door - front left side: Door edge - Scratch(es) - Smart repair

| No. | Component group | Description |
|---|---|---|
| 1 | Door - front left side | Door edge - Scratch(es) - Smart repair |

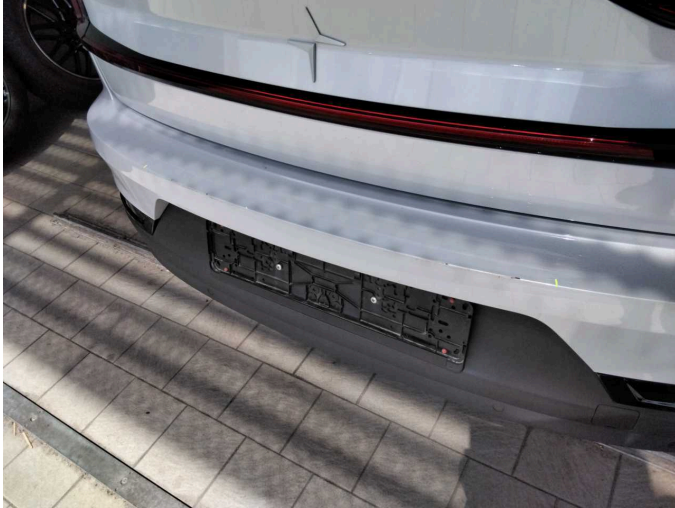
**Damage 2:** Rear bumper: Rear bumper - Scratch(es) - Smart repair

| No. | Component group | Description |
|---|---|---|
| 2 | Rear bumper | Rear bumper - Scratch(es) - Smart repair |

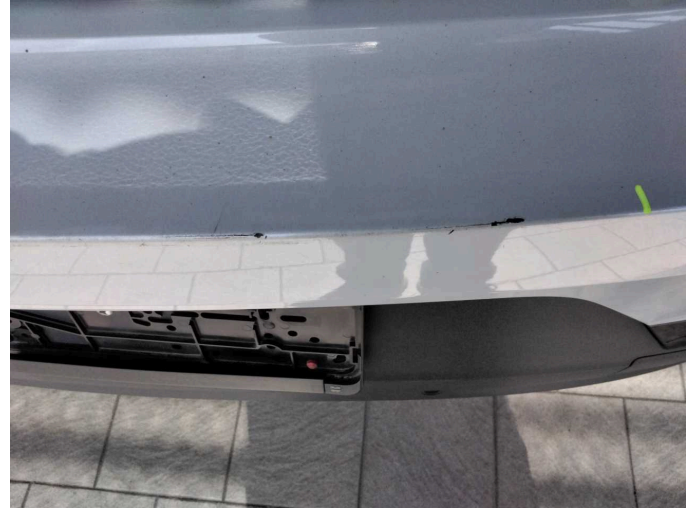
**Damage 2:** Rear bumper: Rear bumper - Scratch(es) - Smart repair

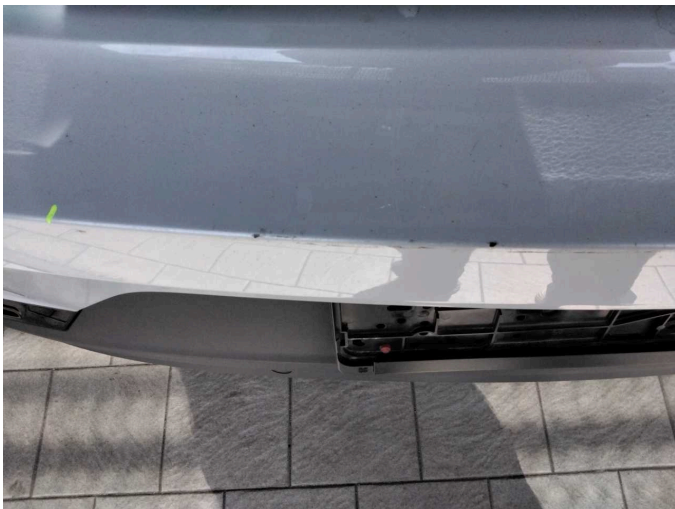
**Damage 2:** Rear bumper: Rear bumper - Scratch(es) - Smart repair

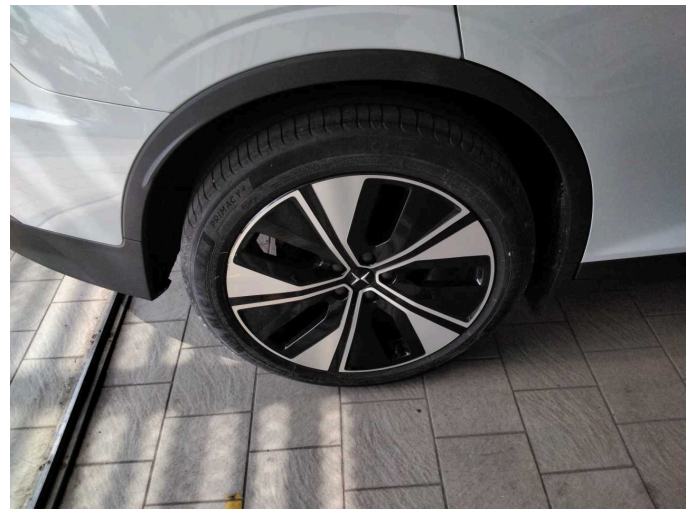
**Damage 3:** Wheel / tyres: Alloy rim - rear right side - Scratch(es) - Loss in value

| No. | Component group | Description |
|---|---|---|
| 3 | Wheel / tyres | Alloy rim - rear right side - Scratch(es) - Loss in value |

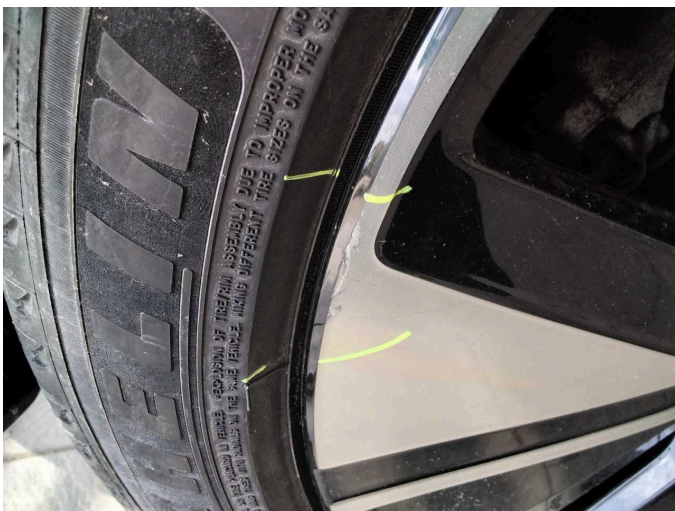
**Damage 3:** Wheel / tyres: Alloy rim - rear right side - Scratch(es) - Loss in value

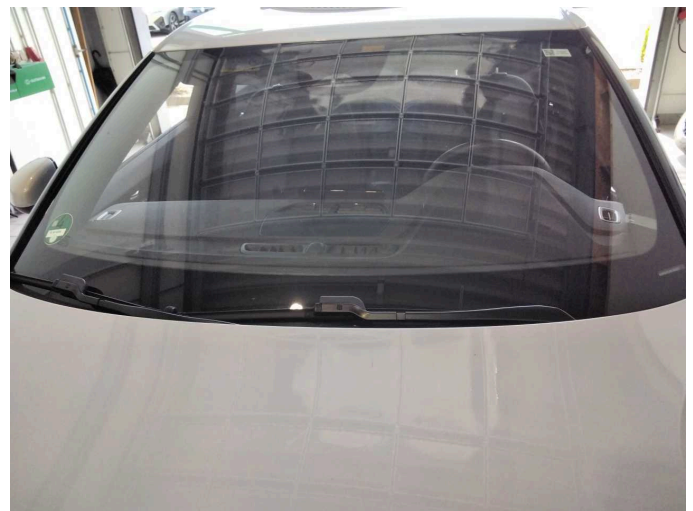
**Wear and tear 1:** Vehicle glazing: Windscreen - Stone chips - No deduction

| No. | Component group | Description |
|---|---|---|
| 1 | Vehicle glazing | Windscreen - Stone chips - No deduction |
