Expertise

Protocol number: 46240298  
Order No. / Reference: 26543828  
Inspection date: 29 Jun 2026

Manufacturer: Ford

Model: Focus Turnier 1.0 EcoBoost Hybrid Aut. ST-LINE X

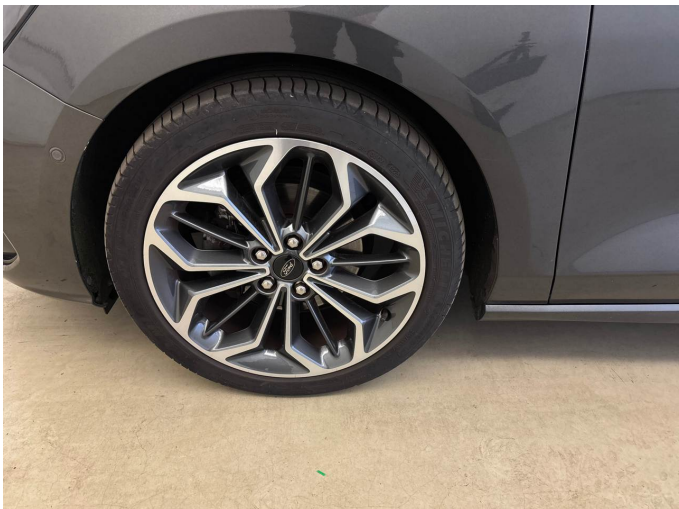
| Tyres | | | |
|---|---|---|---|
| 1) | 235/40 R18 95W | Summer tyres on Light alloy | 4mm / 4mm |
| 2) | 235/40 R18 95W | Summer tyres on Light alloy | 4mm / 4mm |

Figure 12: Mounted tyres

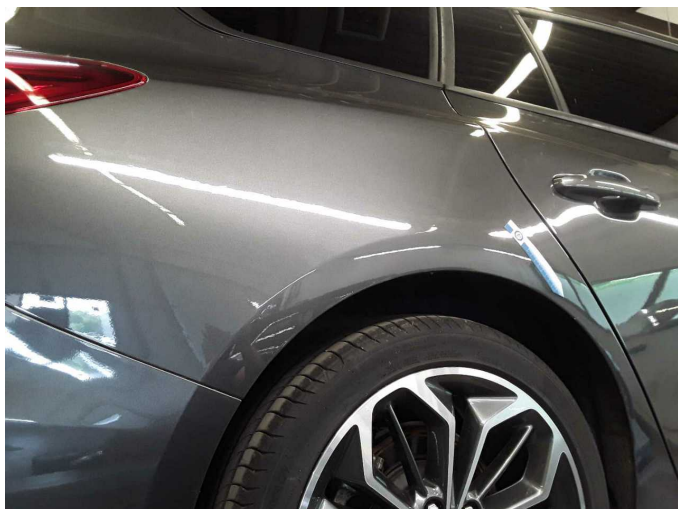
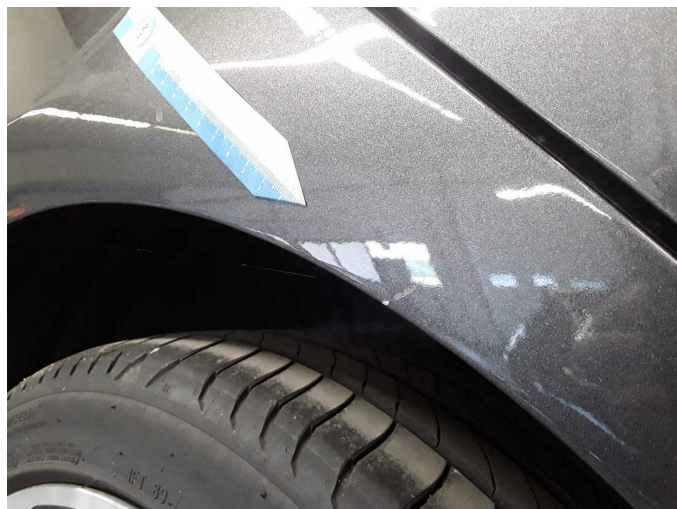
| No. | Component group | Description |
|---|---|---|
| 1 | Side panel - rear right side | Side panel - Scratch(es) - Smart repair |

**Damage 1:** Side panel - rear right side: Side panel - Scratch(es) - Smart repair

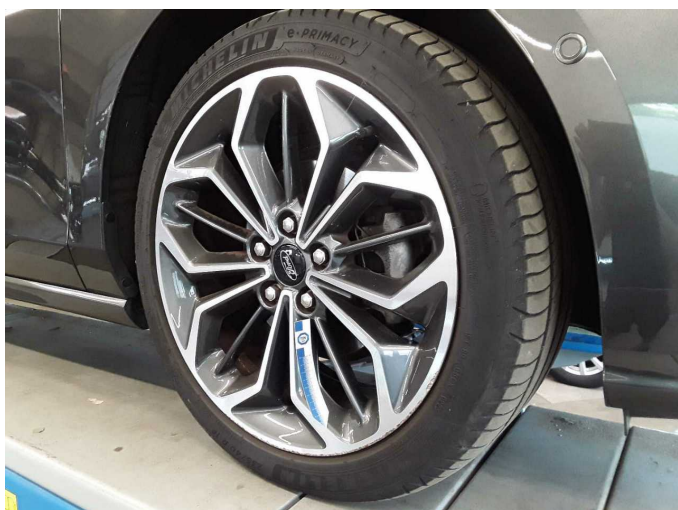
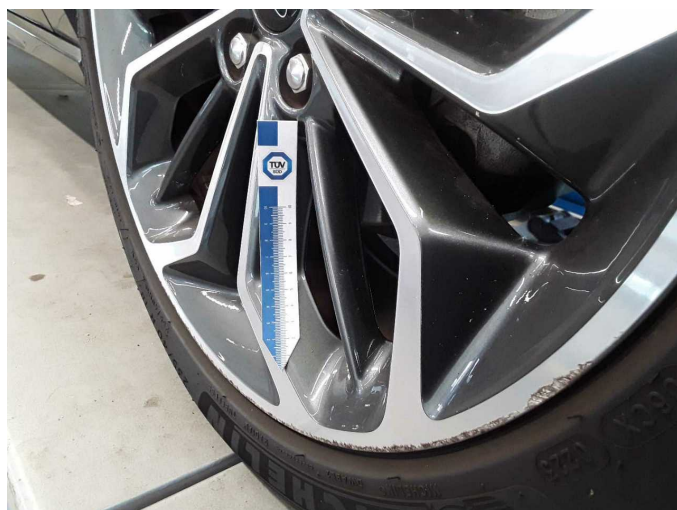
| No. | Component group | Description |
|---|---|---|
| 2 | Wheel / tyres | Alloy rim - front right side - Scratched - Loss in value |

**Damage 2:** Wheel / tyres: Alloy rim - front right side - Scratched - Loss in value

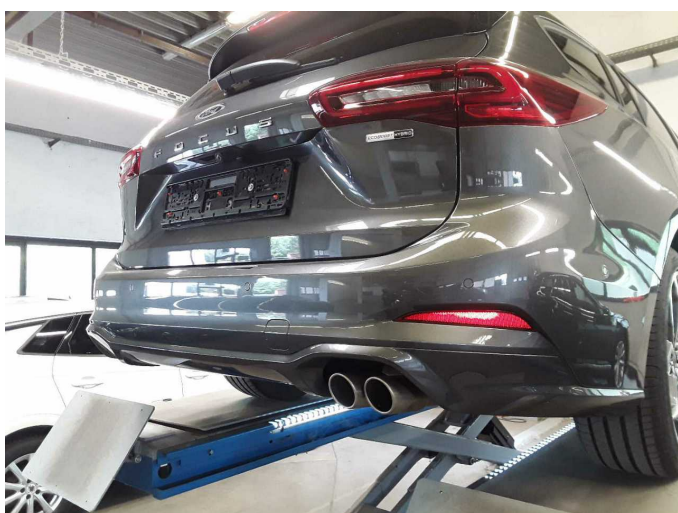
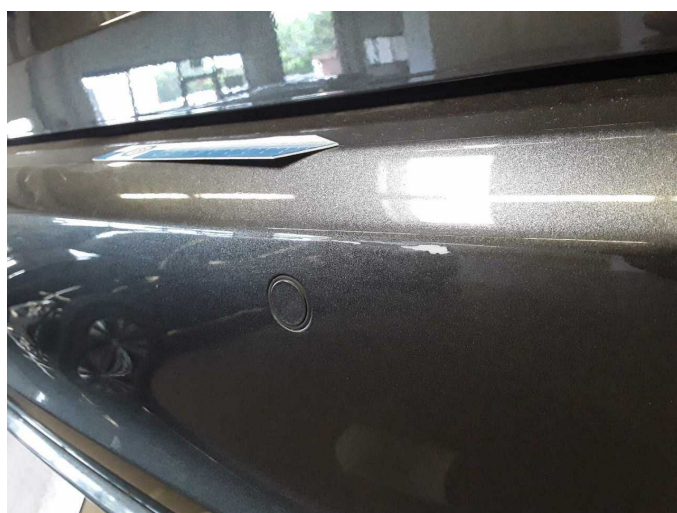
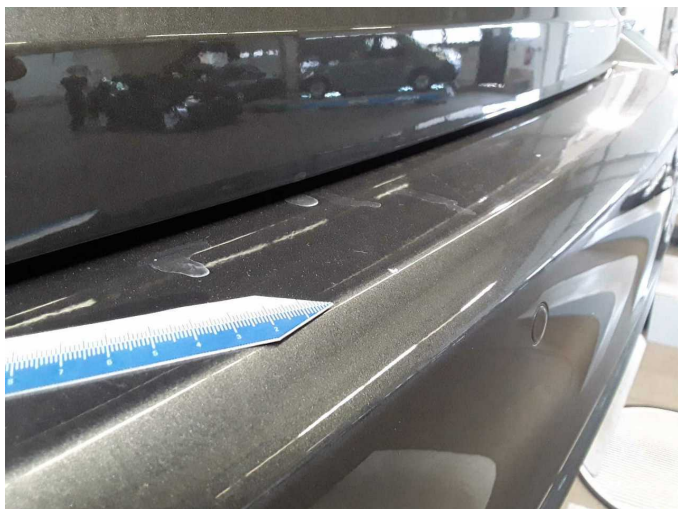
| No. | Component group | Description |
|---|---|---|
| 3 | Rear bumper | Rear bumper - Scratch(es) - Paint |

**Damage 3:** Rear bumper: Rear bumper - Scratch(es) - Paint

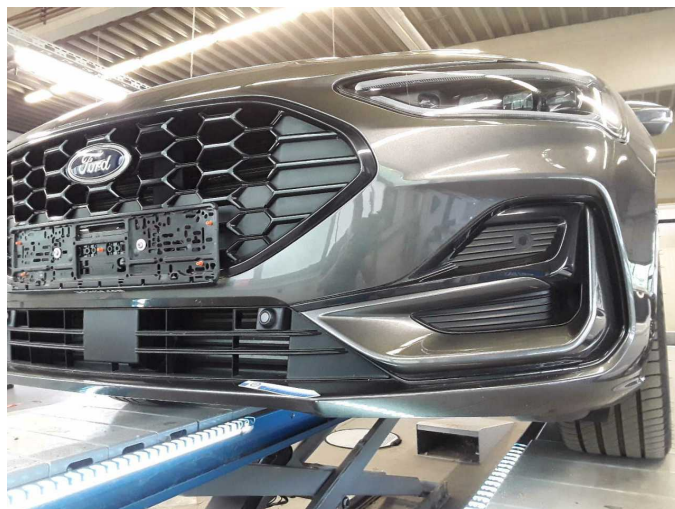
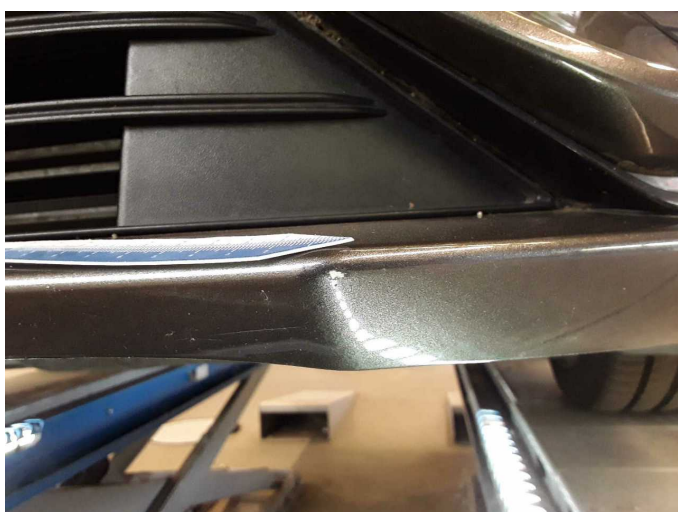
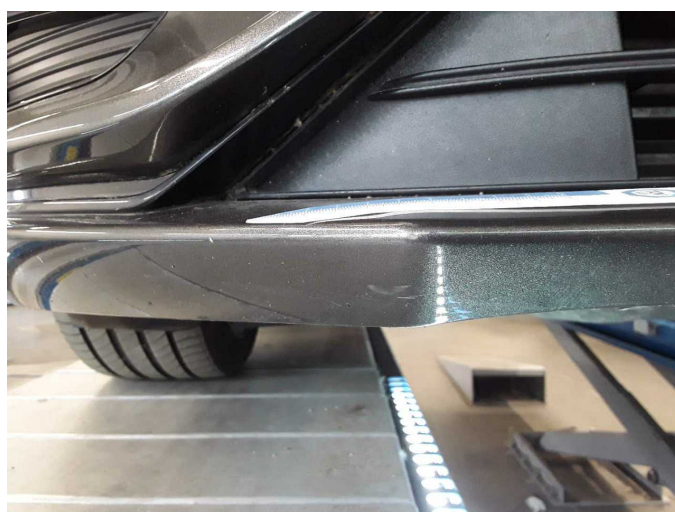
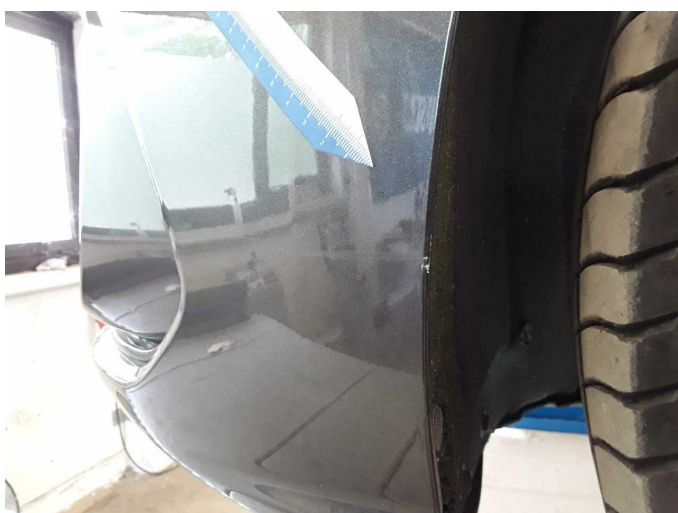
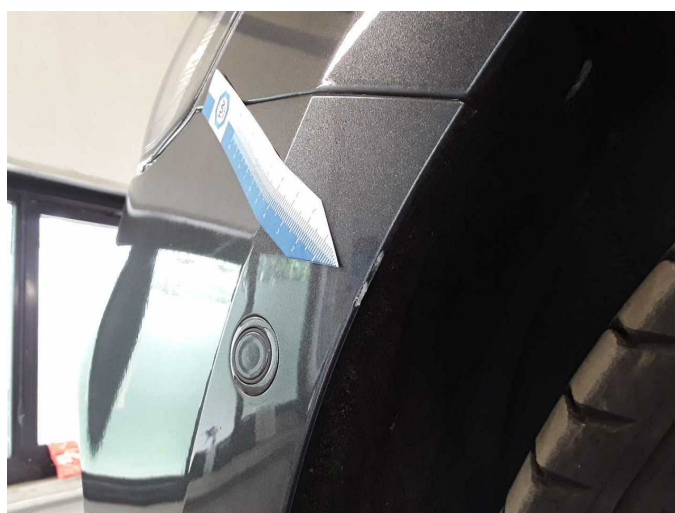
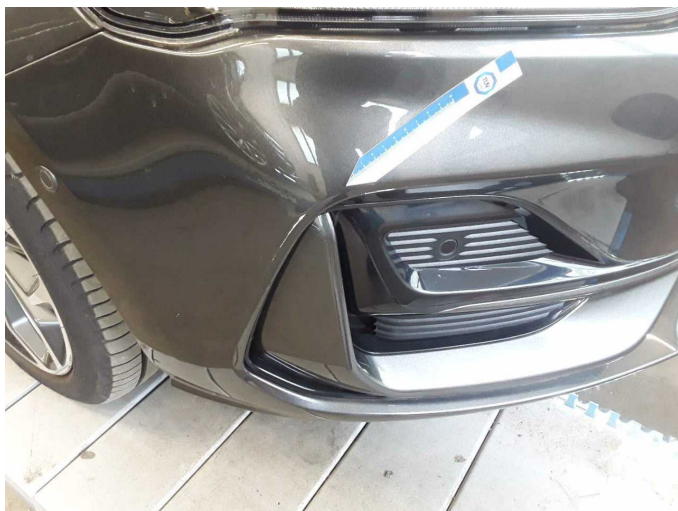
| No. | Component group | Description |
|---|---|---|
| 4 | Front bumper | Front bumper - Scratch(es) - Paint |

**Damage 4:** Front bumper: Front bumper - Scratch(es) - Paint

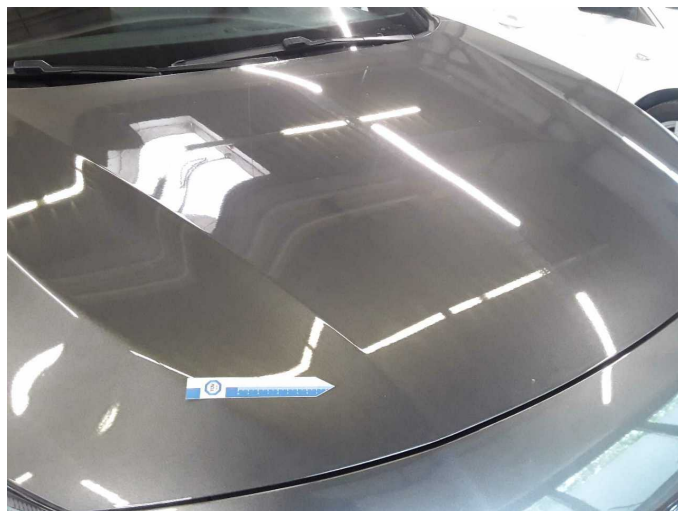
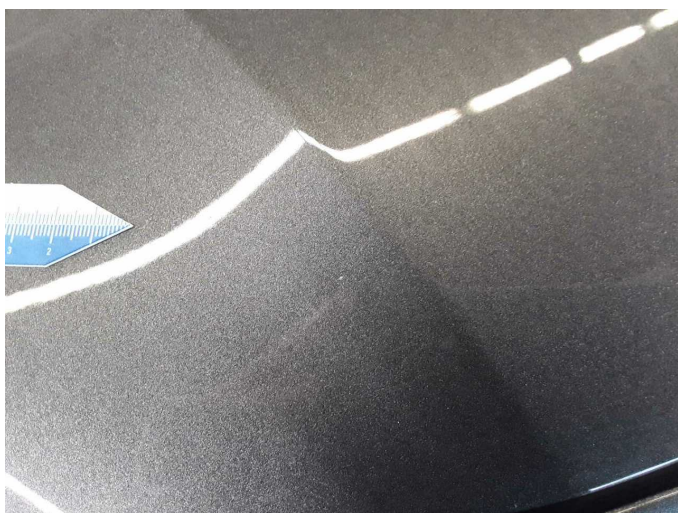
| No. | Component group | Description |
|---|---|---|
| 1 | Bonnet | Bonnet - Stone chips - No deduction |

**Wear and tear 1:** Bonnet: Bonnet - Stone chips - No deduction

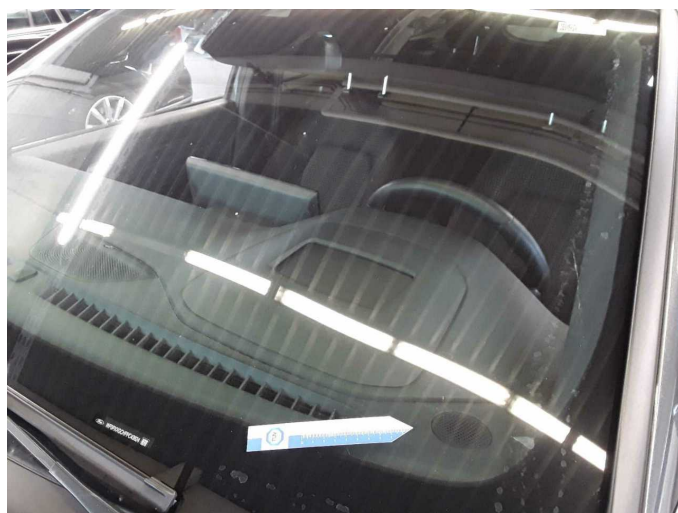
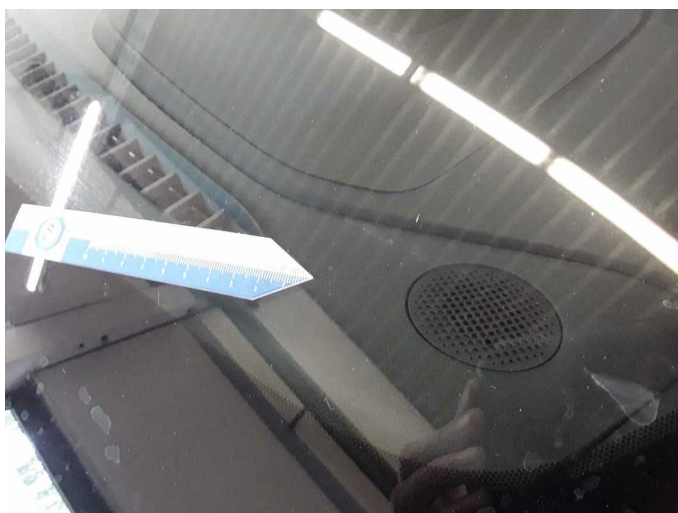
| No. | Component group | Description |
|---|---|---|
| 2 | Vehicle glazing | Windscreen - Stone chips - No deduction |

**Wear and tear 2:** Vehicle glazing: Windscreen - Stone chips - No deduction

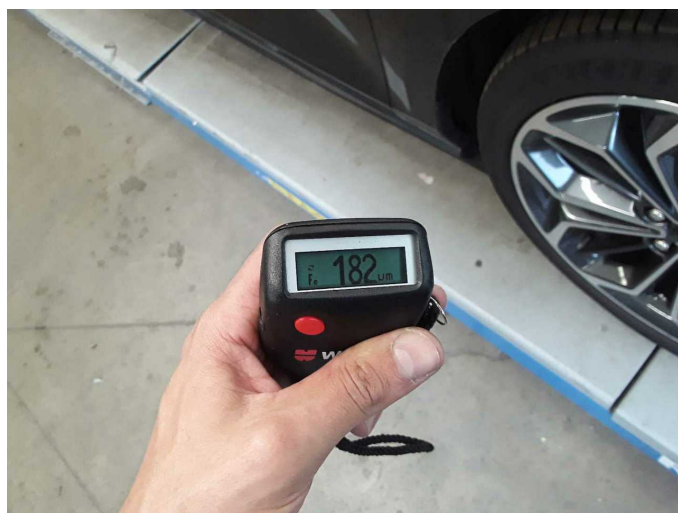
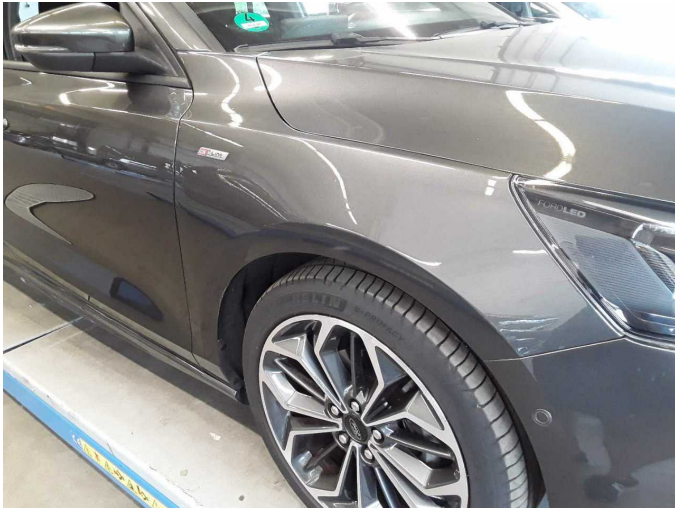
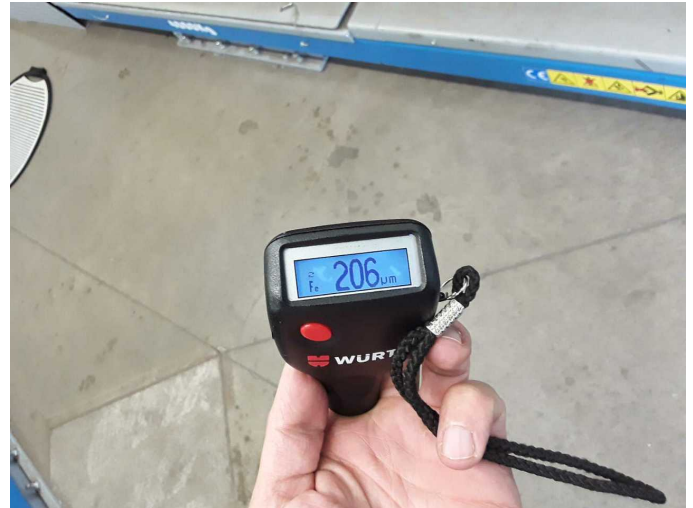
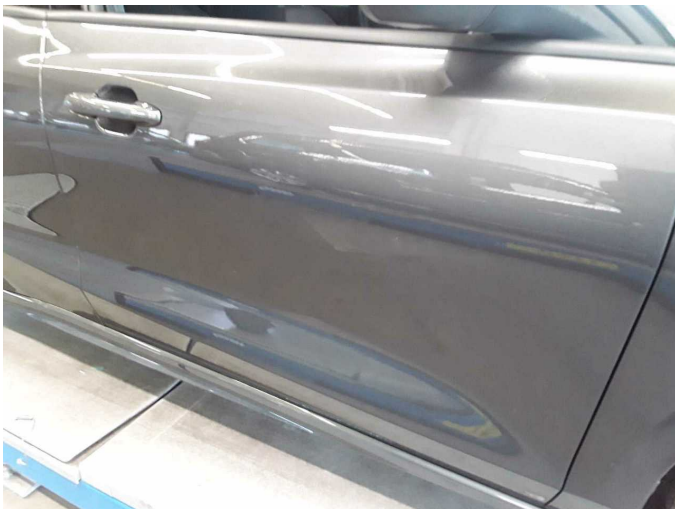
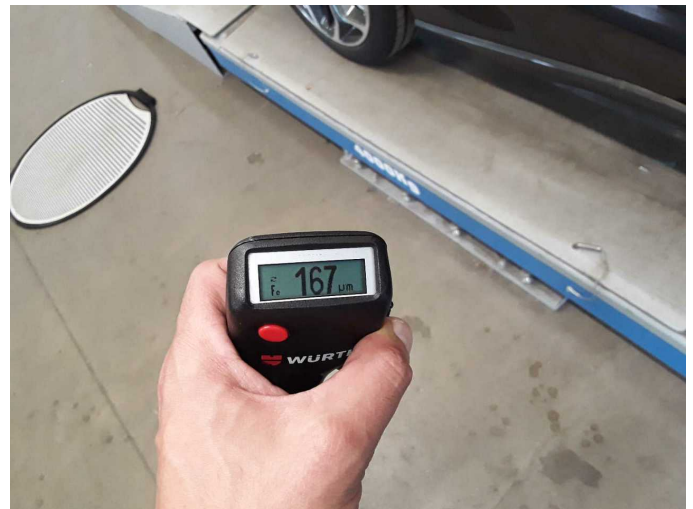
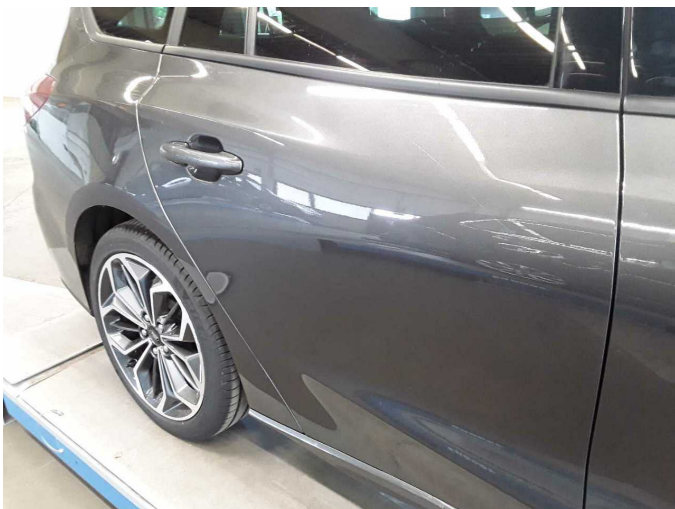
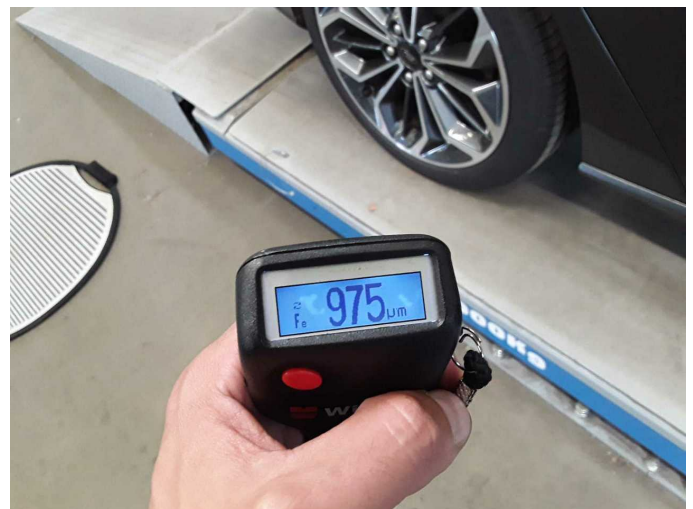
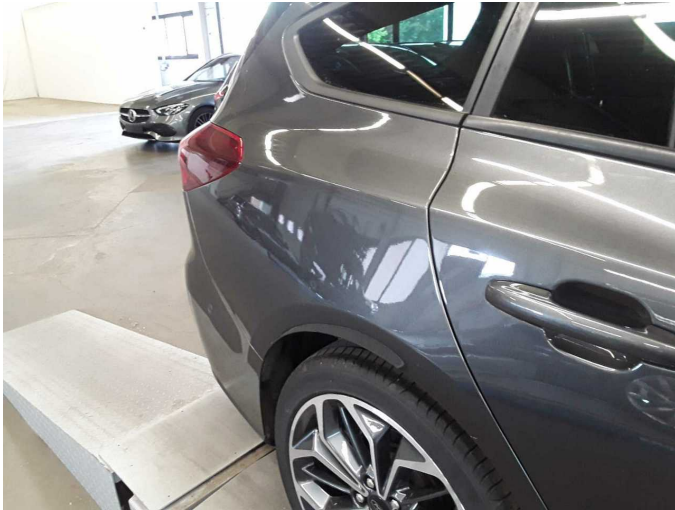
| No. | Repainting |
|---|---|
| 1 | Mudguard - right side, Side panel - rear right side, Door - rear right side, Door - front right side, Professionally carried out, Invoice of repair done<br>Non-existent |

| Mudguard - right side | 182 µm | Side panel - rear right side | 975 µm |
| Door - rear right side | 167 µm | Door - front right side | 206 µm |

**Repainting 1:** Mudguard - right side, Side panel - rear right side, Door - rear right side, Door - front right side
