Expertise

Protocol number: 46375546  
Order No. / Reference: 26597134  
Inspection date: 7 Jul 2026

Manufacturer: Opel

Model: Astra 1.2 Turbo Start/Stop Sports Tourer Business Edition

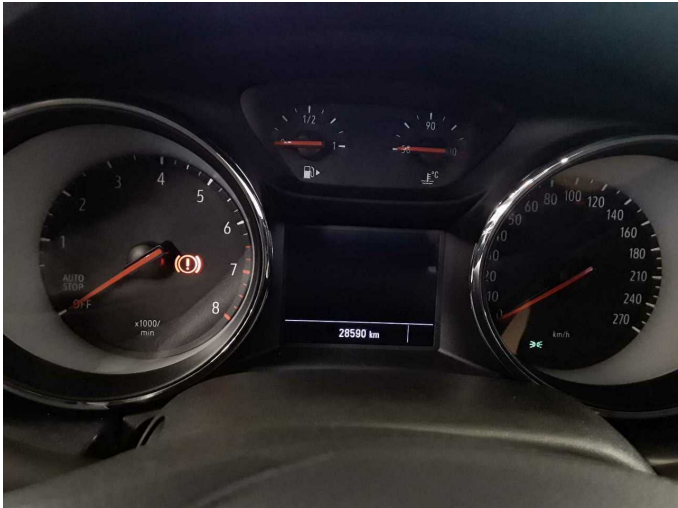
**Vehicle Identification number** W0VBD8ES7N8043173  
**Mileage (Read)** 28,590 km  
**First registration** 9 Jun 2022  
**Number of holders** 1  
**Next periodical technical inspection** 08/2027  
(Report on hand)

Figure 7: Instrument cluster

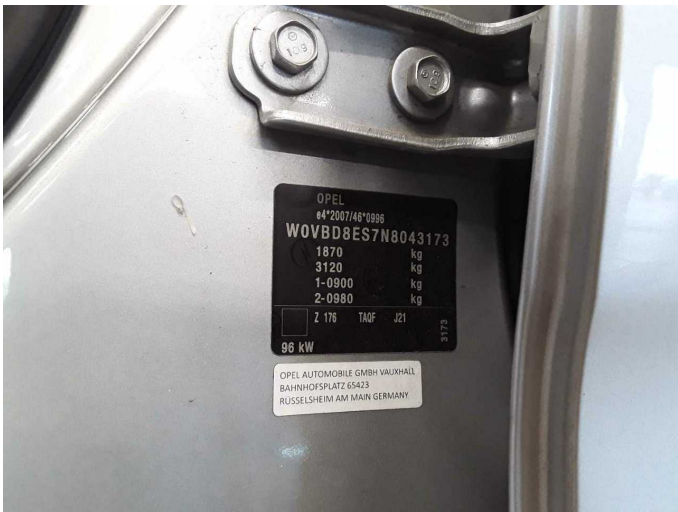
Figure 11: VIN

| VIN comparison | The vehicle identification number (VIN) was read from the vehicle and its conformity with the submitted documents was confirmed by the undersigned during the inspection. |

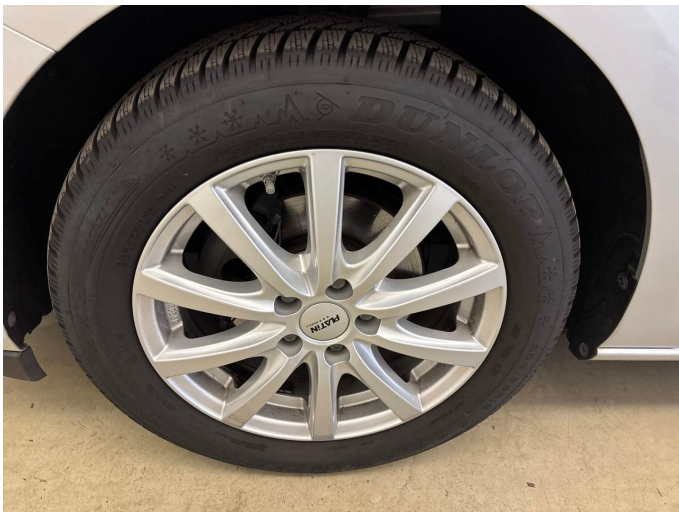
| # | Tyre size | Type of tyre | Manufacturer | Tread depth |
|---|---|---|---|---|
| 1) | 205/55 R16 91H | Winter tyres on Light alloy | Dunlop | 6mm / 6mm |
| 2) | 205/55 R16 91H | Winter tyres on Light alloy | Dunlop | 6mm / 6mm |

Figure 12: Mounted tyres

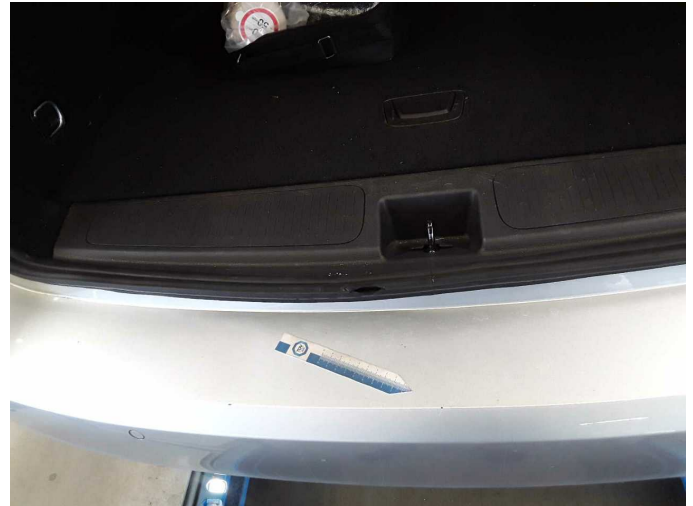
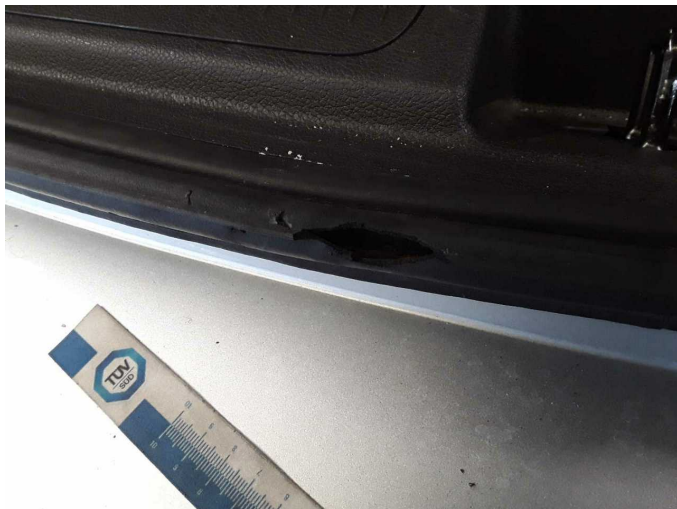
**Damage 1:** Boot lid / rear door: Seal - Damaged - Replace

| No. | Component group | Description |
|---|---|---|
| 1 | Boot lid / rear door | Seal - Damaged - Replace |

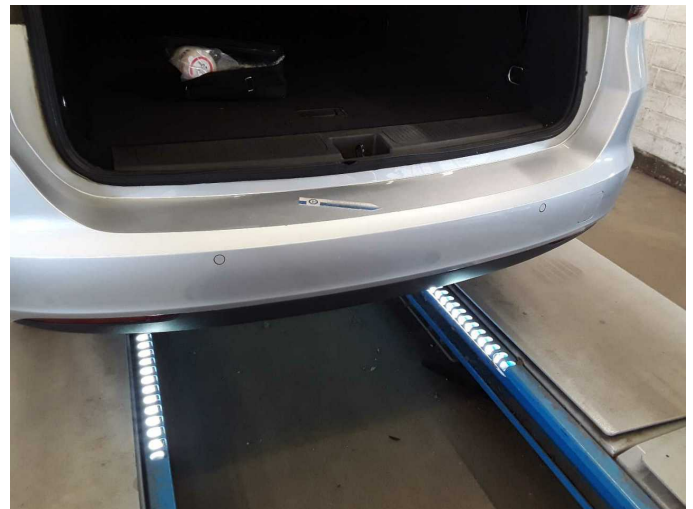
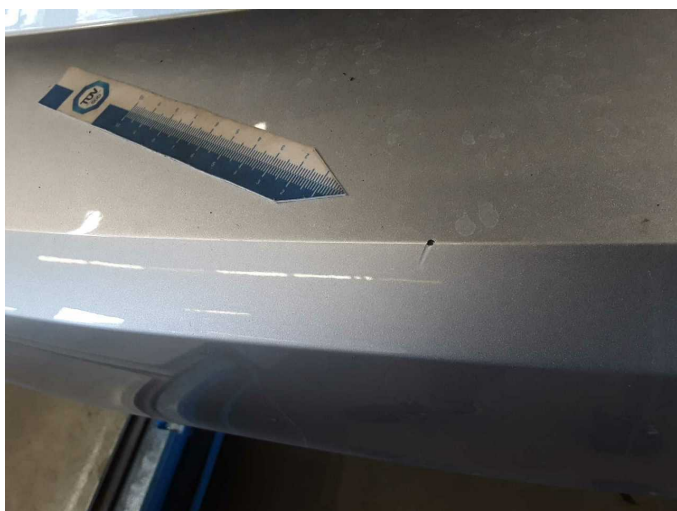
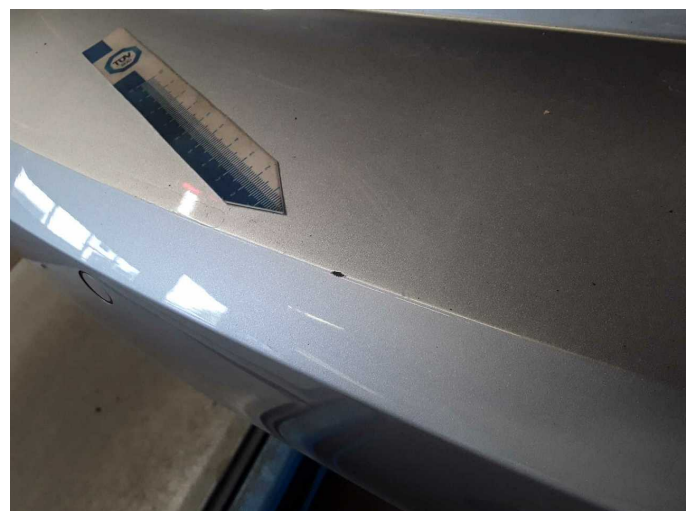
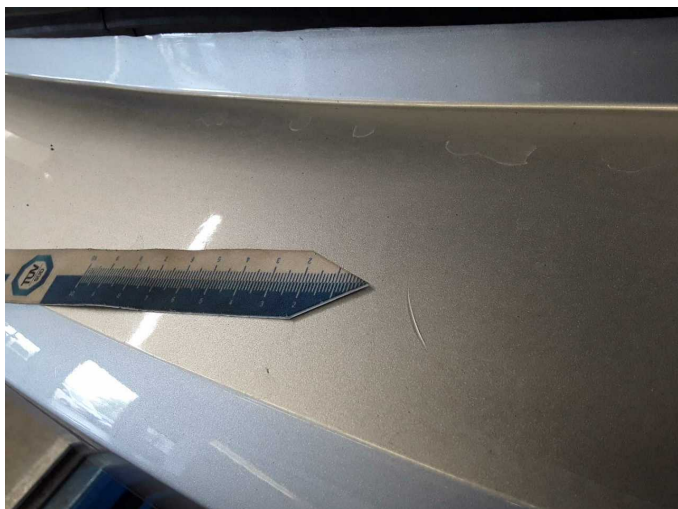
**Damage 2:** Rear bumper: Rear bumper - Scratch(es) - Paint

| No. | Component group | Description |
|---|---|---|
| 2 | Rear bumper | Rear bumper - Scratch(es) - Paint |

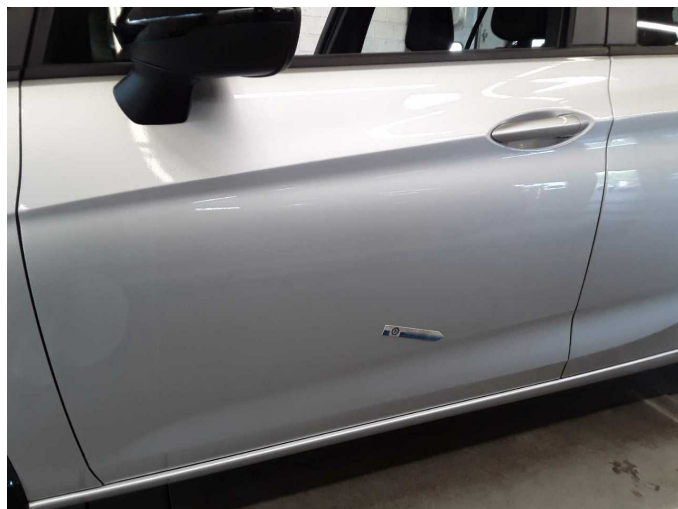
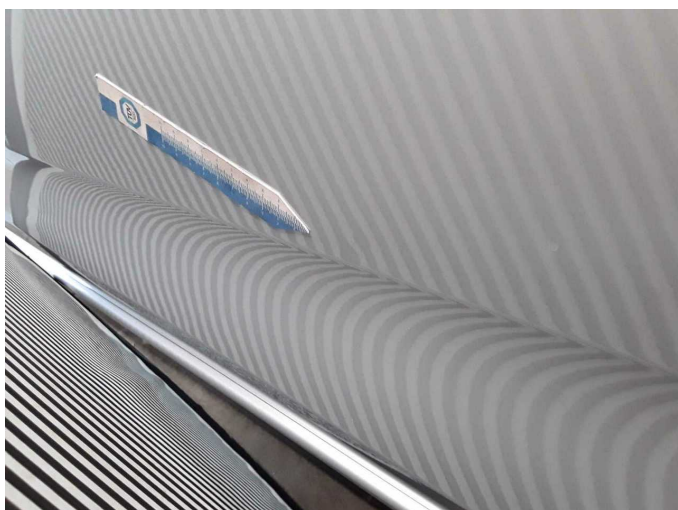
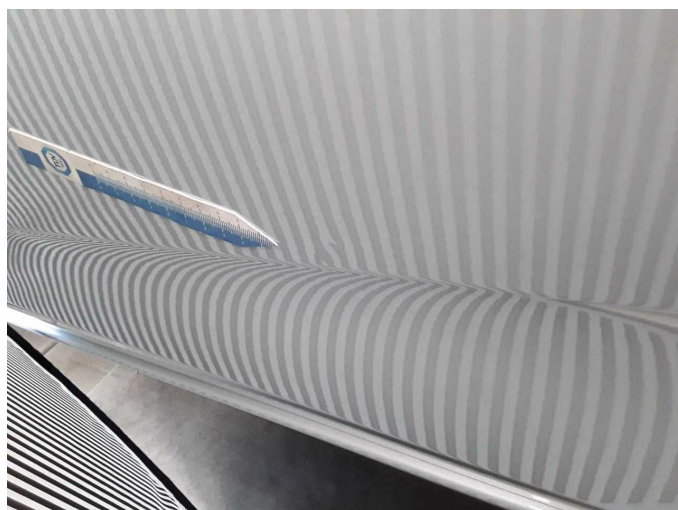
**Damage 3:** Door - front left side: Door - Deformed - Repair and paint

| No. | Component group | Description |
|---|---|---|
| 3 | Door - front left side | Door - Deformed - Repair and paint |

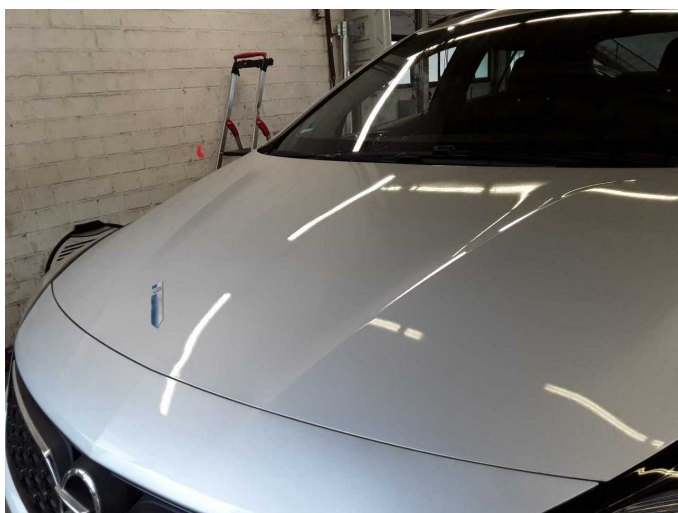
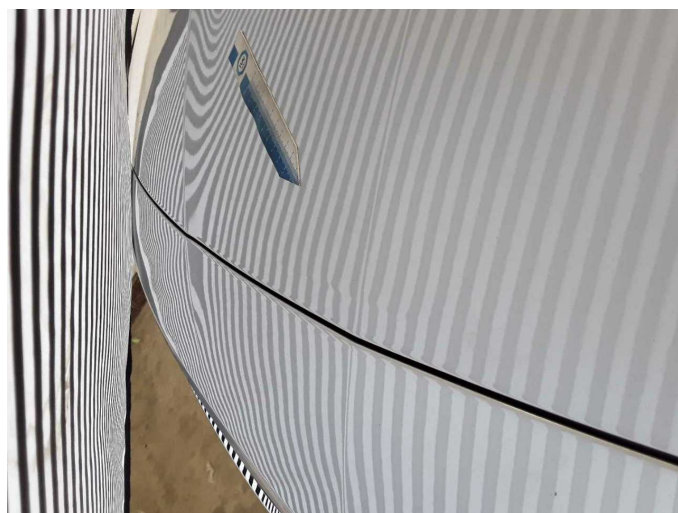
**Damage 4:** Bonnet: Bonnet - Deformed - Repair and paint

| No. | Component group | Description |
|---|---|---|
| 4 | Bonnet | Bonnet - Deformed - Repair and paint |
