Expertise

Protocol number: 46166920  
Order No. / Reference: 26566123  
Inspection date: 25 Jun 2026

Manufacturer: Skoda  
VIN: TMBLJ7NU0P5048254

Model: Karoq 2.0 TDI SCR 4x4 DSG Sportline

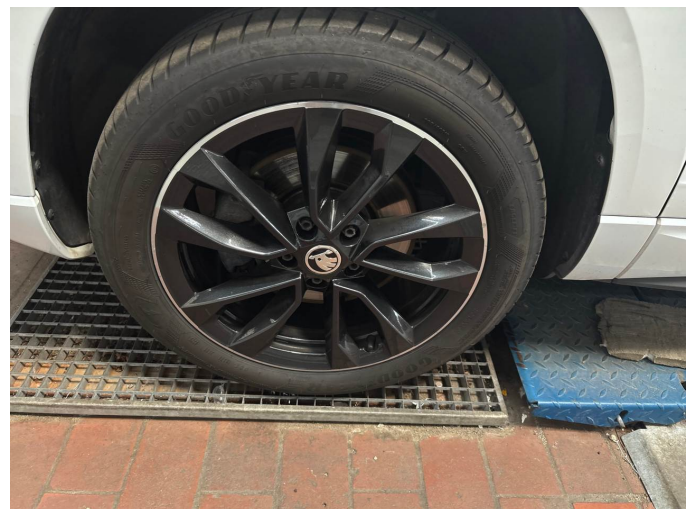
Figure 12: Mounted tyres

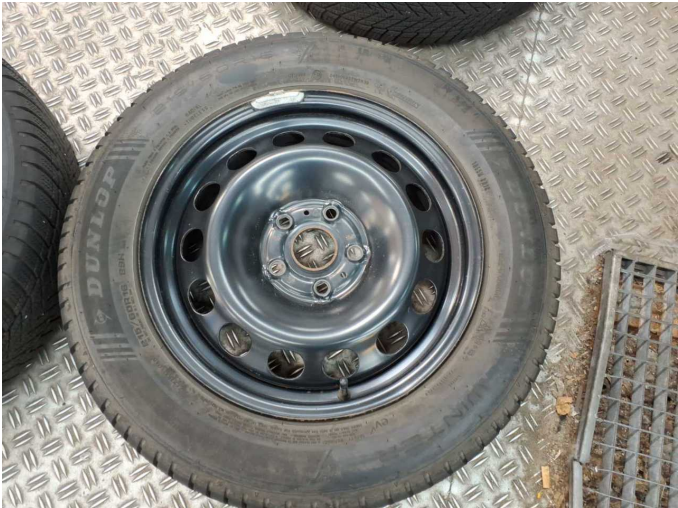
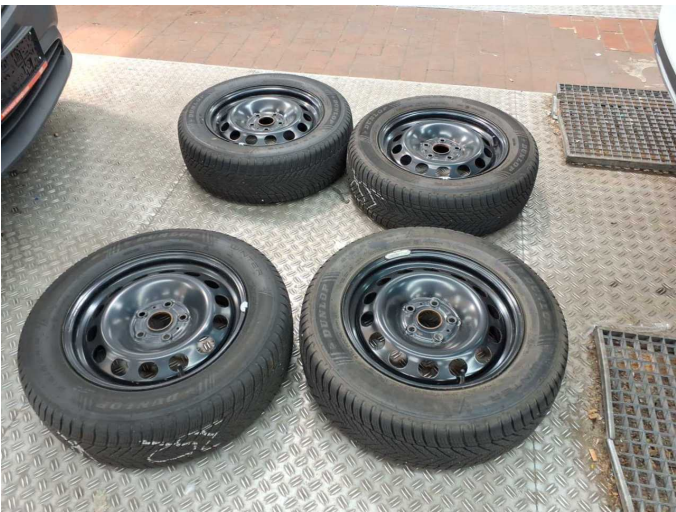
Figure 16: Additional tyres

Figure 17: Additional tyres

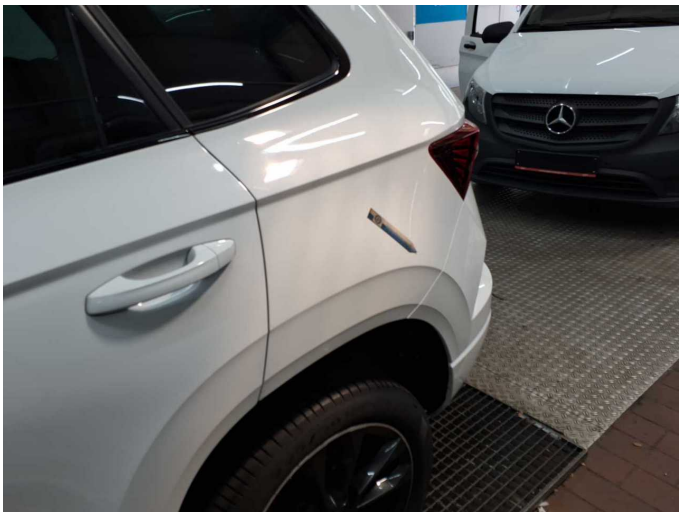
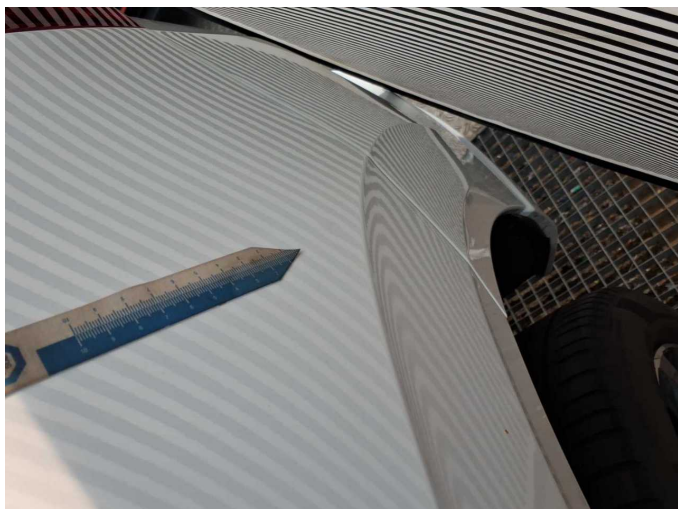
| No. | Component group | Description |
|---|---|---|
| 1 | Side panel - rear left side | Side panel - dent(s) - Smooth repair work |

Damage 1: Side panel - rear left side: Side panel - dent(s) - Smooth repair work

**Damage 1:** Side panel - rear left side: Side panel - dent(s) - Smooth repair work

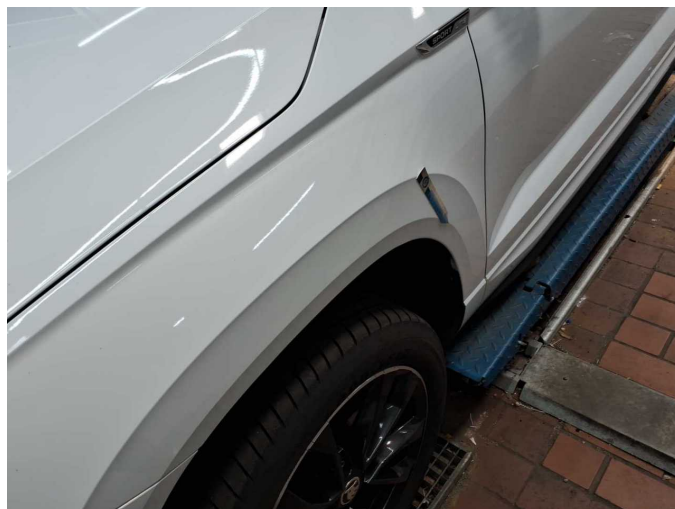
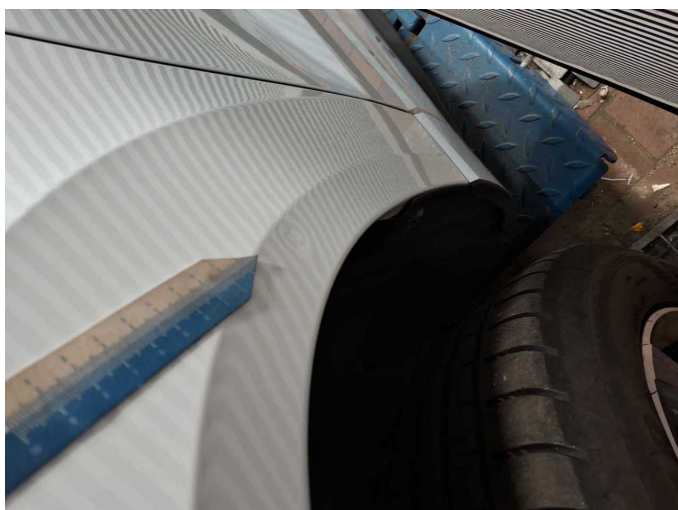
| No. | Component group | Description |
|---|---|---|
| 2 | Mudguard - left side | Mudguard - left side - dent(s) - Smooth repair work |

**Damage 2:** Mudguard - left side: Mudguard - left side - dent(s) - Smooth repair work

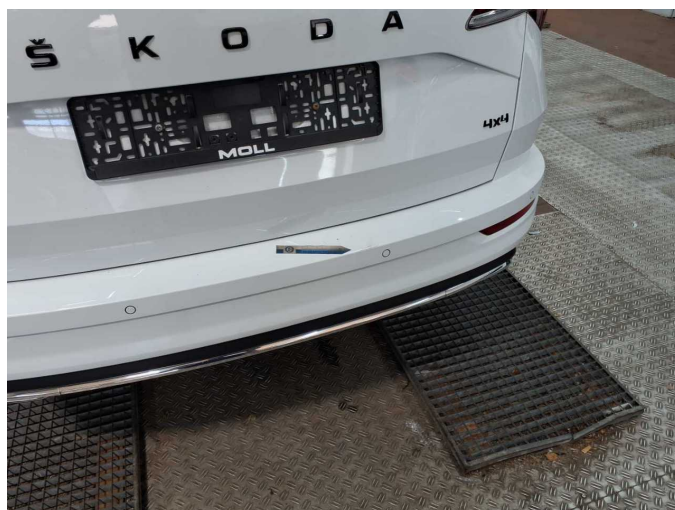
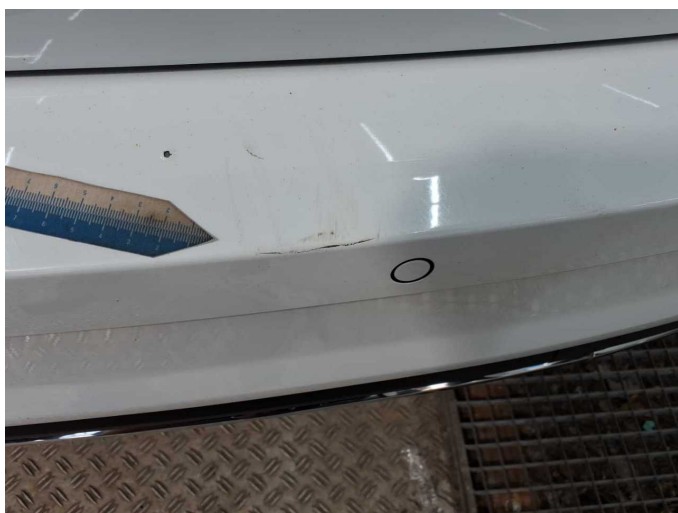
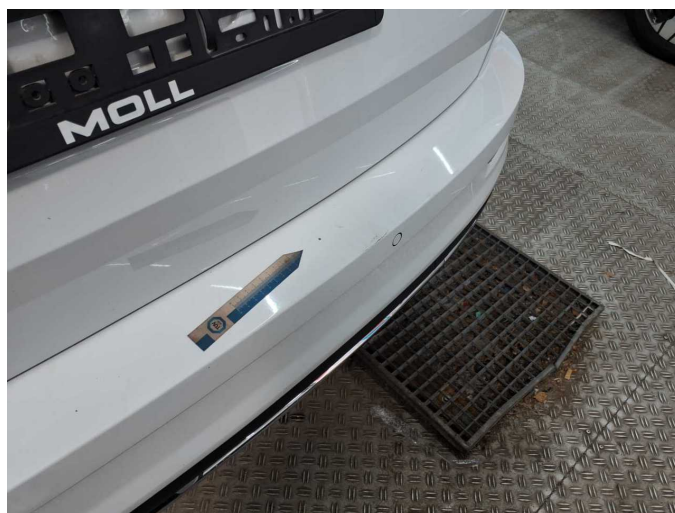
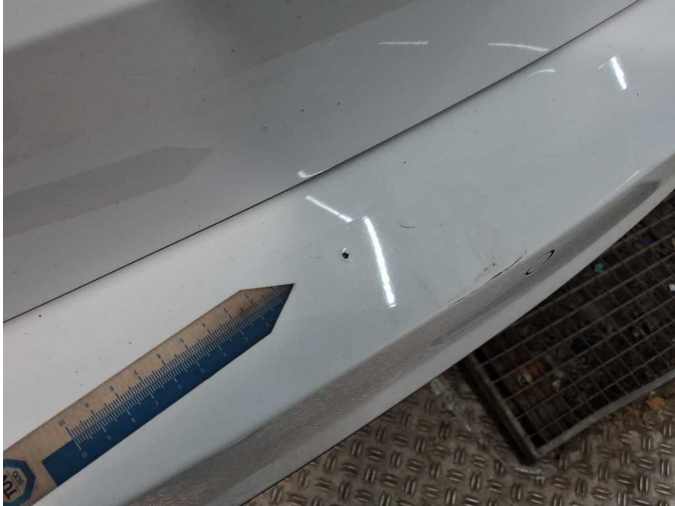
| No. | Component group | Description |
|---|---|---|
| 3 | Rear bumper | Rear bumper - Scratch(es) - Smart repair |

**Damage 3:** Rear bumper: Rear bumper - Scratch(es) - Smart repair

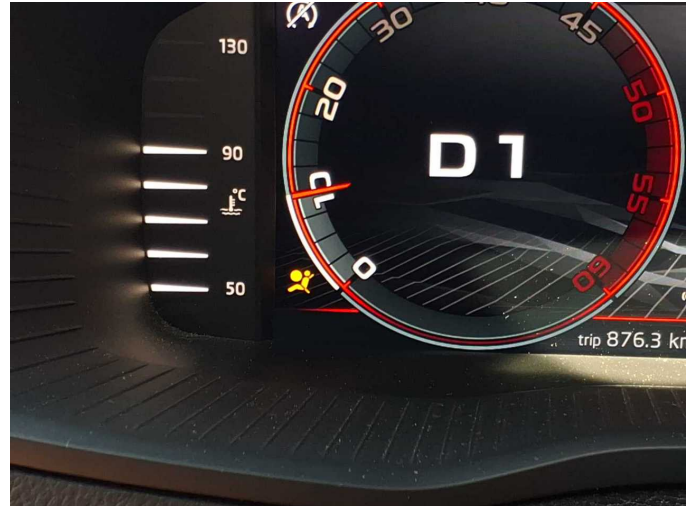
| No. | Component group | Description |
|---|---|---|
| 4 | Instrument panel | Indicator light (Airbag) - on - Perform diagnosis |

**Damage 4:** Instrument panel: Indicator light (Airbag) - on - Perform diagnosis

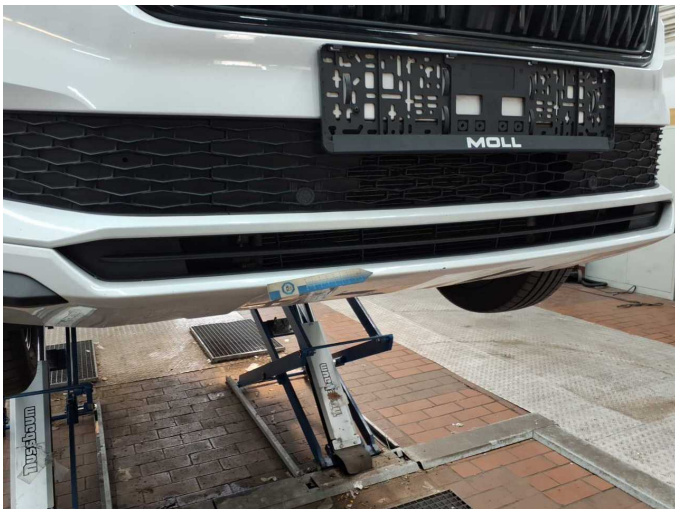
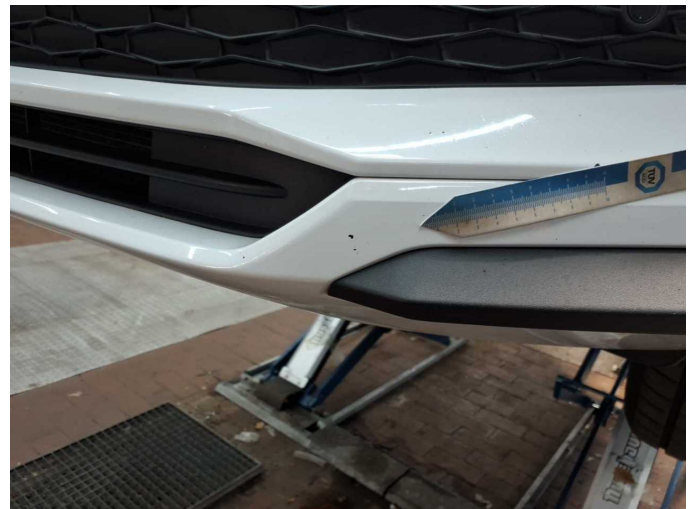
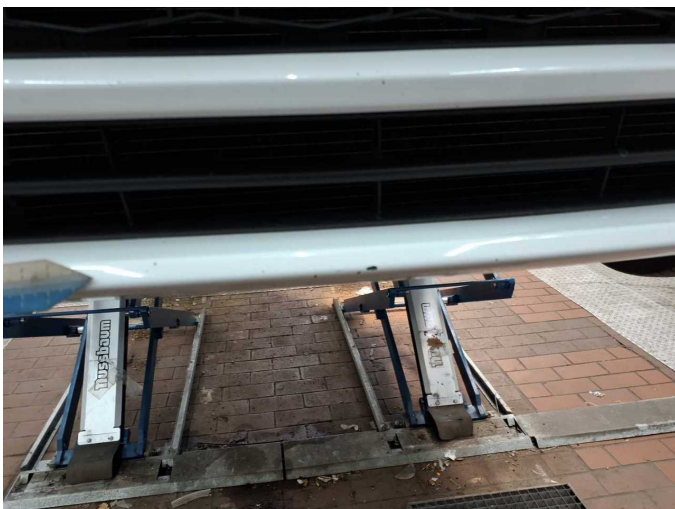
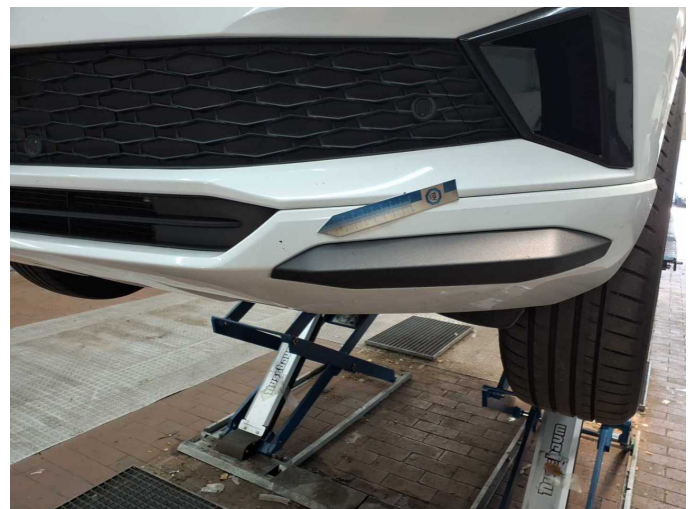
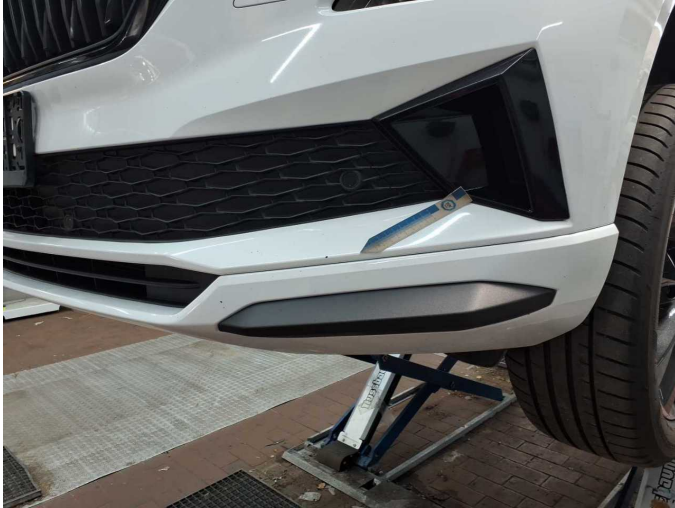
| No. | Component group | Description |
|---|---|---|
| 5 | Front bumper | Front bumper (inkl. Spoiler) - Stone chips - Paint |

**Damage 5:** Front bumper: Front bumper (inkl. Spoiler) - Stone chips - Paint

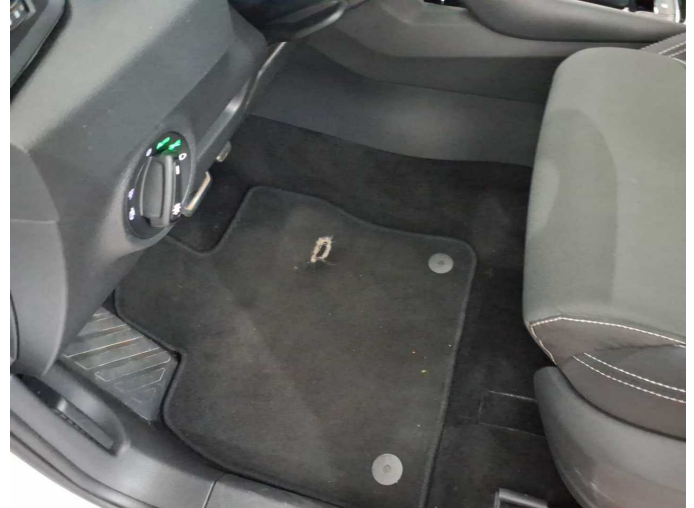
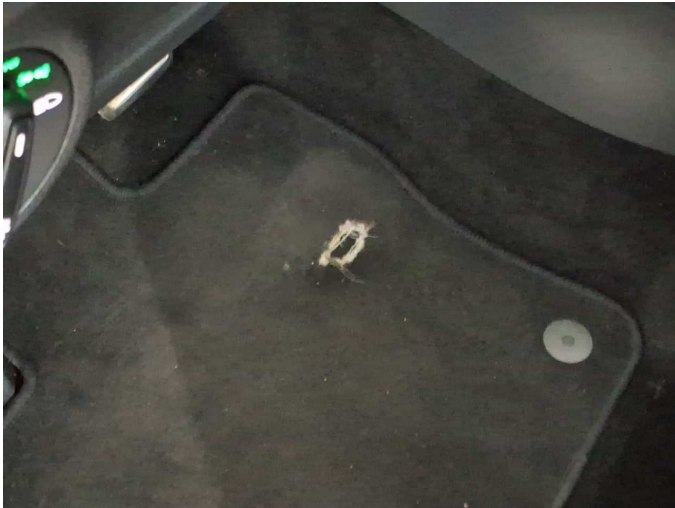
| No. | Component group | Description |
|---|---|---|
| 4 | Trim / covers | Floor mats - Holes - No deduction |

**Wear and tear 4:** Trim / covers: Floor mats - Holes - No deduction
