Expertise

Protocol number: 46405606  
Order No. / Reference: 26639537  
Inspection date: 8 Jul 2026

Manufacturer: Volvo

Model: XC90 T8 AWD Recharge Geartronic Inscription Expression

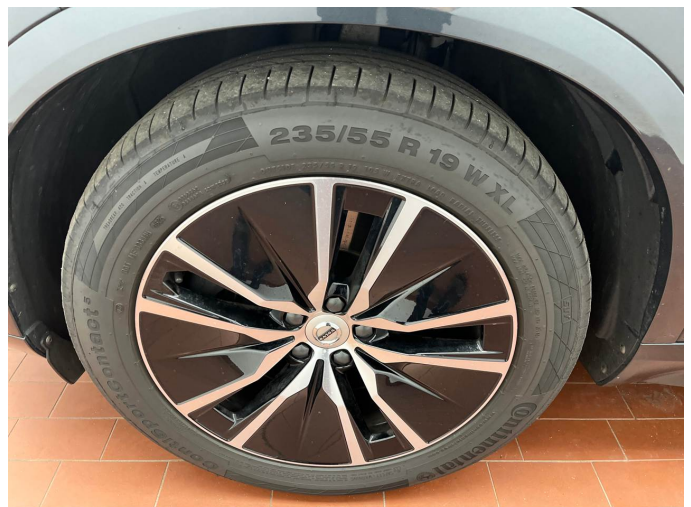
Figure 12: Mounted tyres

| # | Tyre size | Type of tyre | Manufacturer | Tread depth |
|---|---|---|---|---|
| 1) | 235/55 R19 105W | Summer tyres on Light alloy | Continental | 6mm / 6mm |
| 2) | 235/55 R19 105W | Summer tyres on Light alloy | Toyo | 6mm / 6mm |

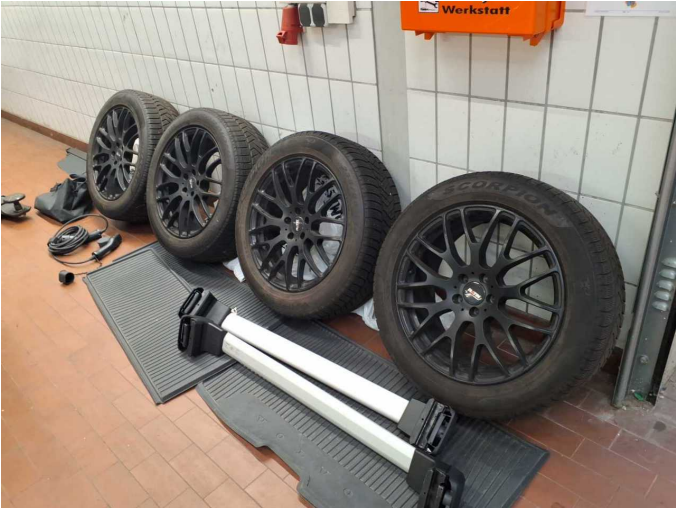
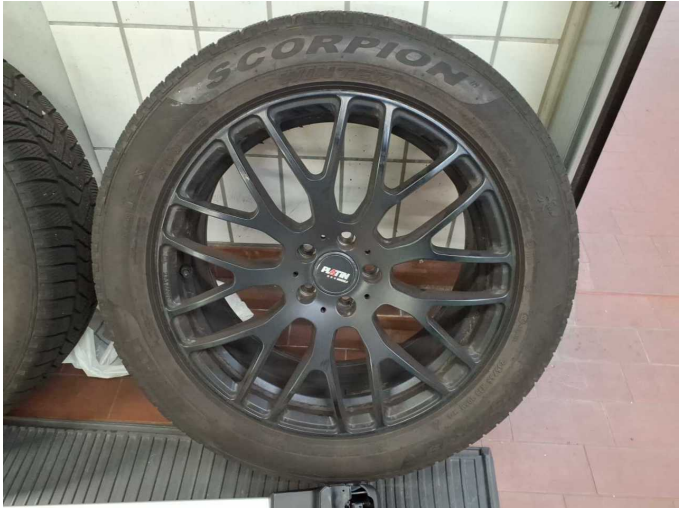
| # | Tyre size | Type of tyre | Manufacturer | Tread depth |
|---|---|---|---|---|
| 1) | 235/55 R19 105H | Winter tyres on Light alloy | Pirelli | 4mm / 4mm |
| 2) | 235/55 R19 105H | Winter tyres on Light alloy | Pirelli | 6mm / 6mm |

Figure 15: Additional tyres

Figure 16: Additional tyres

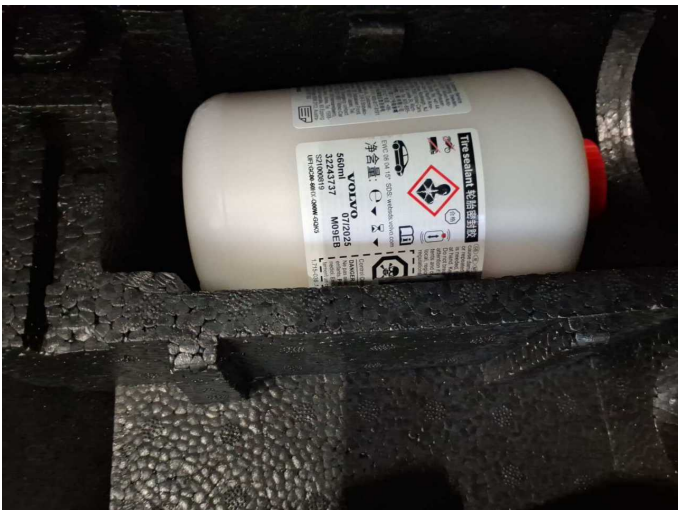
| No. | Component group | Description |
|---|---|---|
| 1 | Equipment | Tirefit filler - Due - Replace |

Damage 1: Equipment: Tirefit filler - Due - Replace

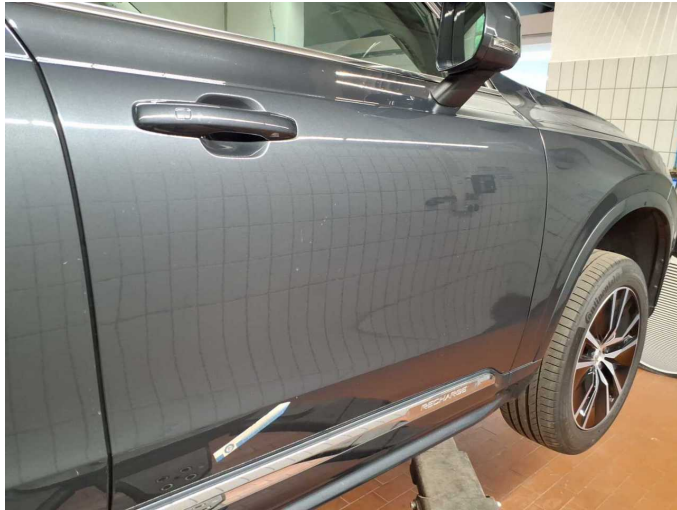
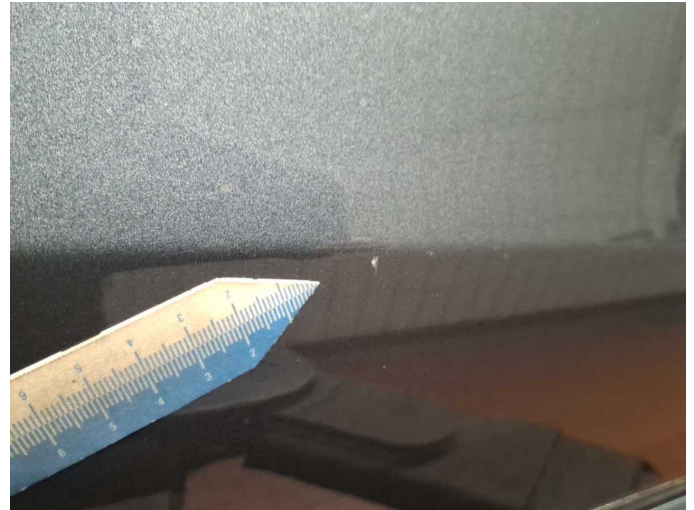
| No. | Component group | Description |
|---|---|---|
| 2 | Door - front right side | Door - Stone chips - Smart repair |

**Damage 2:** Door - front right side: Door - Stone chips - Smart repair

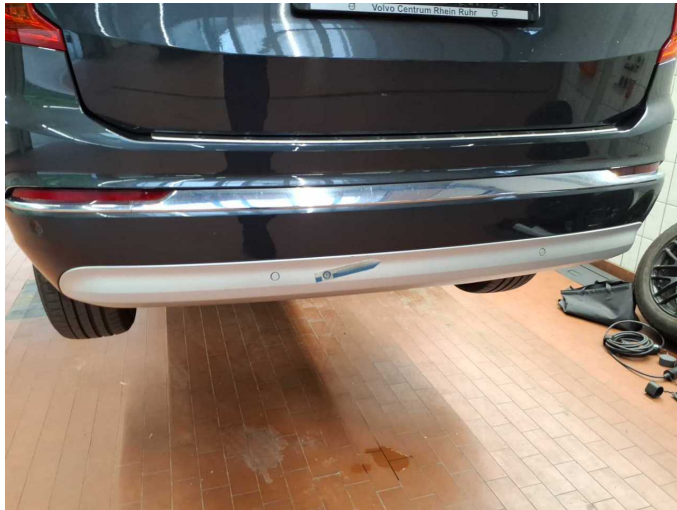
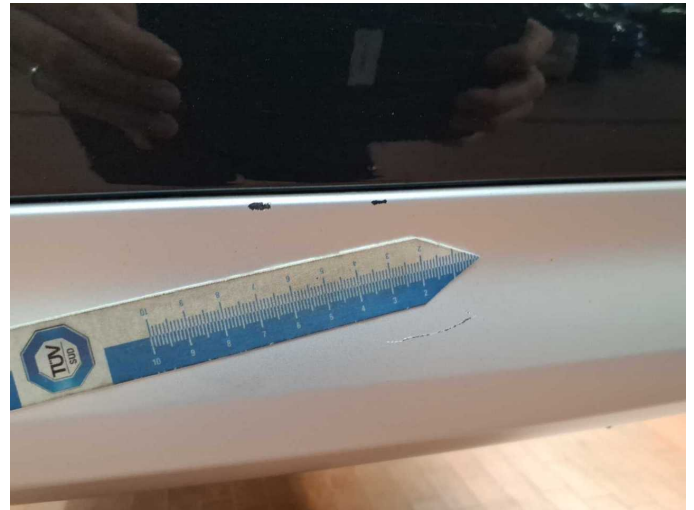
| No. | Component group | Description |
|---|---|---|
| 3 | Rear bumper | Spoiler - Scratched - Replace |

**Damage 3:** Rear bumper: Spoiler - Scratched - Replace

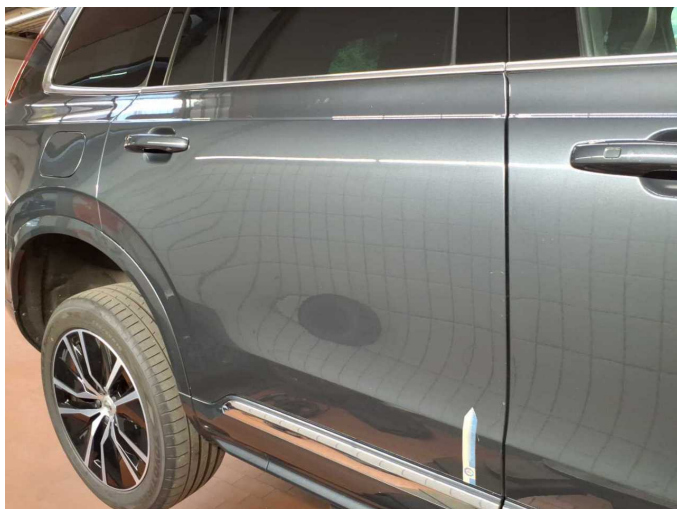
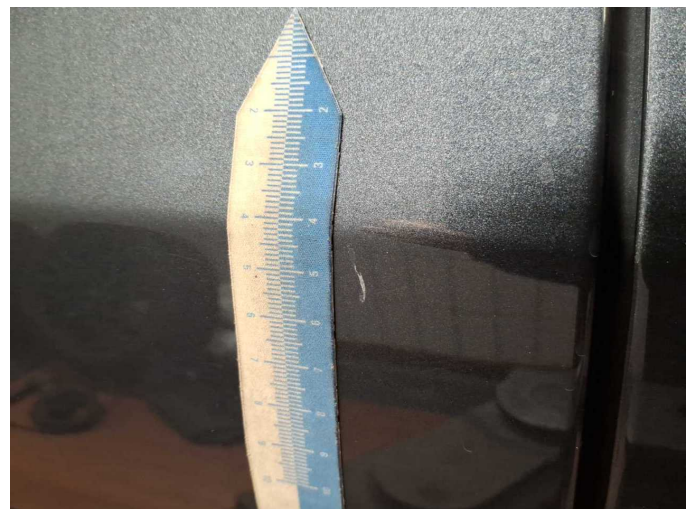
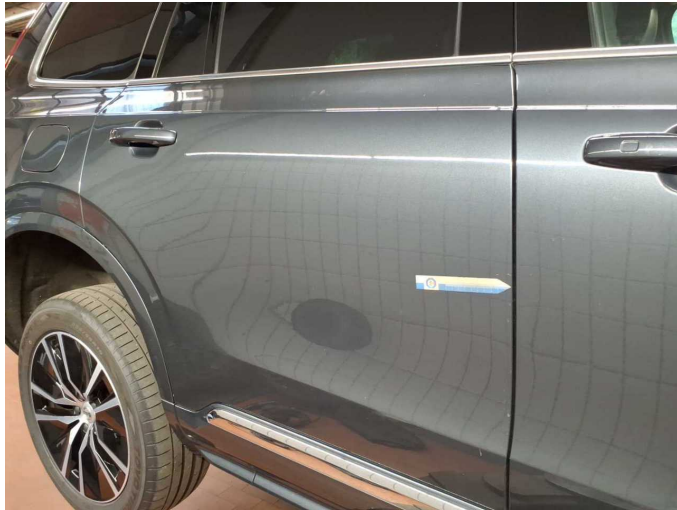
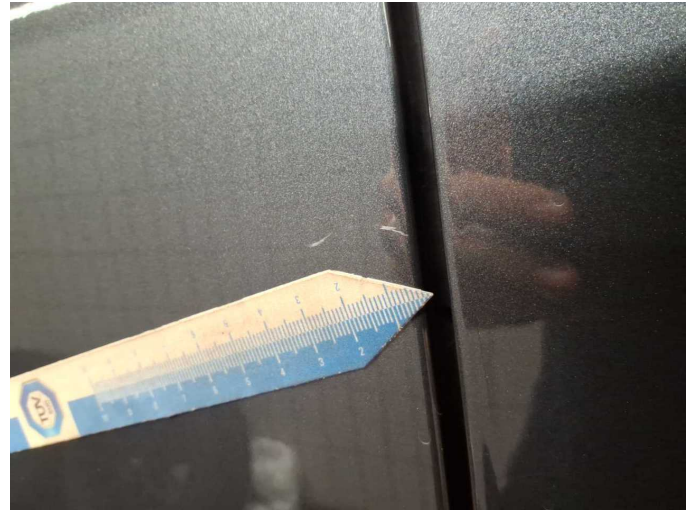
| No. | Component group | Description |
|---|---|---|
| 4 | Door - rear right side | Door - Scratch(es) - Paint |

**Damage 4:** Door - rear right side: Door - Scratch(es) - Paint

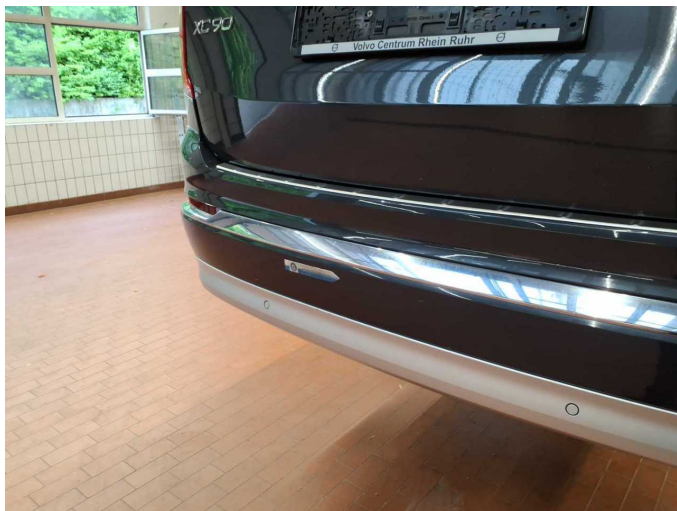
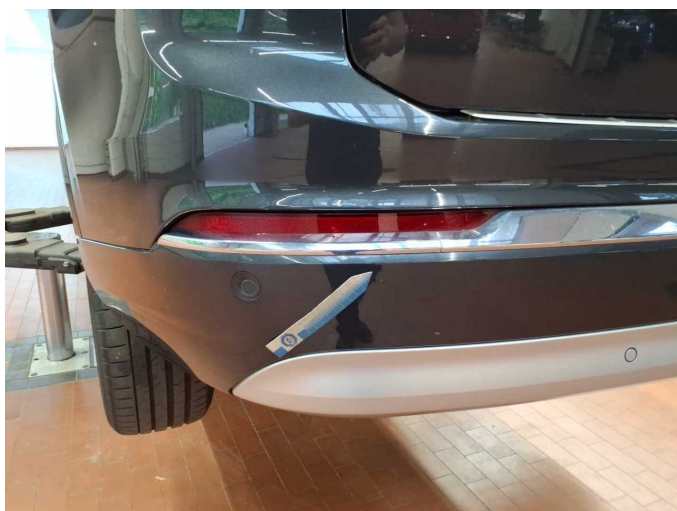
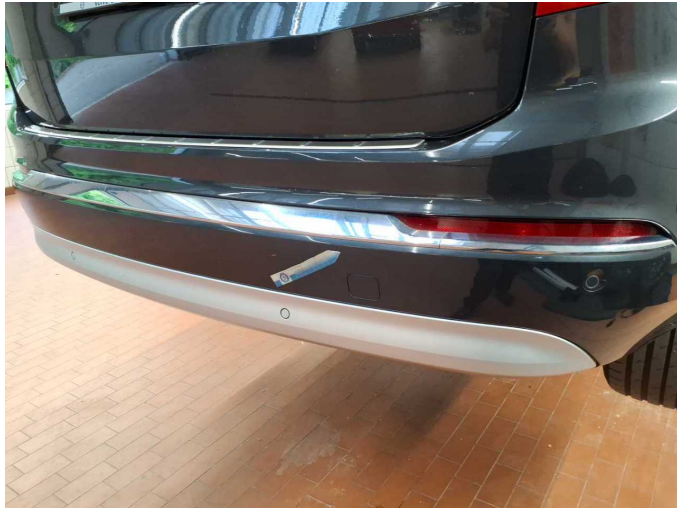
| No. | Component group | Description |
|---|---|---|
| 5 | Rear bumper | Rear bumper (Stossfänger Unten) - Scratch(es) - Paint |

**Damage 5:** Rear bumper: Rear bumper (Stoßfänger Unten) - Scratch(es) - Paint

**Damage 5:** Rear bumper: Rear bumper (Stossfänger Unten) - Scratch(es) - Paint

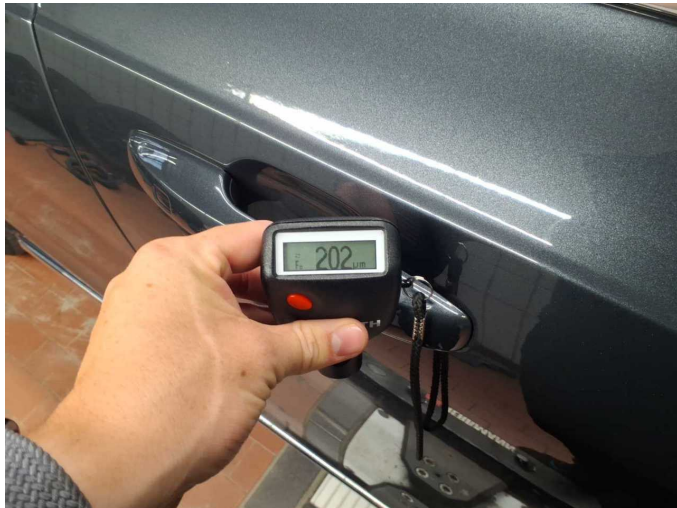
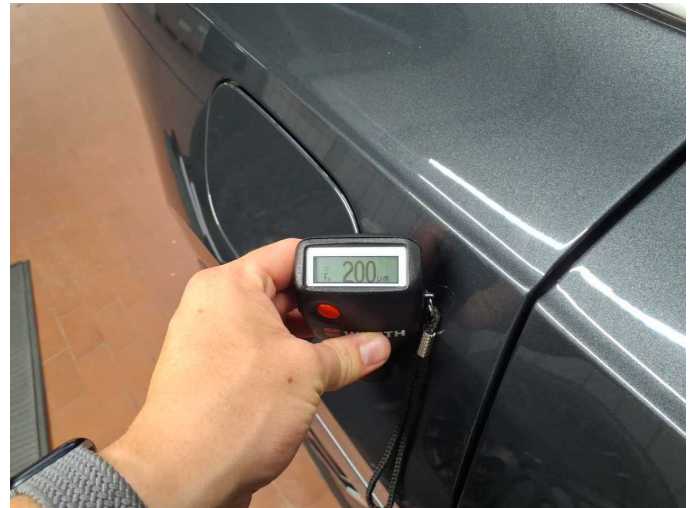
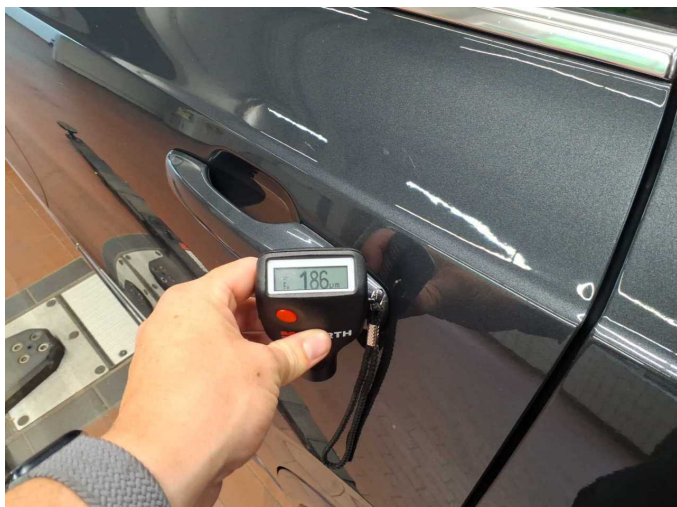
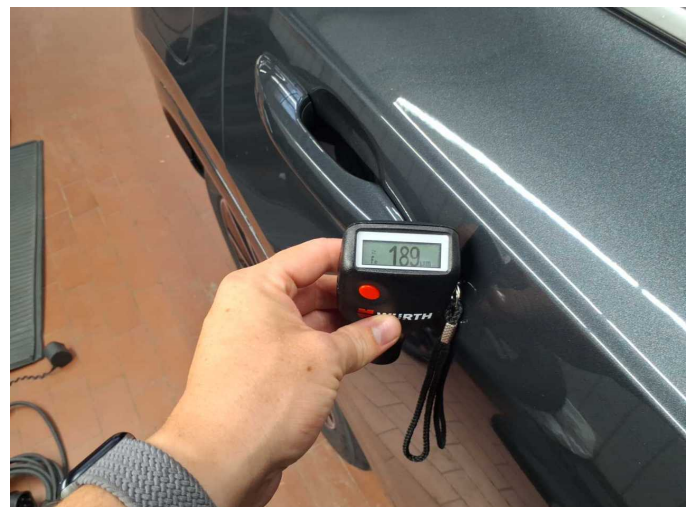
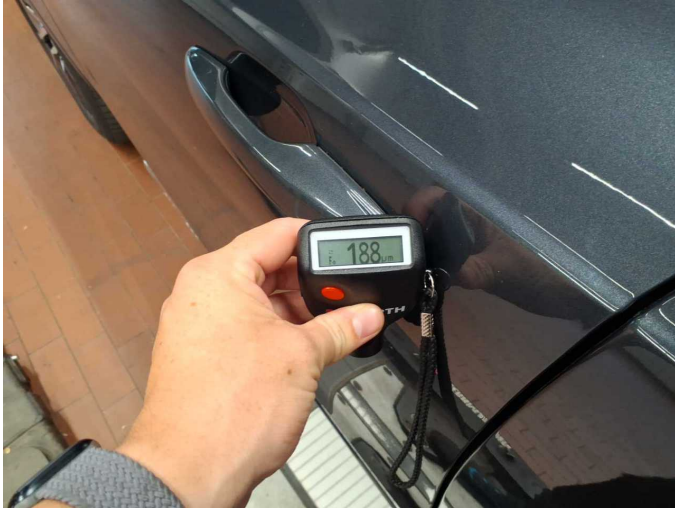
| 1 | Side panel - rear right side, Door - rear left side, Door - rear right side, Door - front left side, Door - front right side, Professionally carried out, Invoice of repair done Non-existent |

| Side panel - rear right side | 200 µm | Door - rear left side | 186 µm |
| Door - rear right side | 189 µm | Door - front left side | 188 µm |
| Door - front right side | 202 µm | | |

**Repainting 1:** Side panel - rear right side, Door - rear left side, Door - rear right side, Door - front left side, Door - front right side
